# Television Baseline Survey Report

iQ Student Accommodation

Echo Street, Manchester

April 2023

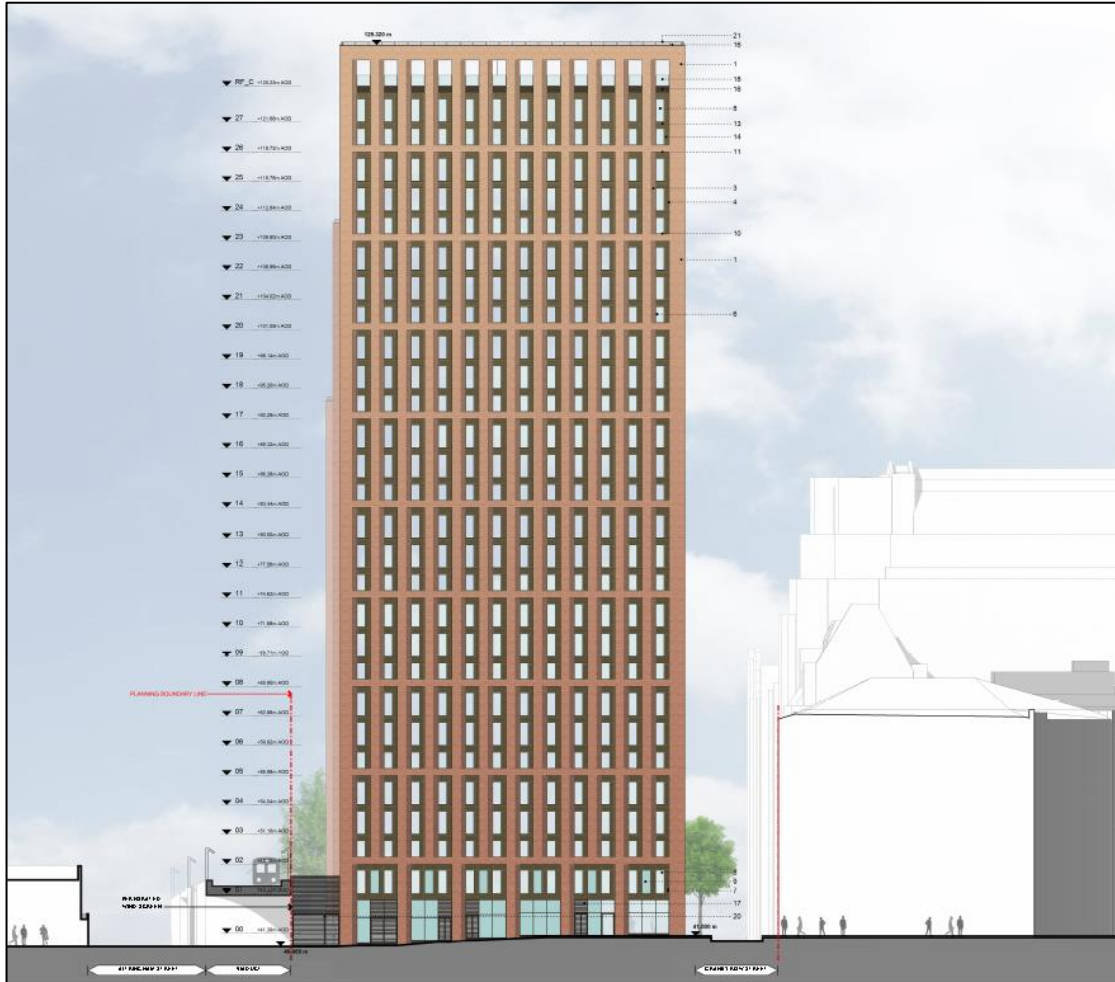
Figure 2 Building elevations

Figure 2 below shows the building elevations.

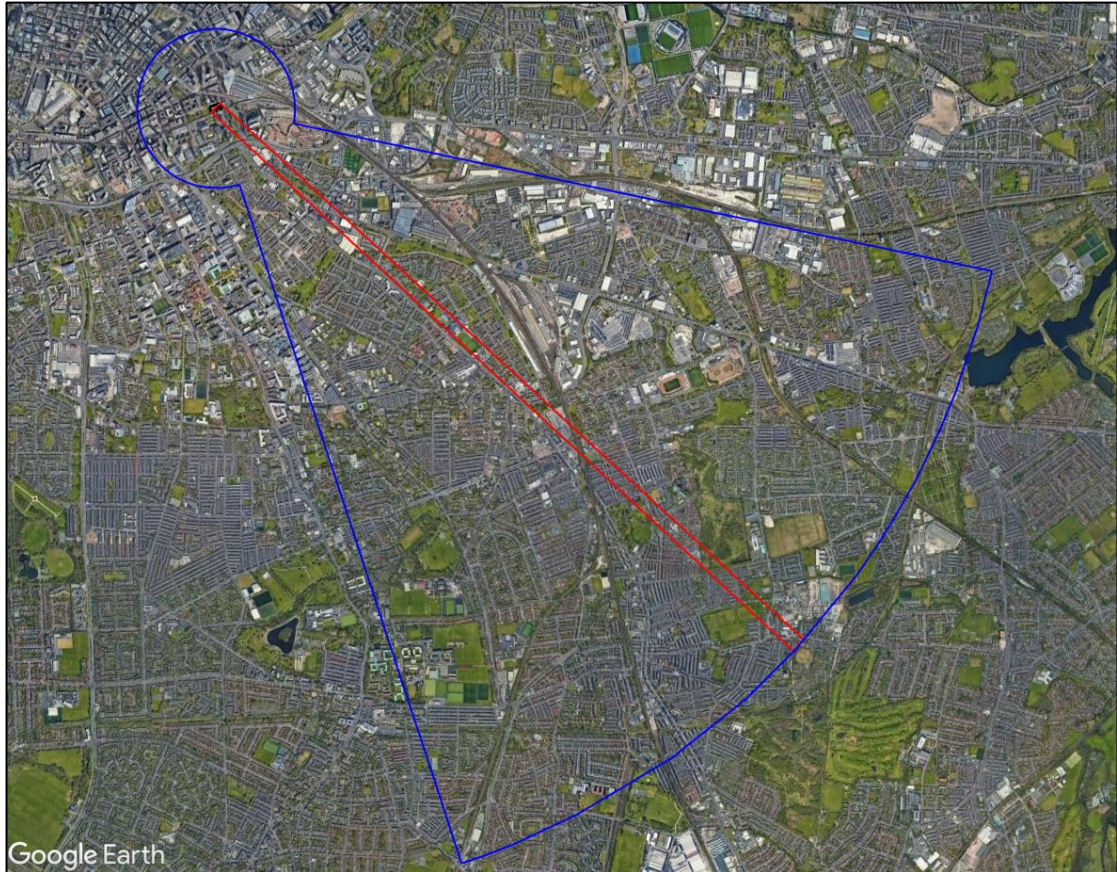
Figure 6 Interference zones map

Figure 6 below shows the interference zones overlaid onto an aerial image of the area.

Urban areas closest to the proposed development are at the highest risk of experiencing television interference. However, based on a review of the aerial imagery, the shadow zone passes over the city centre which contains shops and non-residential buildings.

The closest urban areas with low-rise residential properties within the shadow zone are located approximately 1.5km from the proposed development.

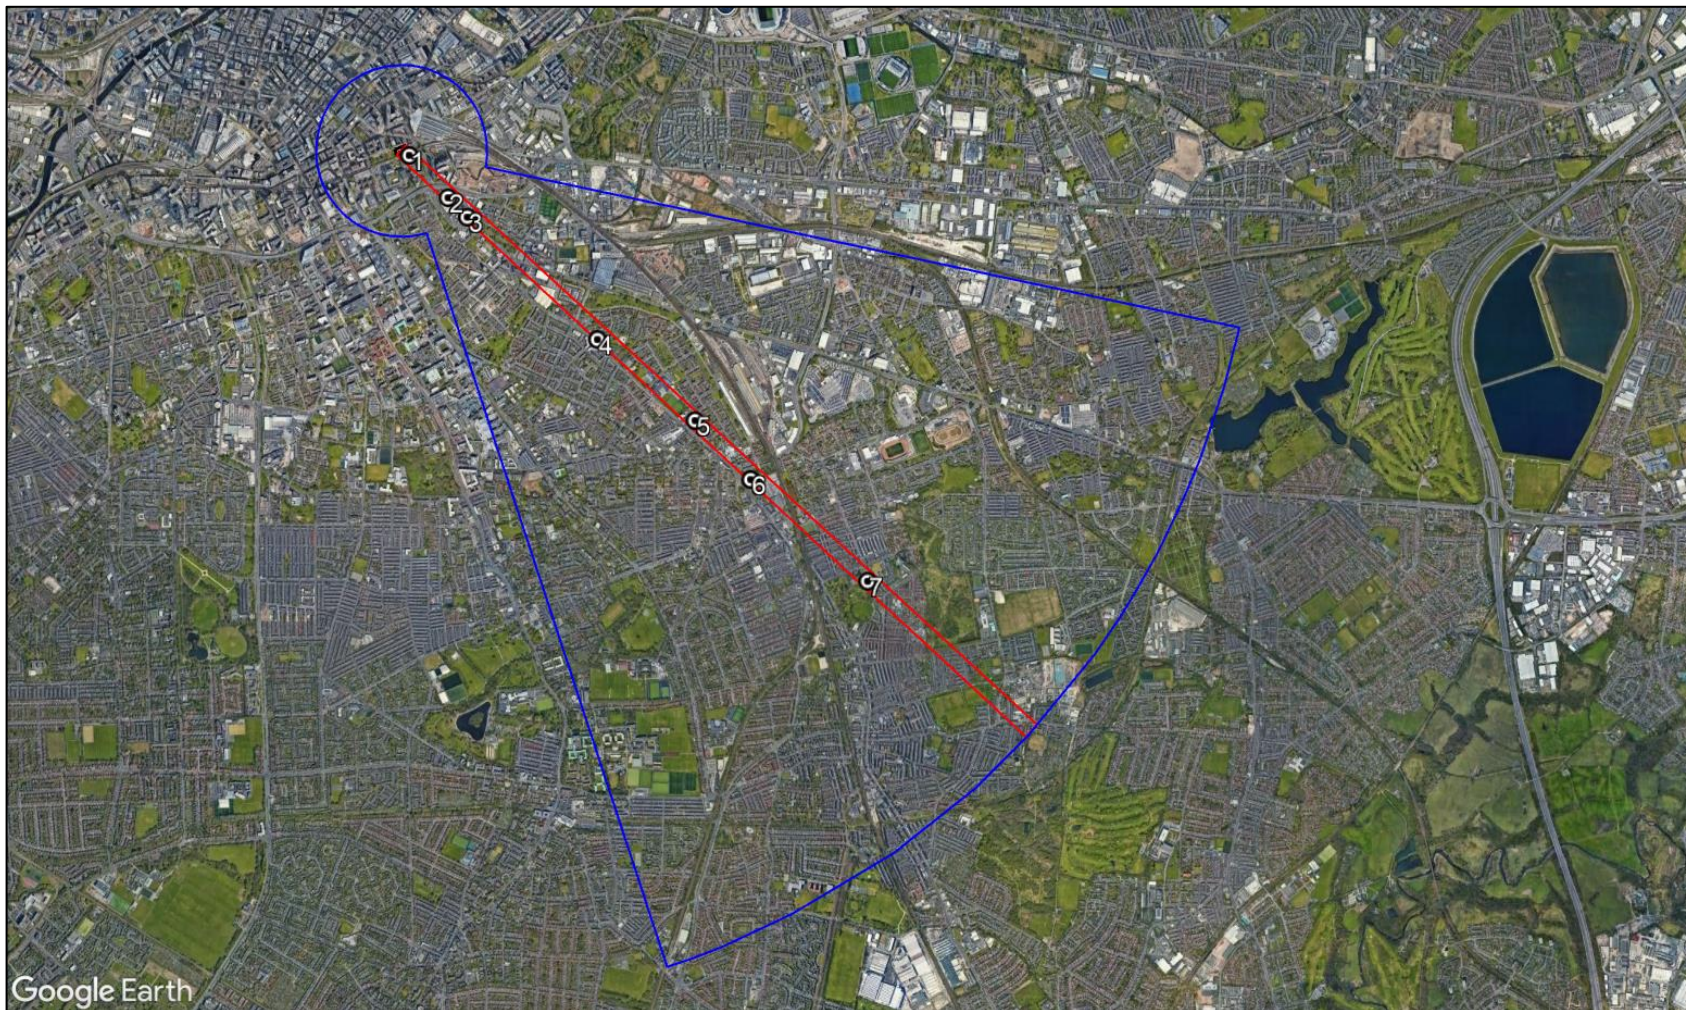
Figure 7 Survey locations

Figure 7 on the following page shows the survey locations overlaid onto aerial photography. The interference zones are also shown.

Locations were selected considering potential residential areas within the building's shadow zone. The locations are deliberately spaced close together nearest the proposed development, as this is the area where effects would generally be the most likely and multiple measurements within a relatively short distance could be the most relevant.

Survey locations were chosen pre-survey (within the shadow zone); however, safe and available access influenced the specific position on the day.

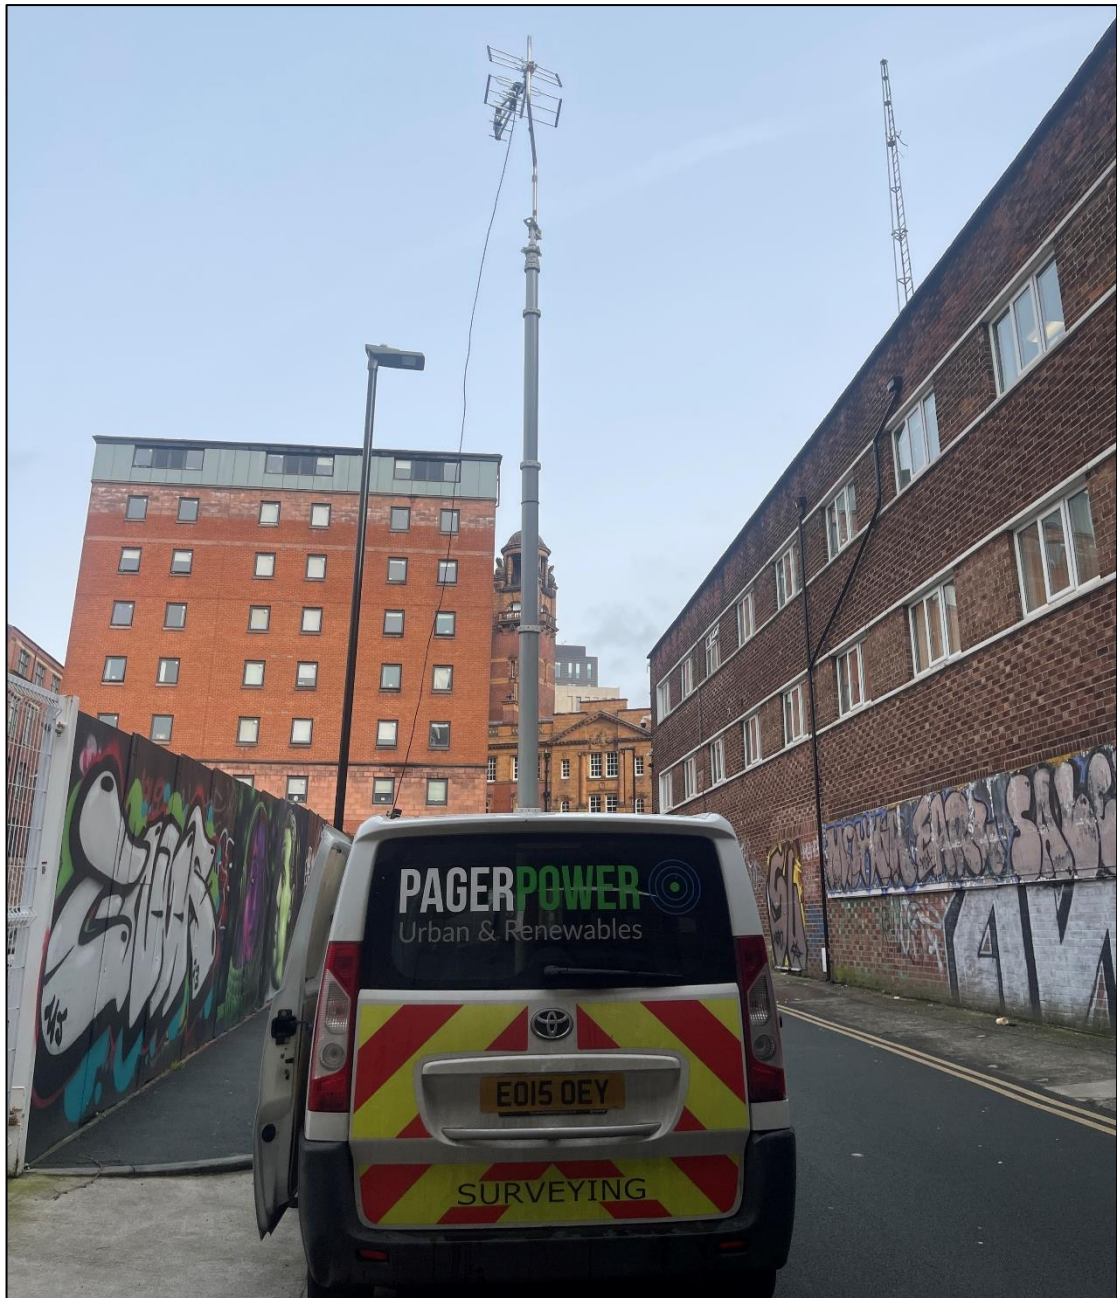
### Location 1

| Location | Average Measured Signal Strength (dB) | Remarks | High-Level Conclusion |
|---|---|---|---|
| 1 | <p>Main TV<br/>MUX: 31.8<br/>(Low)</p> <p>Local TV<br/>MUX: 20.9<br/>(Low)</p> | <p>No aerials observed at this location. It is likely none of the surrounding buildings are residential properties or the aerials are higher than 10m agl<sup>6</sup>.</p> <p>Five out of six multiplexes displayed fine picture and audio quality with no signs of interference.</p> <p>All three local multiplexes did not decode.</p> | <p>The survey location is within 5m of the proposed development and within its shadow zone.</p> <p>Considering the distance from the proposed development, a reduction in signal strength is possible.</p> <p>Noticeable effects are not predicted in practice due to the lack of residential properties or height of any aerials in the area.</p> |

Notes: No HP UHF aerials directed towards the Winter Hill transmitter and satellites were observed.

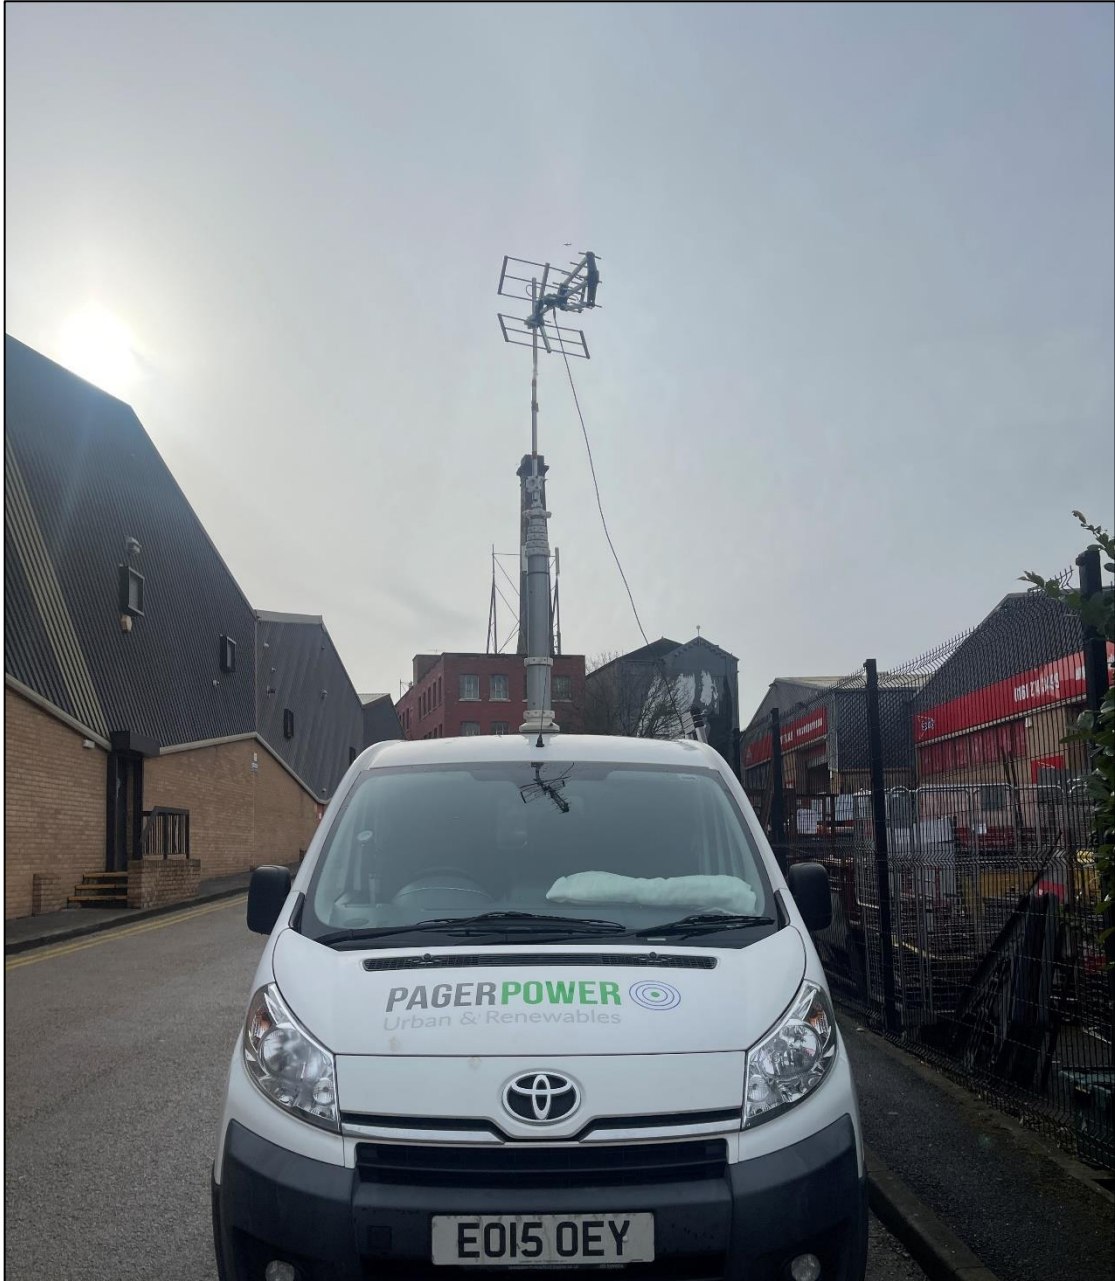
Location 2

| Location | Average Measured Signal Strength (dB) | Remarks | High-Level Conclusion |
|---|---|---|---|
| 2 | <p>Main TV<br/>MUX: 34.3<br/>(Low)</p> <p>Local TV<br/>MUX: 20.7<br/>(Low)</p> | <p>No aerials observed at this location. It is likely none of the surrounding buildings are residential properties or the aerials are higher than 10m agl.</p> <p>All main multiplexes displayed fine picture and audio quality with no signs of interference.</p> <p>All three local multiplexes did not decode.</p> | <p>The survey location is within 400m of the proposed development and within its shadow zone.</p> <p>Considering the distance from the proposed development, a reduction in signal strength is possible.</p> <p>Noticeable effects are not predicted in practice due to the lack of residential properties or height of any aerials in the area.</p> |

Notes: No HP UHF aerials directed towards the Winter Hill transmitter and satellites were observed.

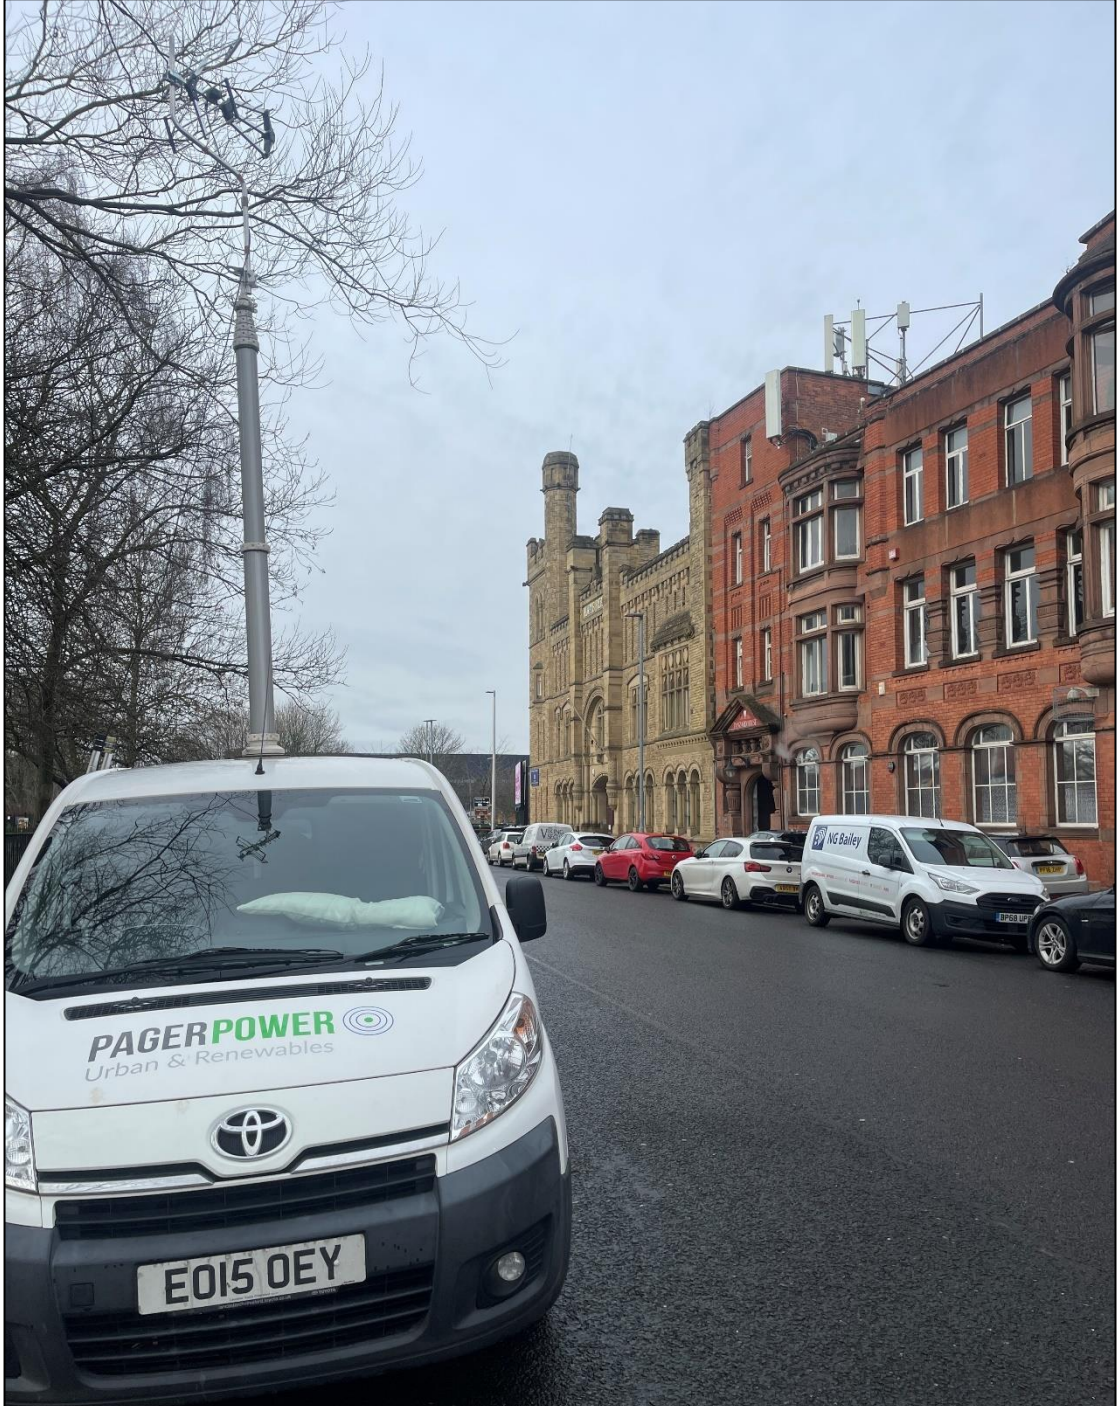
Location 3

| Location | Average Measured Signal Strength (dB) | Remarks | High-Level Conclusion |
|---|---|---|---|
| 3 | <p>Main TV MUX: 31.8 (Low)</p> <p>Local TV MUX: 19.7 (Low)</p> | <p>No aerials observed at this location. It is likely none of the surrounding buildings are residential properties or the aerials are higher than 10m agl.</p> <p>Five out of six multiplexes displayed fine picture and audio quality with no signs of interference.</p> <p>All three local multiplexes did not decode.</p> | <p>The survey location is approximately 570m from the proposed development and within its shadow zone.</p> <p>Considering the distance from the proposed development, a reduction in signal strength is possible.</p> <p>Noticeable effects are not predicted in practice due to the lack of residential properties or height of any aerials in the area.</p> |

Notes: No HP UHF aerials directed towards the Winter Hill transmitter and satellites were observed.

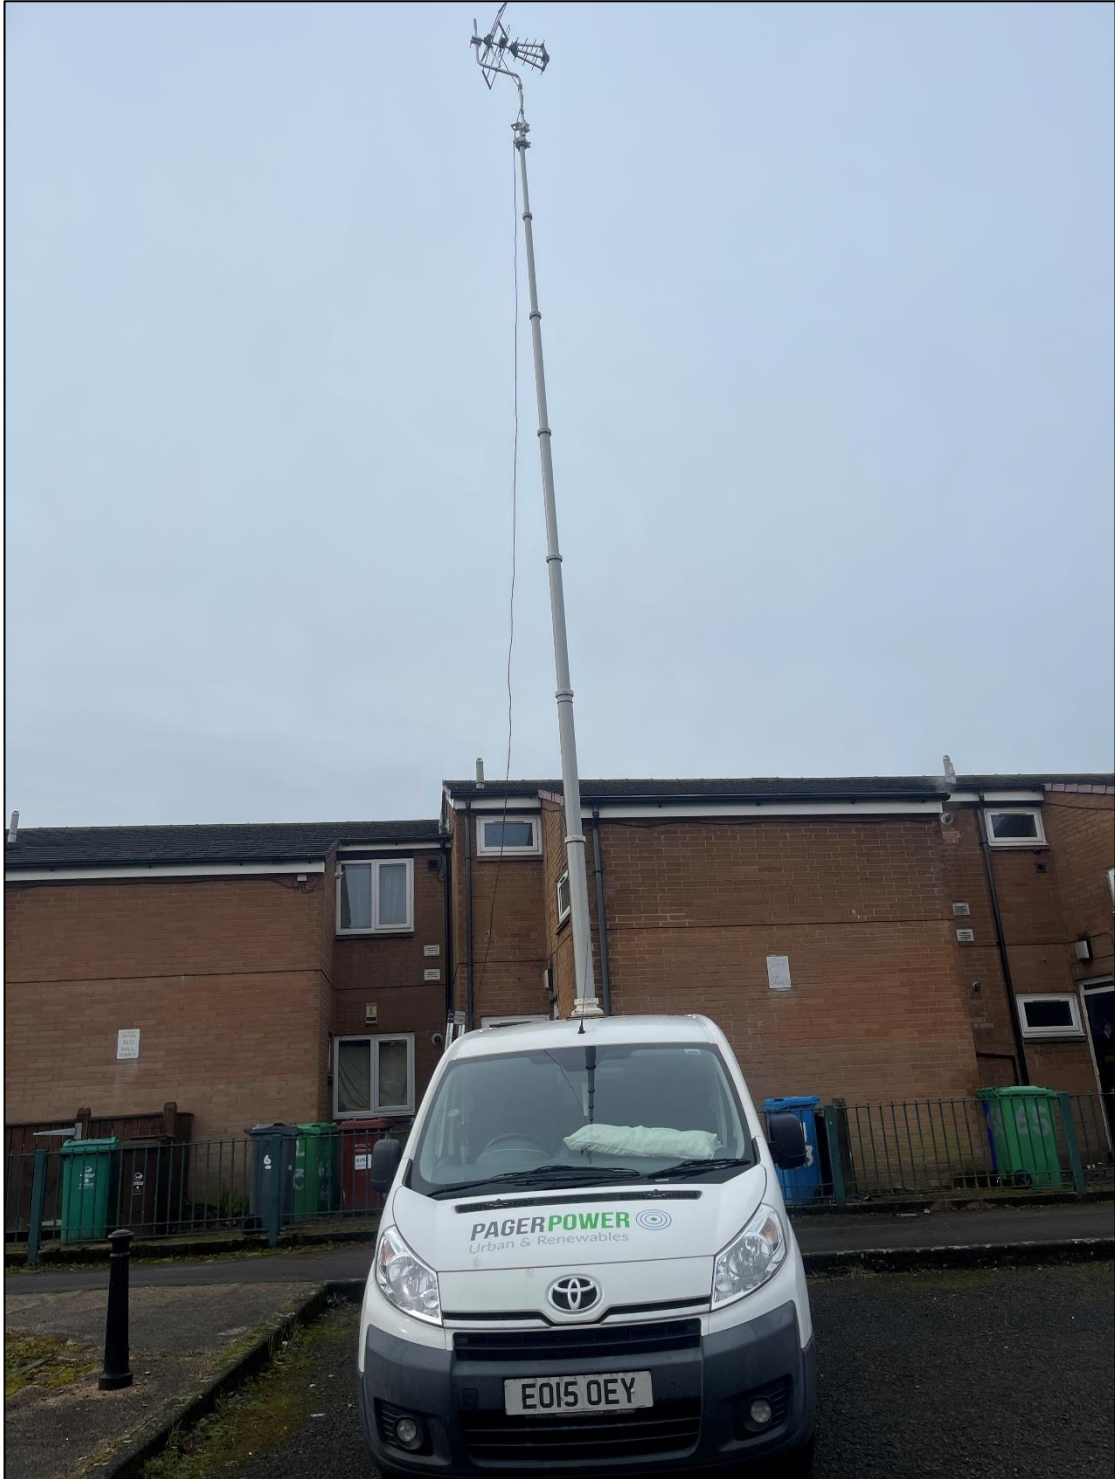
Location 4

| Location | Average Measured Signal Strength (dB) | Remarks | High-Level Conclusion |
|---|---|---|---|
| 4 | <p>Main TV MUX: 56.6 (Very good)</p> <p>Local TV MUX: 27.0 (Low)</p> | <p>Multiple aerials directed towards Winter Hill and satellite dishes observed.</p> <p>All main multiplexes displayed fine picture and audio quality with no signs of interference.</p> <p>One out of three of the local multiplexes displayed fine picture and audio quality. Two did not decode.</p> | <p>The survey location is approximately 1.5km from the proposed development and within its shadow zone.</p> <p>Considering the distance from the proposed development and current signal strength, interference is not anticipated.</p> |

Notes: Multiple HP UHF aerials directed towards the Winter Hill transmitter and satellites were observed.

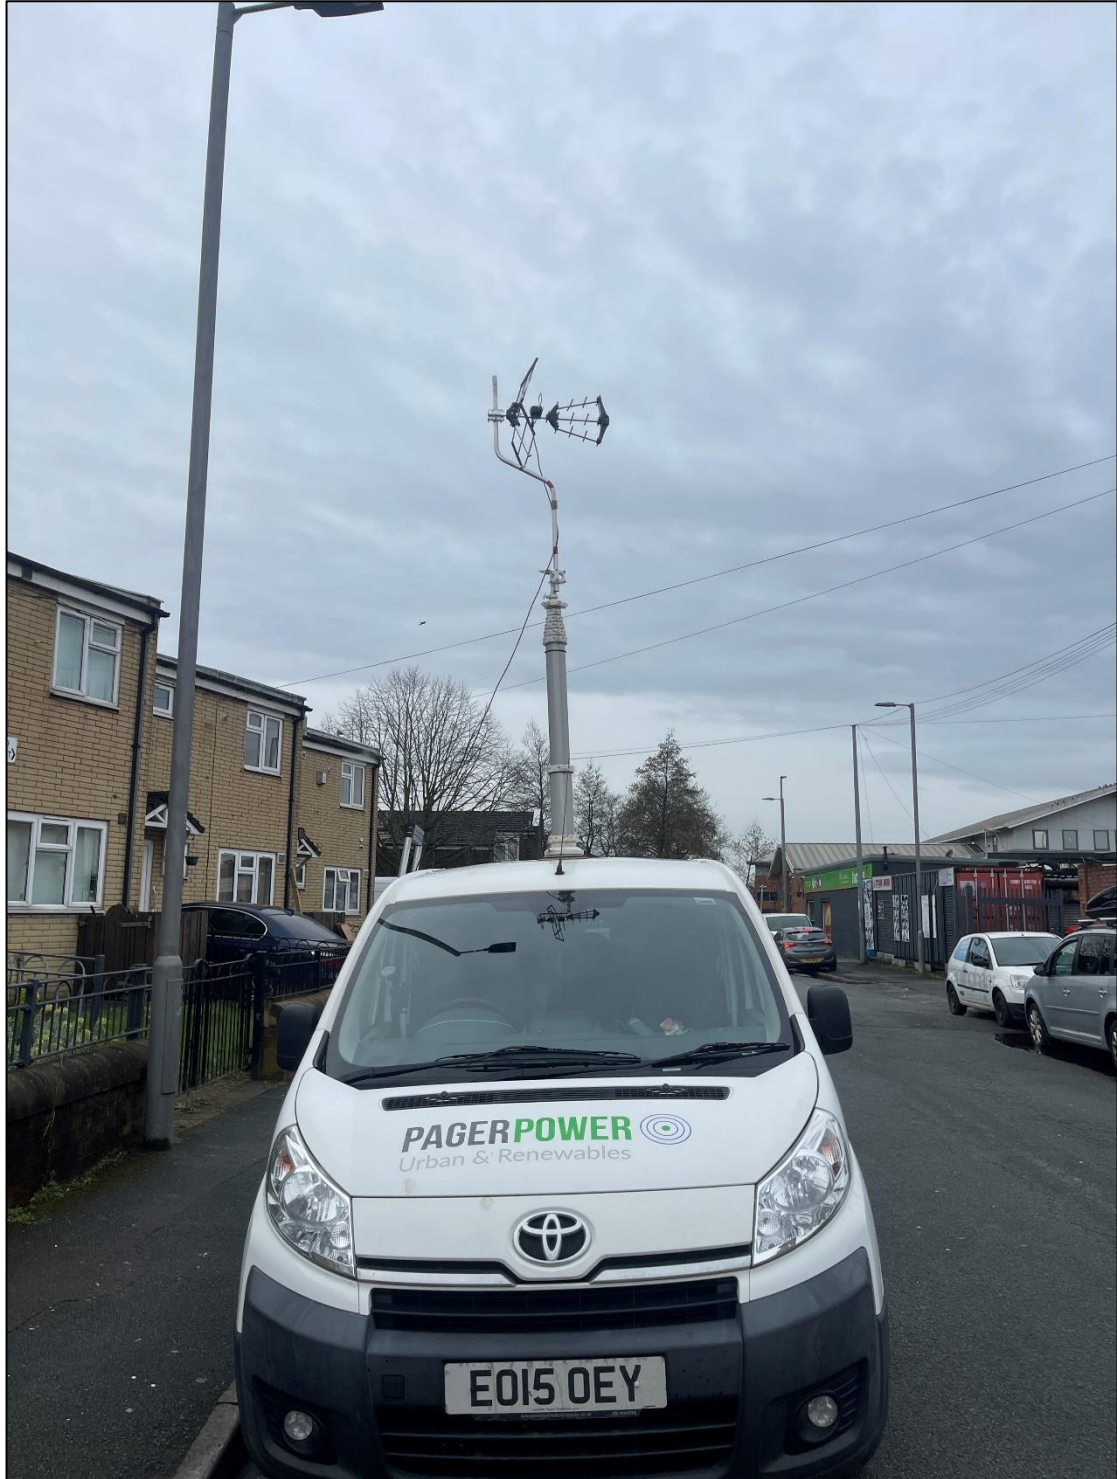
Location 5

| Location | Average Measured Signal Strength (dB) | Remarks | High-Level Conclusion |
|---|---|---|---|
| 5 | <p>Main TV MUX: 56.7 (Very good)</p> <p>Local TV MUX: 33.4 (Low)</p> | <p>Multiple aerials directed towards Winter Hill and satellite dishes observed.</p> <p>All main multiplexes displayed fine picture and audio quality with no signs of interference.</p> <p>One out of three of the local multiplexes displayed fine picture and audio quality. Two did not decode.</p> | <p>The survey location is approximately 2.3km from the proposed development and within its shadow zone.</p> <p>Considering the distance from the proposed development and current signal strength, interference is not anticipated.</p> |

Notes: Multiple HP UHF aerials directed towards the Winter Hill transmitter and satellites were observed.

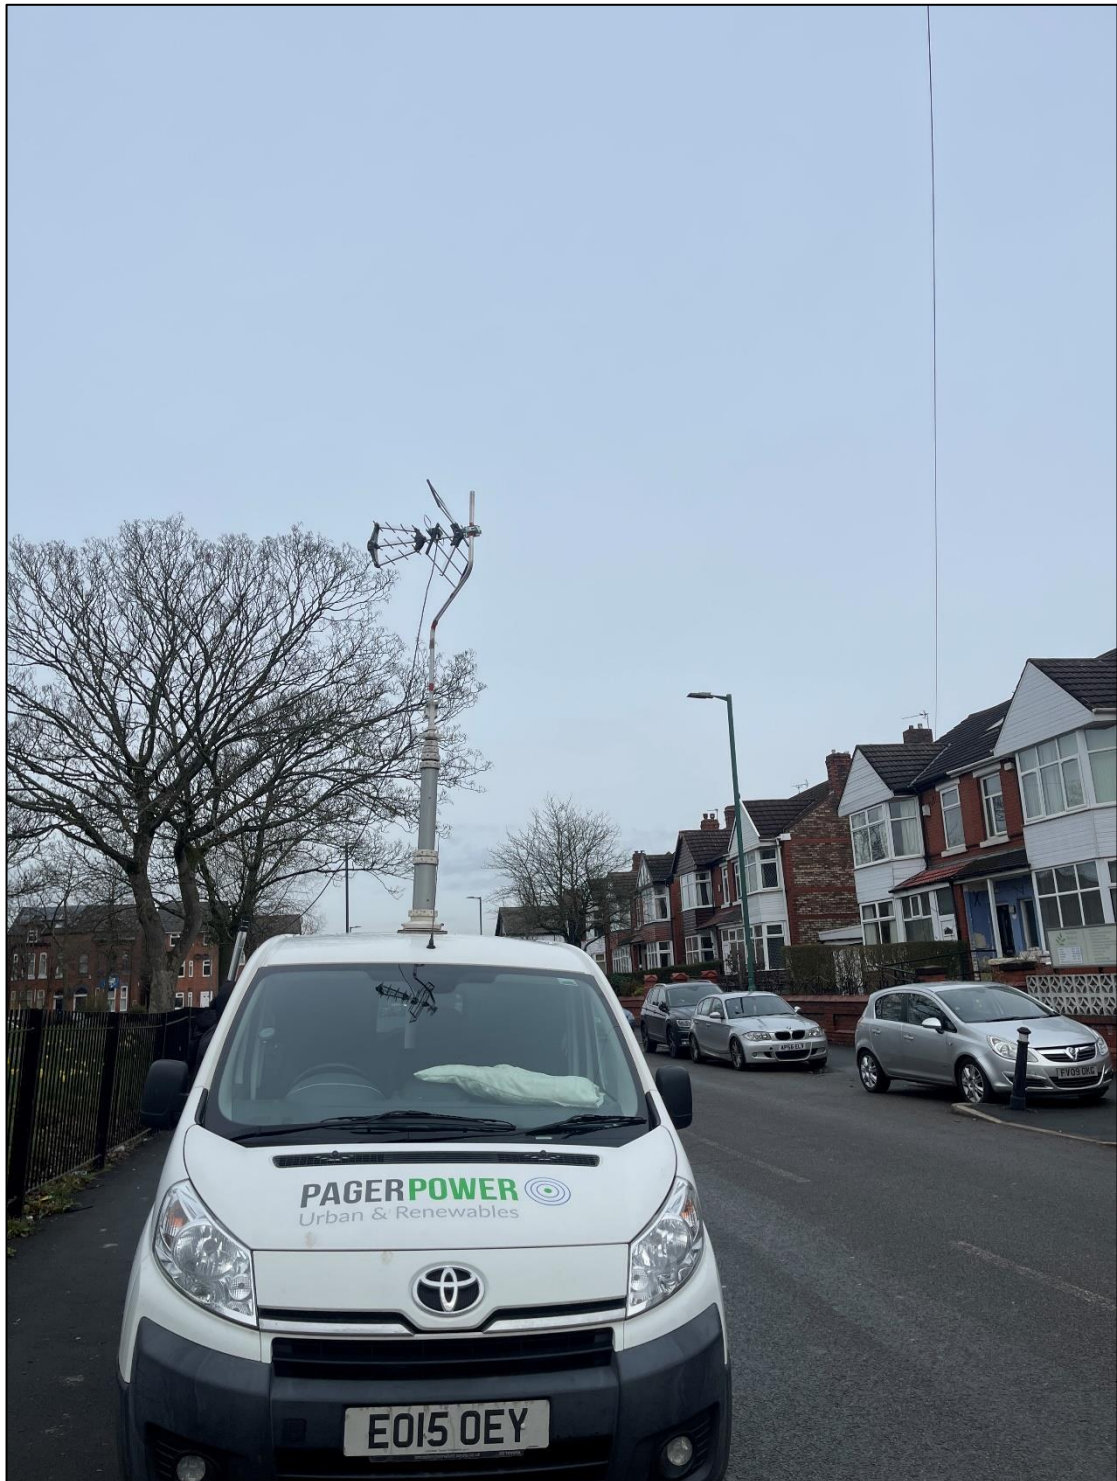
### Location 7

| Location | Average Measured Signal Strength (dB) | Remarks | High-Level Conclusion |
|---|---|---|---|
| 7 | <p>Main TV MUX: 53.3 (Very good)</p> <p>Local TV MUX: 30.9 (Low)</p> | <p>Multiple aerials directed towards Winter Hill and satellite dishes observed.</p> <p>All main multiplexes displayed fine picture and audio quality with no signs of interference.</p> <p>One out of three of the local multiplexes displayed fine picture and audio quality. Two did not decode.</p> | <p>The survey location is approximately 3.7km from the proposed development and within its shadow zone.</p> <p>Considering the distance from the proposed development and current signal strength, interference is not anticipated.</p> |

Notes: Multiple HP UHF aerials directed towards the Winter Hill transmitter and satellites were observed.
