### GEOTECHNICAL INVESTIGATION REPORT

**GEOTECHNICAL SITE INVESTIGATION  
AND INTERPRETATIVE REPORT  
OF LAND AT  
ASHTON CANAL,  
NEW ISLINGTON**

**Manchester City Council**

**January 2022**

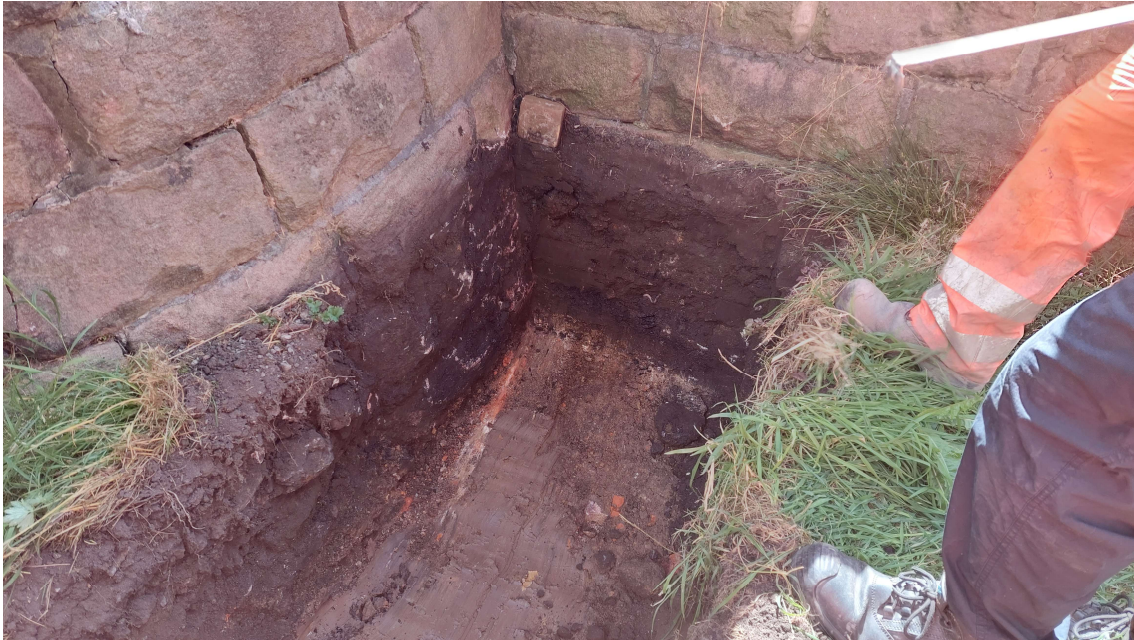
*Figure 1 - Trial pit looking towards exiting stairs*

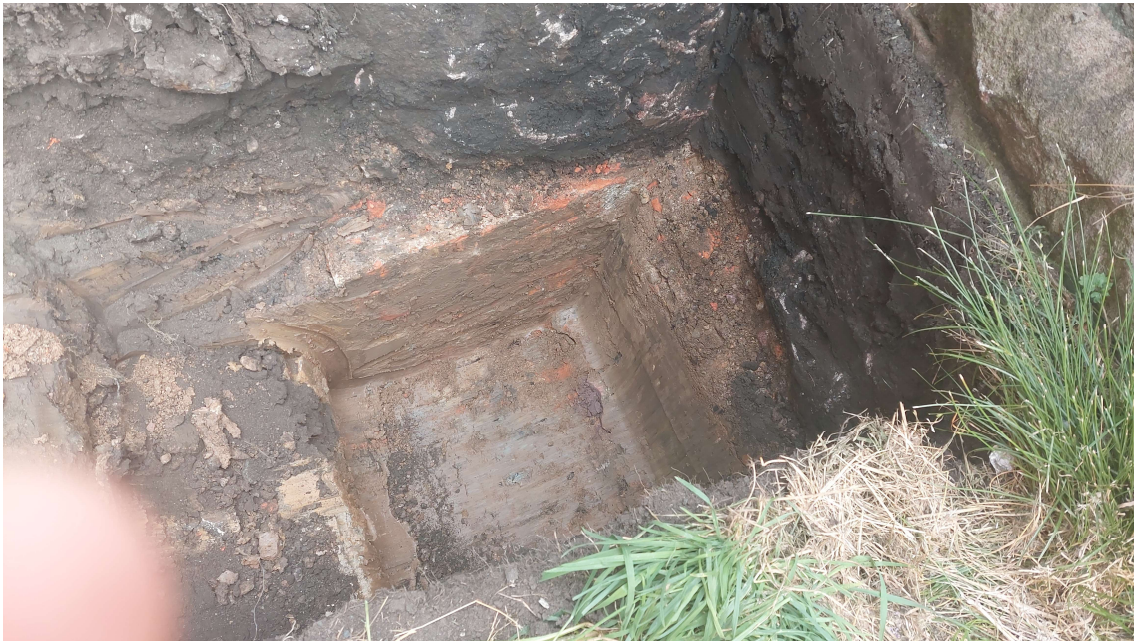
*Figure 2 - Trial Pit - note foundation construction does not step out and therefore will not clash with proposed foundations*

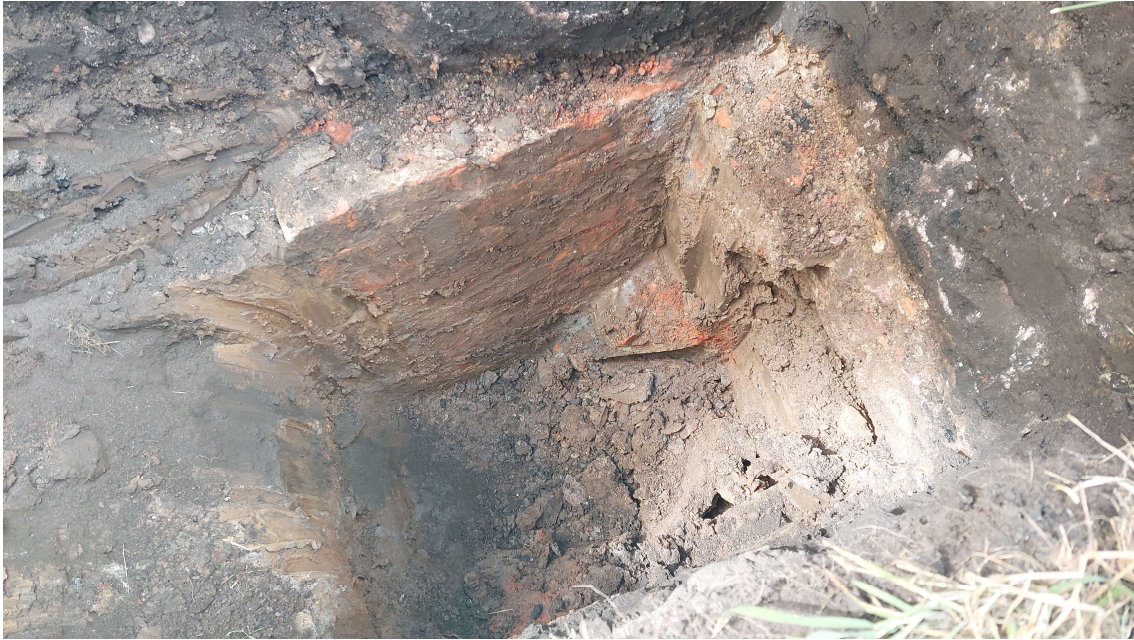
*Figure 3 - Trial Pit*

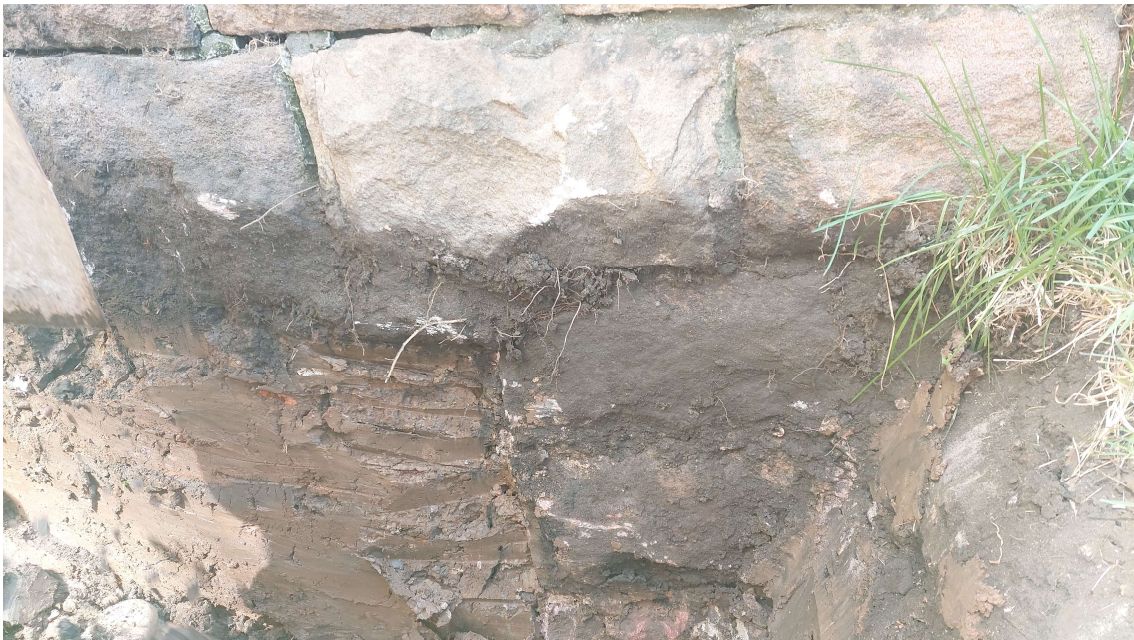
*Figure 4 - Trial pit view looking at existing stairs*
