# Phase 2 Site Investigation

Plot 10B First Street

Vita Group

| TITLE | NAME | SIGNATURE | DATE |
|---|---|---|---|
| Report Reference | 4513-ROC-ZZ-XX-RP-ES-P2SI01 | | |

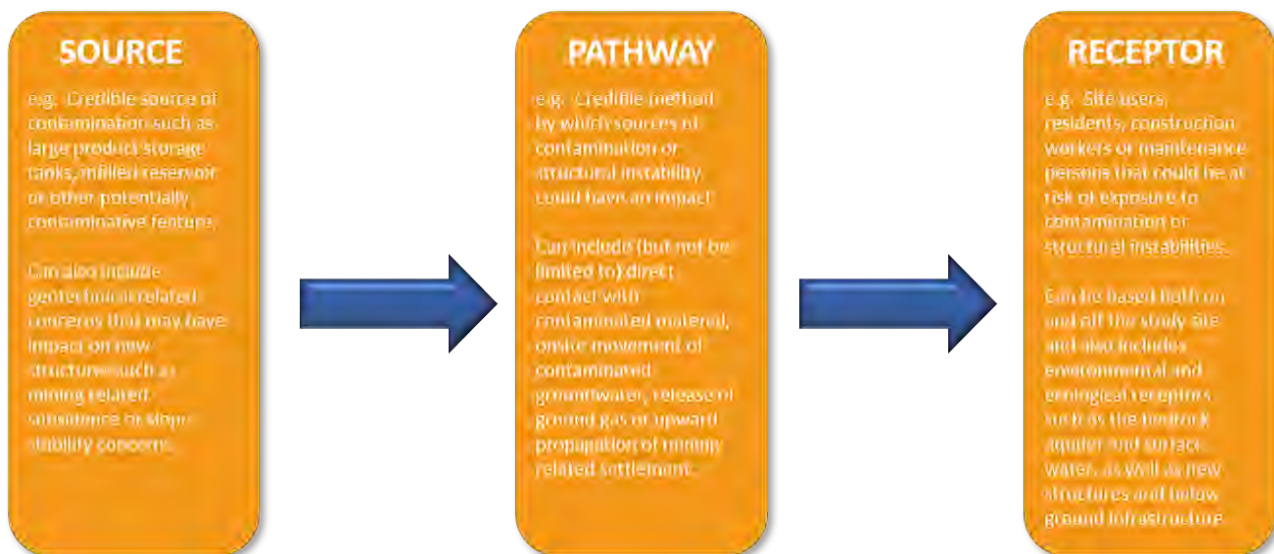
**Figure 8.0 Source Pathway Receptor Diagram**

- 8.0.3 In accordance with this method, a Refined Conceptual Model has been collated for the site based on the results of the desktop review. This model is based around the Source / Pathway / Receptor methodology as outlined in Fig 8.0.

- 8.0.4 Risk assessment is the process of collating known information on a hazard or set hazards in order to establish actual or potential risks to receptors. The receptor may be human health, controlled waters, a sensitive local ecosystem or even construction materials. Receptors can be connected with the hazard under consideration via one or several exposure pathways (e.g., the pathway of direct skin contact and oral exposure).
- 8.0.5 Risks are generally managed by isolating or removing the hazard, isolating the receptor, or by intercepting the exposure pathway. Without the three essential components of a source (hazard),

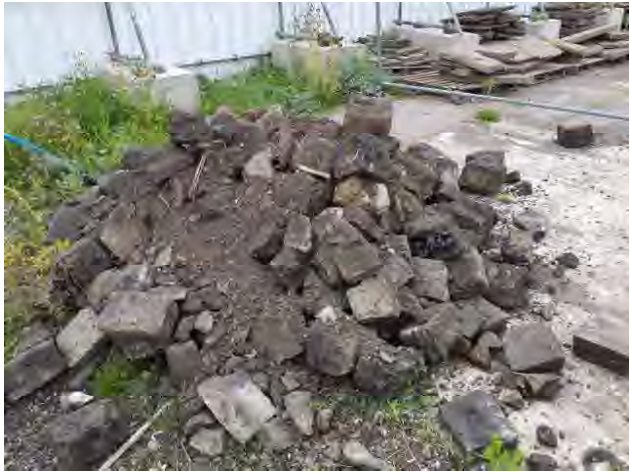
| Select Feature | Description | Direction Taken | |
|---|---|---|---|
| OTHER | Evidence of tar on stockpile | N | |

- 3.1.4 Olfactory evidence of contamination in the form of a hydrocarbon odour was noted within a stockpile of material originating from Plot 9a which was placed in the eastern portion of the site in the vicinity of TP105. With exception to the presence of made ground consisting of concrete hard-standing and compacted hardcore fill, there was no clear visual or olfactory evidence of any further contamination on the surface of the site itself. However, at the time of the visit, several stockpiles of material derived from elsewhere on the wider site were present. During the site walkover a number of stockpiles were also observed only 1 stockpile appeared to have been placed onto a membrane while others were placed directly onto the hard-standing and fill. In one stockpile, suspected tar was observed.

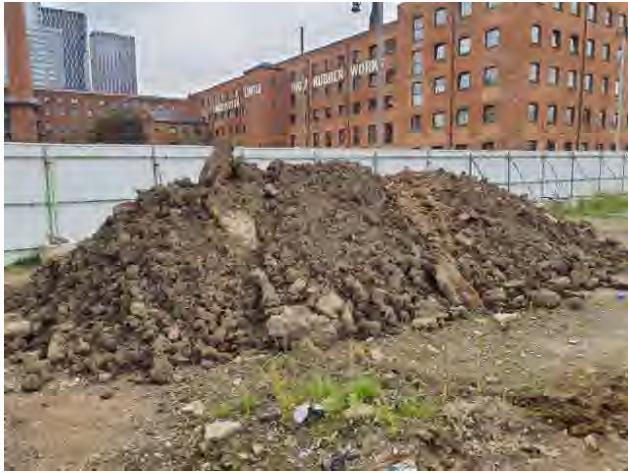
| OTHER | View of stockpile | N | |

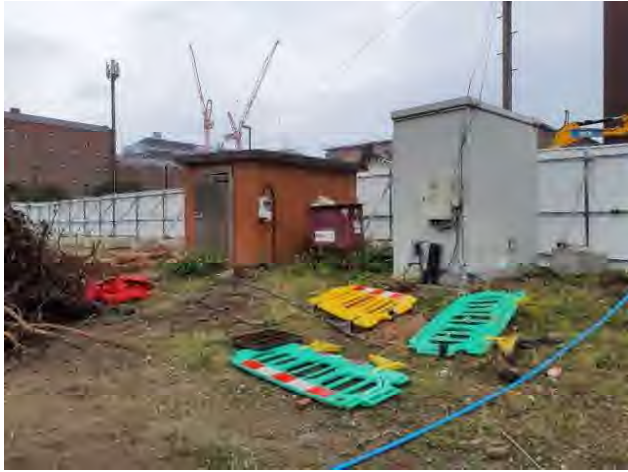
| OTHER | Telecoms and electricity substation | N | |

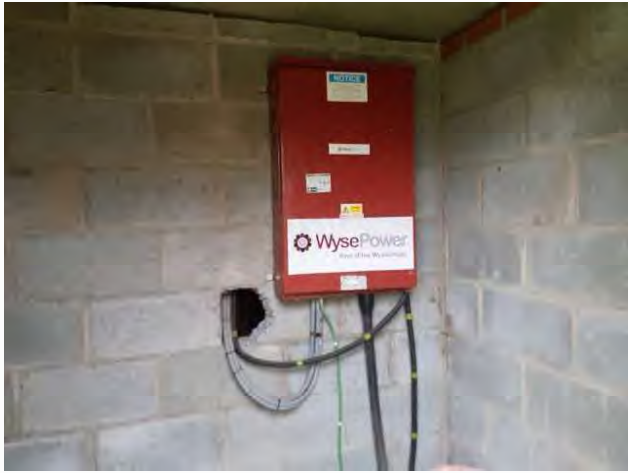
| OTHER | Inside electrical substation | N | |

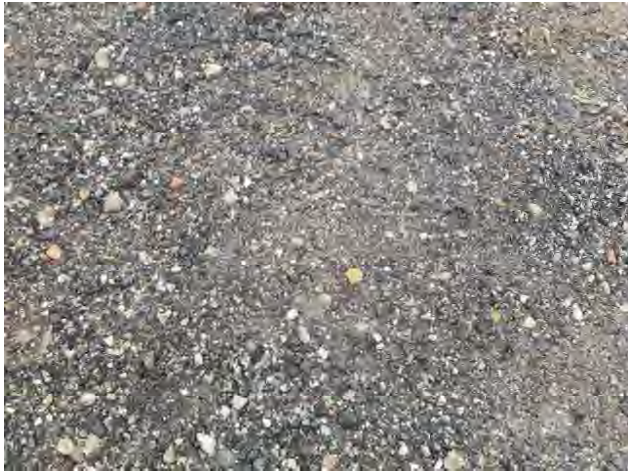
| OTHER | general compacted hard-core fill | N | |

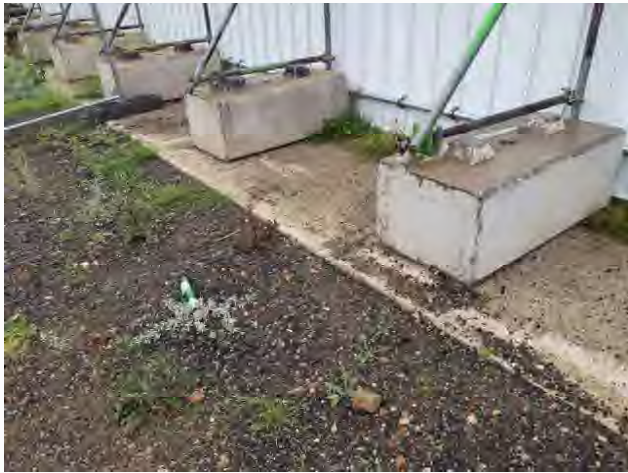
| OTHER | Concrete slab around edge of site | N | |

- 3.1.2 The site is currently in a vacant open area with several stockpiles of demolition waste and pile arisings sourced from plot 9a to the west. The majority of the site is underlain by a concrete slab (measured to be 12cm thick in the north of the Site where visible) or asphalt with the remainder surfaced by compacted hardcore fill. A recently constructed electrical substation and telecoms unit were observed in the south of the site. In the northwest of the site are a garage and bin area at the time of reporting being utilised by on-site contractors as an area of car parking. The site appears highest in the southeast, sloping toward the northwest. A temporary drainage channel is present in the north of the site serving on site welfare cabins running underneath the hardstanding toward the north. The northern, eastern and southern perimeters of the site are marked by a concrete base and metal sheet fencing.

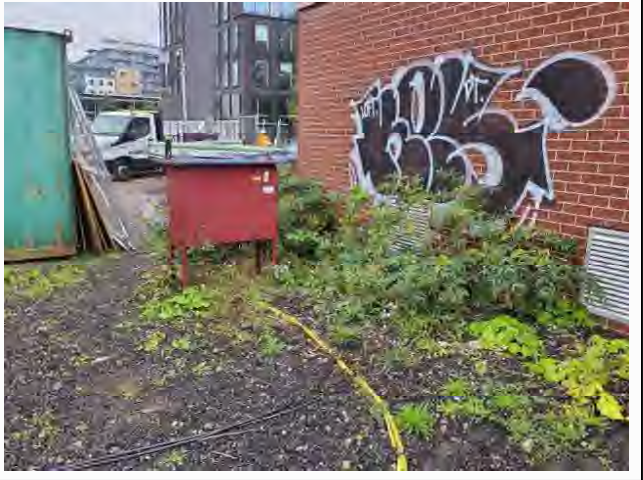
| OTHER | Substation and related service point | N | |

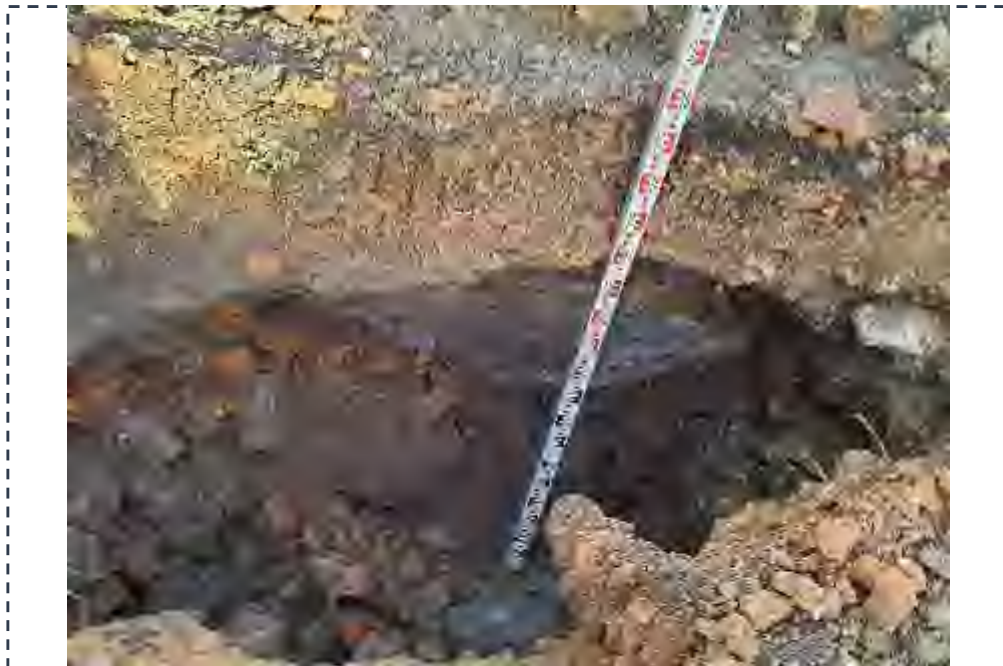
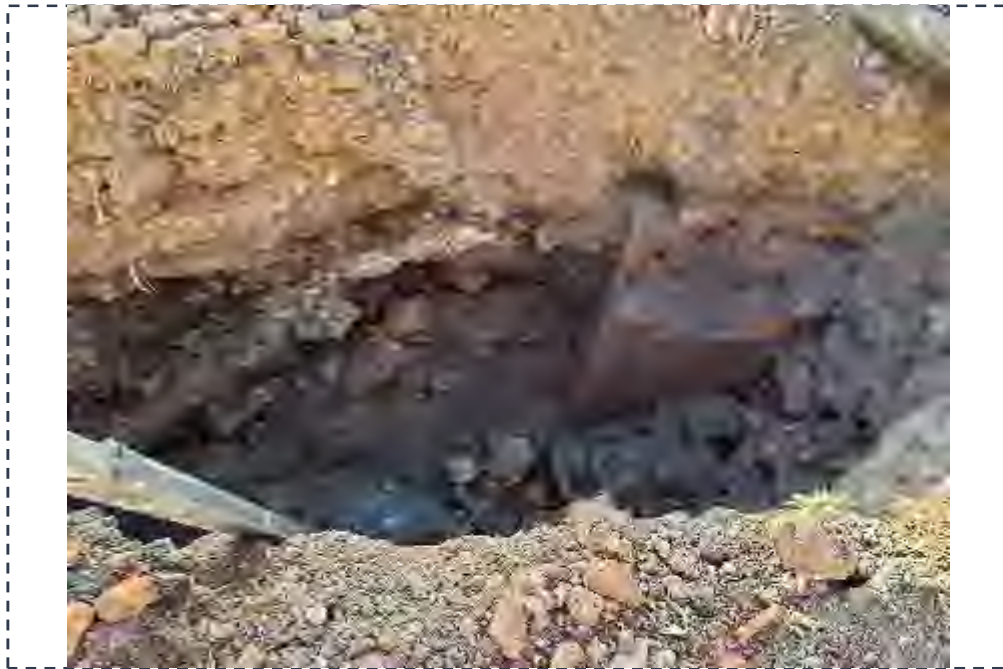
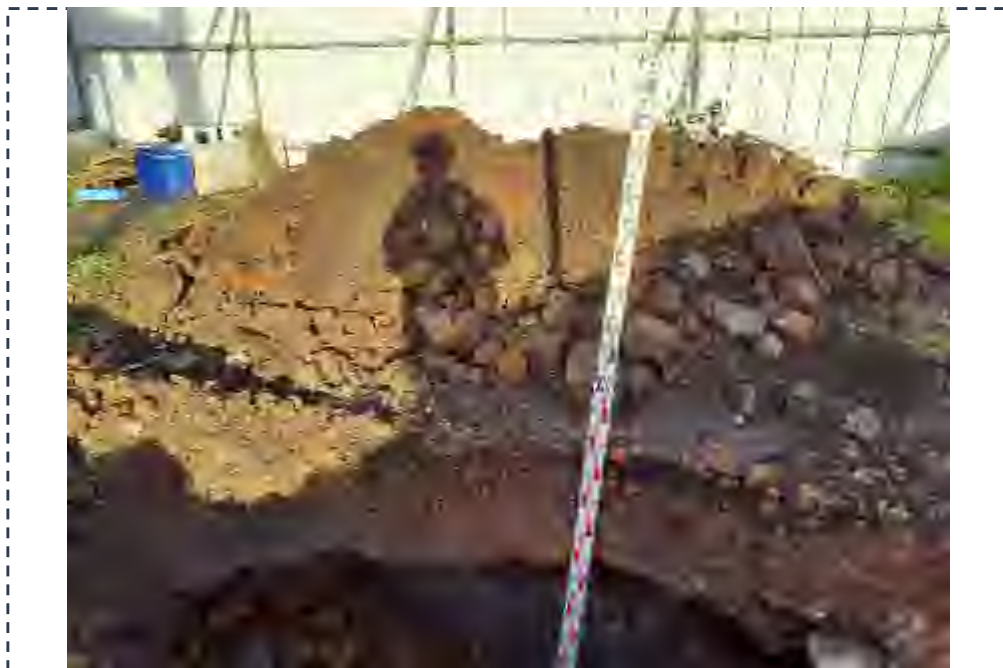
TP105 – West Facing View

TP105 – East Facing View

TP105 – Arisings

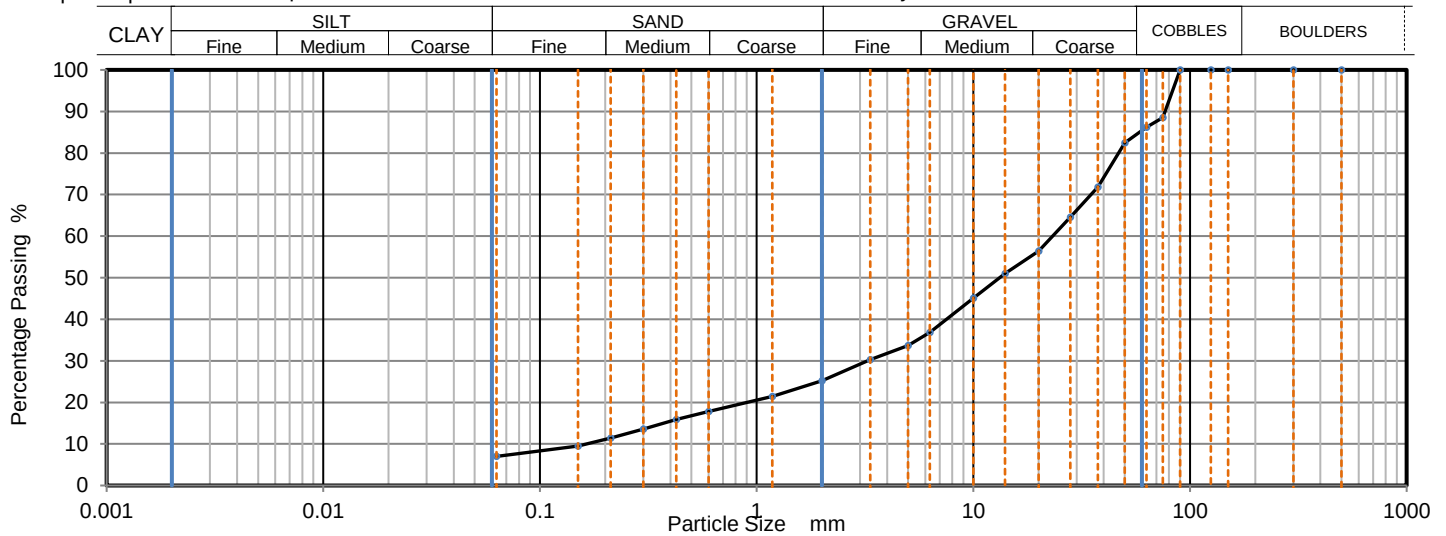
Laboratory Reference: 2501153  
Hole No.: TP106  
Sample Reference: Not Given  
Sample Description: CRUSHED CONCRETE and BRICKS  
Sample Preparation: Sample was whole tested, oven dried at 106.0 °C and broken down by hand.

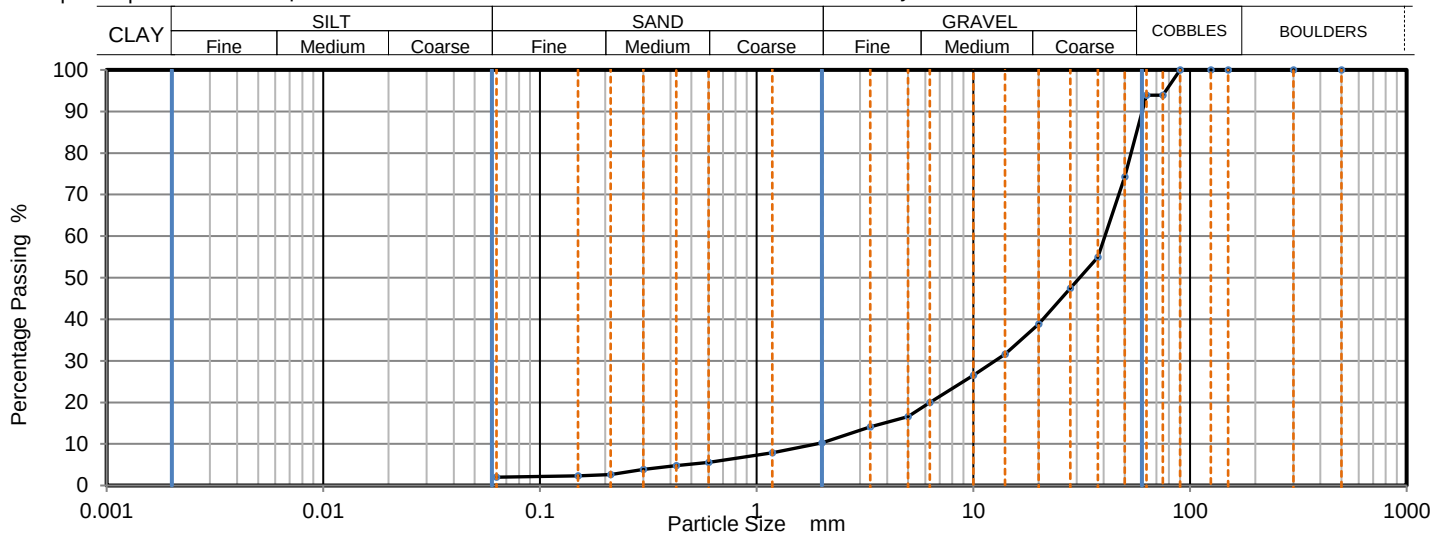
Laboratory Reference: 2501154  
Hole No.: TP107  
Sample Reference: Not Given  
Sample Description: CRUSHED CONCRETE and BRICKS  
Sample Preparation: Sample was whole tested, oven dried at 108.9 °C and broken down by hand.

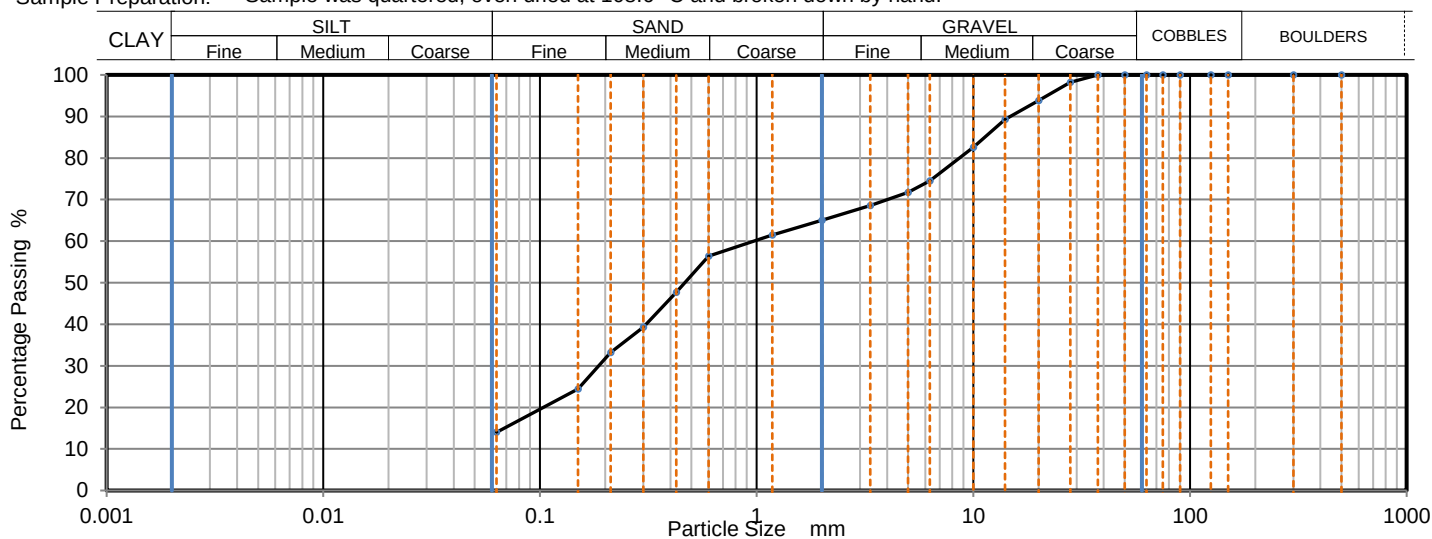
Laboratory Reference: 2501155  
Hole No.: TP109  
Sample Reference: Not Given  
Sample Description: Brownish grey clayey very gravelly SAND  
Sample Preparation: Sample was quartered, oven dried at 108.6 °C and broken down by hand.
