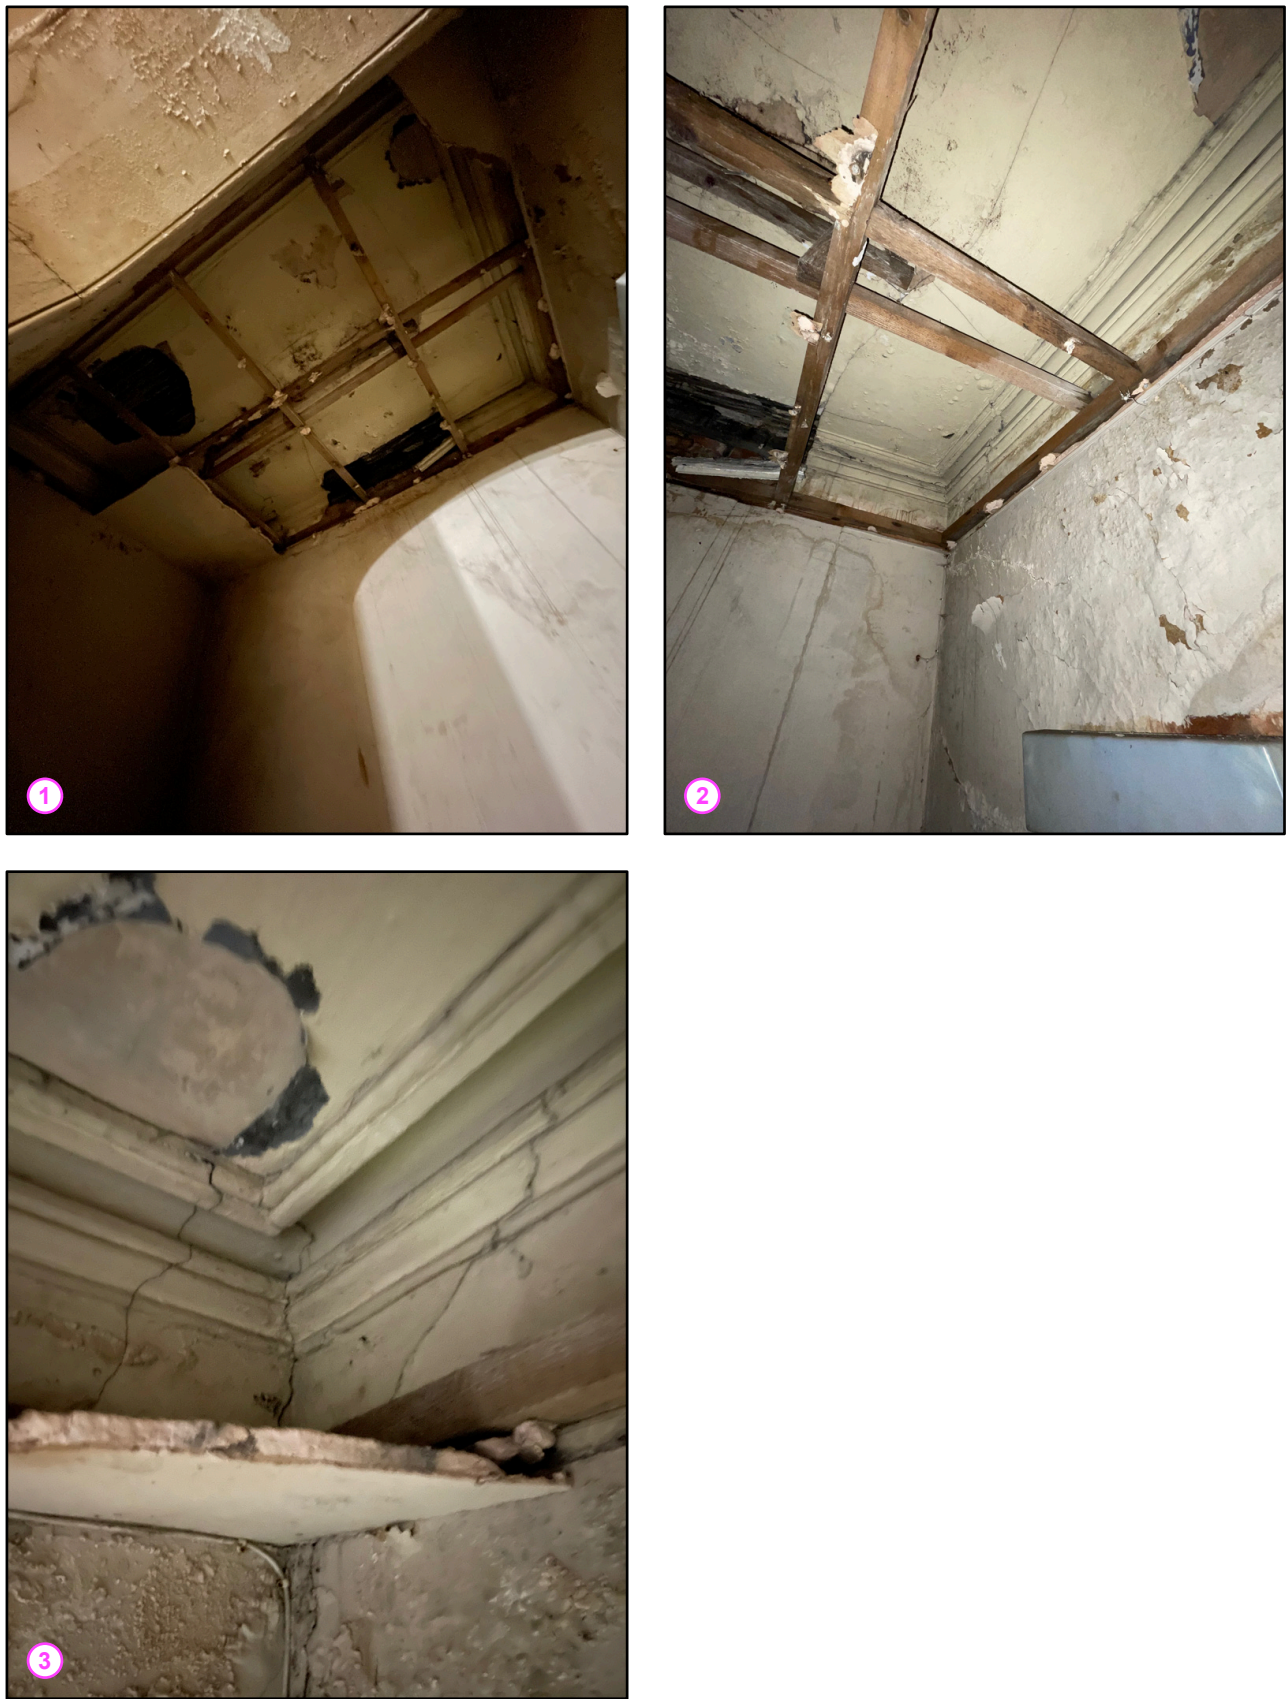
ROOM F.04

- Cornice as noted on the plan
- What looks like suspended ceiling has gone revealing cornice and plasterboard ceiling

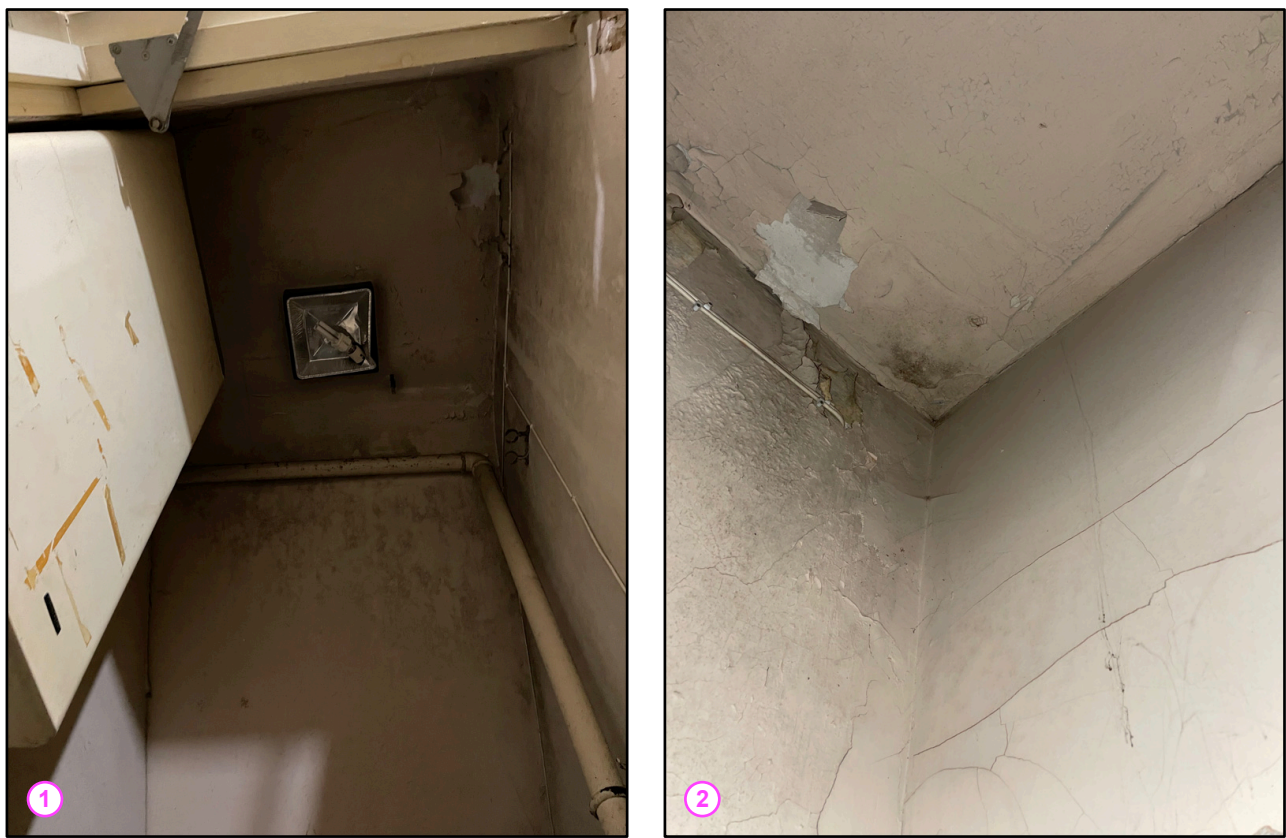
ROOM F.05

- No cornice
- Ceiling in relatively good condition

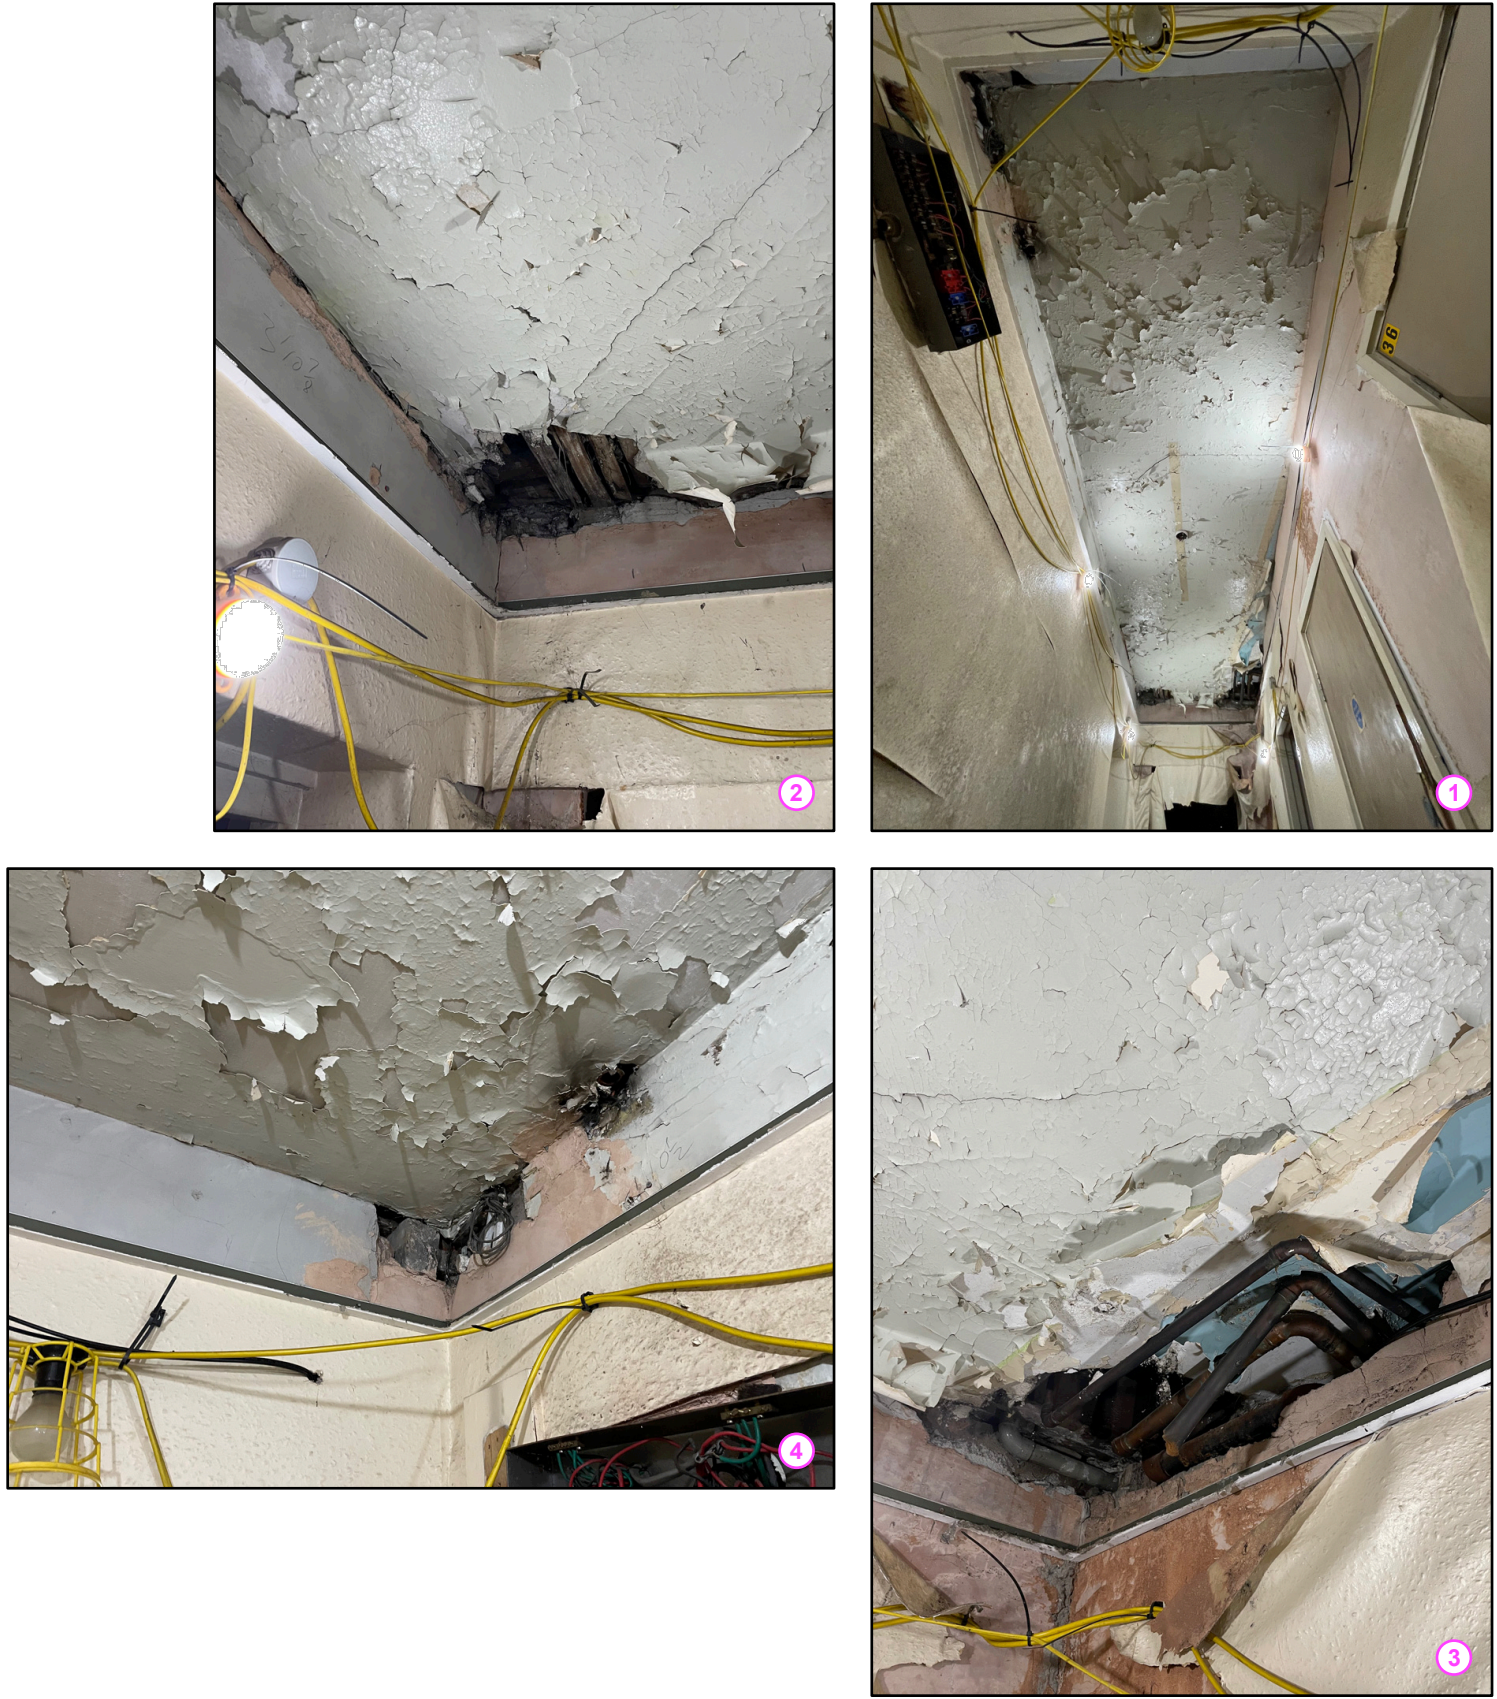
ROOM F.06

- No cornice
- Partially collapsed ceiling as noted on the plan
  - Ceiling in bad condition
- Exposed pipework where ceiling has collapsed

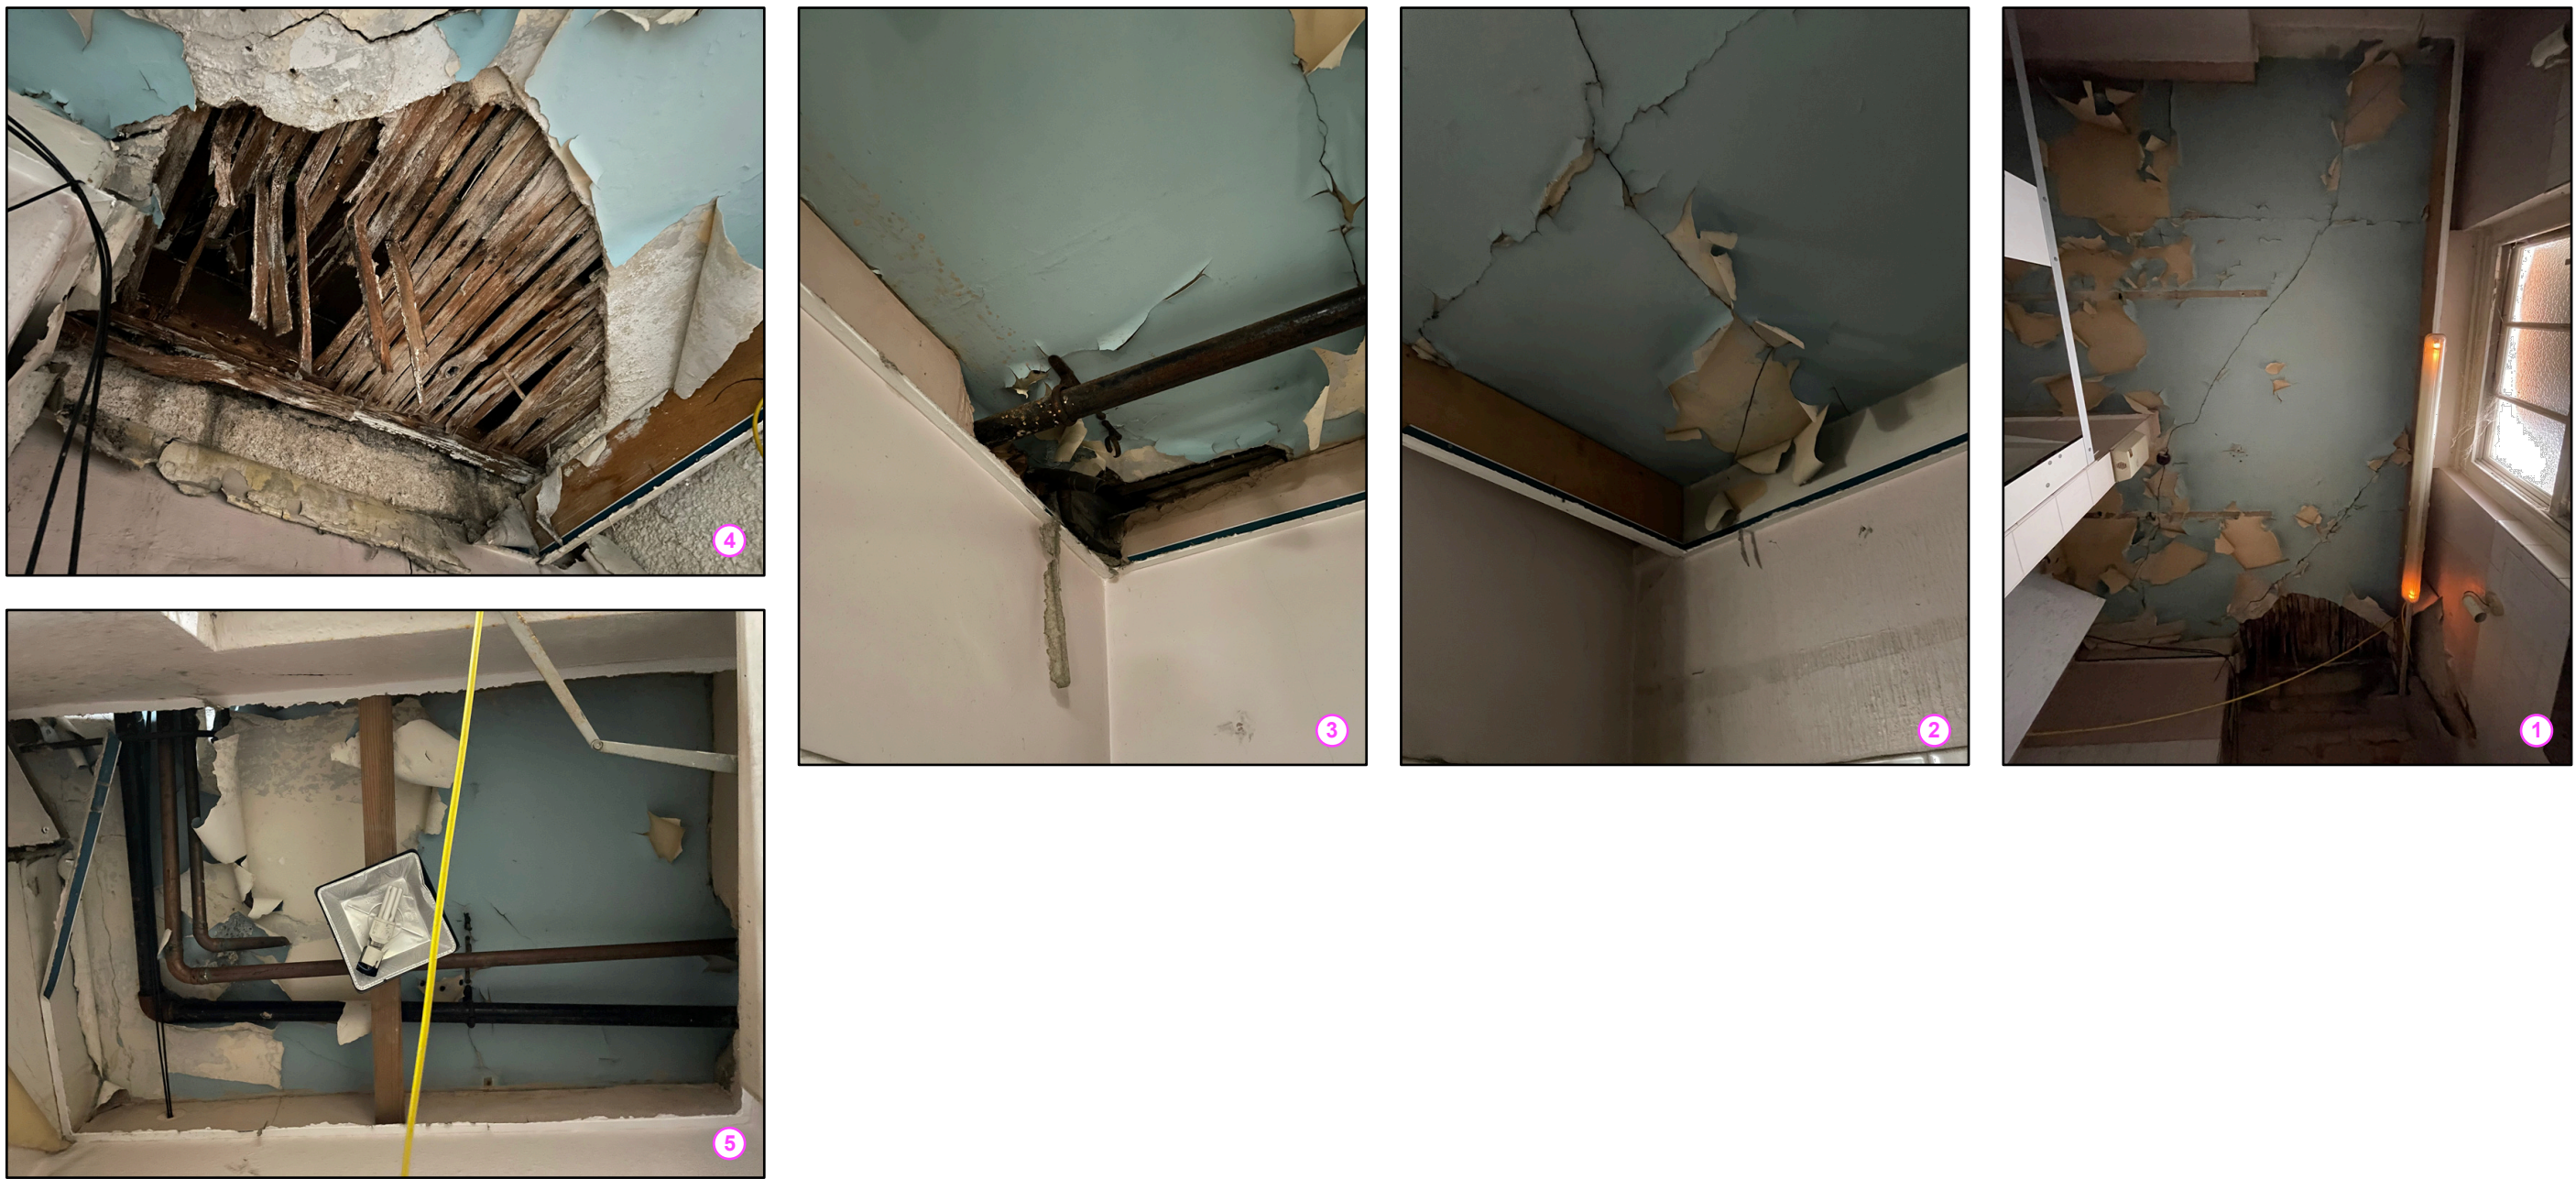
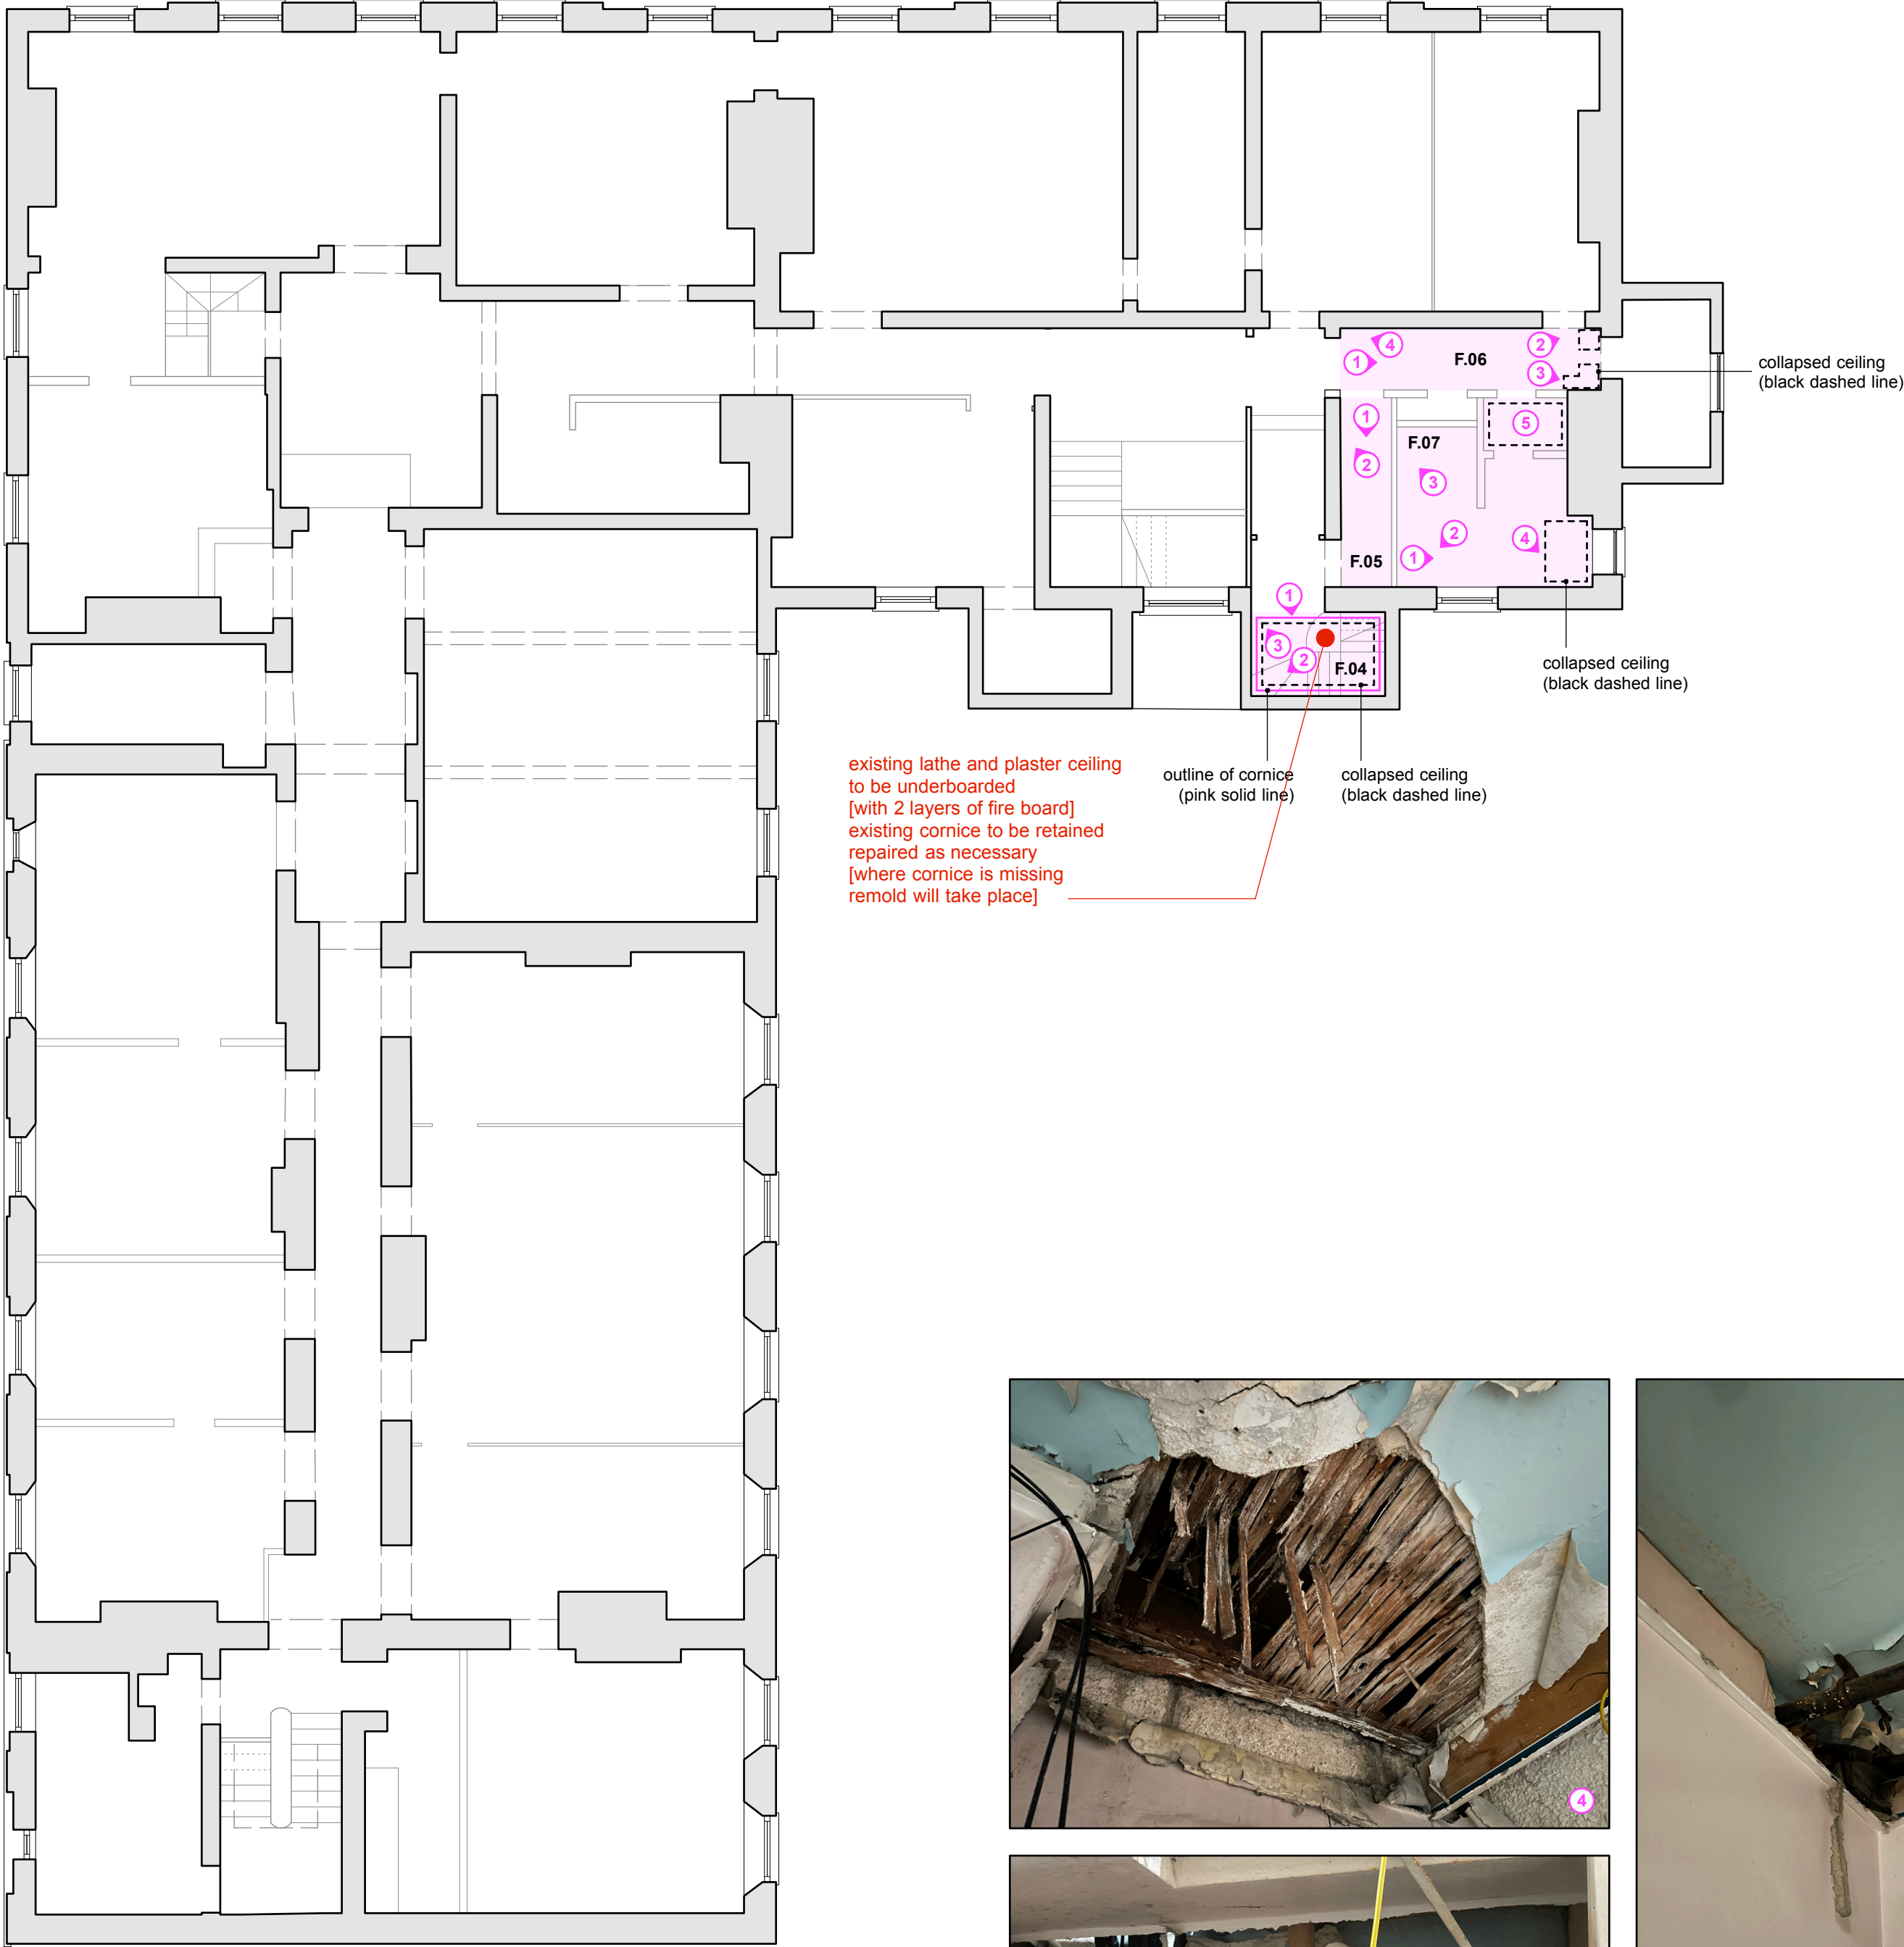
ROOM F.07

- No cornice
- Partially collapsed ceiling as noted on the plan
  - Ceiling in bad condition
- Exposed pipework where ceiling has collapsed
