## **FOUL AND SURFACE WATER DRAINAGE STRATEGY**

FOR  
**SHIPYARD  
(ALBERT SHED)  
WATER STREET  
MANCHESTER**

ON BEHALF OF  
**MANCHESTER QUAYS TWO LTD**

| <b>Flood Risk Assessment for Shipyard (Albert Shed), Water Street, Manchester</b><br><b>2132/01r2a</b> | | | |

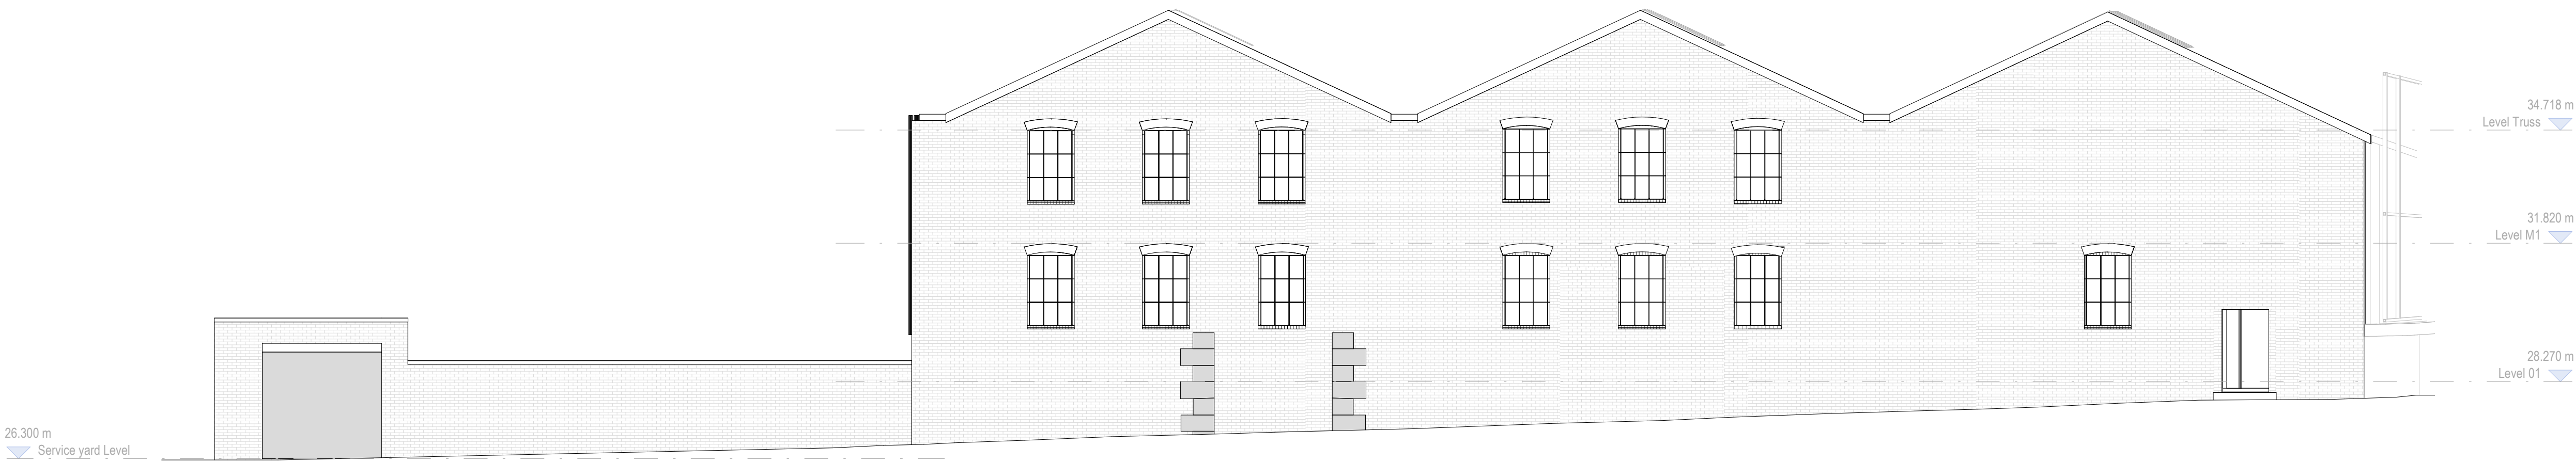
- KEY
- ① Existing windows retained and made good  
If refurbishing is not possible, replace with a new window to match existing.
  - ② Existing brickwork retained, cleaned and made good.
  - ③ New metal canopy in black and free standing signage
  - ④ New timber sliding shutters
  - ⑤ New entrance with curtain wall and sliding doors in black grey
  - ⑥ New metal framed screen to service yard in black grey
  - ⑦ New metal service yard and substation door in black grey
  - ⑧ New metal fire exit gate in black grey
  - ⑨ New metal roof fascia in black grey
  - ⑩ New painted signage and artwork
  - ⑪ New brickwork within existing window opening
  - ⑫ New extract air discharge
  - ⑬ New extract louvre

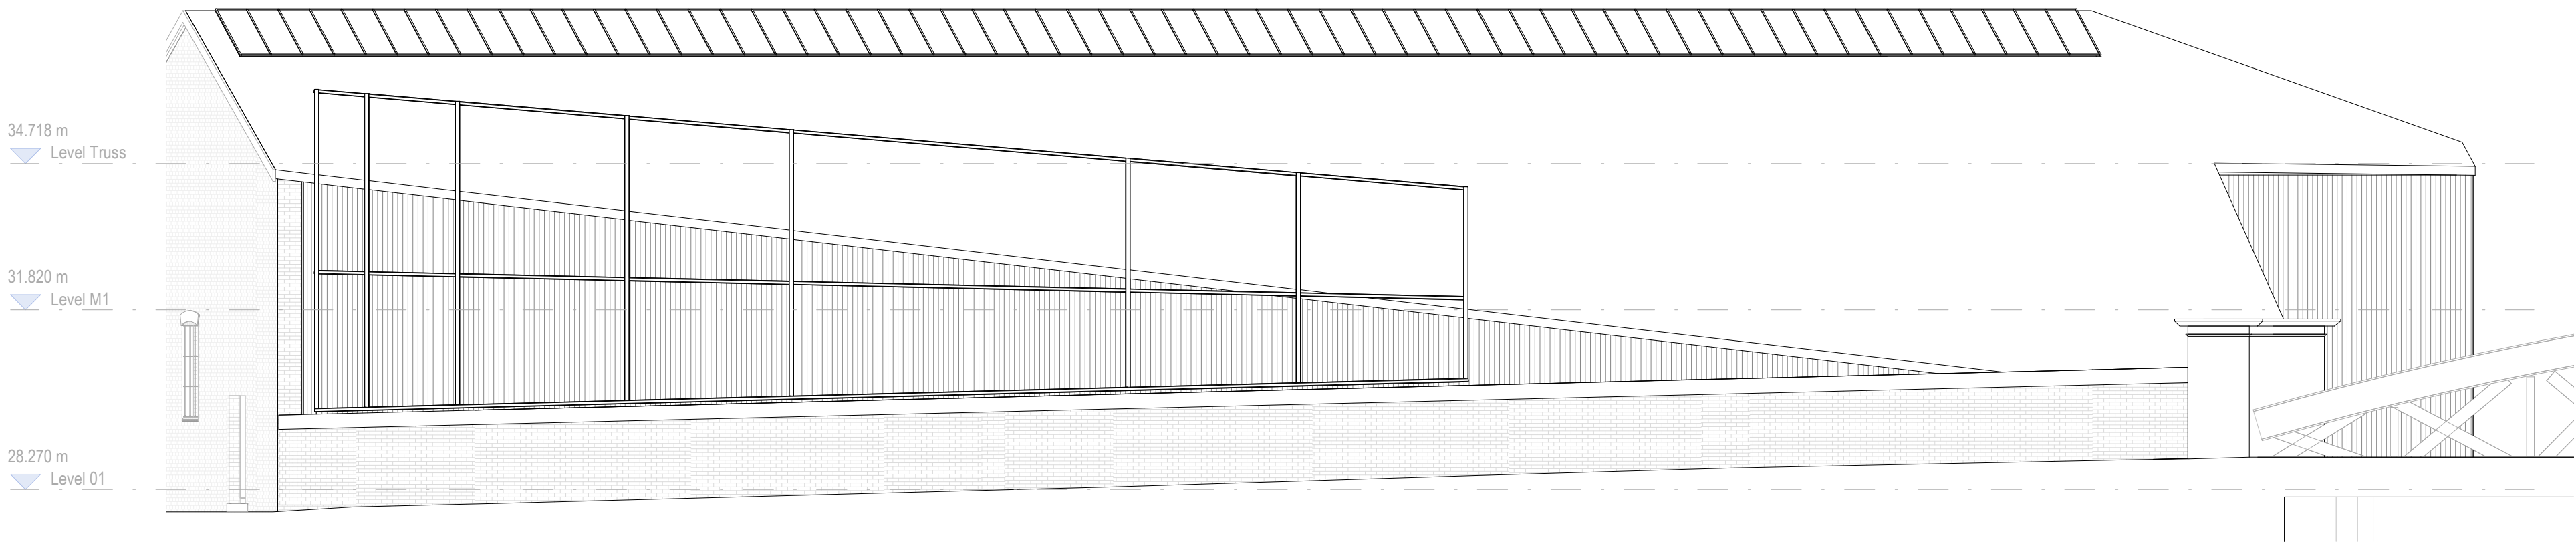
- KEY
- ① New ribbed metal roof finish in black grey
  - ② New framed roof skylights
  - ③ New painted signage
  - ④ New timber cladding to external wall
  - ⑤ Existing advertising board frame reused
  - ⑥ New metal secondary entrance gate in black grey
  - ⑦ New timber canopy
  - ⑧ Existing bridge pier retained
  - ⑨ Existing brick wall made good

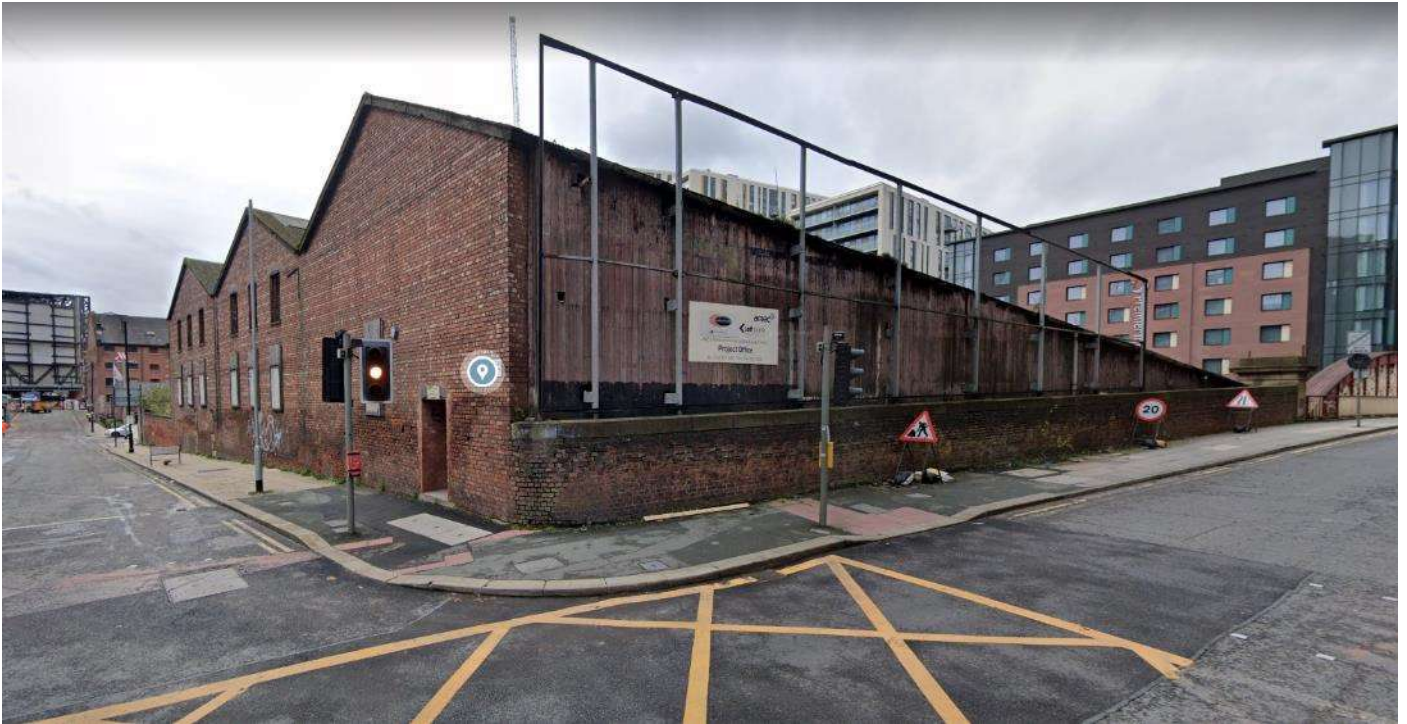
Photograph 1. View towards eastern corner of building from New Quay Street.

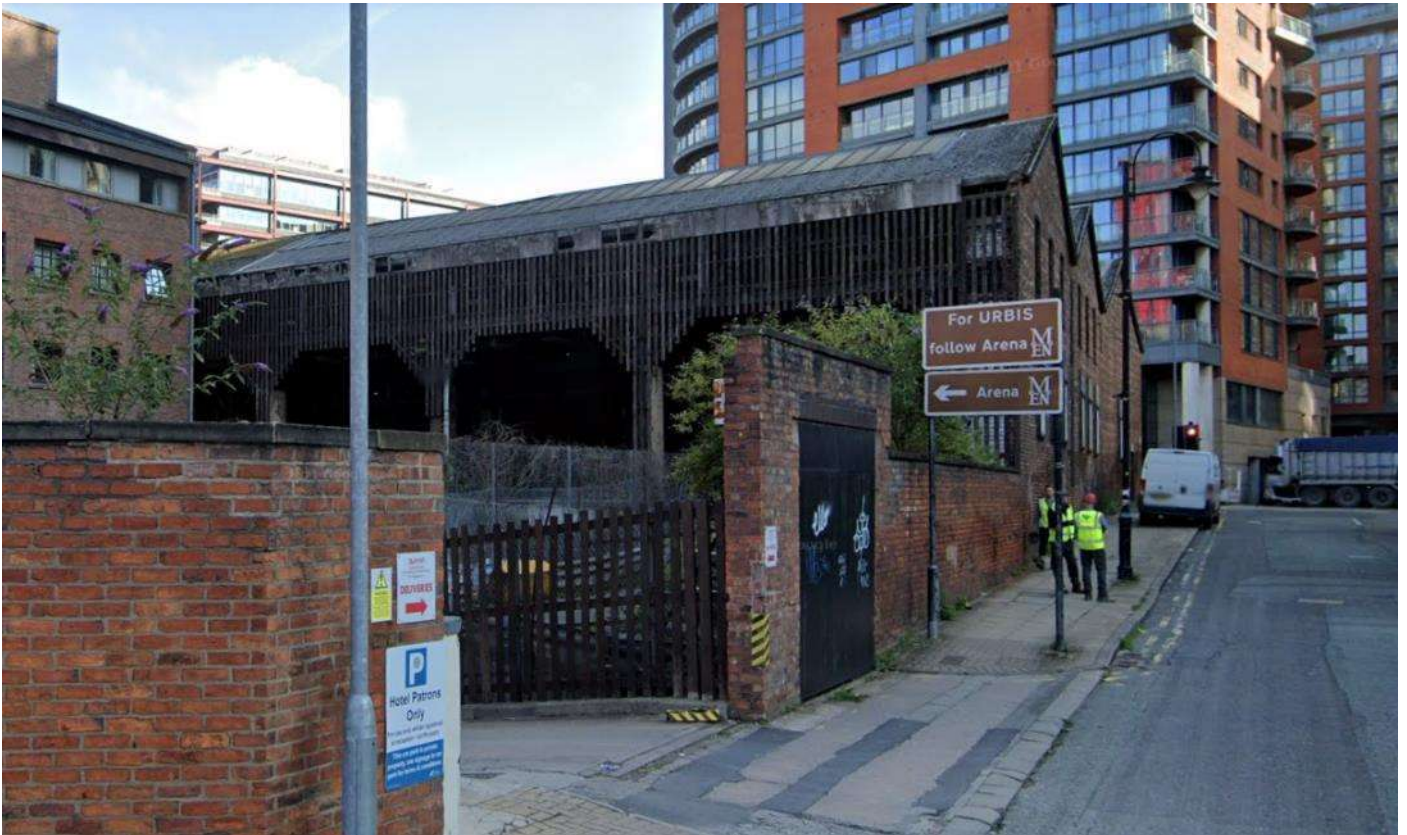
Photograph 2. View northeast along Water Street – existing ramp to Ground Floor level begins from behind black door in centre of photograph.

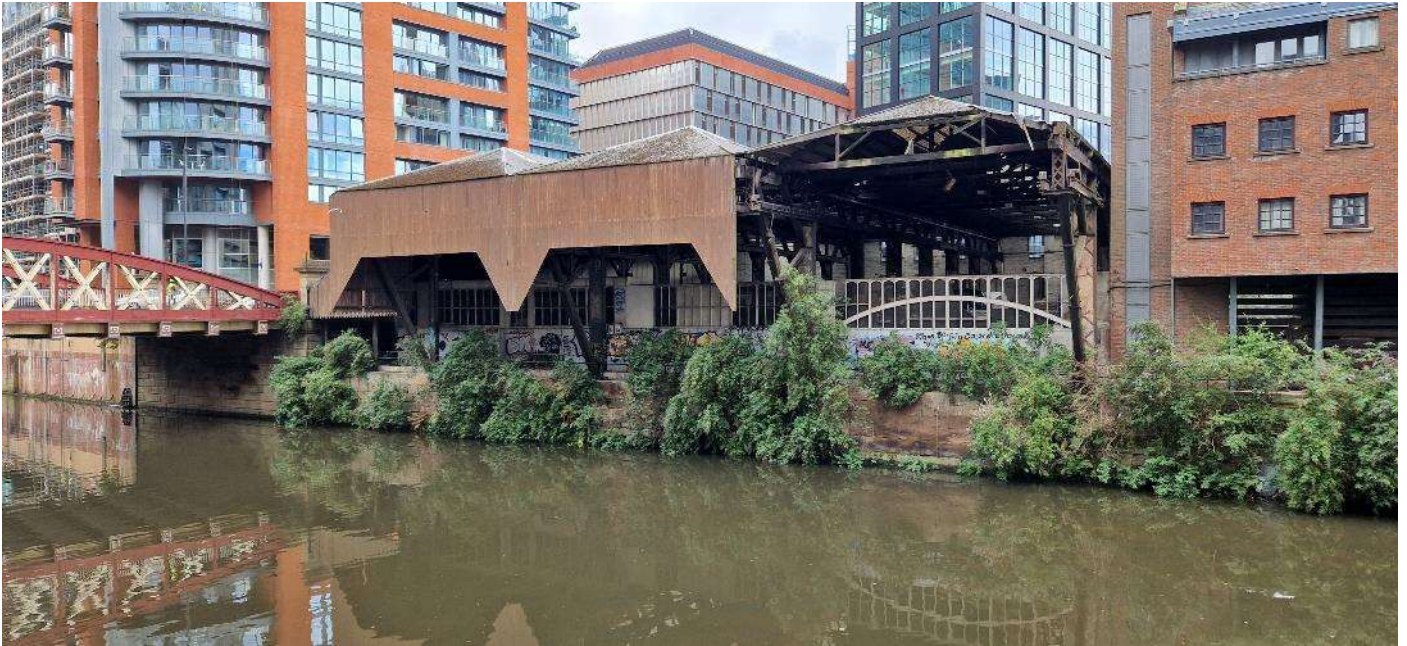
Photograph 3. View from opposite side of River Irwell

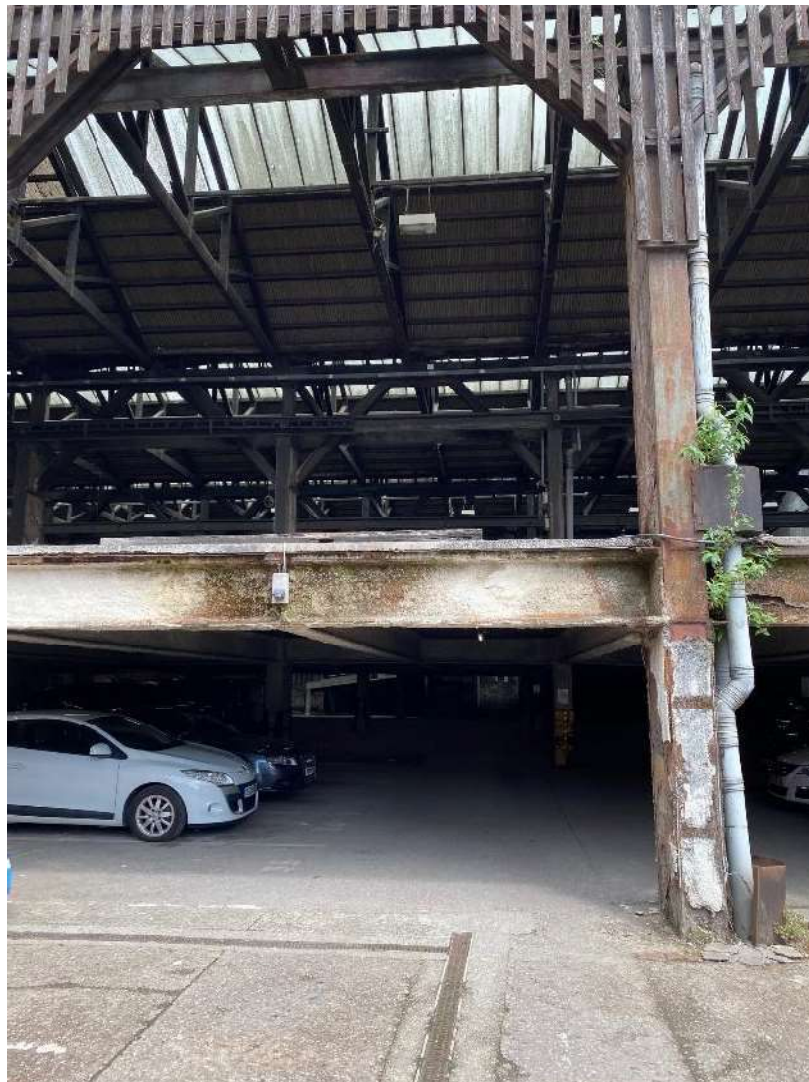
Photograph 3. View on southwest elevation, showing existing basement parking level, existing Ground Floor level and interior of roof.

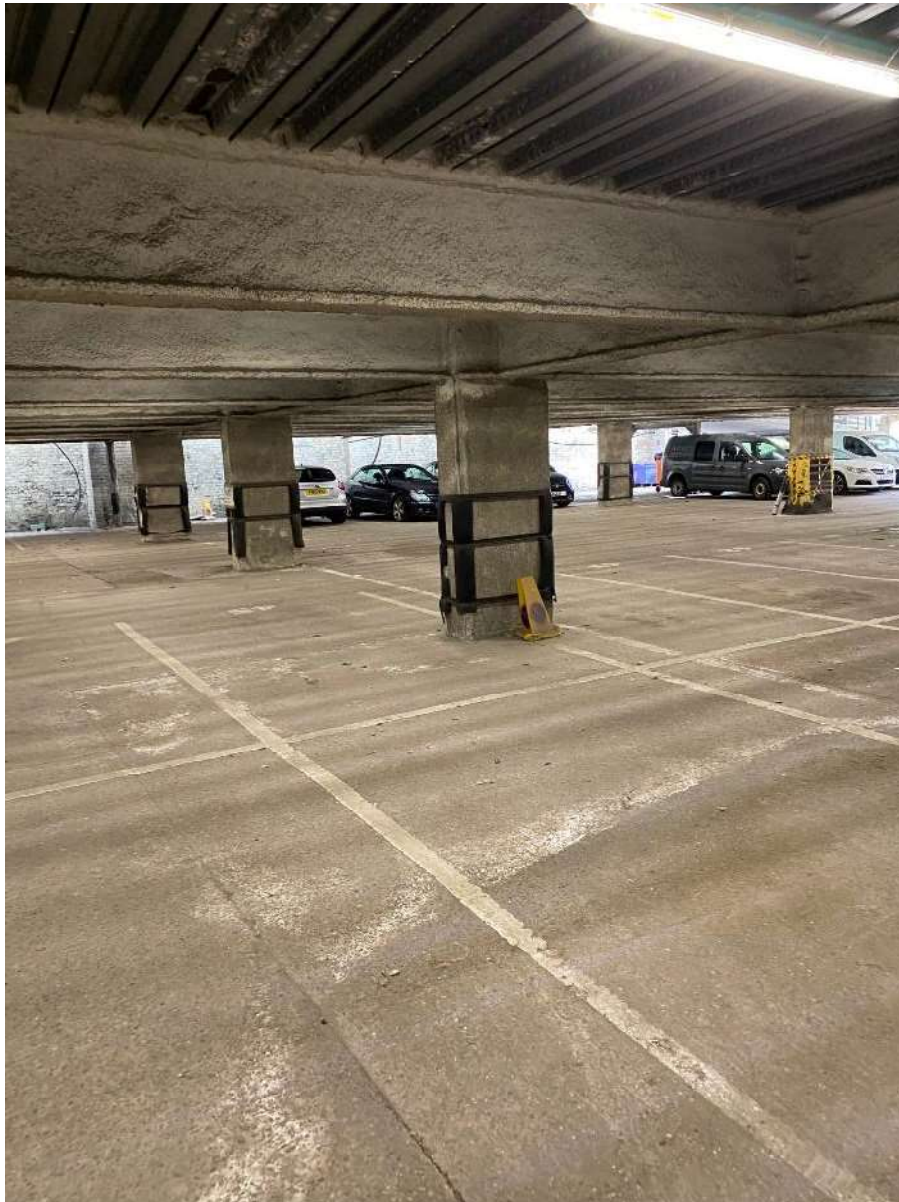
Photograph 4. Typical view within Basement car park level.

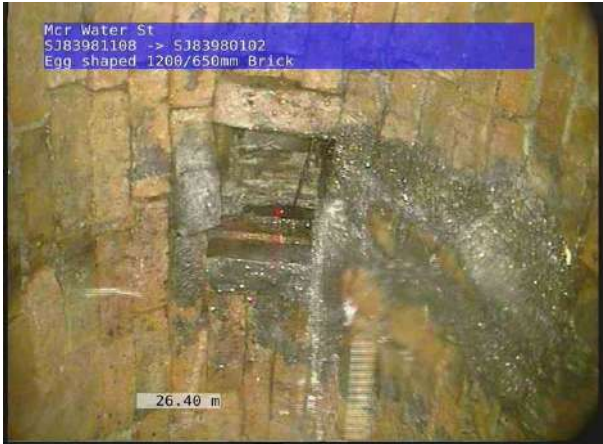
SJ83981108X\_2d31f6c7-d1ba-4647-a7ba-8a75d3cb57f2\_202  
21005\_195425\_046.jpg, 00:04:05, 26.40 m  
Connection other than junction at 12 o'clock, 225mm dia

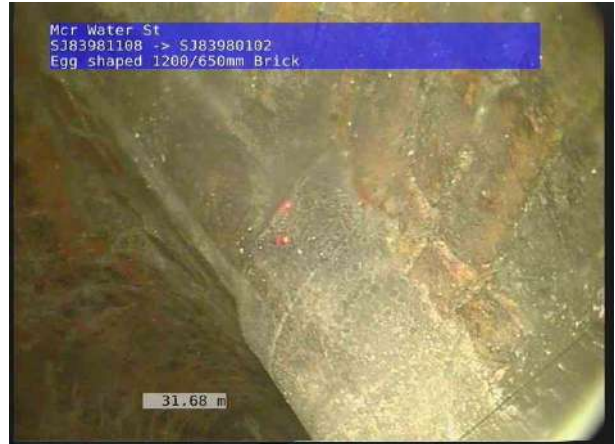
SJ83981108X\_ecb20e68-b8b5-4a7c-8daf-c439e93fb031\_202  
21005\_195602\_766.jpg, 00:05:28, 31.52 m  
Other obstacles, protruding through wall from 1 o'clock to 5  
o'clock, 30% cross-sectional area loss

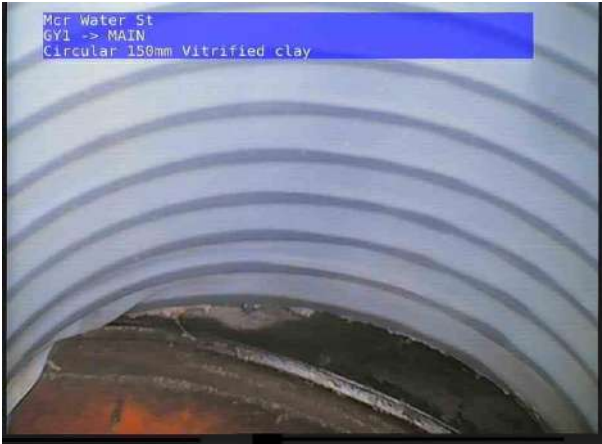
GY1X\_d305ec1e-7a58-4598-add2-ba499467c92f\_20221005\_203459\_956.jpg, 00:00:06, 0.24 m  
Pipe material changes to polyvinyl chloride at this point

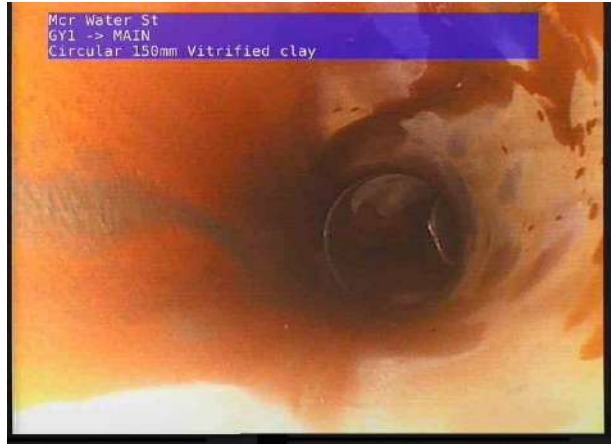
GY1X\_c9148e46-e503-4938-8716-260d03f90f3f\_20221005\_203547\_931.jpg, 00:00:47, 0.81 m  
Pipe material changes to vitrified clay at this point

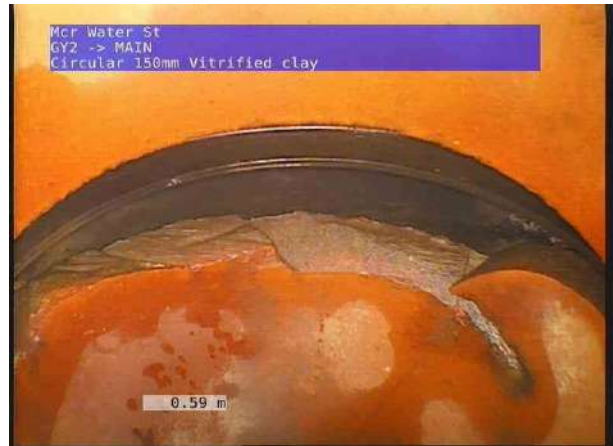
GY2X\_fe931daa-49a9-48dd-afe6-b2ae47cc4b14\_20221005\_203856\_417.jpg, 00:01:06, 0.59 m  
Open joint, large

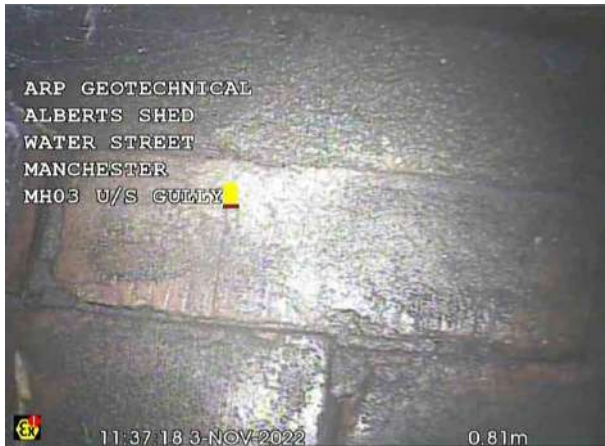
GULLYX\_8b30a0c4-f9c2-486f-8622-9a0cac761c25\_20221103\_110746\_439.jpg, 00:00:07, 0.81 m  
Finish node, gully, reference: GULLY

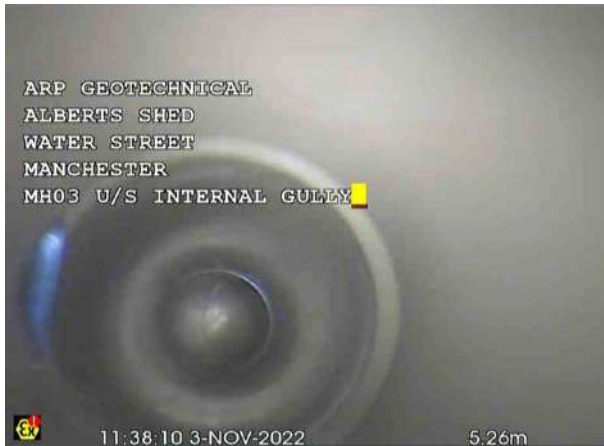
INT  
GULLYX\_62ca5182-b463-47c2-afca-743c1606bd9a\_20221103\_111008\_920.jpg, 00:00:18, 5.62 m  
Sealing ring intruding from 8 o'clock to 10 o'clock

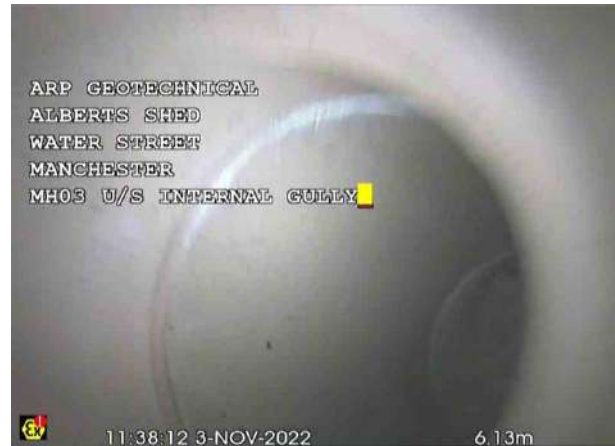
INT  
GULLYX\_3ca9e406-385c-4cb3-aac4-e32f2ab4b197\_20221103\_111020\_695.jpg, 00:00:20, 6.13 m  
Line deviates right

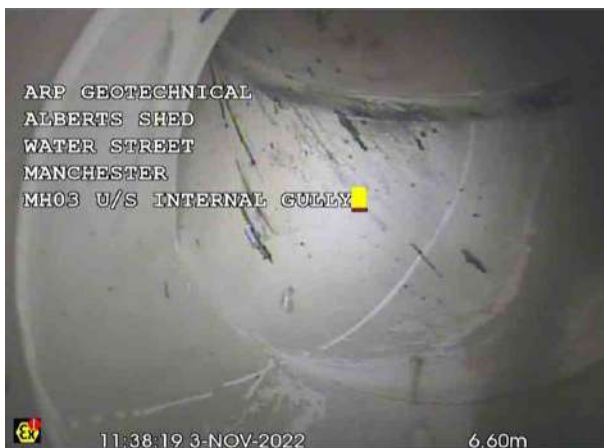
INT  
GULLYX\_b44b2059-3500-4da4-b404-f4379f5f0aee\_20221103\_111043\_704.jpg, 00:00:27, 6.60 m  
Finish node, other special chamber, reference: INT GULLY, INTERNAL GULLY

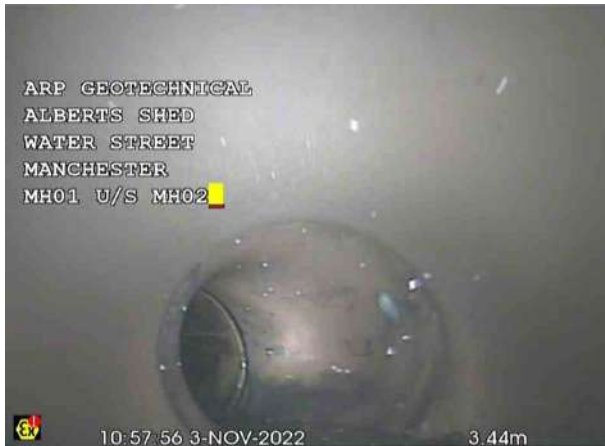
MH02X\_5649f3a6-fc35-4340-aa58-f5dd11ebddb5\_20221103\_115149\_741.jpg, 00:00:12, 3.44 m  
Line deviates left

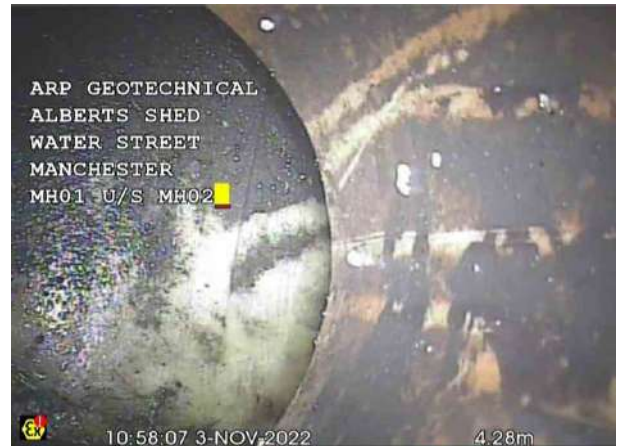
MH02X\_0c80a264-7722-4266-bdd7-9a3ec675f348\_20221103\_115215\_780.jpg, 00:00:23, 4.28 m  
Finish node, manhole, reference: MH02, INTERCEPTOR

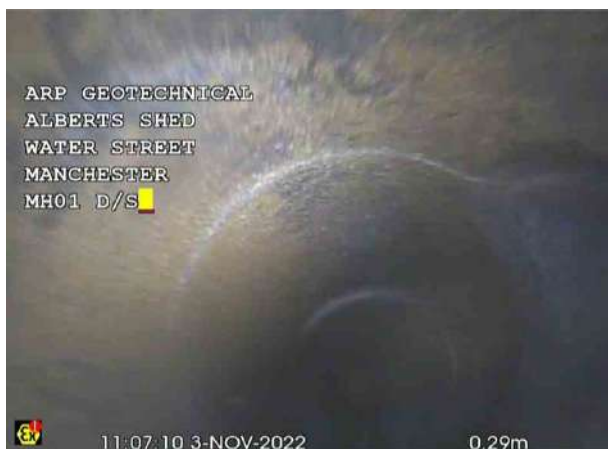
MH01X\_6c986c9b-7597-4e10-bd14-b7b09cb2373c\_20221103\_111732\_185.jpg, 00:00:04, 0.29 m  
Junction at 2 o'clock, 100mm dia

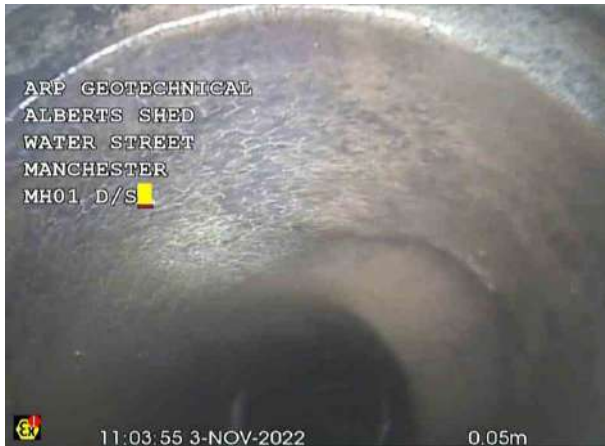
MH01X\_ec86657f-0657-4975-9eda-e6d809d3f18a\_20221103\_111458\_128.jpg, 00:00:01, 0.05 m  
Junction at 2 o'clock, 100mm dia

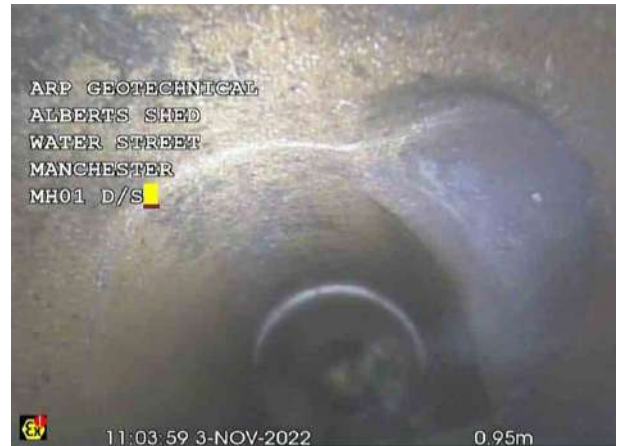
MH01X\_7edd5d05-614e-4d4e-a7f7-91b04670f24d\_20221103\_111518\_598.jpg, 00:00:04, 0.95 m  
Junction at 2 o'clock, 100mm dia

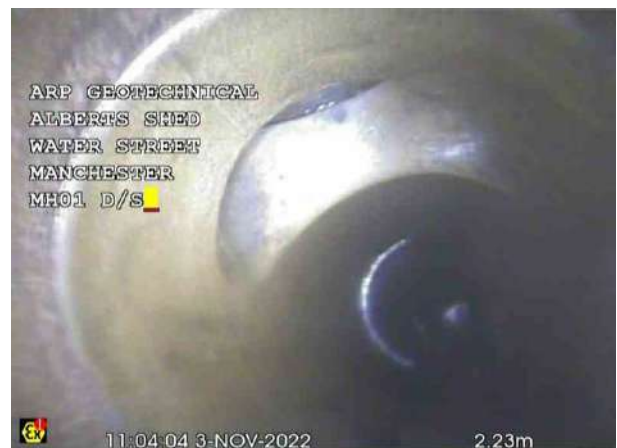
MH01X\_758c0d89-b821-49e1-9045-a0146f49eaf0\_20221103\_111543\_688.jpg, 00:00:08, 2.09 m  
Crack, circumferential from 10 o'clock to 3 o'clock

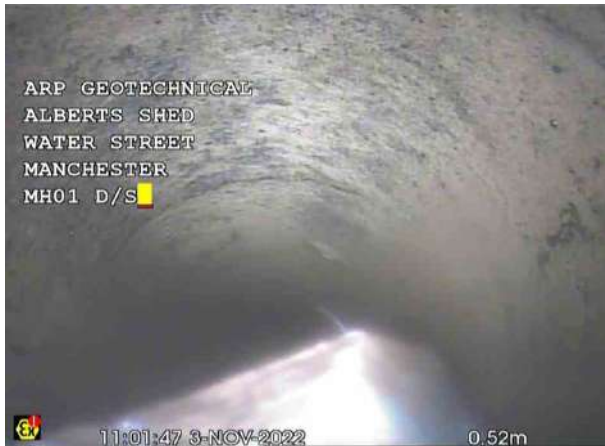
MH01X\_9d1ef569-c7da-4395-8e66-61dcdb648657\_20221103\_111334\_440.jpg, 00:00:14, 0.52 m  
Settled deposits, hard or compacted, 20% cross-sectional area loss, BRICK

- 6.22 To minimise the risk of failure of the drainage systems the exiting below-ground drains should be cleansed, surveyed, and subject to any necessary repair as part of the redevelopment. The above-ground rainwater hardware should also be replaced as per the Architect's details.

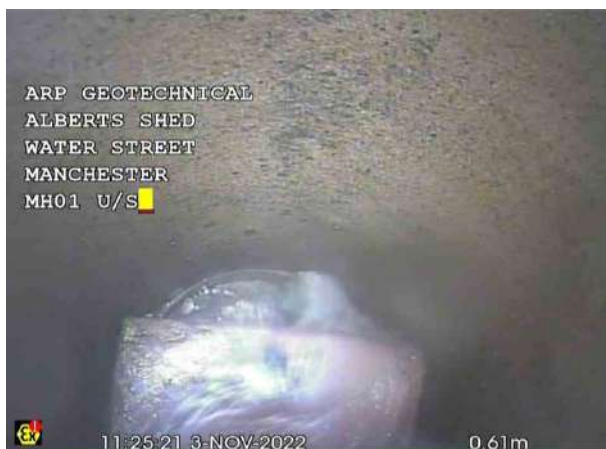
UPSTREAMX\_bbbd1632-55f8-432d-908a-931082e5bfa0\_202  
21103\_114936\_236.jpg, 00:00:14, 0.61 m  
Settled deposits, fine, 80% cross-sectional area loss, BRICK

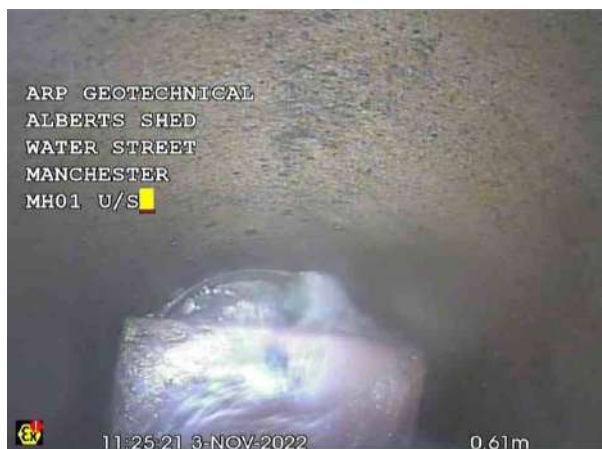
UPSTREAMX\_f23bd0f1-b6de-409b-a45d-34eea2a08706\_202  
21103\_114950\_325.jpg, 00:00:14, 0.61 m  
Survey abandoned, DUE TO BRICK IN THE LINE

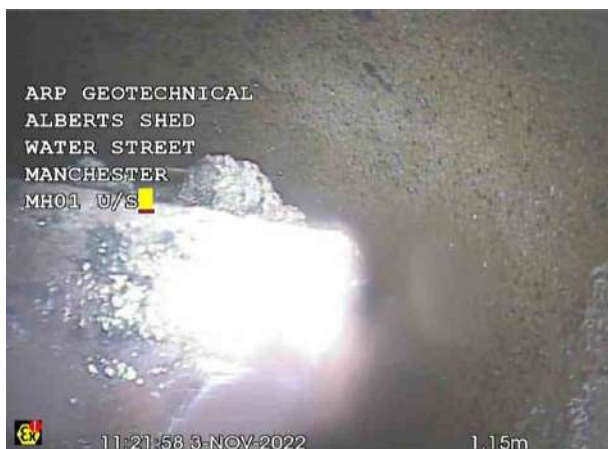
UPSTREAMX\_e9b5231e-8ef0-4888-a9ec-0526debadabe\_202  
21103\_113849\_327.jpg, 00:00:16, 1.15 m  
Settled deposits, fine, 80% cross-sectional area loss, BRICK

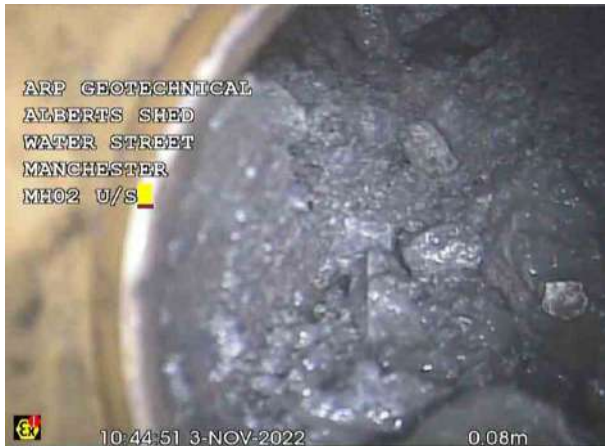
PIPE  
AX\_f1247b96-911d-45ae-b513-4e620648cbef\_20221103\_115  
640\_637.jpg, 00:00:01, 0.08 m  
Settled deposits, fine, 100% cross-sectional area loss

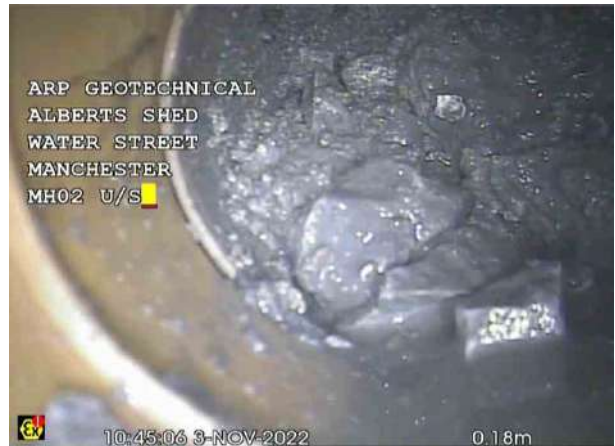
PIPE  
AX\_fd4dab9d-f328-4d40-8b53-bb00776ffb41\_20221103\_1156  
56\_375.jpg, 00:00:17, 0.18 m  
Survey abandoned, DUE TO SILT

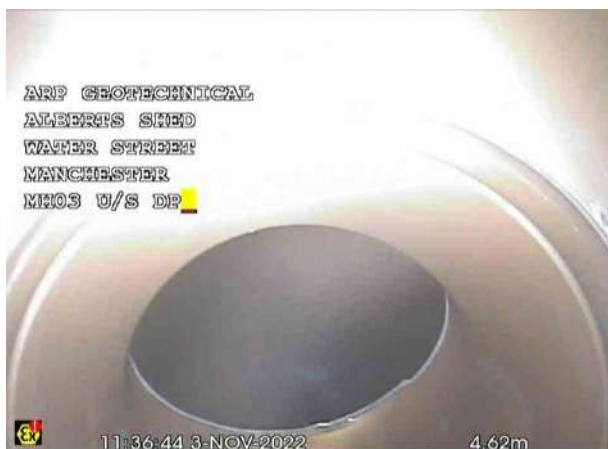
DOWNPIPEX\_73b6c0f5-a6f5-4482-b9bc-03d926337feb\_2022  
1103\_110603\_096.jpg, 00:00:27, 4.62 m  
Finish node, other special chamber, reference: DOWNPIPE,  
RAIN WATER DOWN PIPE

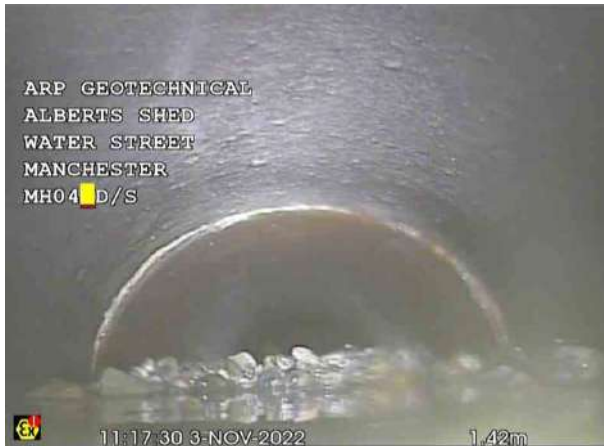
MH04X\_aedf9866-95a1-47ce-85b5-e0ea0ae17a03\_20221103\_113512\_208.jpg, 00:00:22, 1.42 m  
Settled deposits, fine, 50% cross-sectional area loss

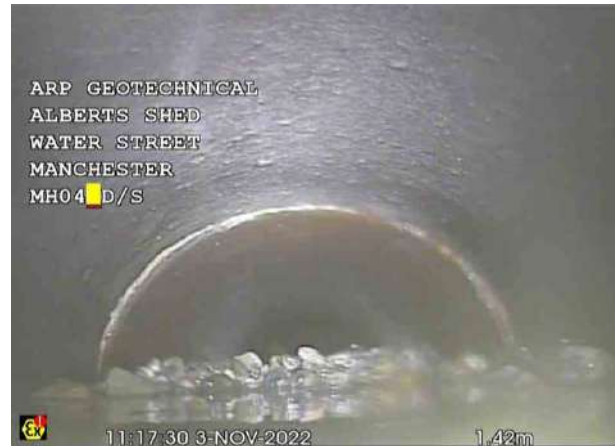
MH04X\_86c1a2af-402a-432c-99a1-a51d12199534\_20221103\_113525\_263.jpg, 00:00:22, 1.42 m  
Survey abandoned, DUE TO SILT AND DEBRIS

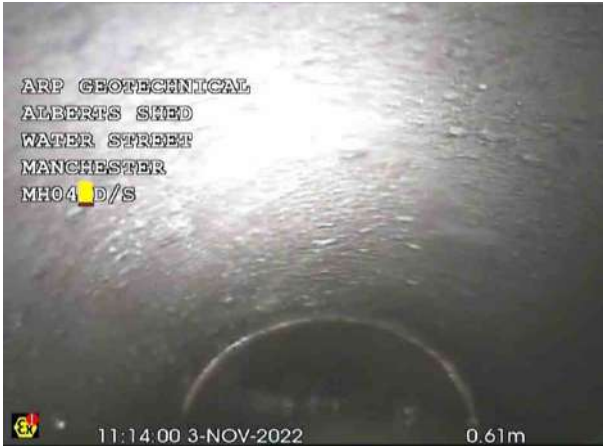
MH04X\_a0d3e00e-9b66-4916-9f05-b42dff528cc\_20221103\_113317\_432.jpg, 00:00:20, 0.61 m  
Survey abandoned, DUE TO SILT AND DEBRIS

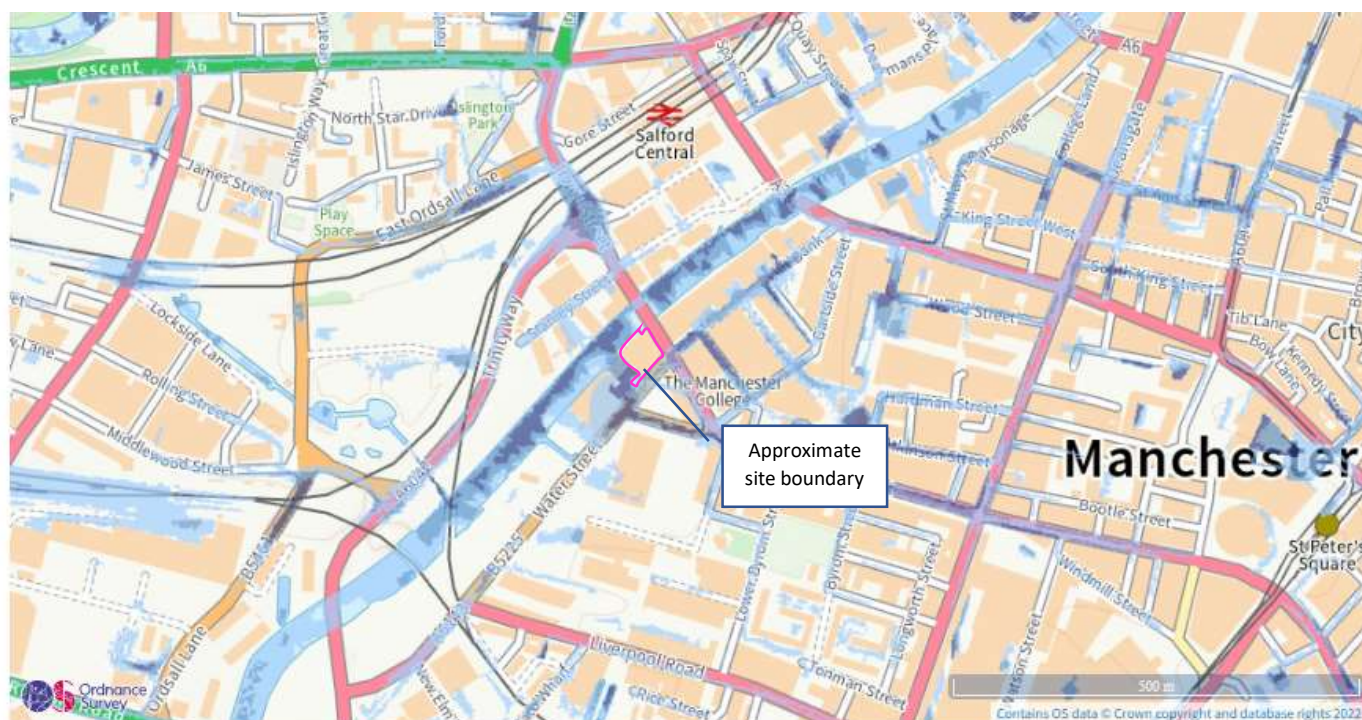
## Extracts from Environment Agency Risk of Flooding from Surface Water Map

Extent of flooding from surface water

High Medium Low Very low

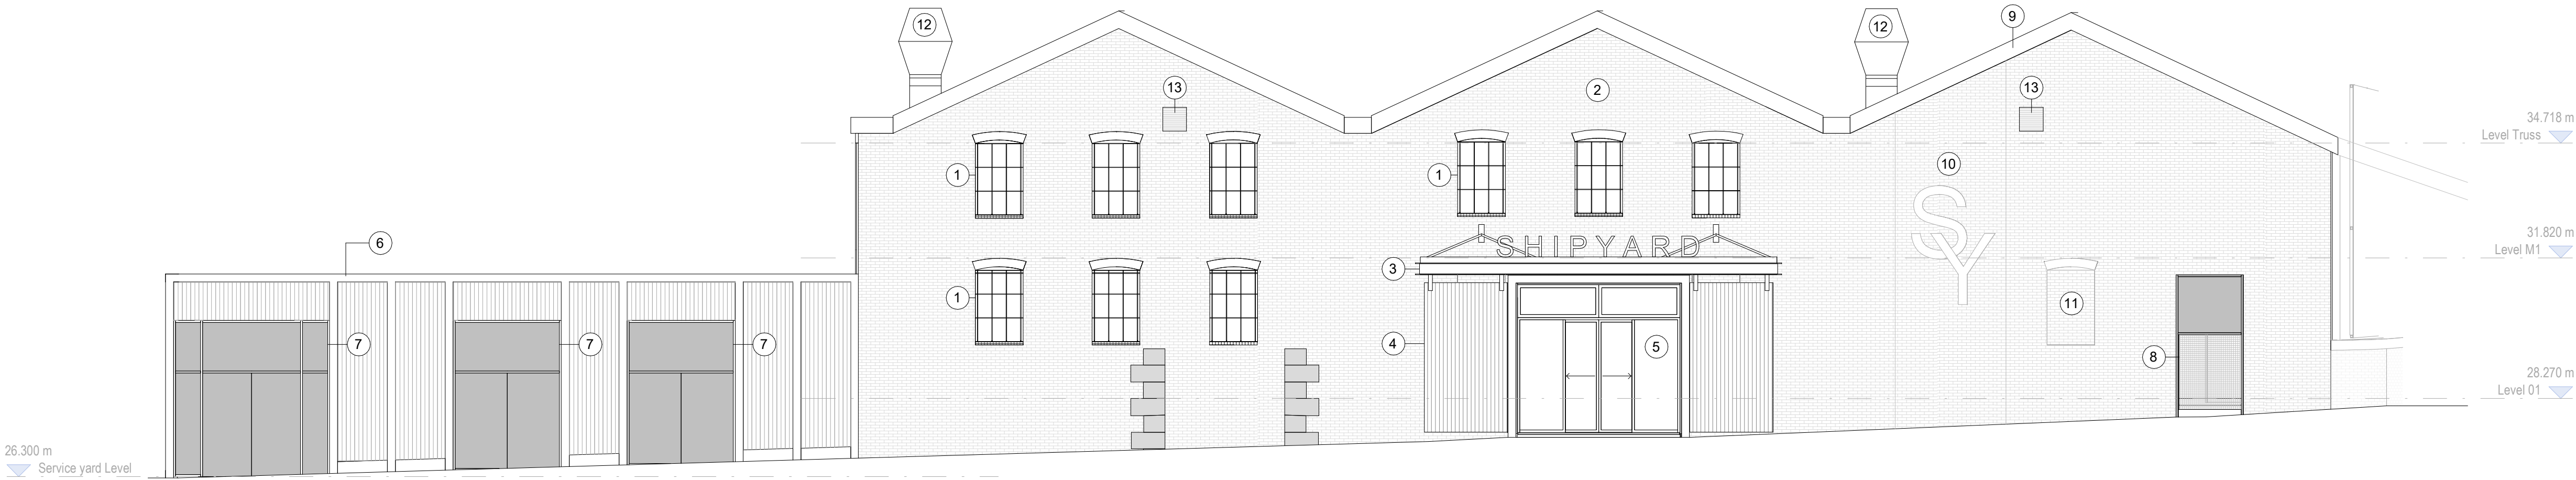
- ① Existing windows retained and made good  
If refurbishing is not possible, replace with a new window to match existing.
- ② Existing brickwork retained, cleaned and made good.
- ③ New metal canopy in black and free standing signage
- ④ New timber sliding shutters
- ⑤ New entrance with curtain wall and sliding doors in black grey
- ⑥ New metal framed screen to service yard in black grey
- ⑦ New metal service yard and substation door in black grey
- ⑧ New metal fire exit gate in black grey
- ⑨ New metal roof fascia in black grey
- ⑩ New painted signage and artwork
- ⑪ New brickwork within existing window openig
- ⑫ New extract air discharge
- ⑬ New extract louvre

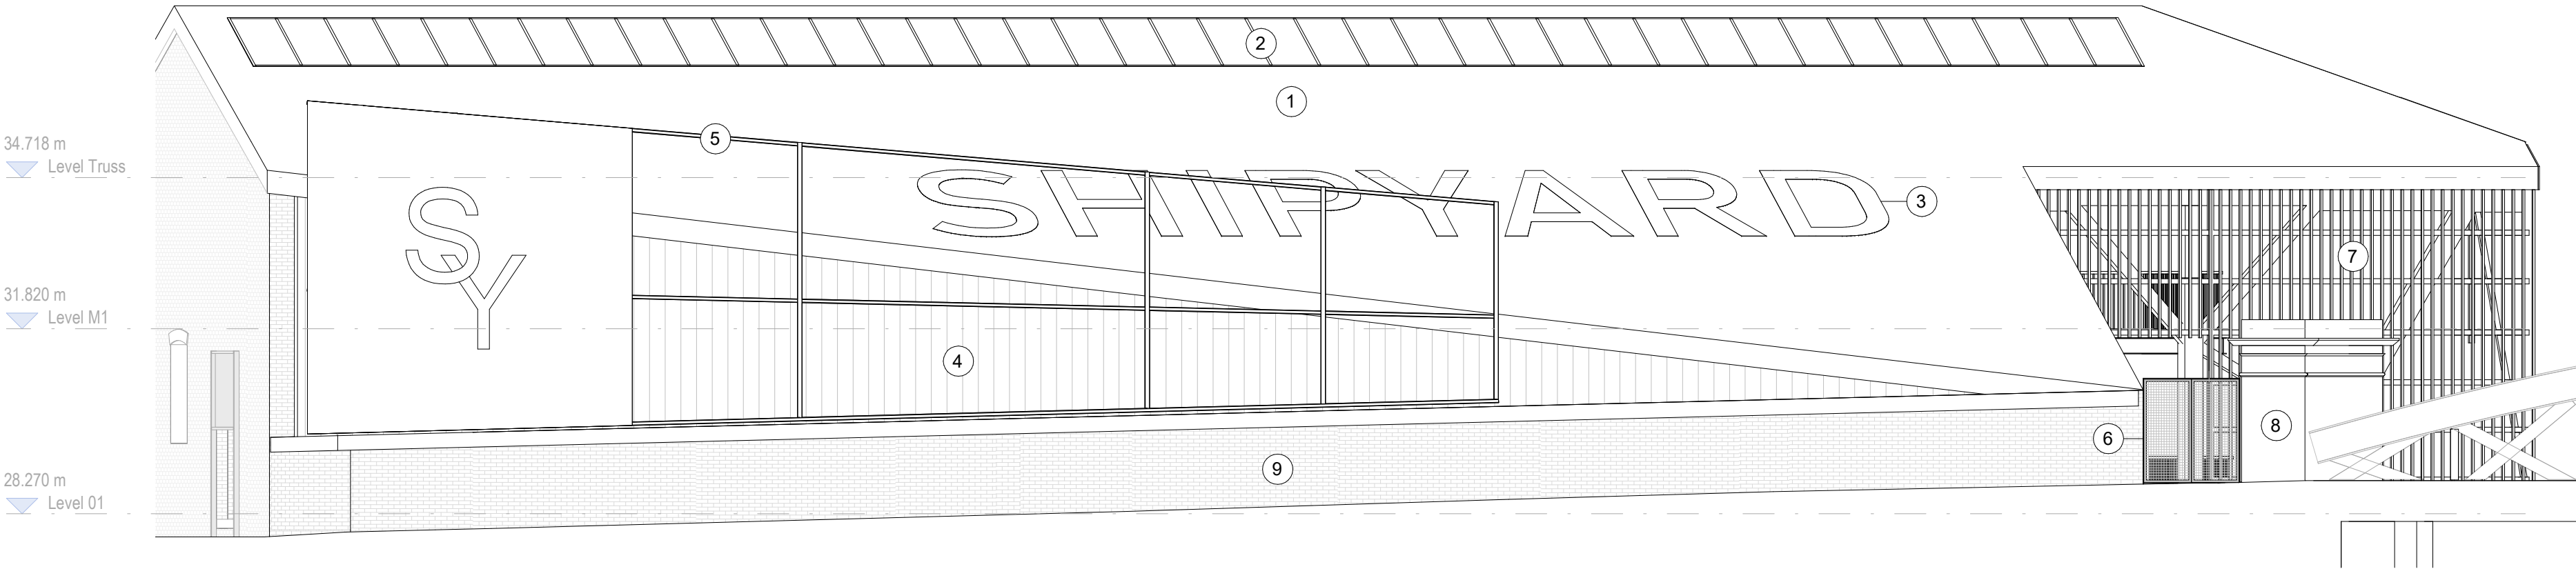
- 1 New ribbed metal roof finish in black grey
- 2 New framed roof skylights
- 3 New painted signage
- 4 New timber cladding to external wall
- 5 Existing advertising board frame reused
- 6 New metal secondary entrance gate in black grey
- 7 New timber canopy
- 8 Existing bridge pier retained
- 9 Existing brick wall made good

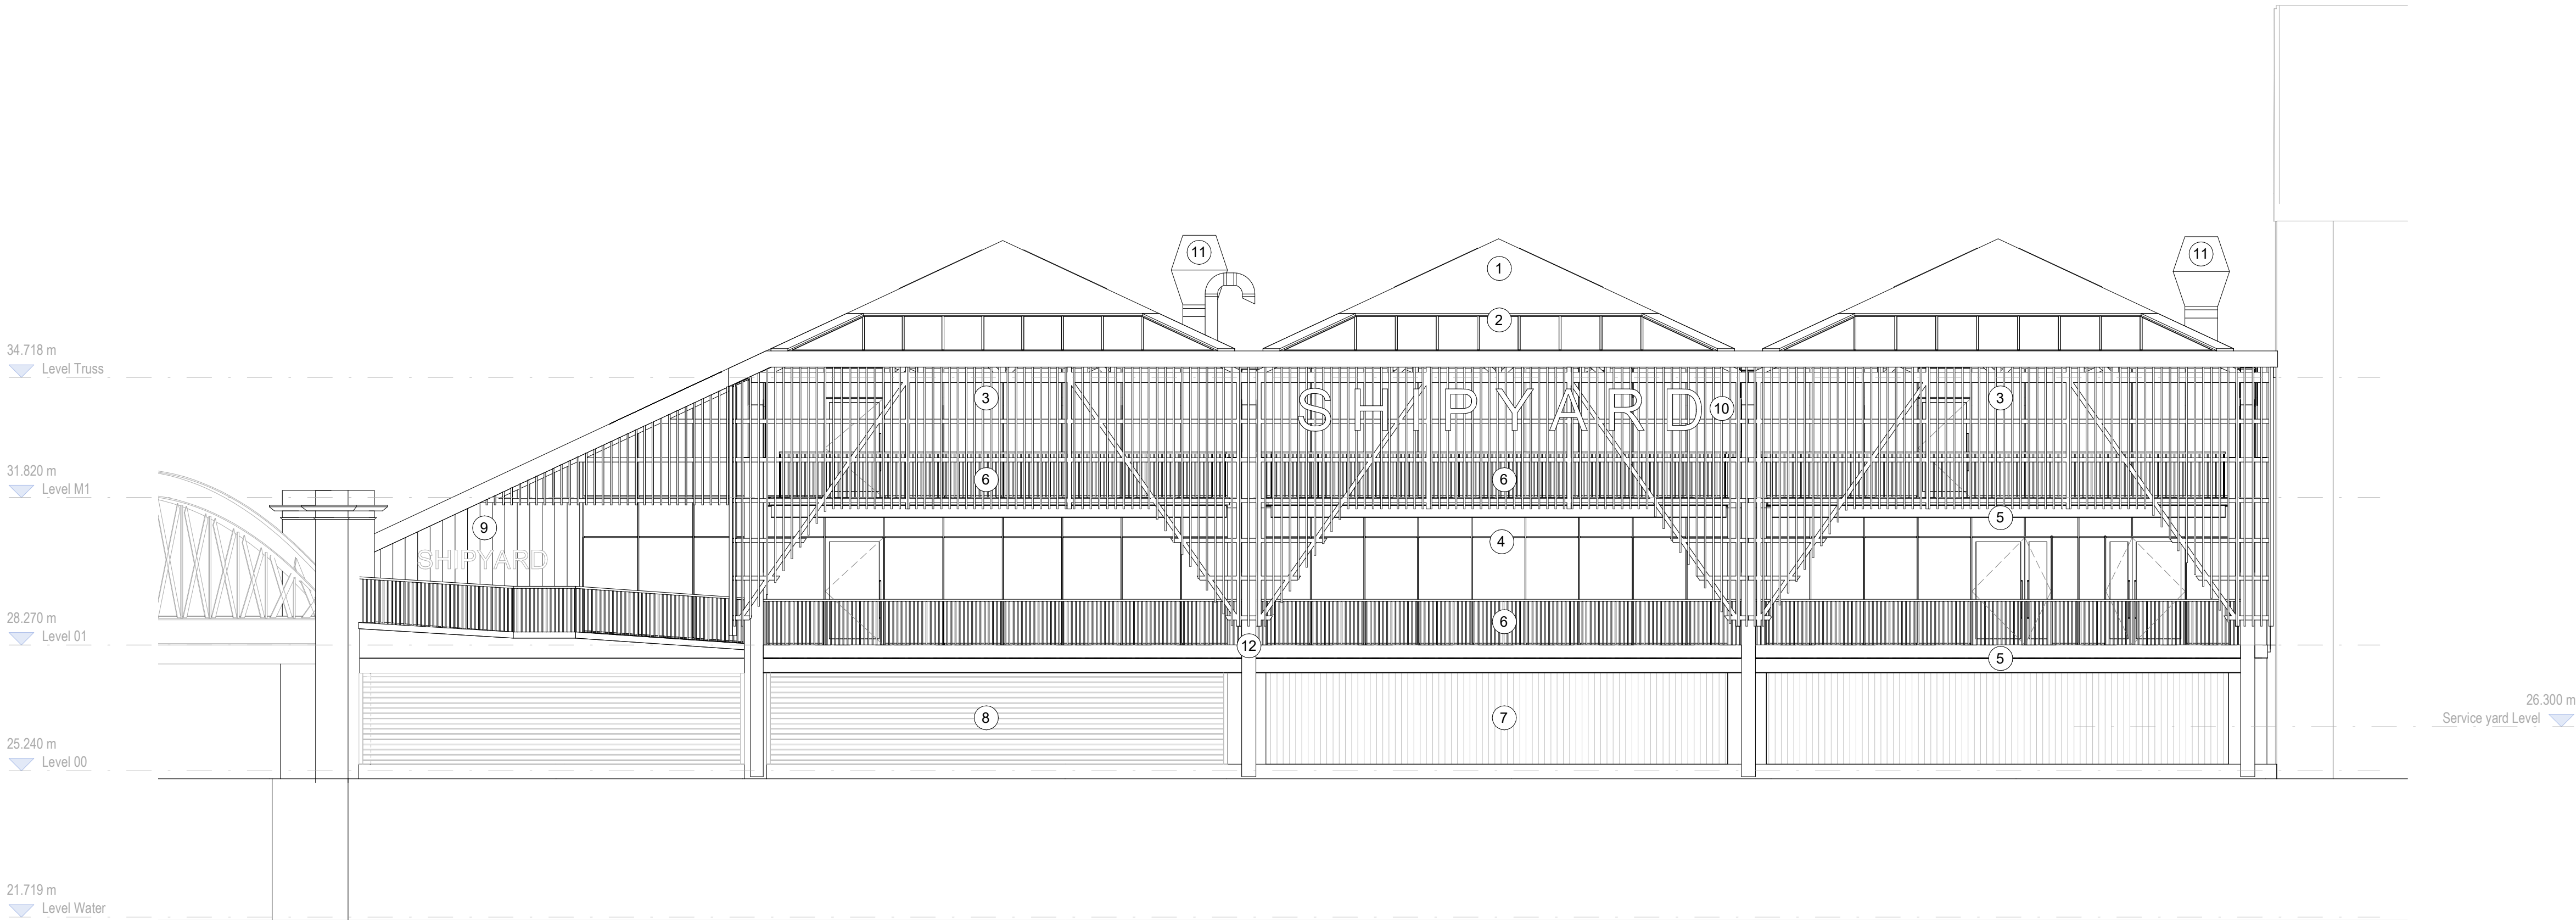
- 1 New ribbed metal roof finish in black grey
- 2 New framed roof skylights
- 3 New slatted timber cladding in line with the original form
- 4 New curtain wall glazing and access doors in black grey
- 5 New external terrace with composite decking
- 6 New metal balustrade in black grey
- 7 New timber cladding in dark grey
- 8 New metal louvre screen in black grey
- 9 New painted signage
- 10 New signage in black fixed to the face of timber cladding
- 11 New extract air discharge
- 12 Existing structure to be retained and made good
