## **FOUL AND SURFACE WATER DRAINAGE STRATEGY**

FOR  
**SHIPYARD  
(ALBERT SHED)  
WATER STREET  
MANCHESTER**

ON BEHALF OF  
**MANCHESTER QUAYS TWO LTD**

| <b>Flood Risk Assessment for Shipyard (Albert Shed), Water Street, Manchester</b><br><b>2132/01r2a</b> | | | |

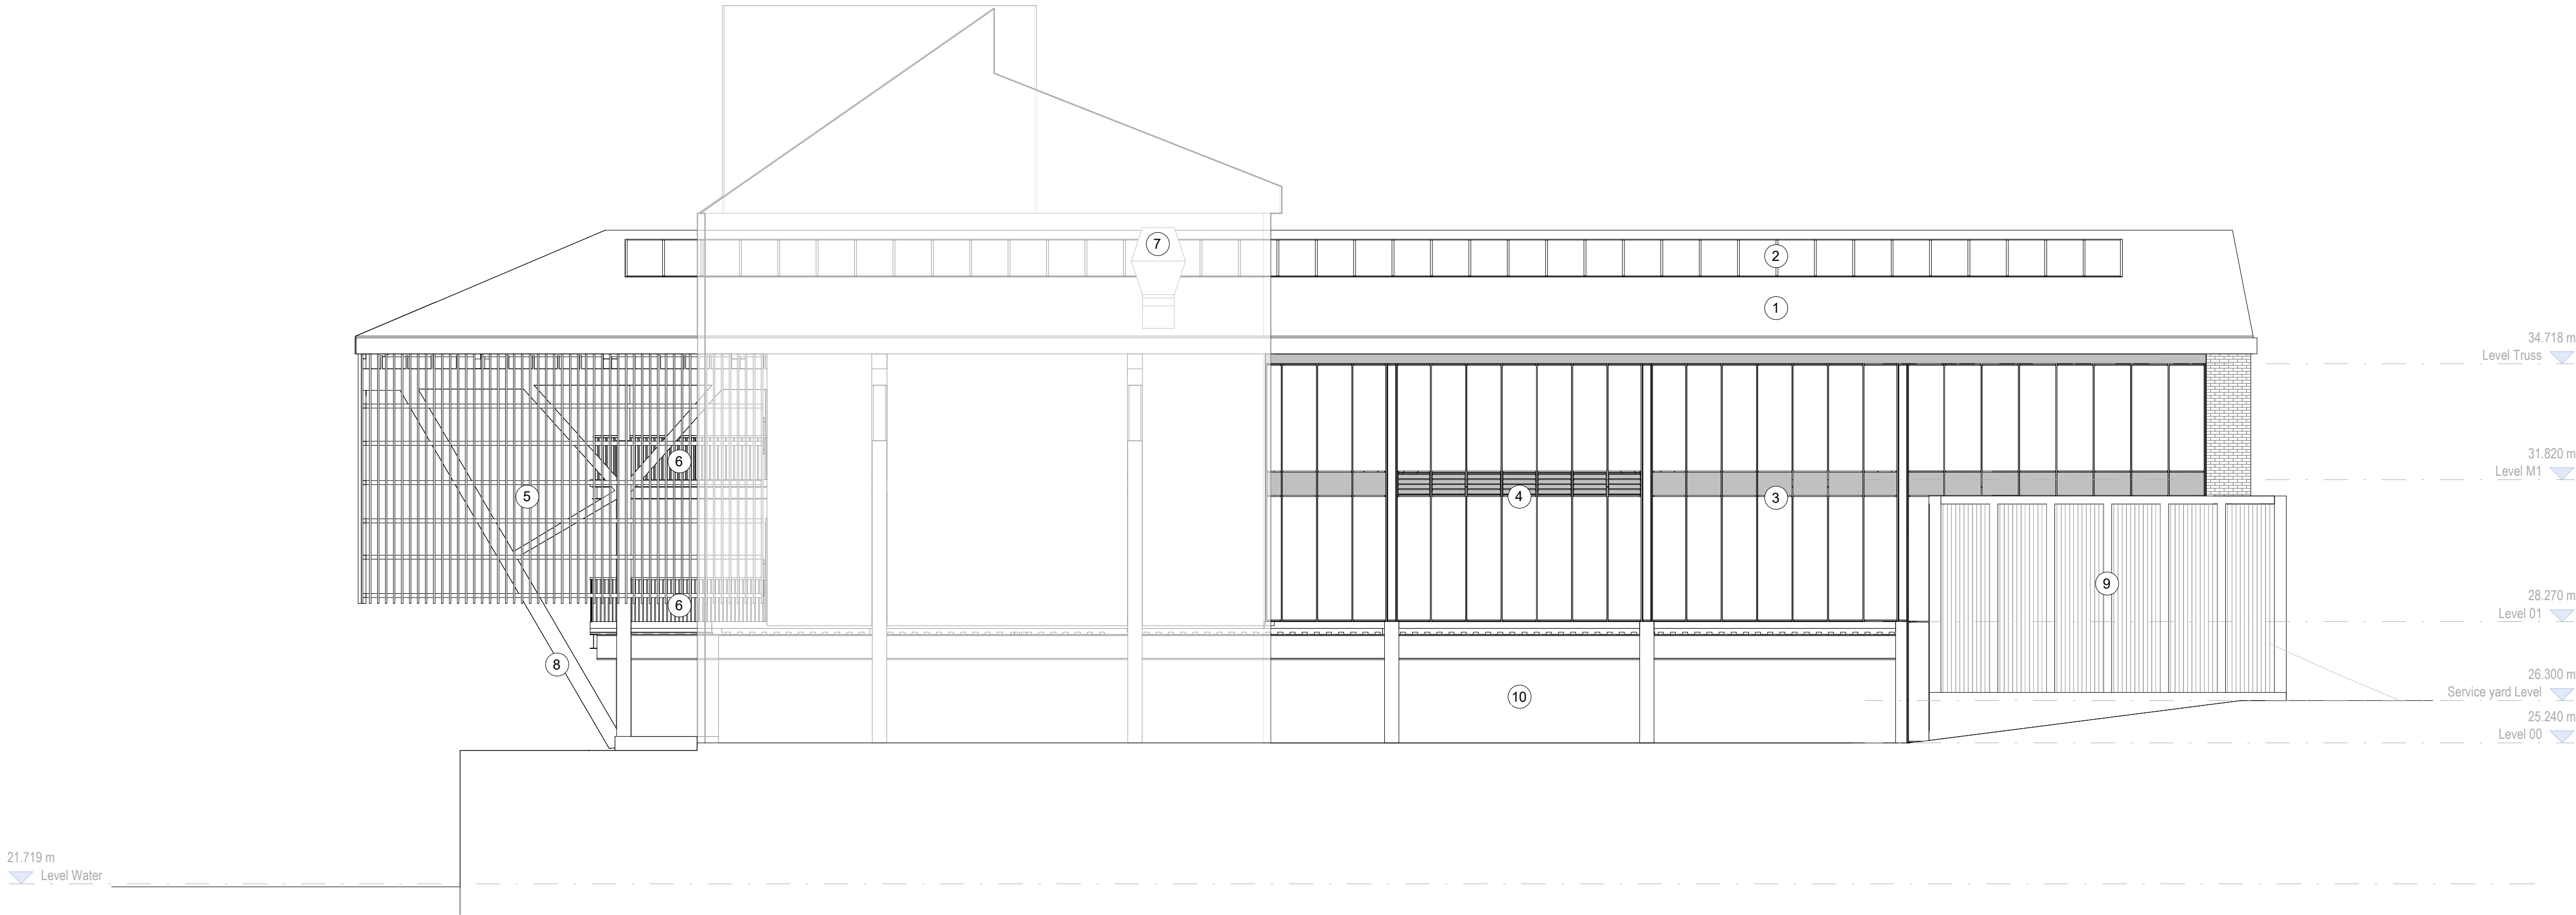
- 1 New ribbed metal roof finish in black grey
- 2 New framed roof skylights
- 3 New curtain wall with solid metal panels in mid grey
- 4 New metal louvre in curtain wall in dark grey
- 5 New slatted timber cladding in line with the original form
- 6 New metal balustrade in black grey
- 7 New extract air discharge
- 8 Existing structure to be retained and made good
- 9 New metal framed screen to service yard in black grey
- 10 Existing ground floor car park
