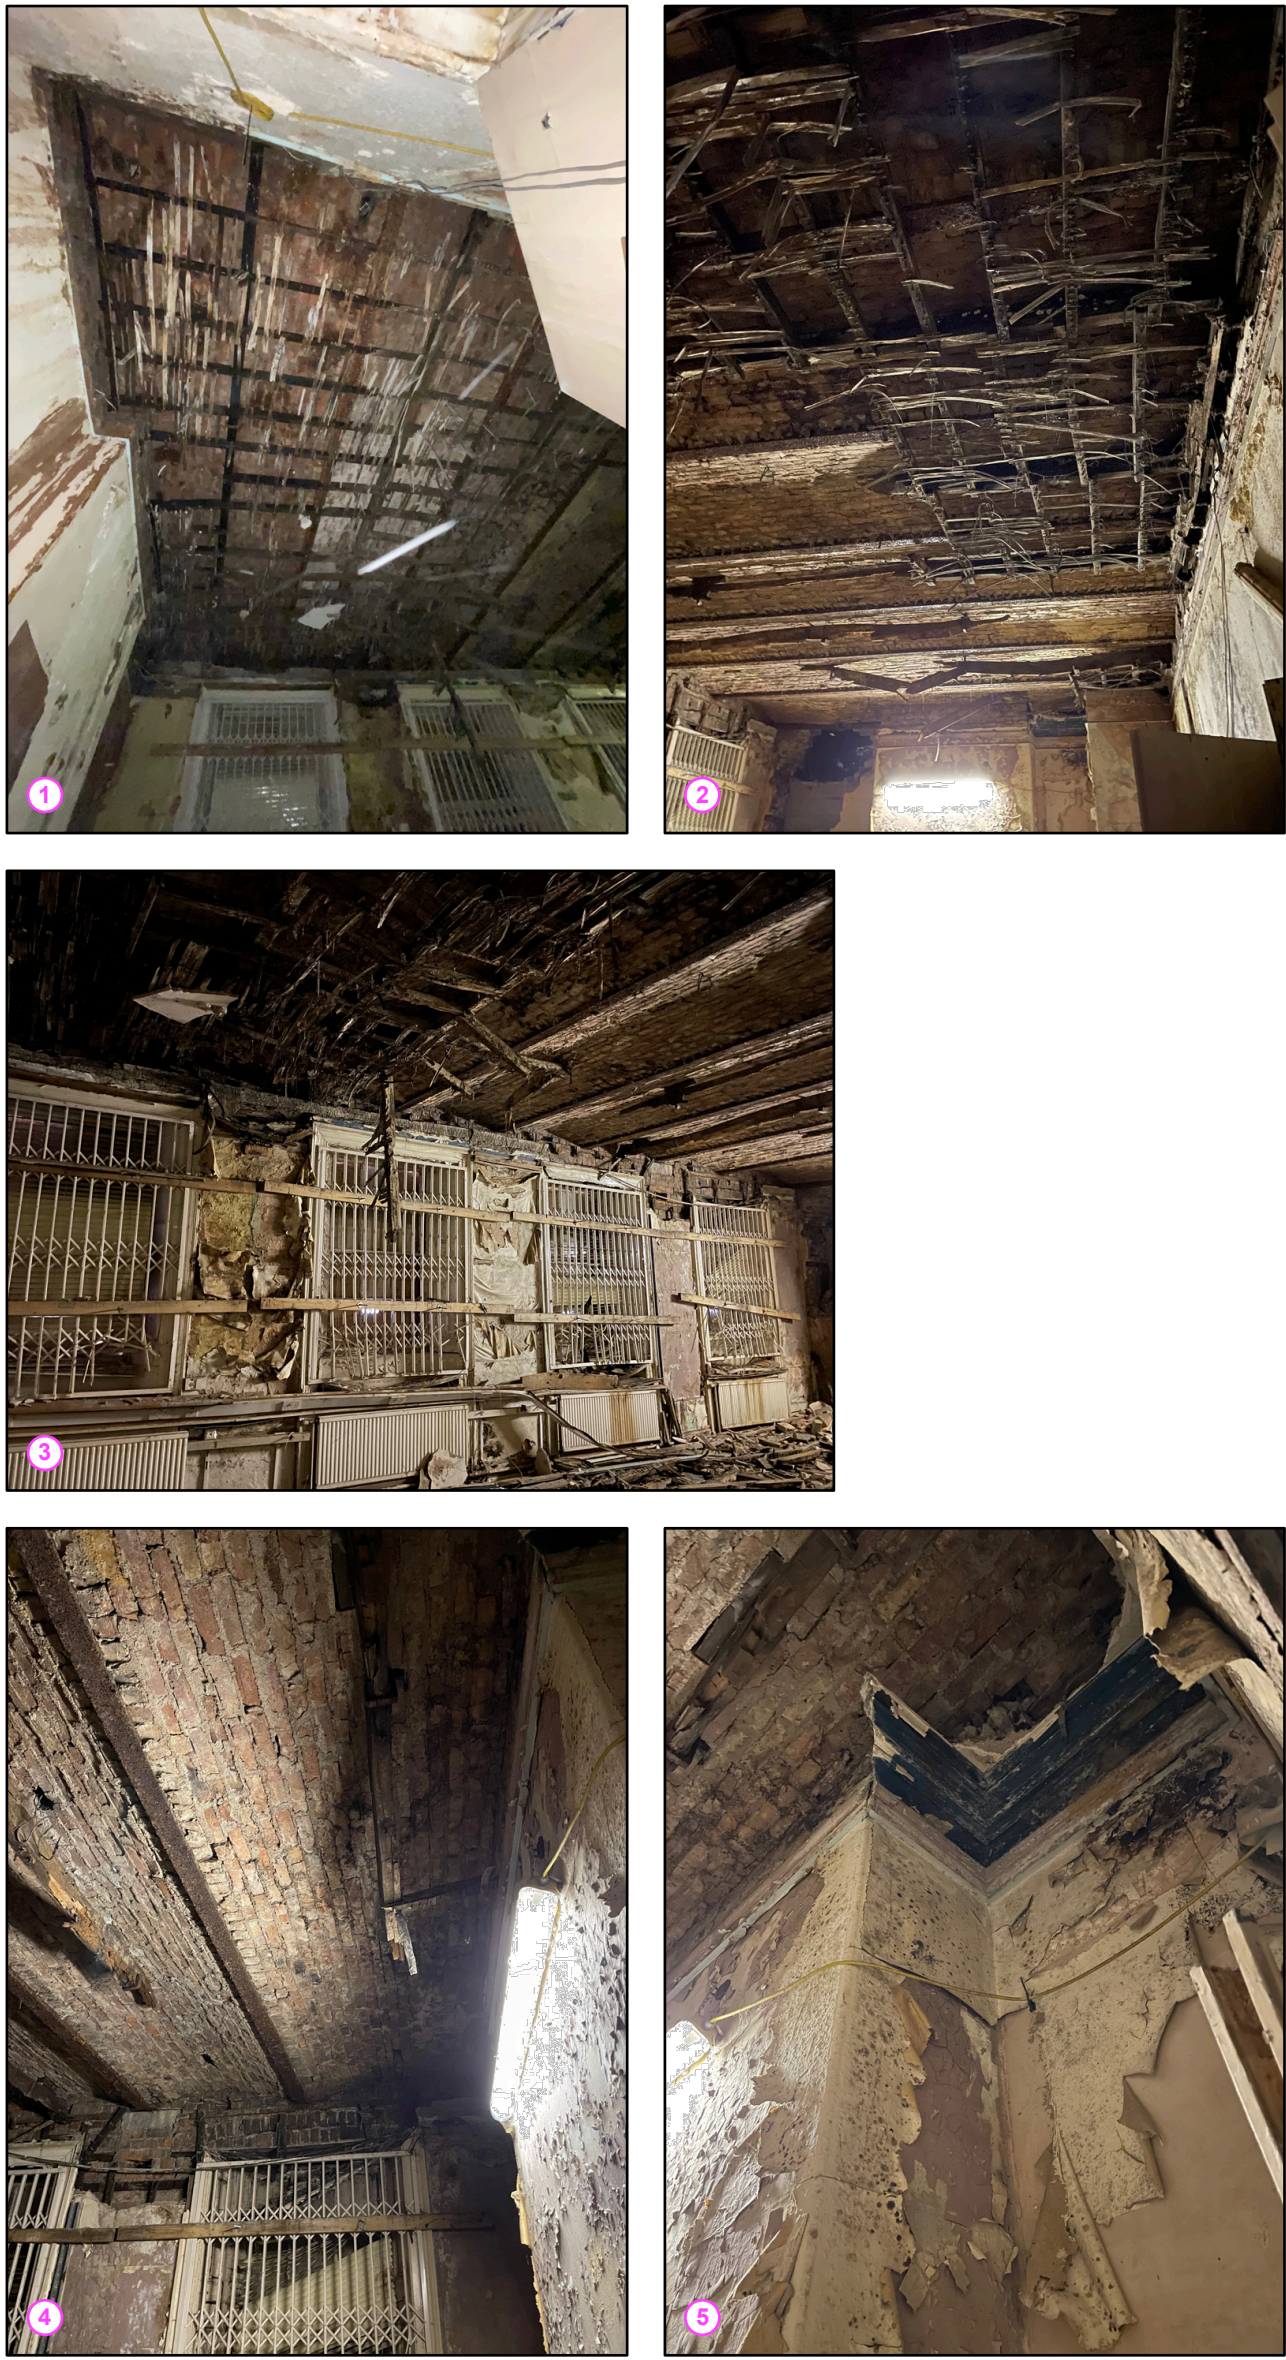
ROOM G.27

- Restricted access - Room is inaccessible due to collapsed ceiling and/or unsafe floor structure
- No cornice
- Ceiling has collapsed completely
- Vaulted ceiling has been exposed (brickwork)

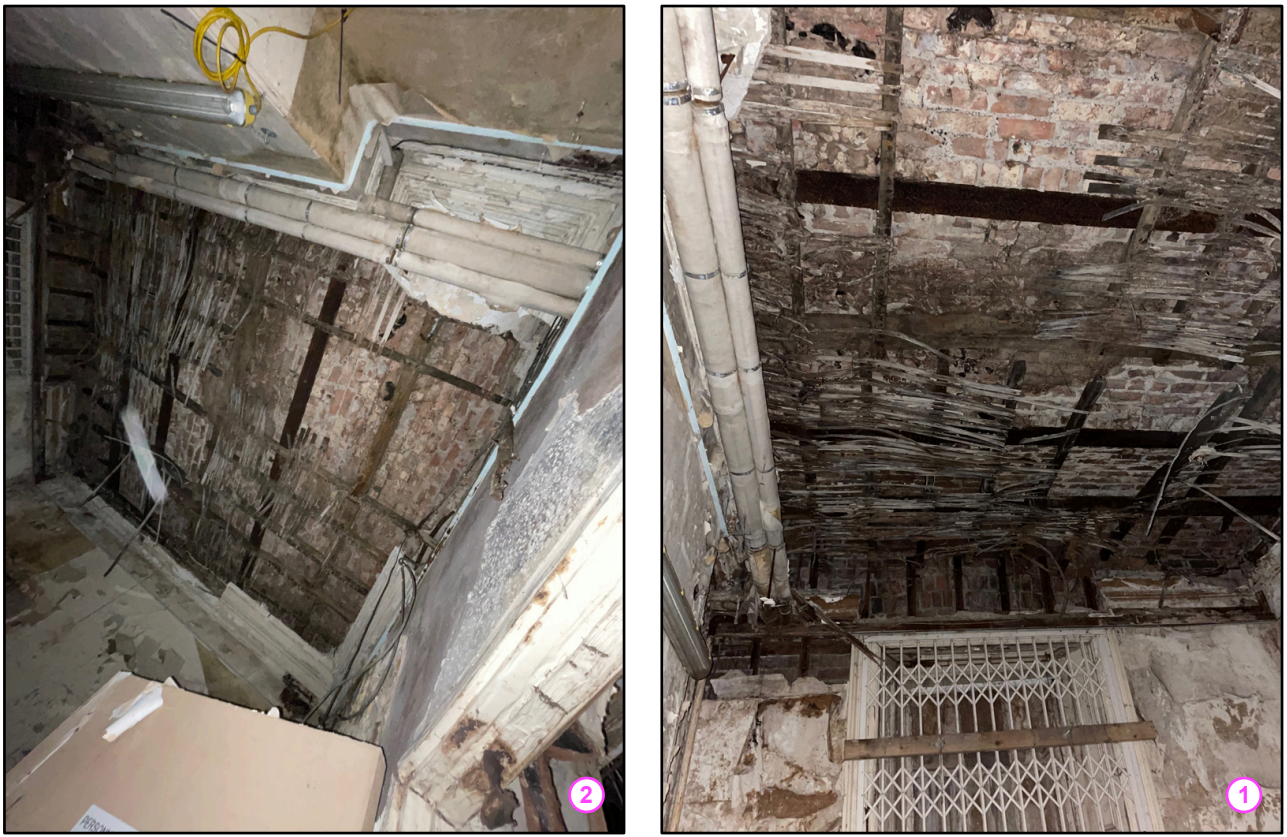
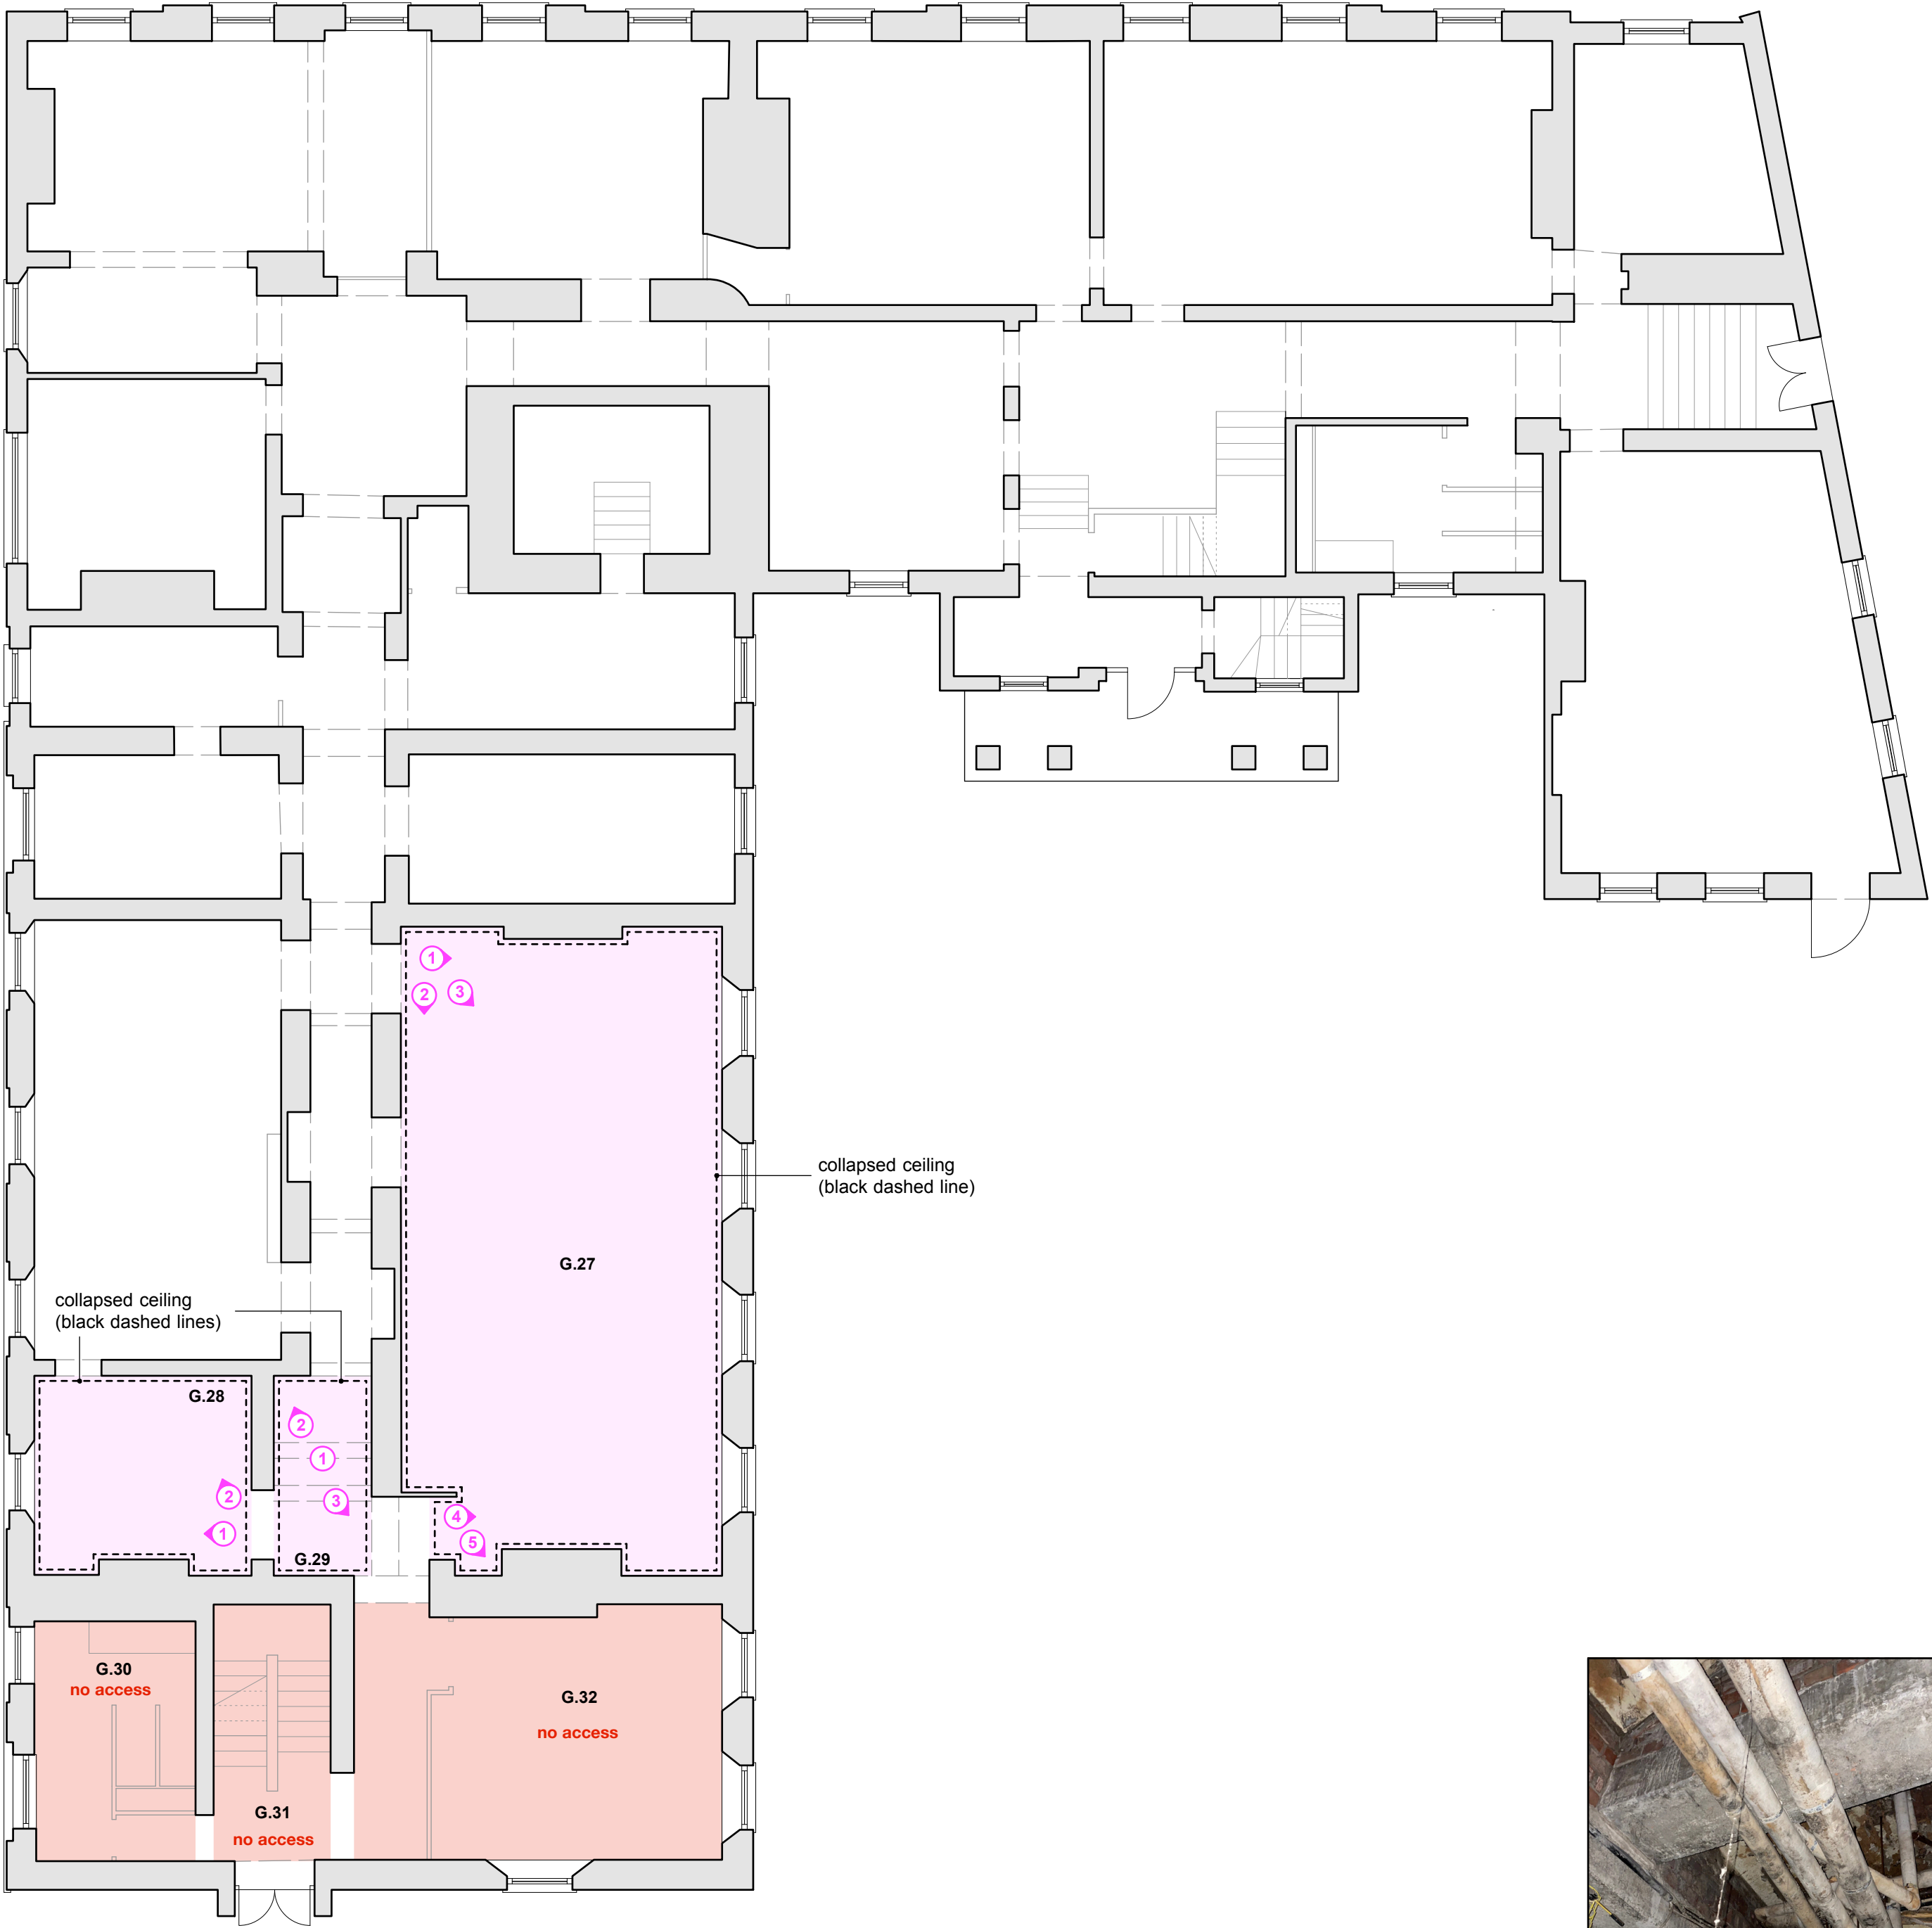
ROOM G.28

- Restricted access - Room is inaccessible due to collapsed ceiling and/or unsafe floor structure
- No cornice
- Ceiling has collapsed completely
- Vaulted ceiling has been exposed (brickwork)

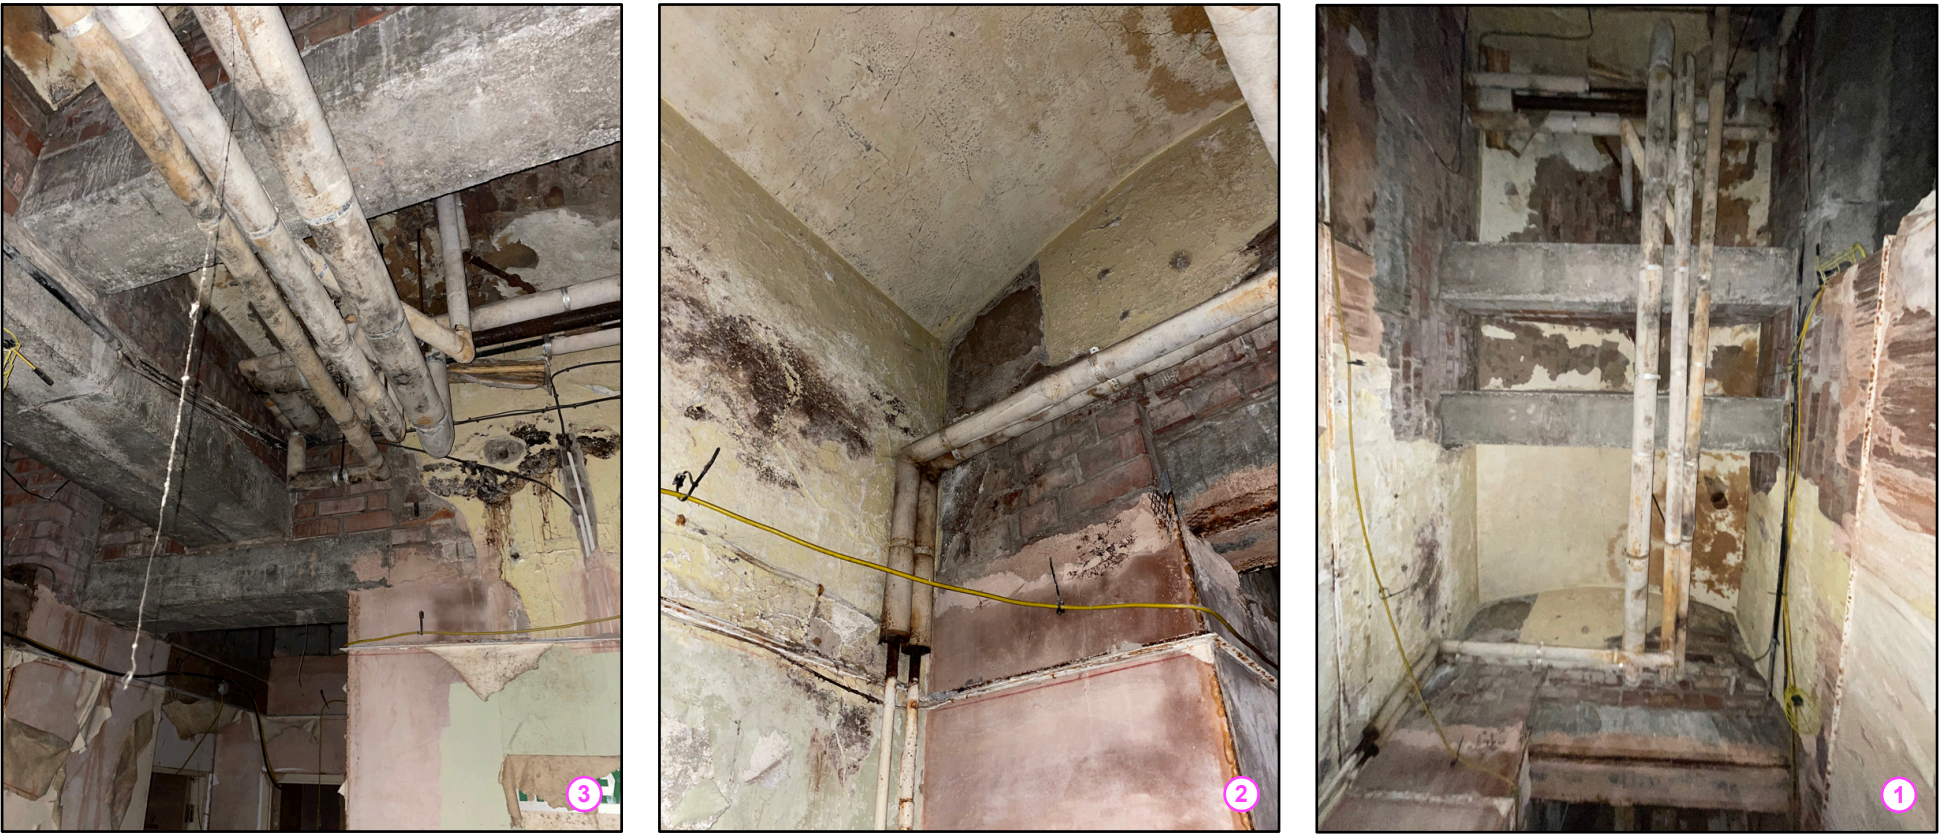
ROOM G.29

- No cornice
- Ceiling has collapsed completely
- Vaulted ceiling has been exposed
