| | | | | <div>Drawing purpose</div> <div>For Information</div> | <div>Client</div> <div>Pomona</div> | | <div>Drawing Title</div> <div>Window Surround Profile</div> | | |
| | | | | <div>This drawing copyright 2020 by Up North Architects Ltd. and is licensed to the client for the purposes related to the RIBA work stage above only</div> | <div>Job No.</div> <div>M867</div> | <div>Drawing no.</div> <div>045</div> | <div>Revision</div> <div>-</div> | <div>Scale</div> <div>Varies @ A3</div> | <div>Date</div> <div>Jan 2023</div> |

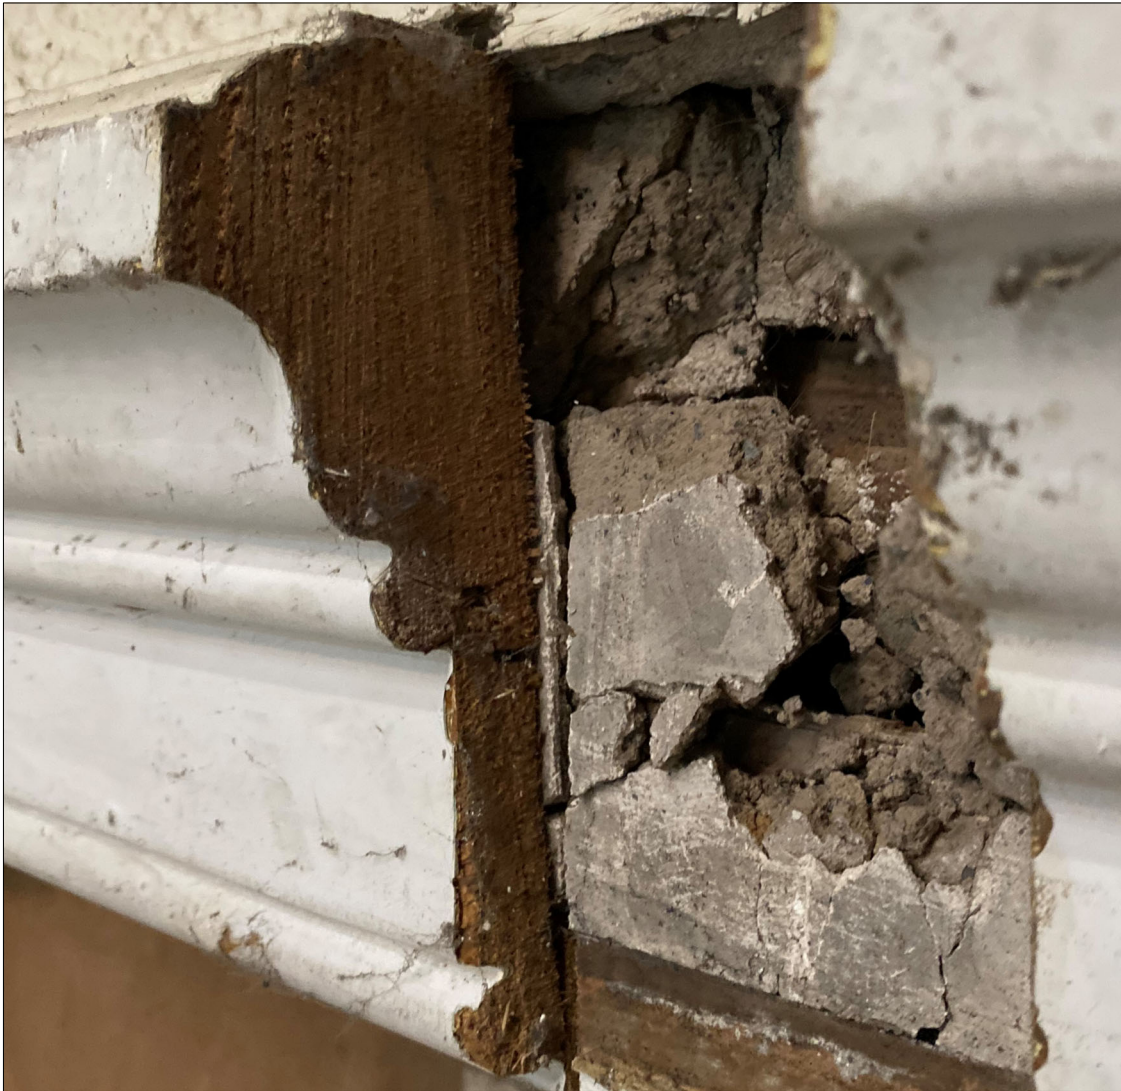
IMAGE OF DAMAGED SECTION OF WINDOW SURROUND  
SHOWING PROFILE

Where repairs to window surrounds are required a matching profile should be sourced and fitted. The finishes to this molding should match the existing finish of the window surrounds
