## 38 to 42 Mosley Street Paint Analysis

### Report on Findings Report No HPM38MS01

ISSUE 01– 06/02/2023

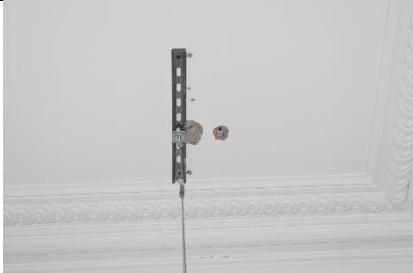
| Sample Ref: 01 | Location: 38 to 42 Mosley Street |
|---|---|
| <p>Paint sample removed from:</p> <p>Location: 01 – Second Floor (Room A) Ceiling.</p> <p>A total of 9 separate paint layers were found.</p> | |

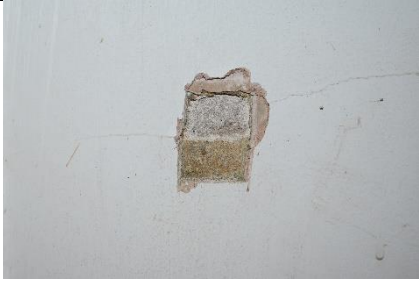
| Sample Ref: 02 | Location: 38 to 42 Mosley Street |
|---|---|
| <p>Paint sample removed from:</p> <p>Location: 02 – Second Floor (Room A) Wall.</p> <p>A total of 21 separate paint layers were found.</p> | |

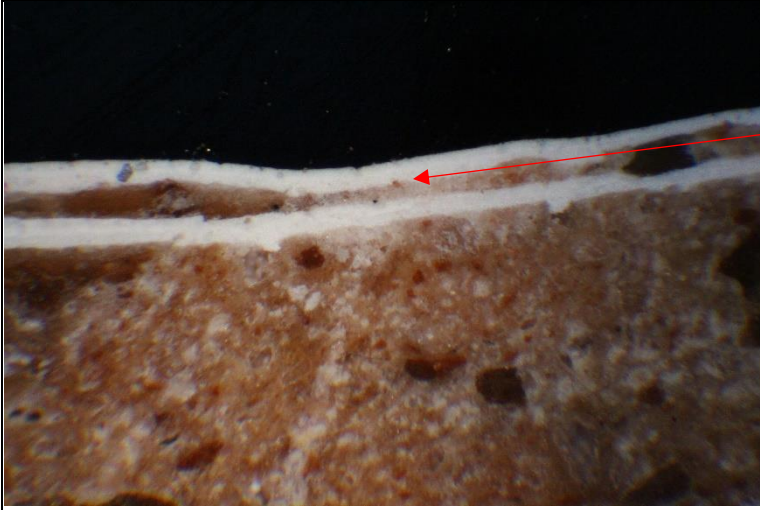
| Sample Ref: 02 | Location: 38 to 42 Mosley Street |
|---|---|
| | <p>X50 Magnification –</p> <p>Single modern Titanium white paint coating over plaster (2No coatings are present but assumed part of the same scheme.</p> <p>Plaster is modern gypsum plaster.</p> <p>Plaster was removed locally to reveal earlier layers/</p> |
| | <p>X50 Magnification -</p> <p>Earlier paint layers.</p> <p>2No white paint coatings.</p> <p>Stone over off-white.</p> <p>2No stone paint schemes.</p> <p>Light, mid and dark green schemes.</p> <p>Light green paint scheme</p> <p>Red paint scheme.</p> <p>Green</p> <p>2No salmon paint schemes.</p> <p>6No green schemes.</p> |

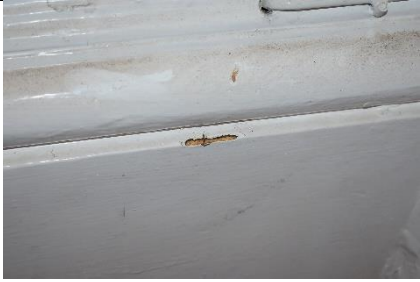
| Sample Ref: 03 | Location: 38 to 42 Mosley Street |
|---|---|
| <p>Paint sample removed from:</p> <p>Location: 03 – Second Floor (Room A), Skirting.</p> <p>A total of 28 separate paint / varnish layers were found.</p> | |

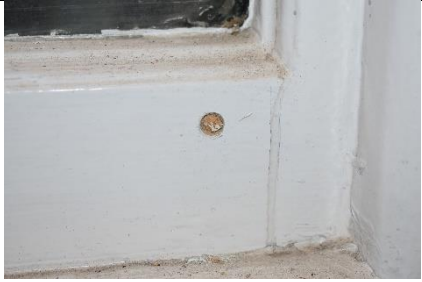
| Sample Ref: 04 | Location: 38 to 42 Mosley Street |
|---|---|
| <p>Paint sample removed from:</p> <p>Location: 04 – Second Floor (Room A), Window.</p> <p>A total of 10 separate paint layers were found.</p> | |

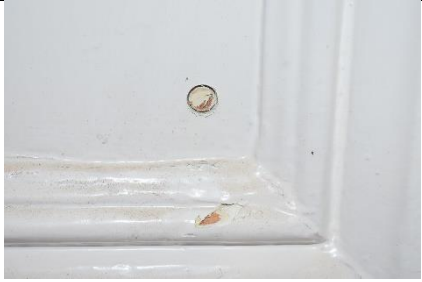
| Sample Ref: 05 | Location: 38 to 42 Mosley Street |
|---|---|
| <p>Paint sample removed from:</p> <p>Location: 05 – Second Floor (Room A), Reveal Panel.</p> <p>A total of 15 separate paint / varnish layers were found.</p> | |

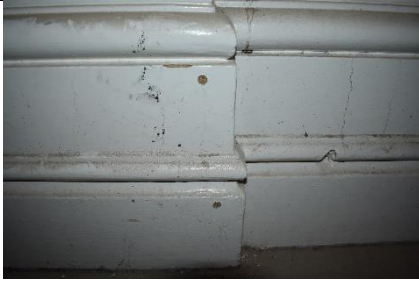
| Sample Ref: 06 | Location: 38 to 42 Mosley Street |
|---|---|
| <p>Paint sample removed from:</p> <p>Location: 06 – Second Floor (Corridor), Skirting.</p> <p>A total of 27 separate paint / varnish layers were found.</p> | |

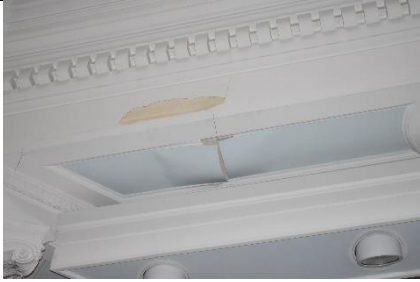
| Sample Ref: 07 | Location: 38 to 42 Mosley Street |
|---|---|
| <p>Paint sample removed from:</p> <p>Location: 07 – Second Floor (Room B, Dome Room), Down stand Beams.</p> <p>A total of 26 separate paint layers were found.</p> | |

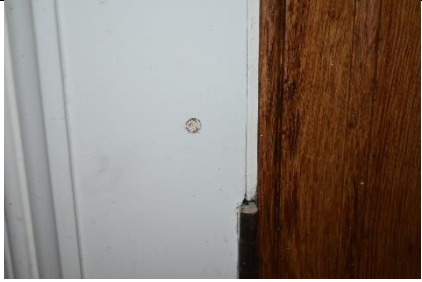
| Sample Ref: 08 | Location: 38 to 42 Mosley Street |
|---|---|
| <p>Paint sample removed from:</p> <p>Location: 08 – Second Floor (Room B – Dome Room), Door.</p> <p>A total of 18 separate paint layers were found.</p> | |

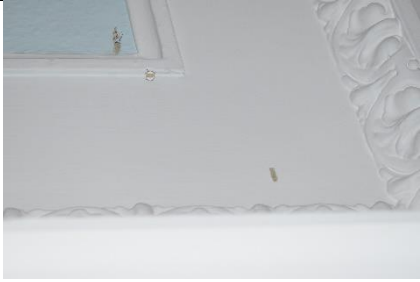
| Sample Ref: 09 | Location: 38 to 42 Mosley Street |
|---|---|
| <p>Paint sample removed from:</p> <p>Location: 09 – Second Floor (Room B – Dome Room), white panel borders.</p> <p>A total of 16 separate paint layers were found.</p> | |

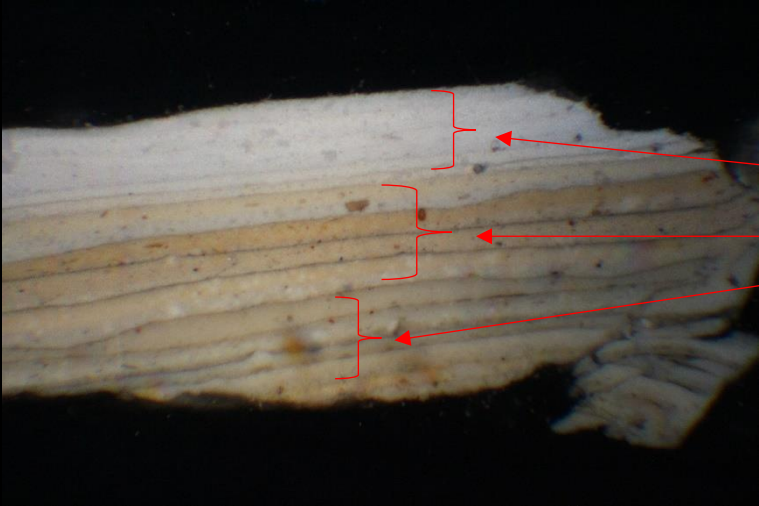
| Sample Ref: 09 | Location: 38 to 42 Mosley Street |
|---|---|
| | <p>X50 Magnification –<br/>Current visible paint scheme.</p> <p>5No Titanium white decorative schemes.</p> <p>4No light stone paint schemes.</p> <p>4No off-white paint schemes.</p> <p>Light stone scheme</p> <p>2No White decorative schemes.</p> |
| | <p>X400 Magnification -<br/>Earliest paint layers.</p> <p>Earliest paint scheme – white paint based on lead carbonate.</p> |

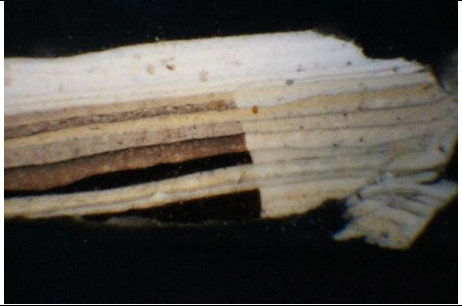
| Sample Ref: 09 | Location: 38 to 42 Mosley Street |
|---|---|
| <p>Early schemes tested for lead</p> <p>Yes – evidence of white lead present.</p> | |

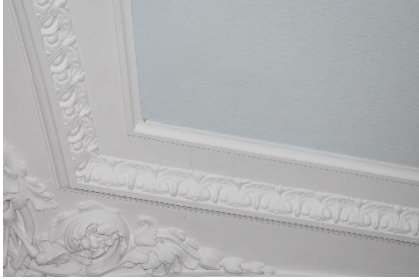
| Sample Ref: 10 | Location: 38 to 42 Mosley Street |
|---|---|
| <p>Paint sample removed from:</p> <p>Location: 10 – Second Floor (Room B – Dome Room), blue infill panels. Note: Blue panel is decorated with a layer of woodchip wall paper (not included in the analysis).</p> <p>A total of 16 separate paint layers were found.</p> | |

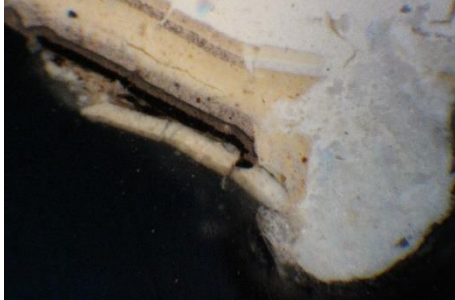
| Sample Ref: 10 | Location: 38 to 42 Mosley Street |
|---|---|
| <p>Early schemes tested for lead</p> <p>Yes – evidence of white lead present.</p> | |

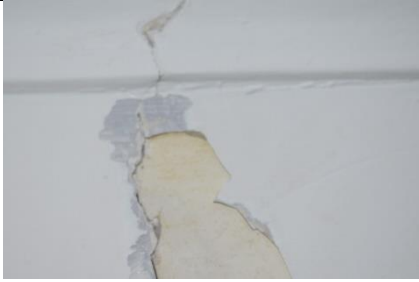
| Sample Ref: 11 | Location: 38 to 42 Mosley Street |
|---|---|
| <p>Paint sample removed from:</p> <p>Location: 11 – Second Floor (Room B – Dome Room), base ring to dome.</p> <p>A total of 20 separate paint layers were found.</p> | |

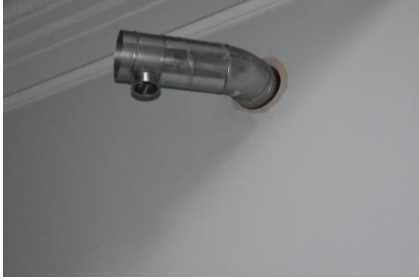
| Sample Ref: 12 | Location: 38 to 42 Mosley Street |
|---|---|
| <p>Paint sample removed from:</p> <p>Location: 12 – Second Floor (Room B – Dome Room), wall areas (painted blue).</p> <p>A total of 18 separate paint layers were found.</p> | |

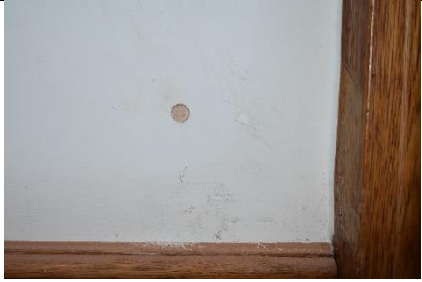
| Sample Ref: 13 | Location: 38 to 42 Mosley Street |
|---|---|
| <p>Paint sample removed from:</p> <p>Location: 13 – Second Floor (Room B – Dome Room), wall areas (painted white).</p> <p>A total of 4 separate paint layers were found.</p> | |

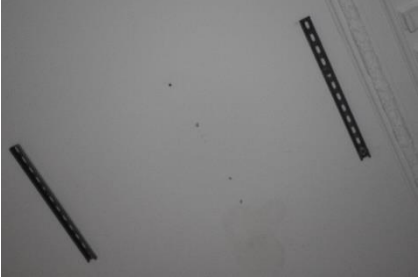
| Sample Ref: 14 | Location: 38 to 42 Mosley Street |
|---|---|
| <p>Paint sample removed from:</p> <p>Location: 14 – Second Floor (Room C ), ceiling.</p> <p>A total of 1 separate paint layers was found.</p> | |

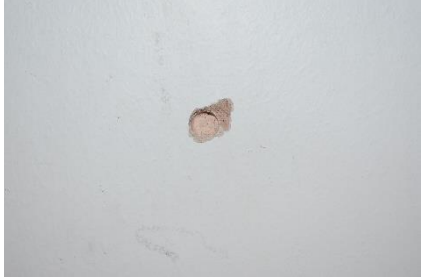
| Sample Ref: 15 | Location: 38 to 42 Mosley Street |
|---|---|
| <p>Paint sample removed from:</p> <p>Location: 15 – Second Floor (Room C), wall.</p> <p>A total of 3 separate paint layers were found.</p> | |

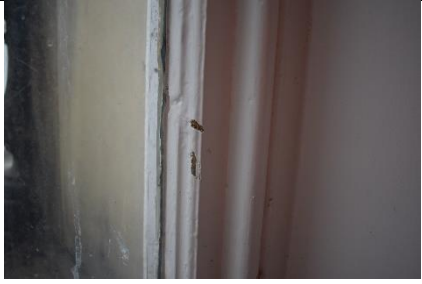
| Sample Ref: 16 | Location: 38 to 42 Mosley Street |
|---|---|
| <p>Paint sample removed from:</p> <p>Location: 16 – Second Floor (Room C), window.</p> <p>A total of 24 separate paint and varnish layers were found.</p> | |

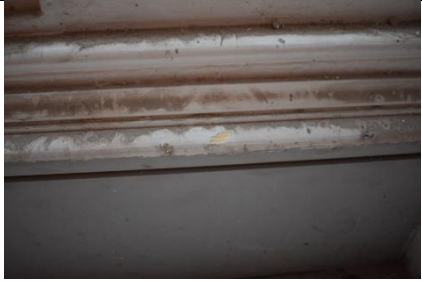
| Sample Ref: 17 | Location: 38 to 42 Mosley Street |
|---|---|
| <p>Paint sample removed from:</p> <p>Location: 17 – Second Floor (Room C), skirting.</p> <p>A total of 2 separate paint layers were found.</p> | |

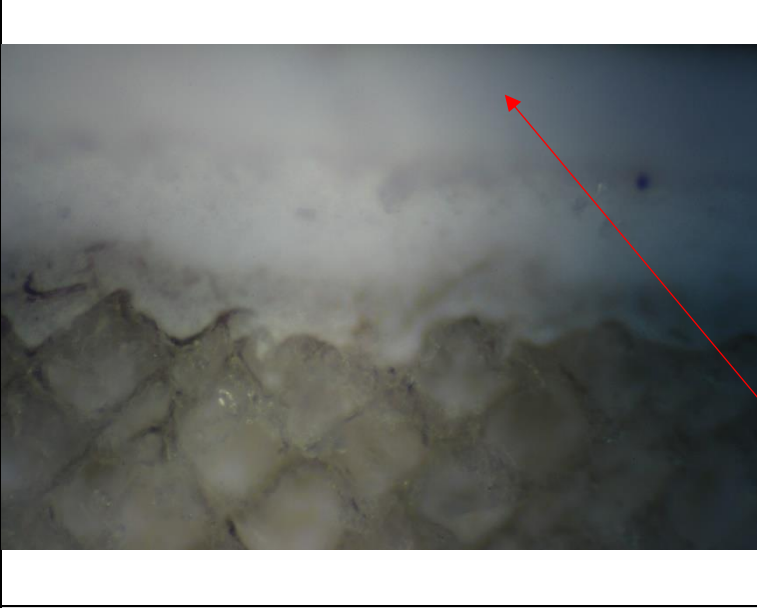
| Sample Ref: 17 | Location: 38 to 42 Mosley Street |
|---|---|
| | <p>X400 Magnification - Earliest paint layers.</p> <p>Earliest paint scheme – Titanium white alkyd paint over white primer / intermediate layer.</p> |

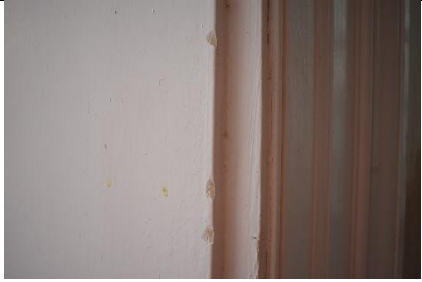
| Sample Ref: 18 | Location: 38 to 42 Mosley Street |
|---|---|
| <p>Paint sample removed from:</p> <p>Location: 18 – Second Floor (Room C), window reveal.</p> <p>A total of 14 separate paint layers were found.</p> | |

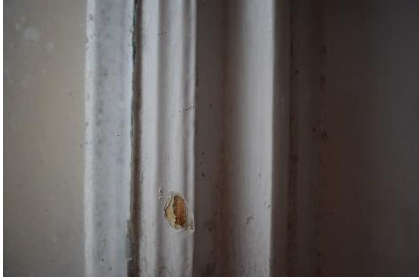
| Sample Ref: 19 | Location: 38 to 42 Mosley Street |
|---|---|
| <p>Paint sample removed from:</p> <p>Location: 19 – Third Floor (Room D), window.</p> <p>A total of 26 separate paint / varnish layers were found.</p> | |

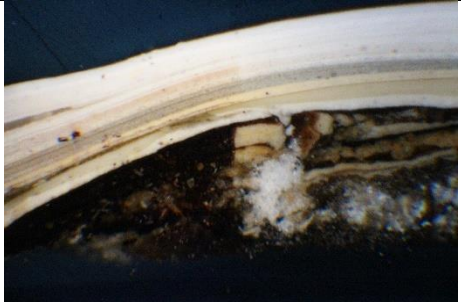
| Sample Ref: 19 | Location: 38 to 42 Mosley Street |
|---|---|
| <p>Early schemes tested for lead</p> <p>Yes – evidence of white lead present in earlier graining schemes.</p> | |

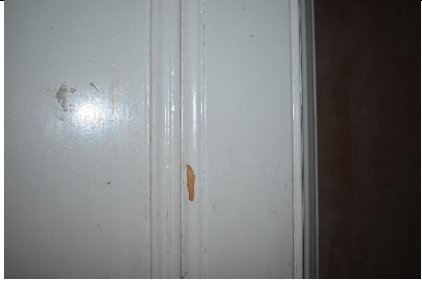
| Sample Ref: 20 | Location: 38 to 42 Mosley Street |
|---|---|
| <p>Paint sample removed from:</p> <p>Location: 20 – Third Floor (Room D), window reveal.</p> <p>A total of 12 separate paint layers were found.</p> | |

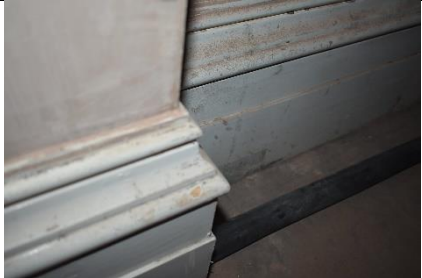
| Sample Ref: 21 | Location: 38 to 42 Mosley Street |
|---|---|
| <p>Paint sample removed from:</p> <p>Location: 21 – Third Floor (Room D), skirting.</p> <p>A total of 4 separate paint layers were found.</p> | |

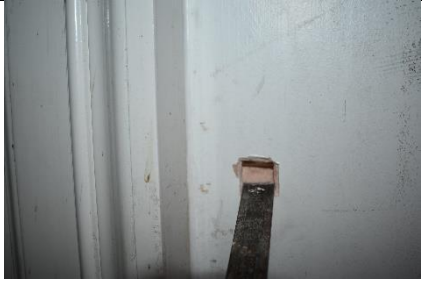
| Sample Ref: 22 | Location: 38 to 42 Mosley Street |
|---|---|
| <p>Paint sample removed from:</p> <p>Location: 22 – Third Floor (Room D), wall.</p> <p>A total of 1 separate paint layers were found.</p> | |

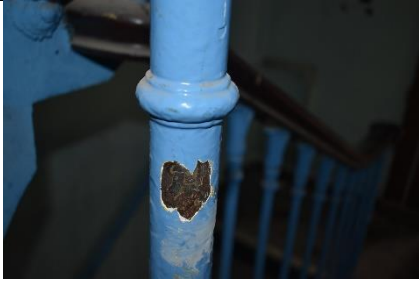
| Sample Ref: 23 | Location: 38 to 42 Mosley Street |
|---|---|
| <p>Paint sample removed from:</p> <p>Location: 23 – Ground floor (stairs), balusters.</p> <p>A total of 25 separate paint layers were found.</p> | |

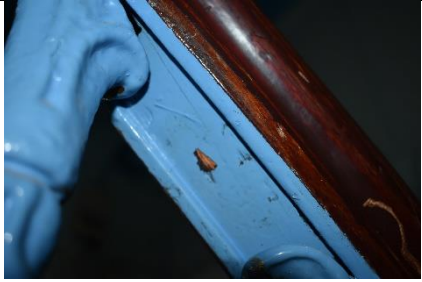
| Sample Ref: 24 | Location: 38 to 42 Mosley Street |
|---|---|
| <p>Paint sample removed from:</p> <p>Location: 24 – Ground floor (stairs), underside of handrail.</p> <p>A total of 1 separate paint layers over existing varnish layers were found.</p> | |

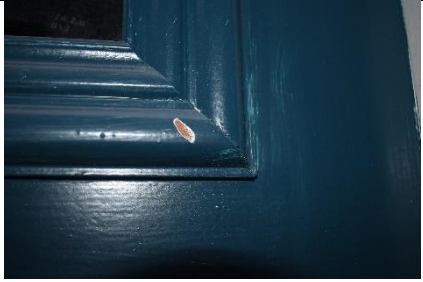
| Sample Ref: 25 | Location: 38 to 42 Mosley Street |
|---|---|
| <p>Paint sample removed from:</p> <p>Location: 25 – Doors to rear.</p> <p>A total of 3 separate paint layers were found.</p> | |

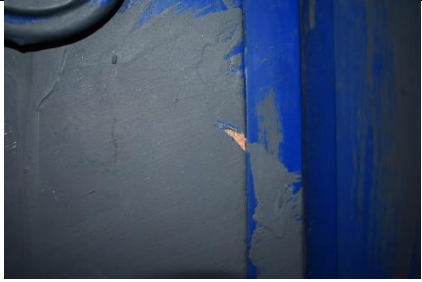
| Sample Ref: 26 | Location: 38 to 42 Mosley Street |
|---|---|
| <p>Paint sample removed from:</p> <p>Location: 26 – Doors to Mosley Street.</p> <p>A total of 8 separate paint layers were found.</p> | |

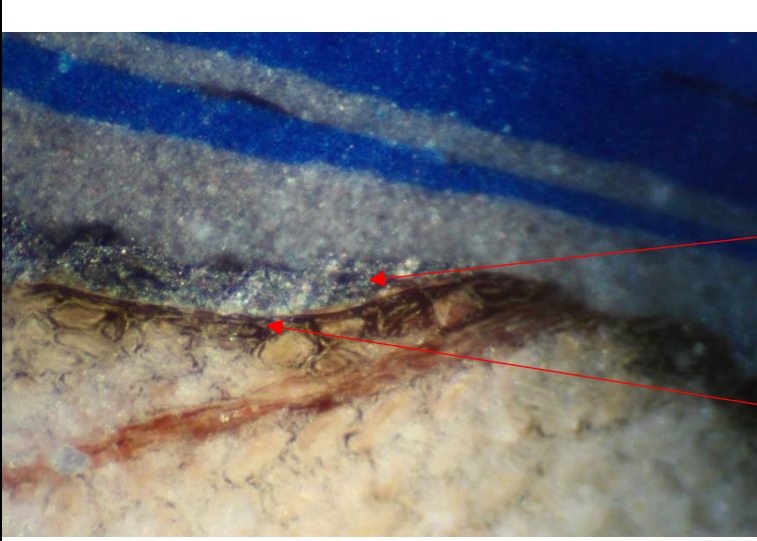
| Sample Ref: 26 | Location: 38 to 42 Mosley Street |
|---|---|
| | <p>X400 Magnification -</p> <p>Earliest paint layers.</p> <p>Blue decorative scheme is modern.</p> <p>Some evidence of earlier paint schemes is present in the hollows of the timber. (Possible aluminium primer).</p> <p>Earliest paint scheme – varnish / stain to timber face.</p> |

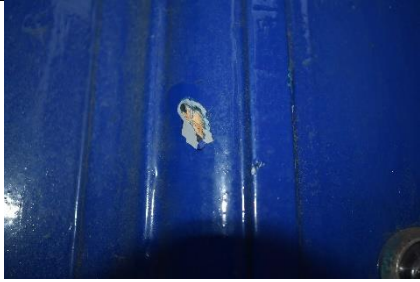
| Sample Ref: 27 | Location: 38 to 42 Mosley Street |
|---|---|
| <p>Paint sample removed from:</p> <p>Location: 27 – Side Doors.</p> <p>A total of 8 separate paint layers were found.</p> | |
