# Renaissance Hotel Manchester

Supplementary Geo-environmental Assessment Report

| Project Number | 1602 |

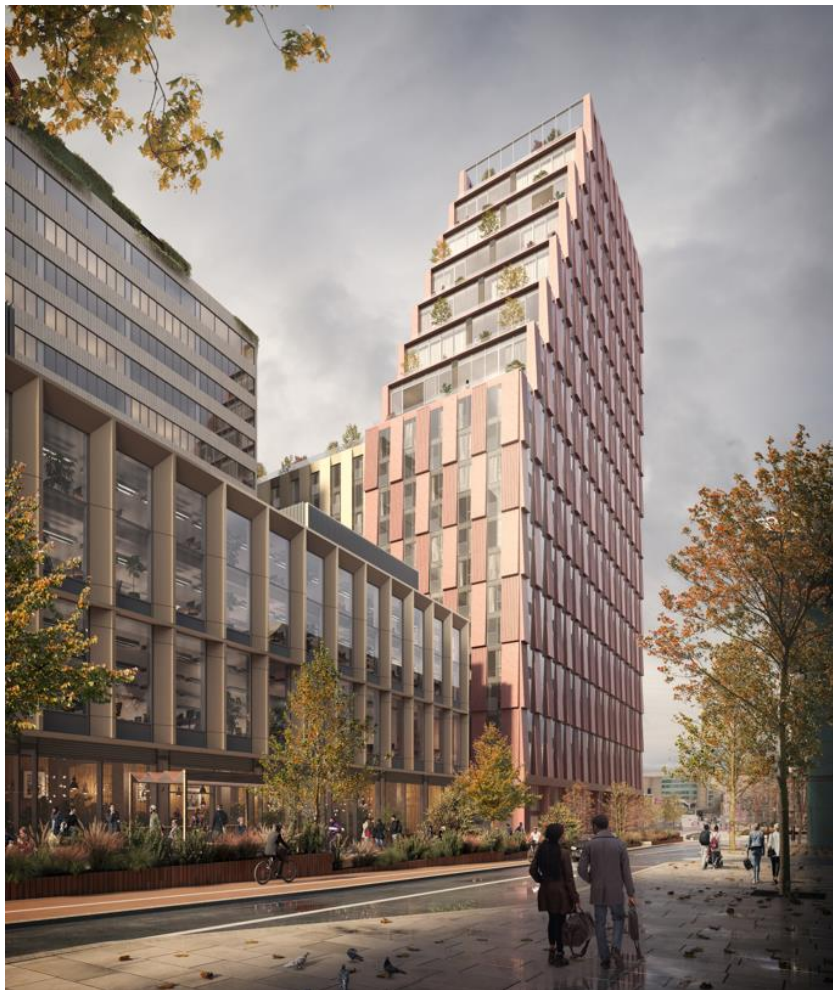
Figure 2.1 Proposed development scheme image 1

The proposed development across the site comprises the refurbishment of the existing Premier House office building including a lateral extension over Deansgate and over-cladding the existing façade. The office building and hotel are proposed to be partially demolished in the north, to enable the construction of a residential building. The hotel is also proposed to undergo refurbishment. The architectural scheme of the proposed development is shown in Figure 2.1 and 2.2.

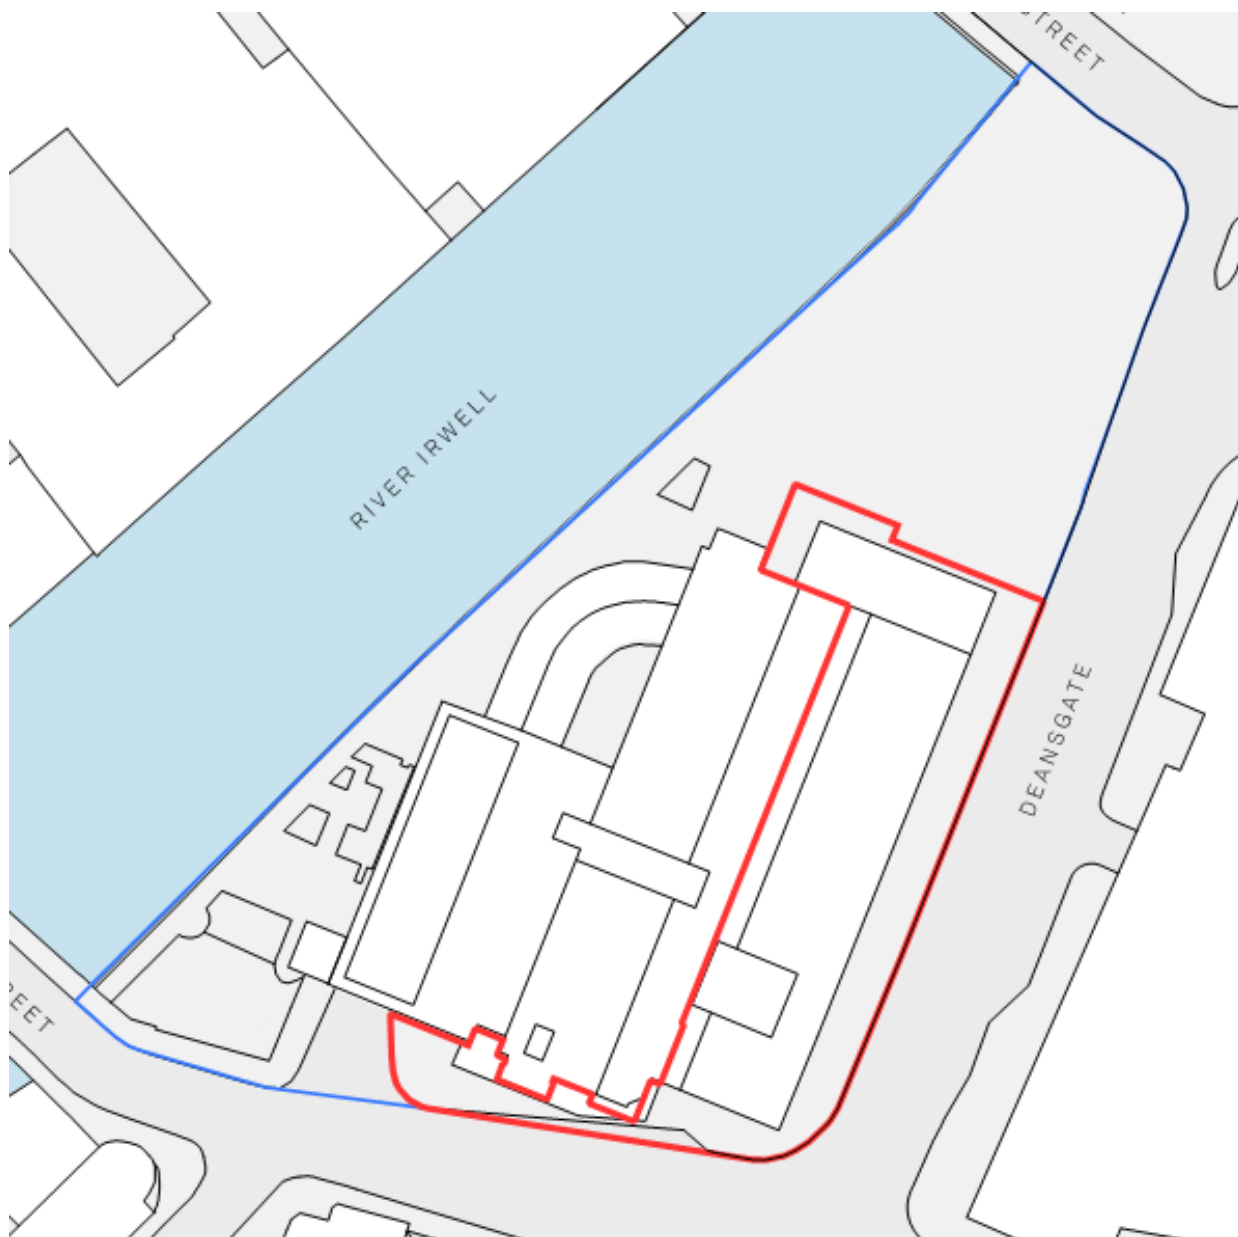
**Figure 2.3** Application boundary (application boundary shown in red) and site boundary (shown in blue)

Figure 2.3 shows the application boundary for the planning application this report has been prepared to support. The application boundary forms only a part of the wider site redevelopment. The redevelopment works specific to the application boundary (also known as Premier House) are:

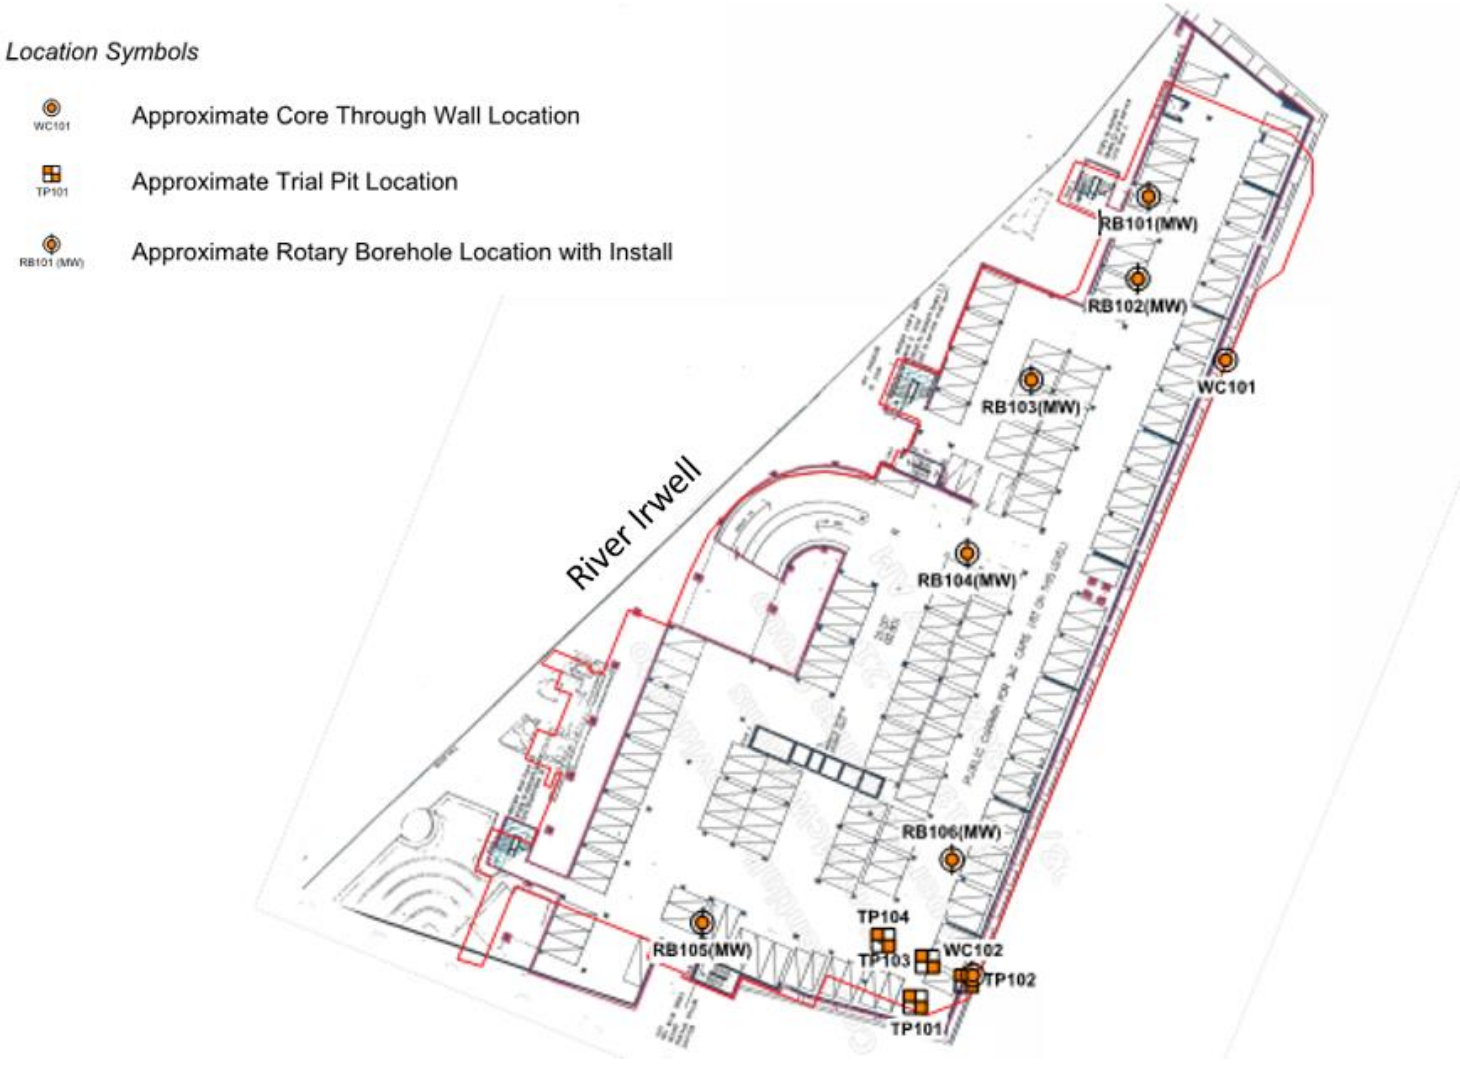
Figure 3.1 E3P (2021) Exploratory Hole Location Plan

Table 3.1 and 3.2 summarise the depths of all the E3P borehole and trial pit investigation locations. All the works were carried out within the site boundary. It is to note that all the boreholes were conducted from the existing public car park level of +25.25mOD, and therefore the ground directly beneath the Deansgate level where a new contiguous pile wall is proposed in the north-east of the site was not investigated.

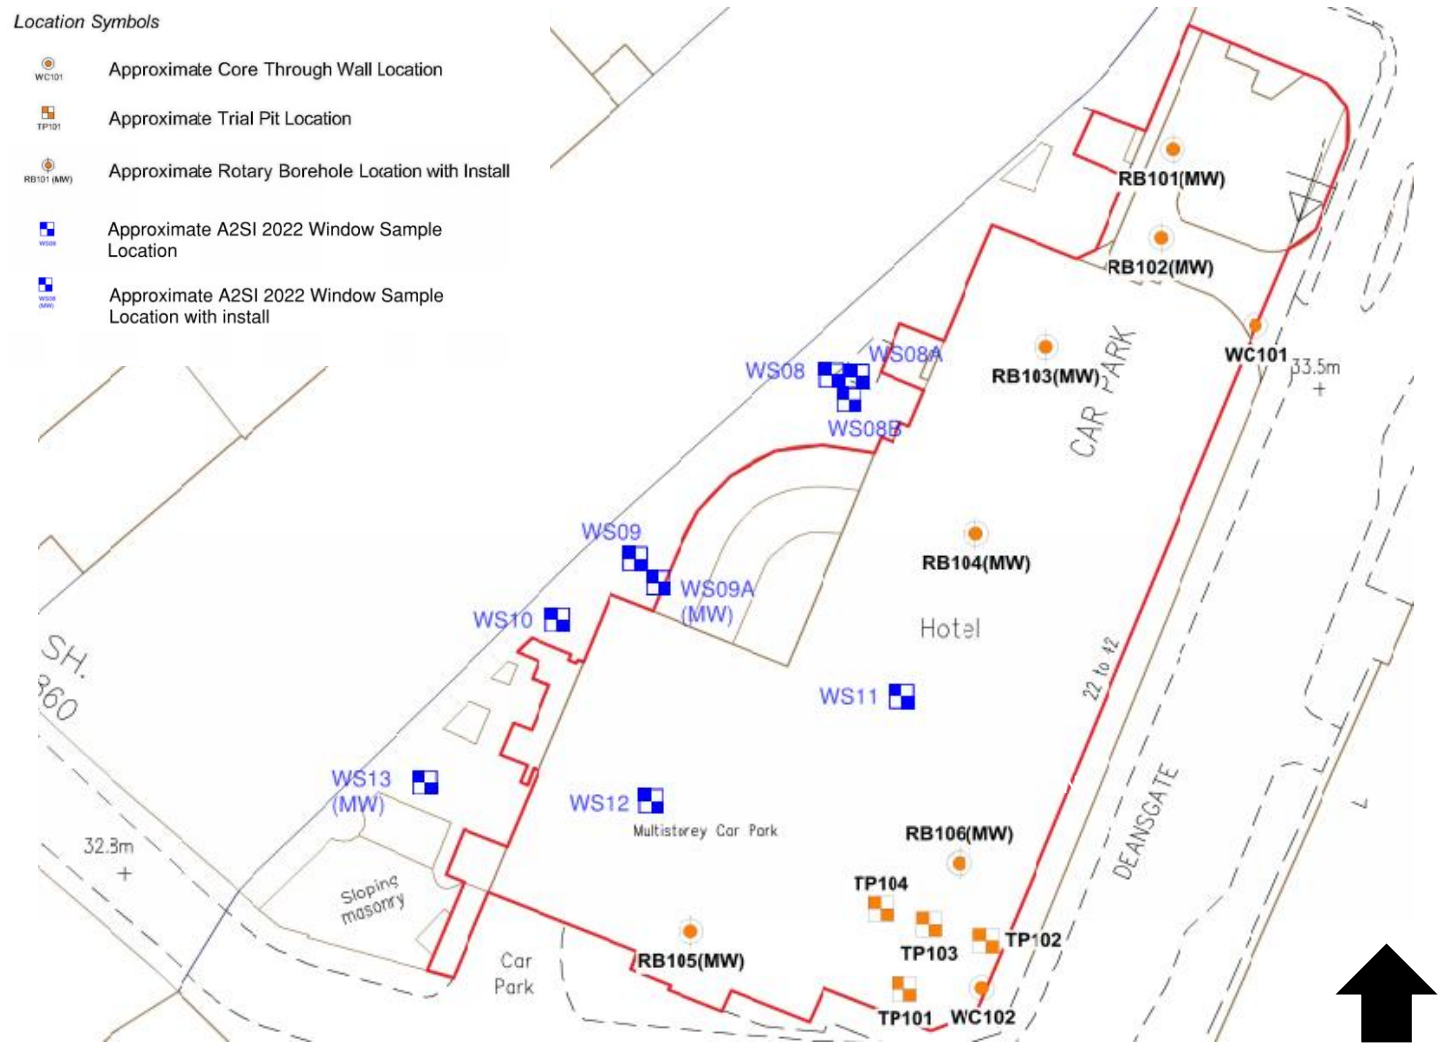
Figure 4.1 Exploratory hole location plan for A2SI (2022) and E3P (2021)

- 9no. window sampler holes (WS08 - WS13) to a maximum depth of approximately 6m bgl.
- Engineer logging and photographing of the soils encountered.
- Installation of 2no. combined groundwater and ground gas monitoring standpipes within WS09A and WS13.
- Collection of soil samples for laboratory analysis.
- Collection of groundwater samples for laboratory analysis.
- Monitoring and sampling of the well installations.
- In-situ geo-environmental testing including soil sample head-space testing using a PID.

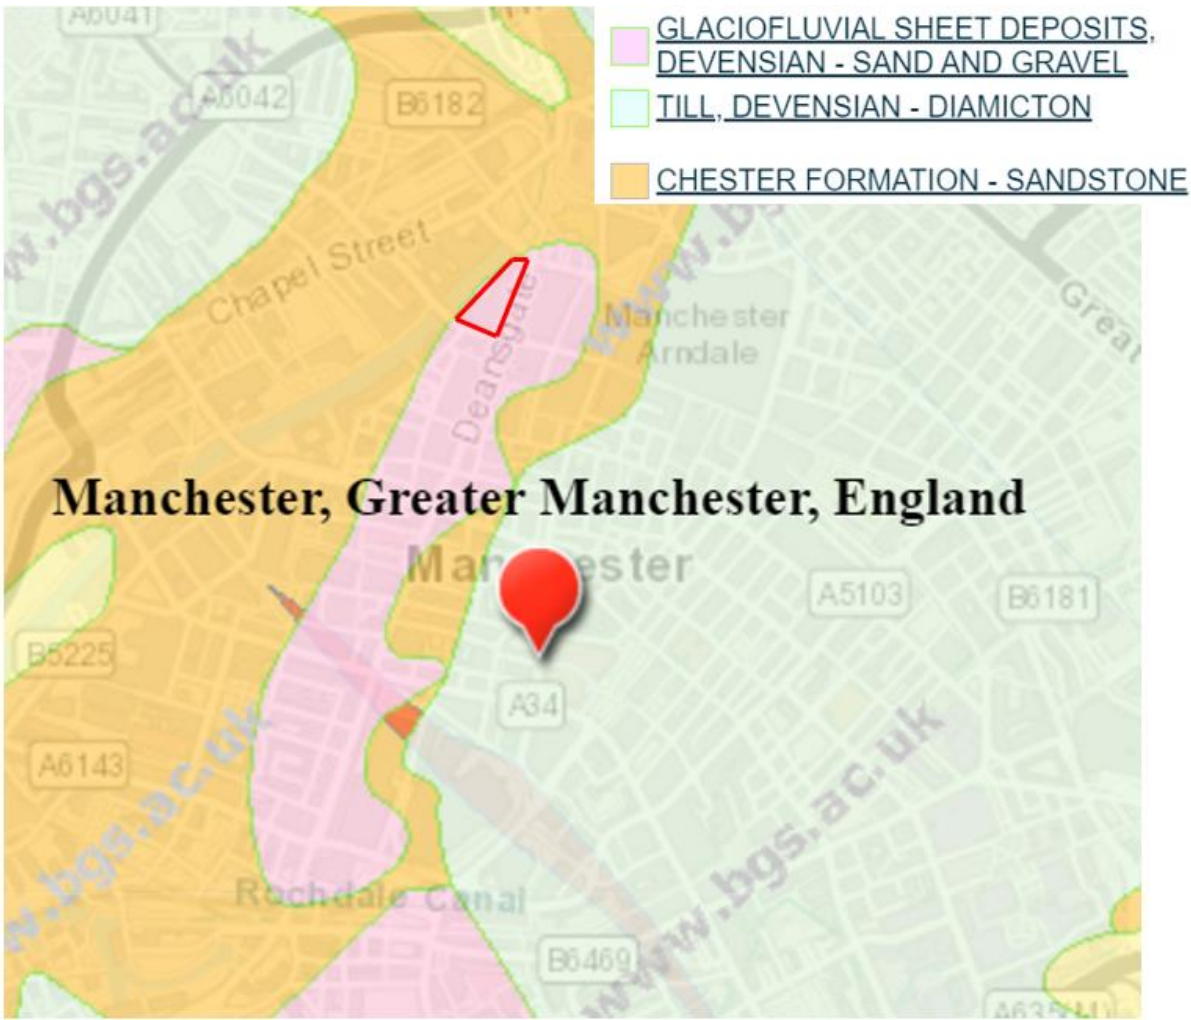
Figure 5.1 Geological context of the site

Approximate site boundary shown by the red line. Image source: BGS Maps [accessed June 2021]

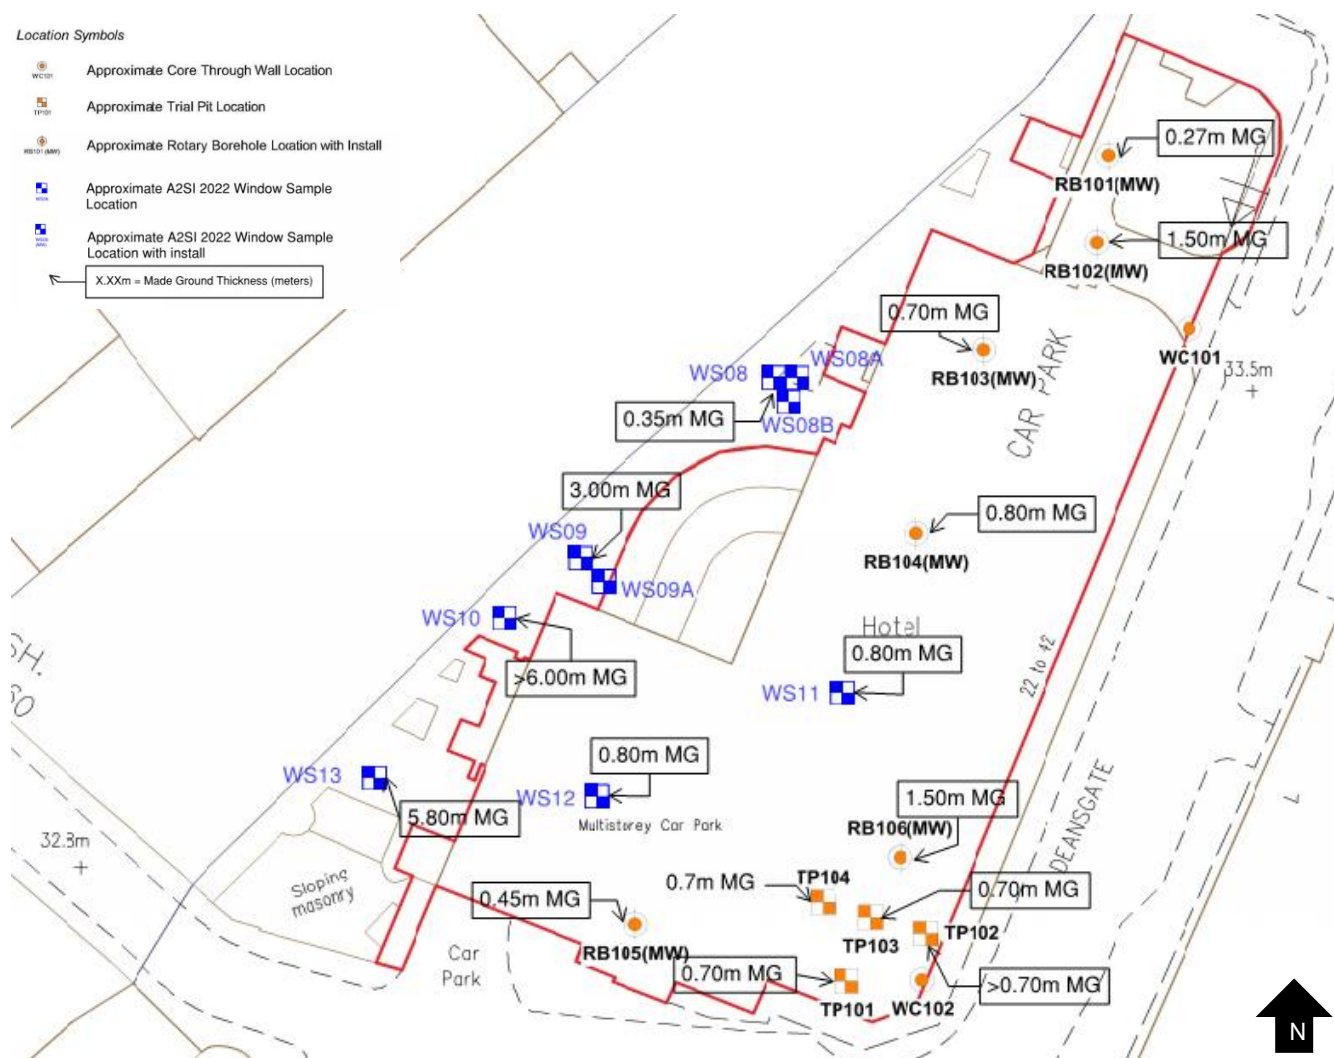
**Figure 5.2**     **Made Ground Thickness Plan**

A Made Ground thickness plan is included as Figure 5.2.

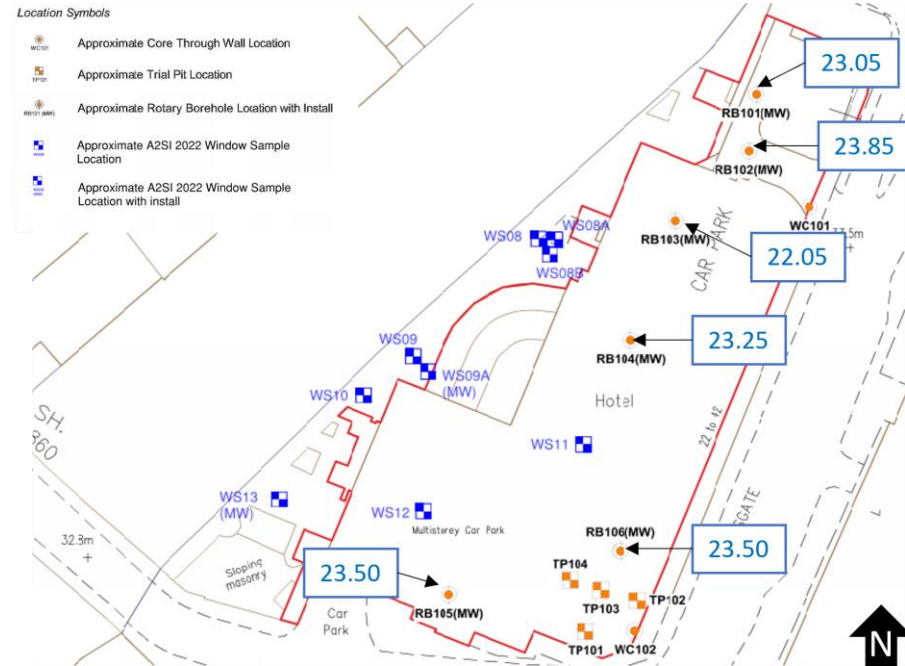
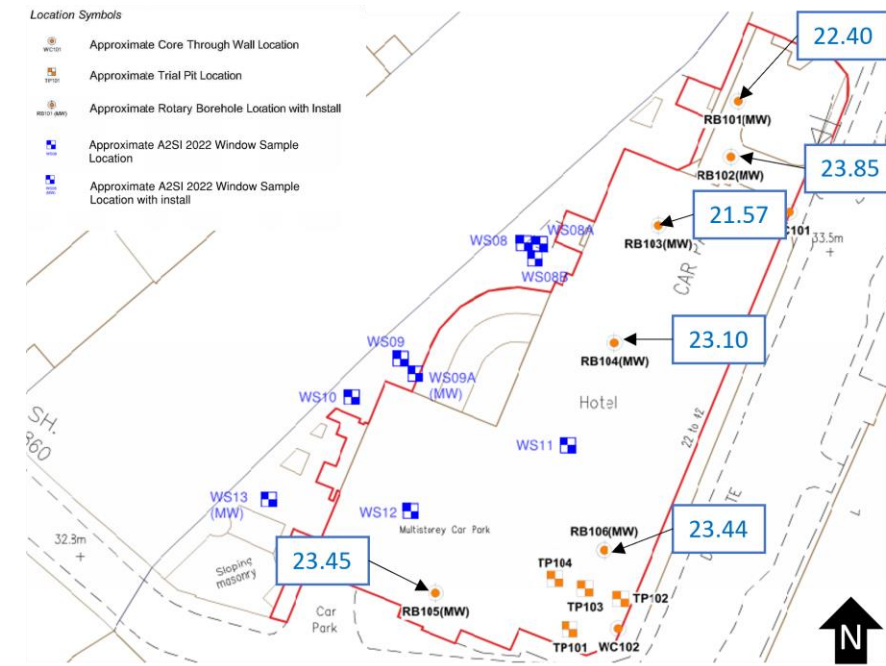
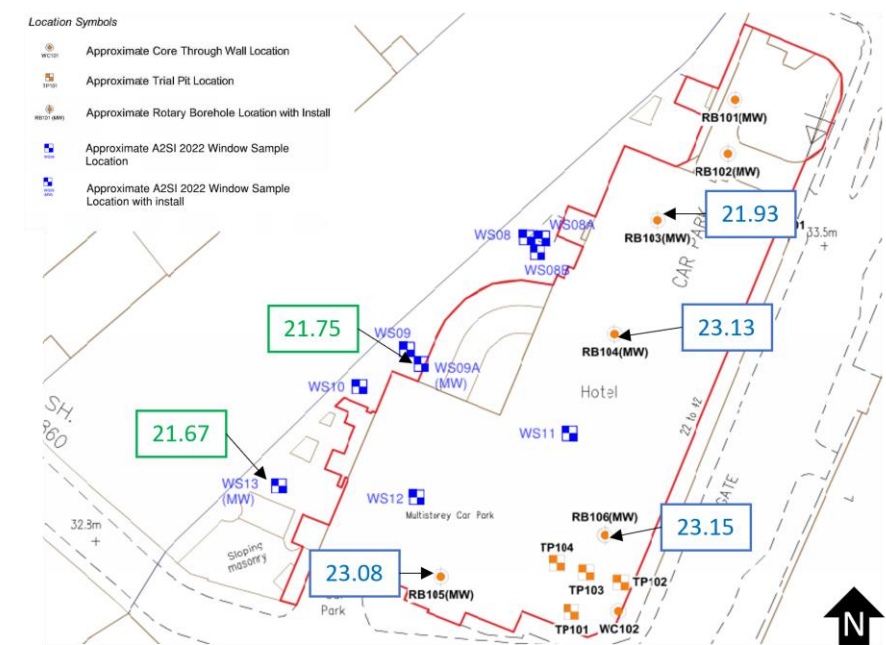
Figure 5.3 Shallow groundwater elevation plots

- X.XX Groundwater level within the Chester Formation (mAOD)
- X.XX Groundwater level within the Made Ground (mAOD)

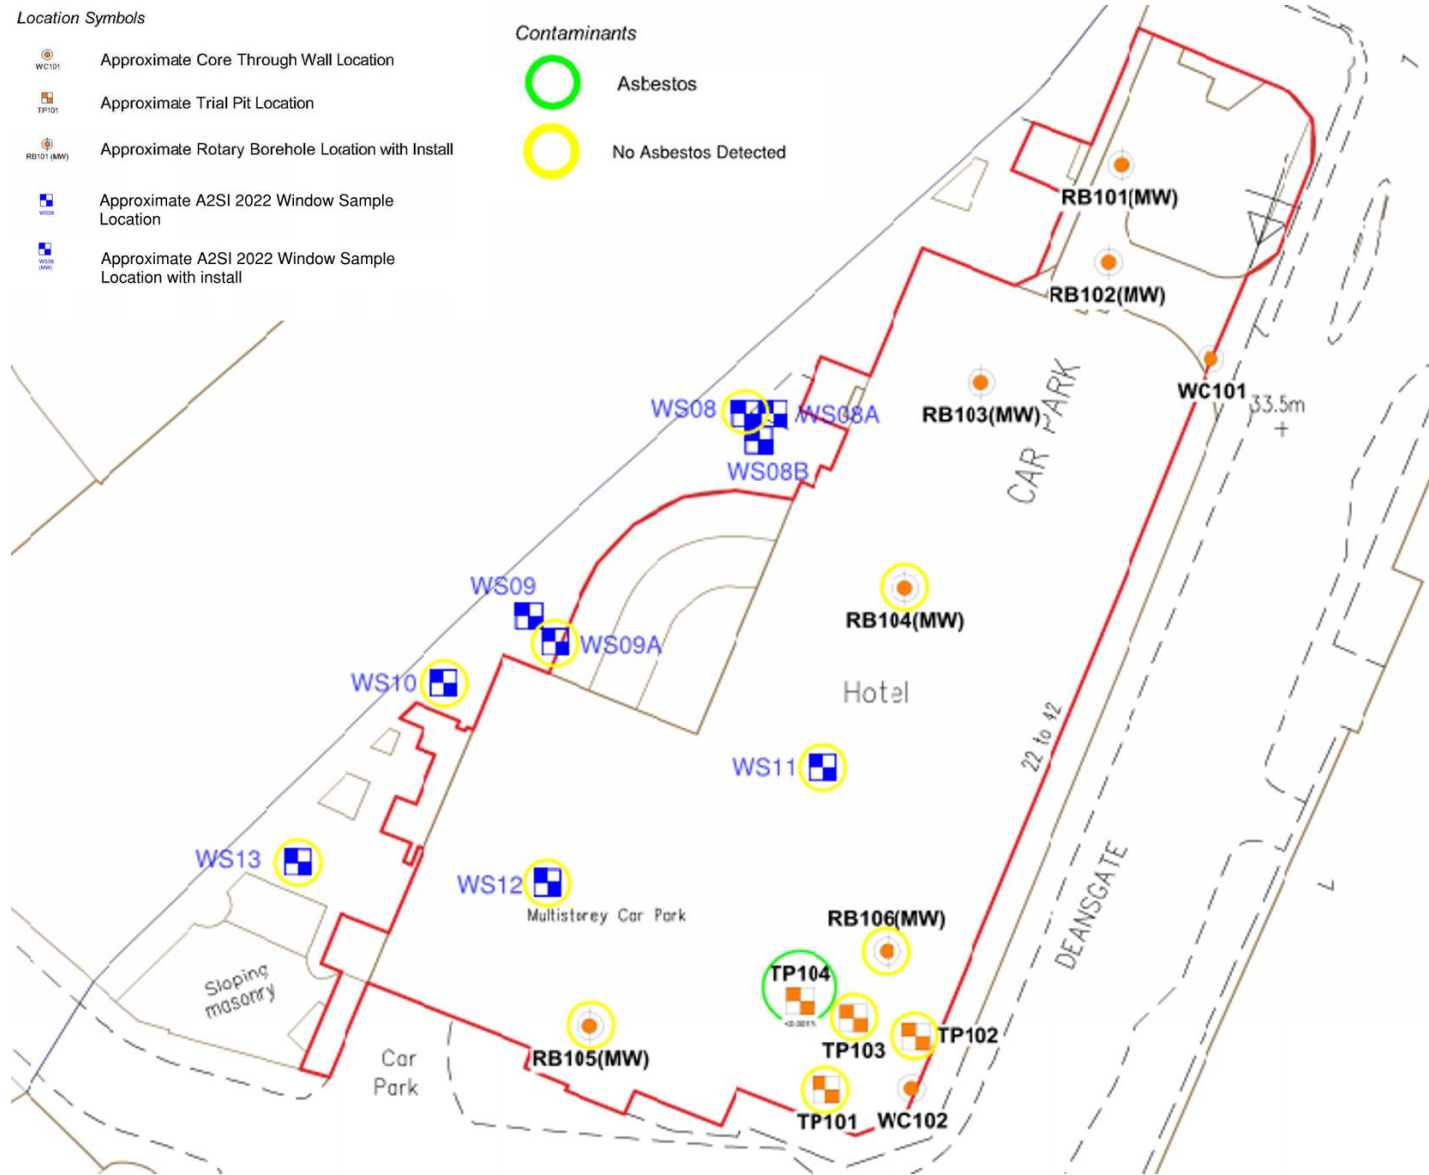
Figure 6.1 Asbestos detection plan for Made Ground

Asbestos has previously been identified by E3P in the form of loose chrysotile fibres in Made Ground at TP104 (at concentration of <0.001% w/w).

A-squared also recommend that if new underground services are installed in the impacted area of Made Ground surrounding TP104 then they should be installed in oversize clean service corridors. This will mitigate the risk to future site maintenance workers who may need to excavate soils around underground services. A suitable specification for the oversize clean service corridors should be included in a Remediation Strategy for the site along with appropriate verification protocols.

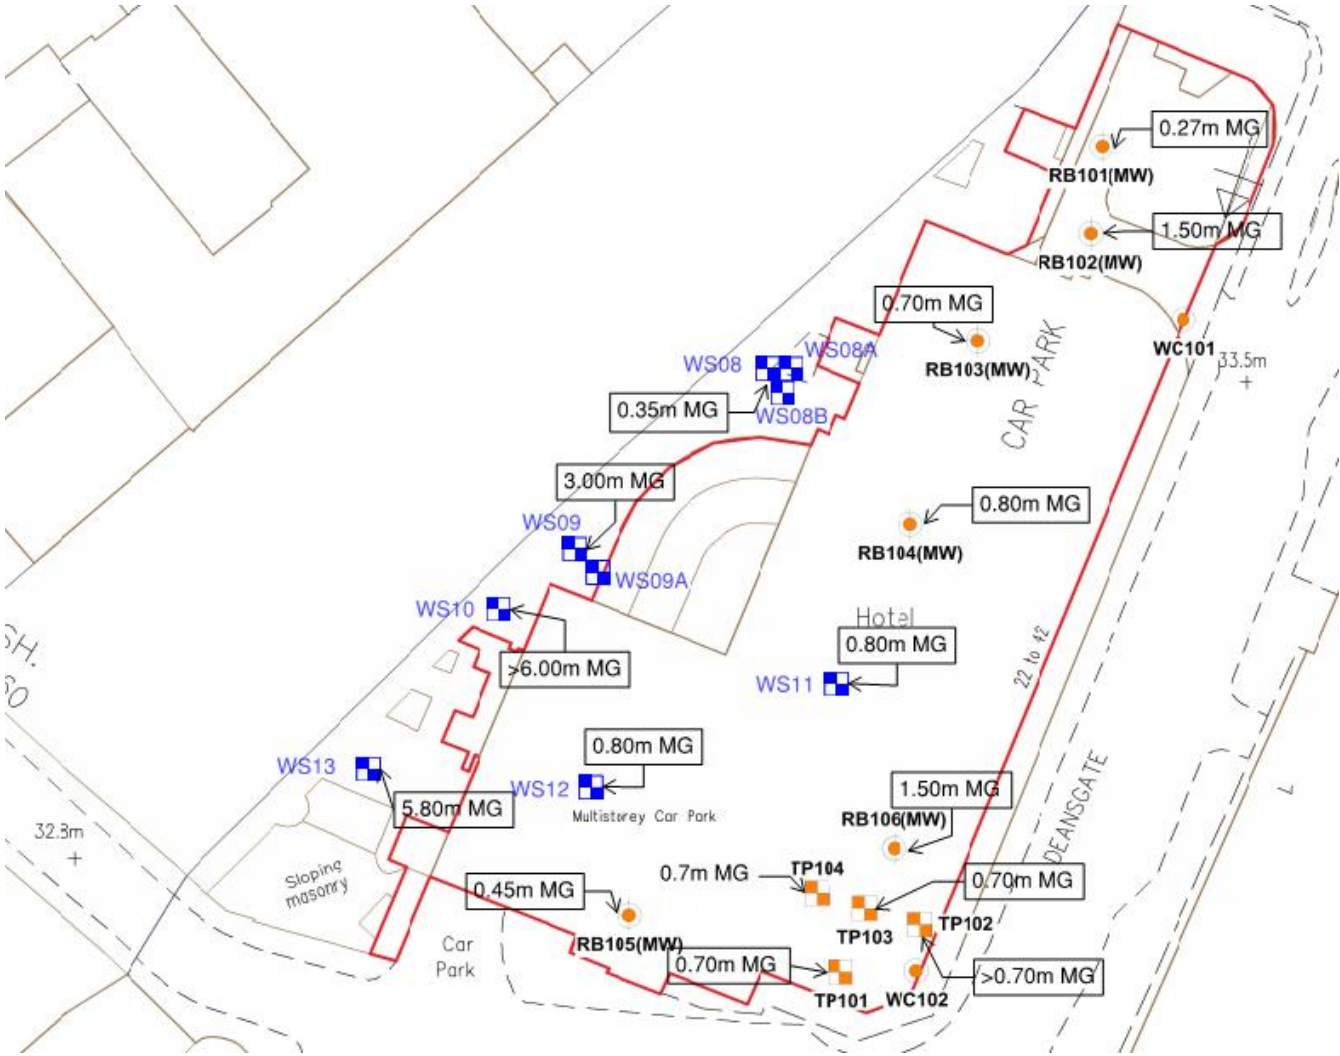
Figure 6.2 Made Ground thickness plan

The engineering logs do not indicate the presence of degradable organic materials in Made Ground with elevated potential for ground gas generation. Indeed, much of the Made Ground is logged as comprising mainly inert materials and non-degradable natural clasts such as brick and ceramic. No visual or olfactory evidence of contamination was identified within the Made Ground. These details indicate low risk with respect to ground gas. Furthermore, the excavation of Made Ground from across the proposed building footprint in the north of

the site effectively removes the potential source of ground gas from this area. Therefore, the risks from ground gas are assessed as low (i.e. no unacceptable risk) and not requiring of ground gas monitoring or remediation.

The deeper Made Ground encountered in the southwest of the site at WS09, WS10 and WS13 does require some further consideration however. The thicker Made Ground is considered to be localised fill behind the existing river wall. The fill has been identified as not extensive. The fill is not present across a widespread area which may represent an elevated ground gas risk. The area is also located where soft-landscaping is proposed with no building footprint directly above, so the potential of any ground gas generated to impact buildings is reduced by the preferential migration of ground gas to atmosphere via open ground.

The deeper Made Ground encountered in the southwest of the site at WS09, WS10 and WS13 should also be considered in view of *Ciria C795 Retrofitting hazardous ground gas protection measures in existing or refurbished buildings, 2020*. The proposed redevelopment in this area of the site includes a refurbishment of the existing building structure rather than construction of new buildings. There will be very limited and possibly no groundworks undertaken in this area of the site. It is understood that there is no existing ground gas protection system and there are no known issues of gas ingress to the existing building or nearby buildings. The proposed development also maintains the current human health end-use in this area of the site (i.e. commercial end-use) and does not introduce a more sensitive receptor. This being the case, *Ciria C795 (2020)* indicates that the proposed refurbishment works in the southwest of the site would not require fitting of ground gas protection.

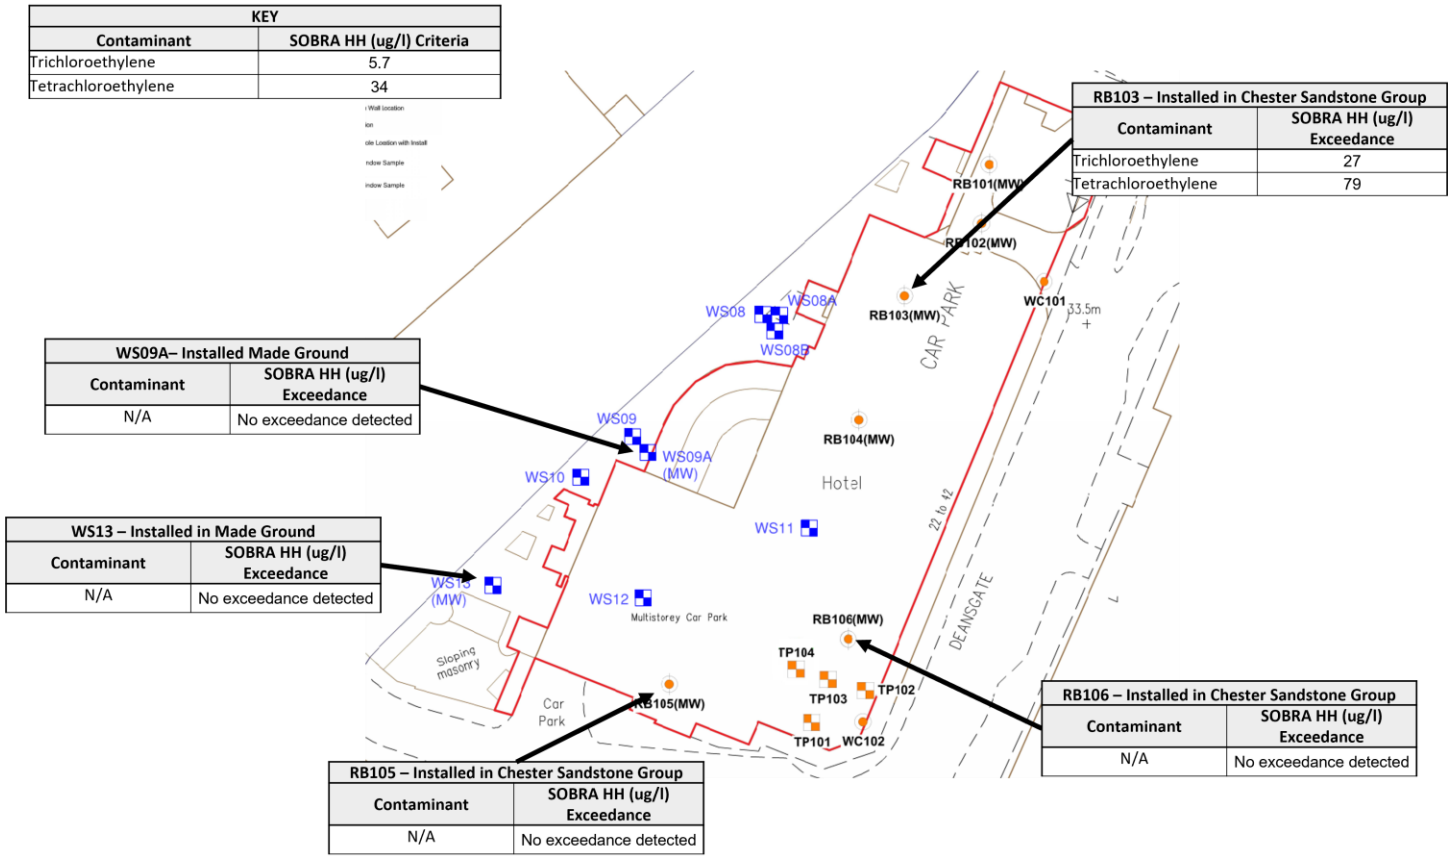
Figure 6.4 Human health exceedances plan for volatile determinants in groundwater (SOBRA 'residential' criteria)

Monitoring well RB103 (where exceedances of the SOBRA assessment criteria have been identified) is located in the northern area of the site proposed for residential use. The exceedances of the SoBRA assessment criteria therefore require further consideration, as provided below.

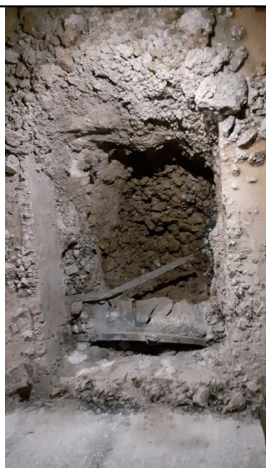
TP103

Remarks: 1. Foundation pad observed at 0.70m bgl 2. Foundation pad 0.70m in length from supporting pillar 3. Depth of pad could not be determined

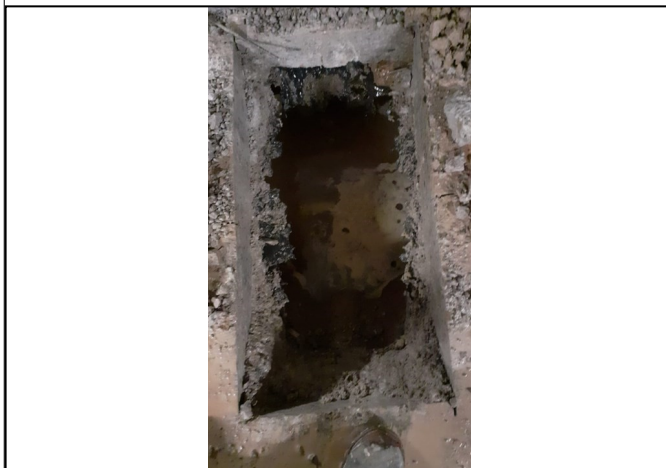
TP104

Remarks: 1. Foundation pad observed at 0.70m bgl 2. Foundation pad 0.70m in length from supporting pillar 3. Depth of pad could not be determined

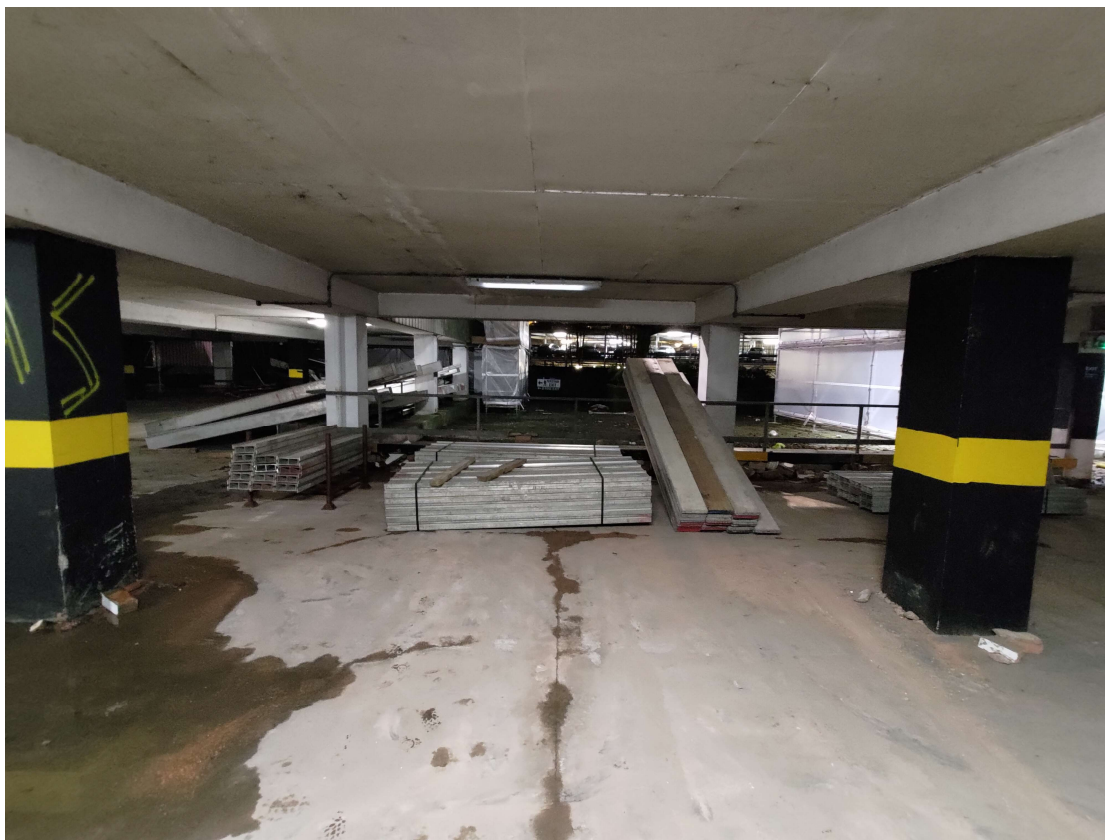
Due to the description presented on the engineer logs, A-squared consider that it is possible that this strata was actually weathered sandstone bedrock of the Chester Formation.

During the site walkover, all previous installed wells at the basement car park level were identified with the exception of RBH102, which at the time of the walkover had heavy pallets, possibly obstructing the headworks as shown in the photo 7.4.1.

**Figure 7.4.1 Possible RBH102 location with obstruction.**
