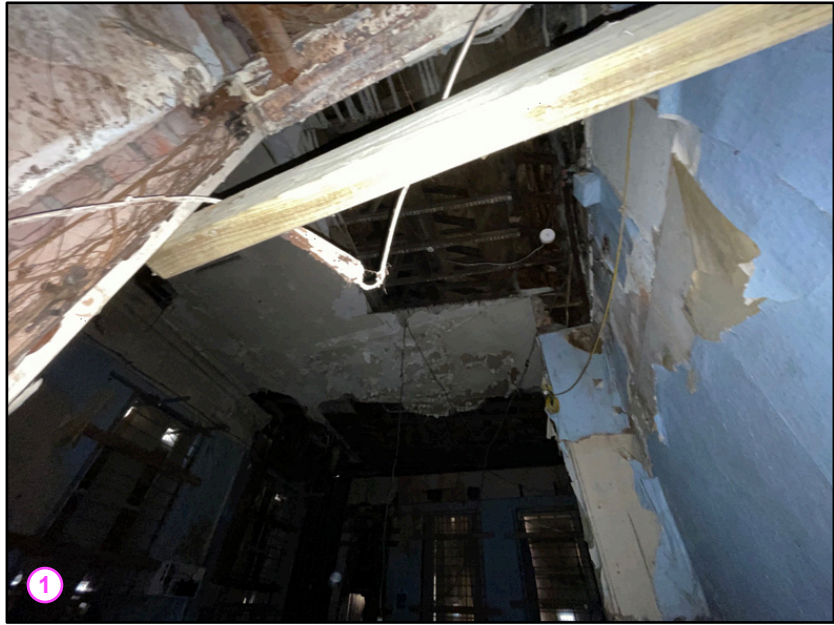
ROOM G.05

- Restricted access - Room is inaccessible due to collapsed ceiling and/or unsafe floor structure
- No cornice
- Most of the ceiling has collapsed - the rest looks damaged

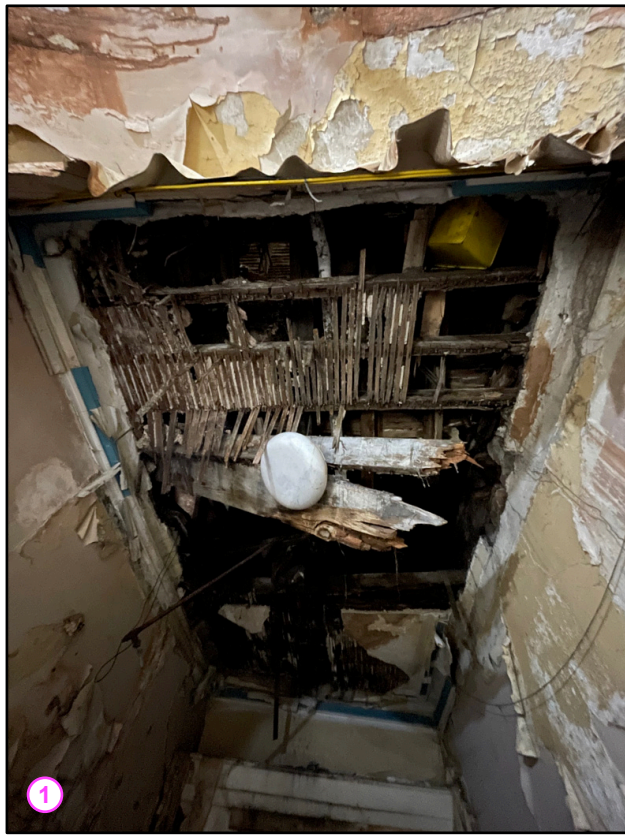
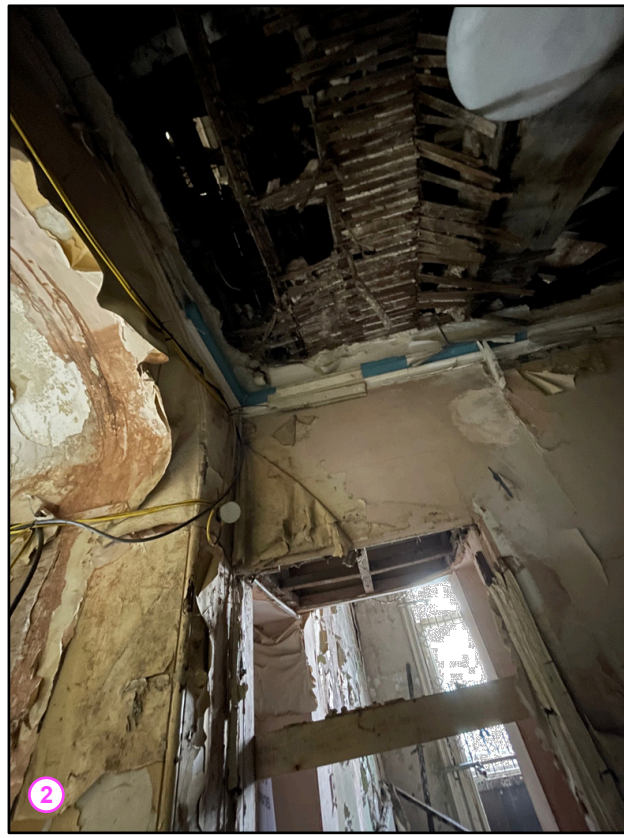
ROOM G.06

- Restricted access - Room is inaccessible due to collapsed ceiling and/or unsafe floor structure
- No cornice
- Ceiling is gone completely
- Exposed timber above ceiling looks severely damaged

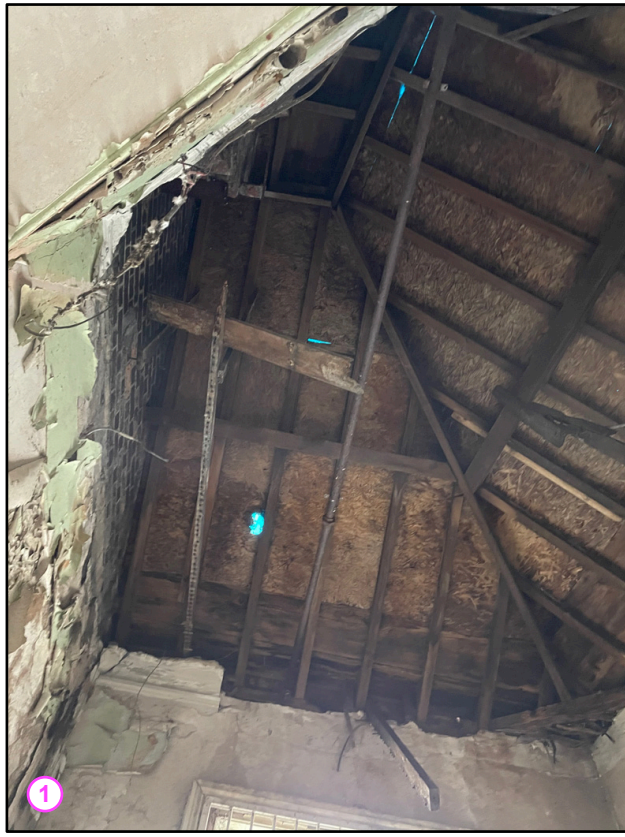
ROOM G.07

- Restricted access - Room is inaccessible due to collapsed ceiling and/or unsafe floor structure
- No cornice
- Ceiling is gone completely
- Exposed roof timber structure

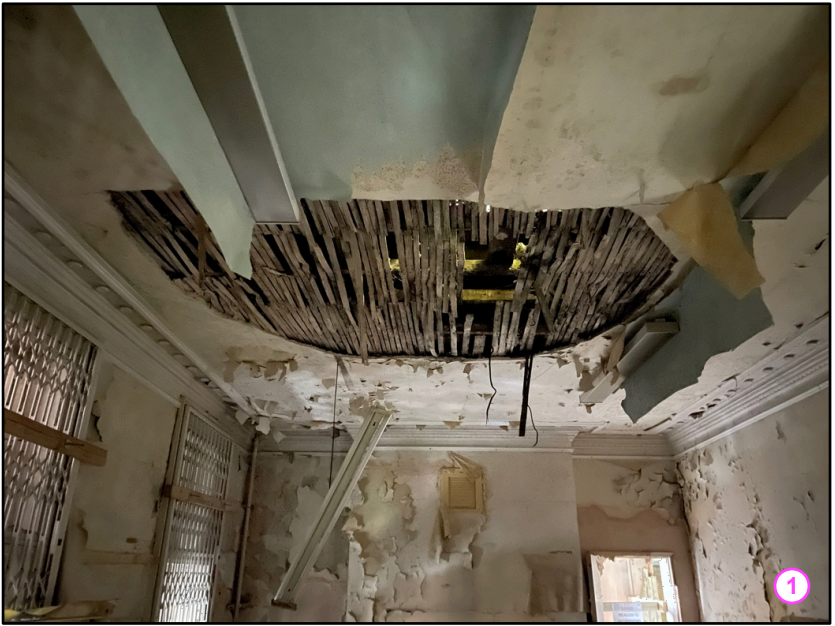
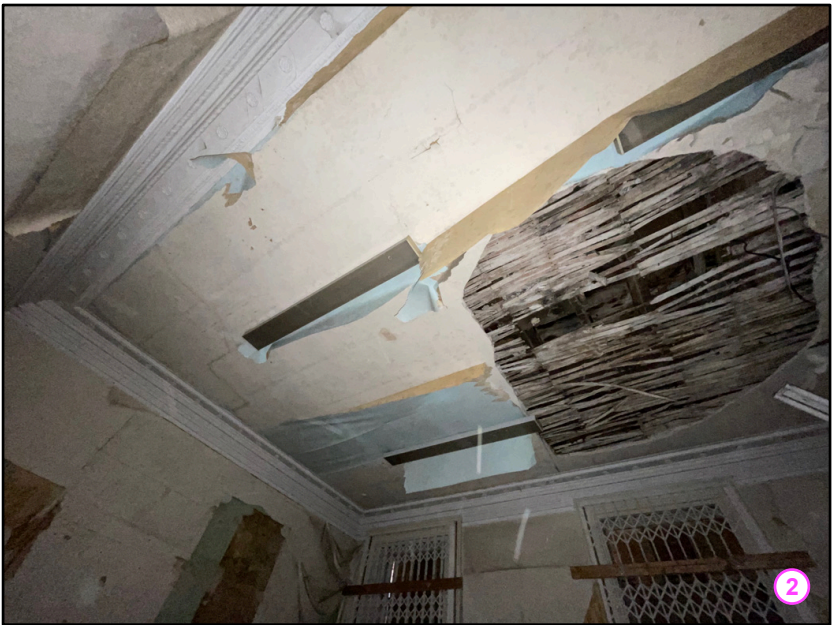
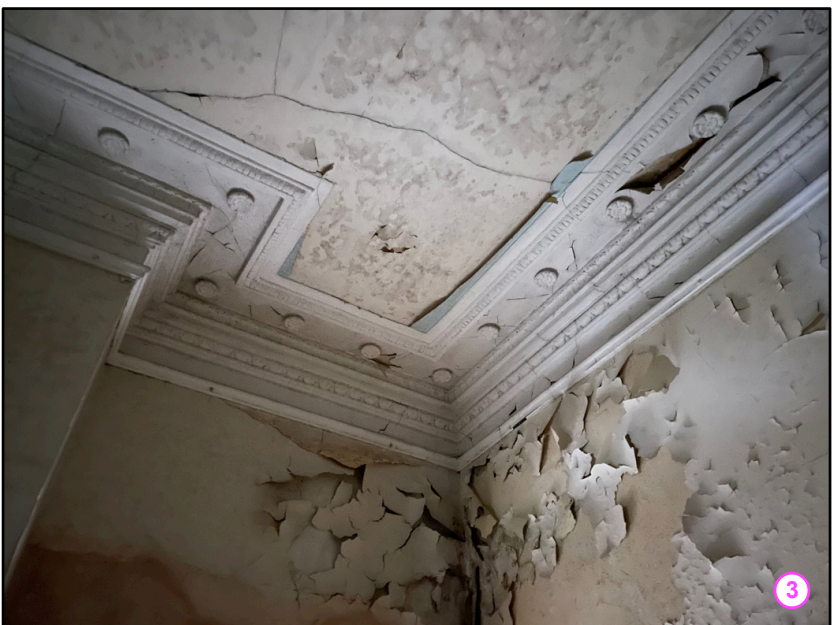
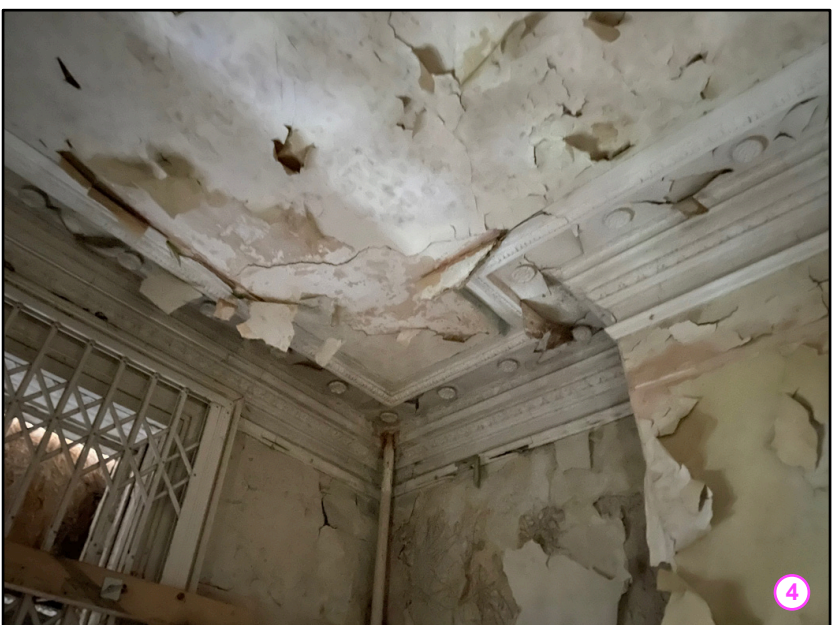
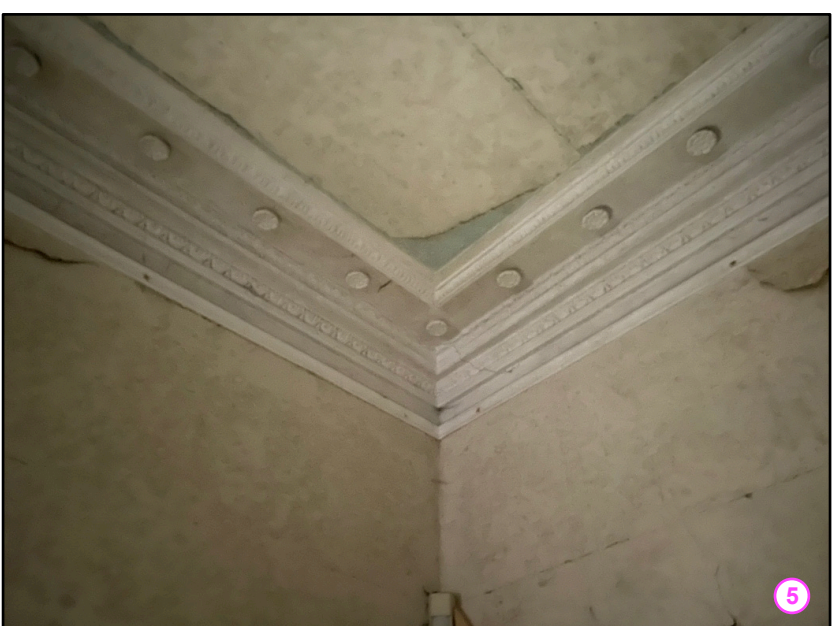
ROOM G.08

- Cornice as noted on the plan
- Partially collapsed ceiling as noted on the plan
- Plasterboard ceiling
- Ceiling is badly damaged
