# Arboricultural Impact Assessment (AIA)

**Albert Bridge House**

1 Bridge Street

| <b>Title:</b> | Arboricultural Impact Assessment | | | |

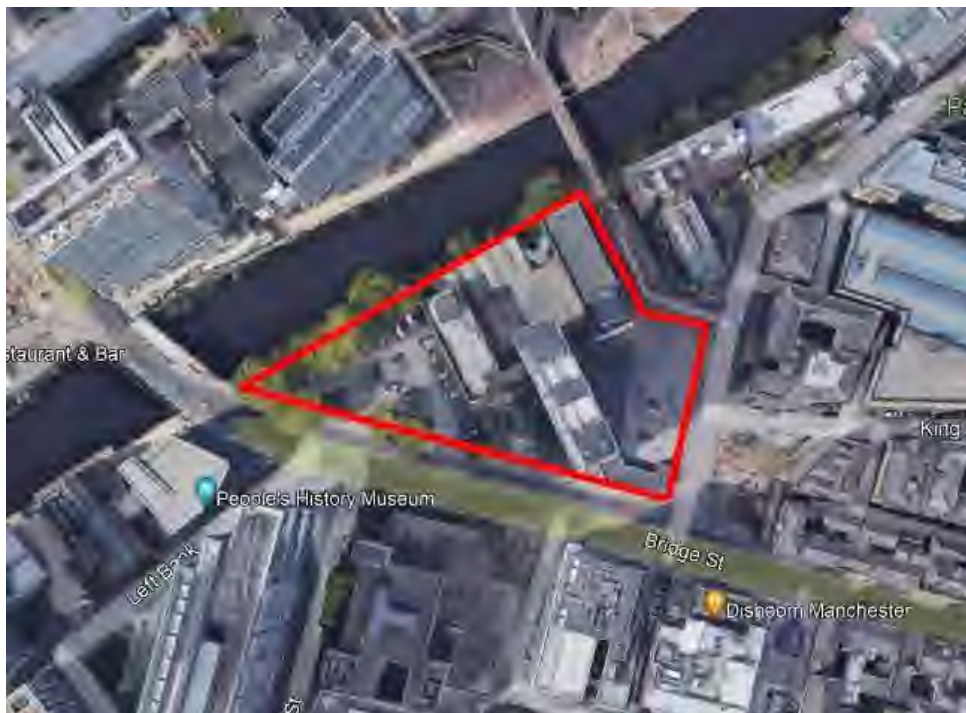
Figure 1 – Site Redline Boundary

- 1.2.4. The site is located in the area shown in Figure 1. The OS Grid Reference is SJ 83437 98372.
