| THE WENTWOOD<br>NEWTON STREET<br>MANCHESTER | | |
| EXTENTS OF REMEDIAL WORKS<br>TO EXISTING GROUND FLOOR<br>CONSTRUCTION | | |
| LK.01 | LK.102 | A |

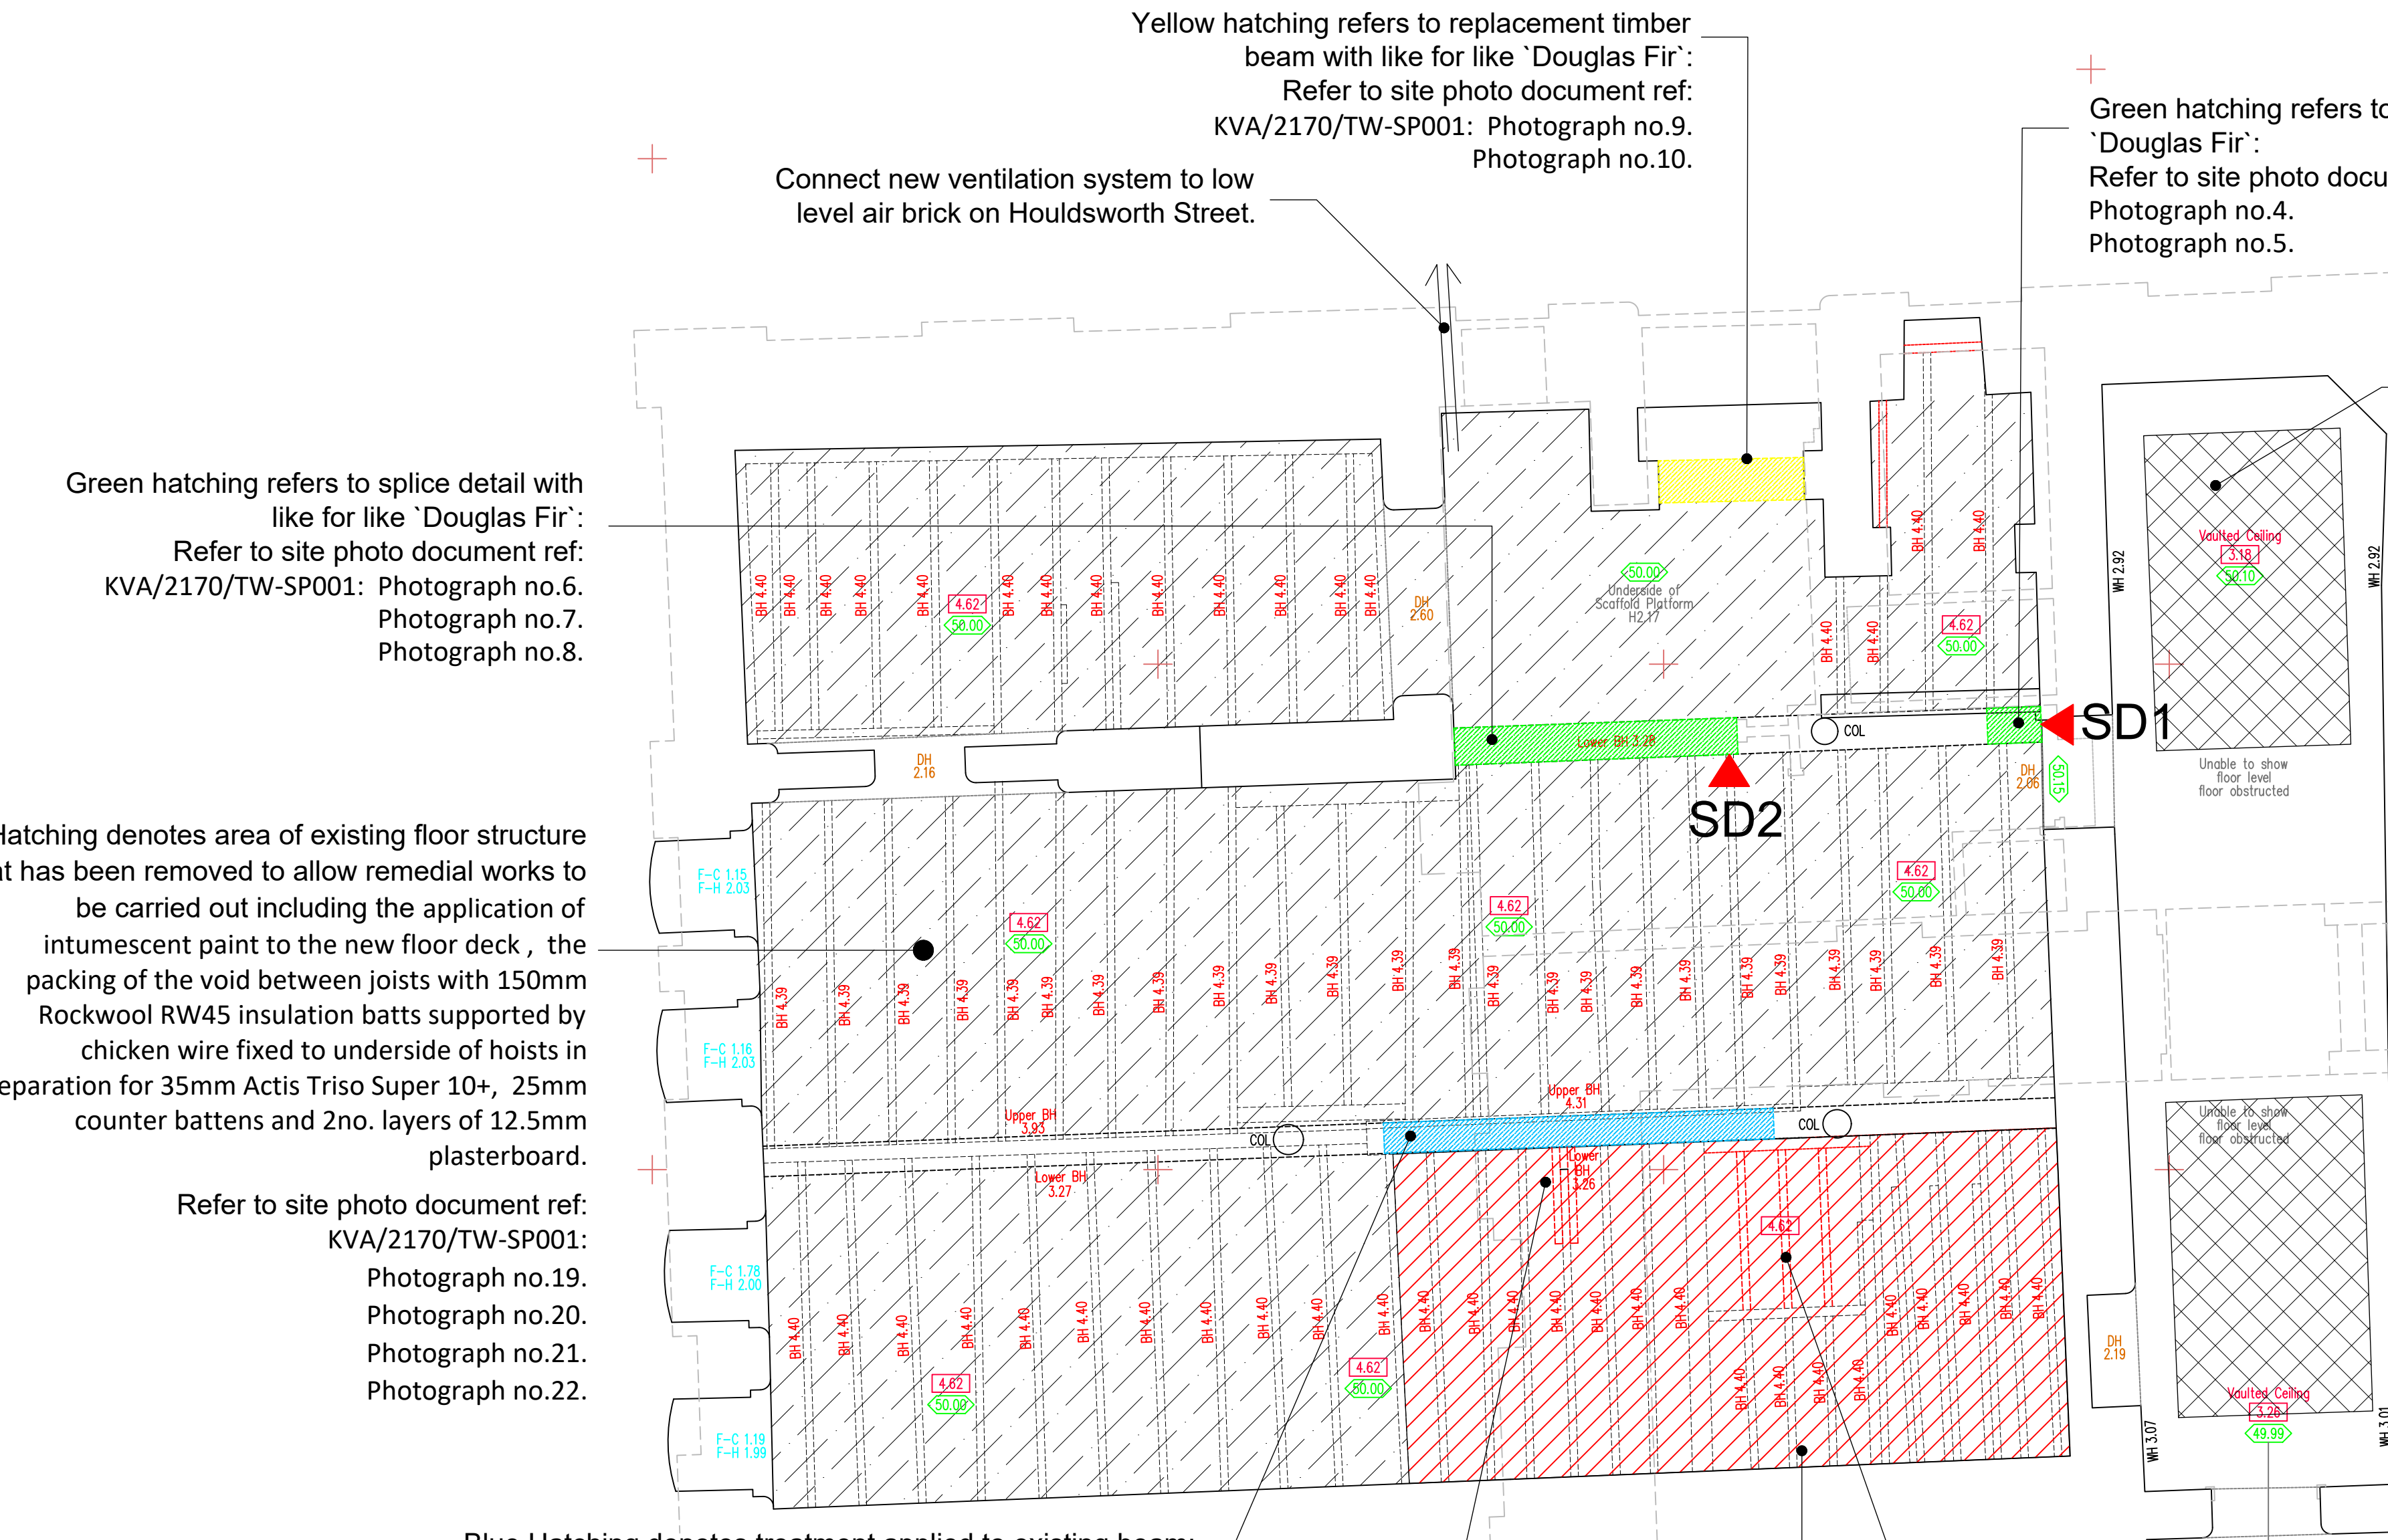
Green hatching refers to splice detail with like for like `Douglas Fir`:  
Refer to site photo document ref: KVA/2170/TW-SP001: Photograph no.6. Photograph no.7. Photograph no.8.

Hatching denotes area of existing floor structure that has been removed to allow remedial works to be carried out including the application of intumescent paint to the new floor deck , the packing of the void between joists with 150mm Rockwool RW45 insulation batts supported by chicken wire fixed to underside of hoists in preparation for 35mm Actis Triso Super 10+, 25mm counter battens and 2no. layers of 12.5mm plasterboard.

Blue Hatching denotes treatment applied to existing beam:  
Refer to site photo document ref: KVA/2170/TW-SP001: Photograph no.13.

Existing floor joist noted as rotten during  
site visit dated 18.01.23 to be cut back  
to good timber and spliced each side  
with new like for like timber.

Red hatching denotes existing timber floor structure to be  
retained and underdrawn with 2no. layers of 12.5mm  
plasterboard fixed to 25x50mm treated timber battens to  
provide basic fire protection:

Green hatching refers to splice detail with like for like  
`Douglas Fir`:  
Refer to site photo document ref: KVA/2170/TW-SP001:  
Photograph no.4. Photograph no.5.

Hatching denotes floor joists that  
have been removed and stored  
onsite.  
Refer to site photo document ref:  
KVA/2170/TW-SP001:  
Photograph no.1.  
Photograph no.2.  
Photograph no.3.

Reinstate floor joists from  
retained timber floor joists.

Rev A 23.01.2023 Proposed vent duct added. Area of floor to be reinstated following  
site vist dated 18.01.2023
