Ten Acres Lane

Contract No:  
PSL22/3506  
Client Ref:  
LD10385

Project Id: LD10385  
Project Title: Ten Acres Lane  
Location: Newton Heath  
Client: NUVU Developments Ltd

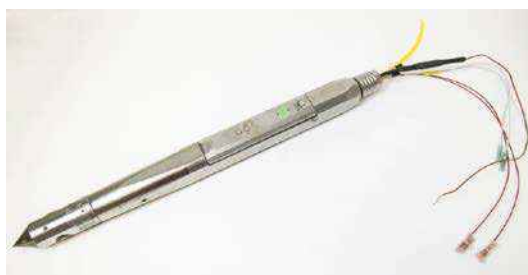
### 2.2 MIP

The MIP is an interface between contaminants in the soil and the detectors at ground surface. It is a mapping tool used to find the depth at which contamination is located, but is not used to determine concentration of the compound. Two advantages of using the MIP are that it detects contamination in situ and can be used in all types of soil conditions. The MIP is a logging tool used to make continuous measurements of VOCs in soil. Volatile compounds outside the probe diffuse across a membrane and are swept from the probe to a gas phase detector at ground surface. A log is made of detector response versus probe depth. In order to speed diffusion, the probe membrane is heated to approximately 121°C. Along with the detection of VOCs in the soil, the MIP also measures the electrical conductivity of the soil to give a probable lithology of the subsurface. This is accomplished by using a dipole measurement arrangement at the end of the MIP probe so that both conductivity and detector readings may be taken simultaneously. A simultaneous log of soil electrical conductivity is recorded with the detector response.

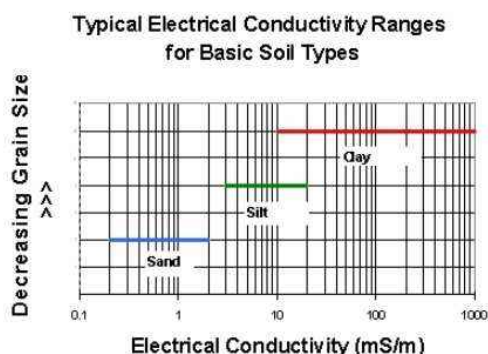
The MIHP probe also includes an electrical conductivity (EC) measuring device housed close to the end of the probe, and a continuous profile of EC is logged alongside the MIP and HPT logs. Soil conductivity and resistivity (the inverse of conductivity) have long been used as tools

to classify soils. The power of this tool stems from the fact that, in general, silts and clays exhibit higher electrical conductivity readings than sands and gravels. The conductance of the soil is based upon its parent mineralogy as well as the conductance of the pore fluids within the formation.

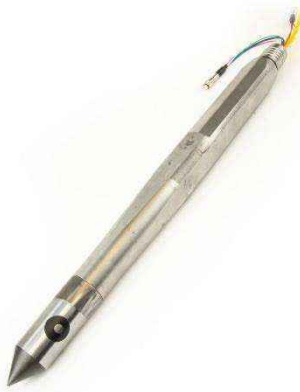
## 2.4 OIP

The OIP (Optical Image Profiler) is a direct push tool used for the delineation of non-aqueous phase liquid (NAPL) hydrocarbon fuels and oils. The OIP-UV probe is designed with UV and visible light sources which are directed out a sapphire window. As the probe is advanced into the subsurface, the UV light source will induce fluorescence of the fuel polycyclic aromatic hydrocarbons (PAHs). This fluorescence is captured by an onboard camera which operates at 30 images per second. Images are saved throughout the advancement of the log and still photos are taken using UV and visible light sources each meter as well as at operator chosen depths. Soil fluorescence images (20 per ft) are saved throughout the log

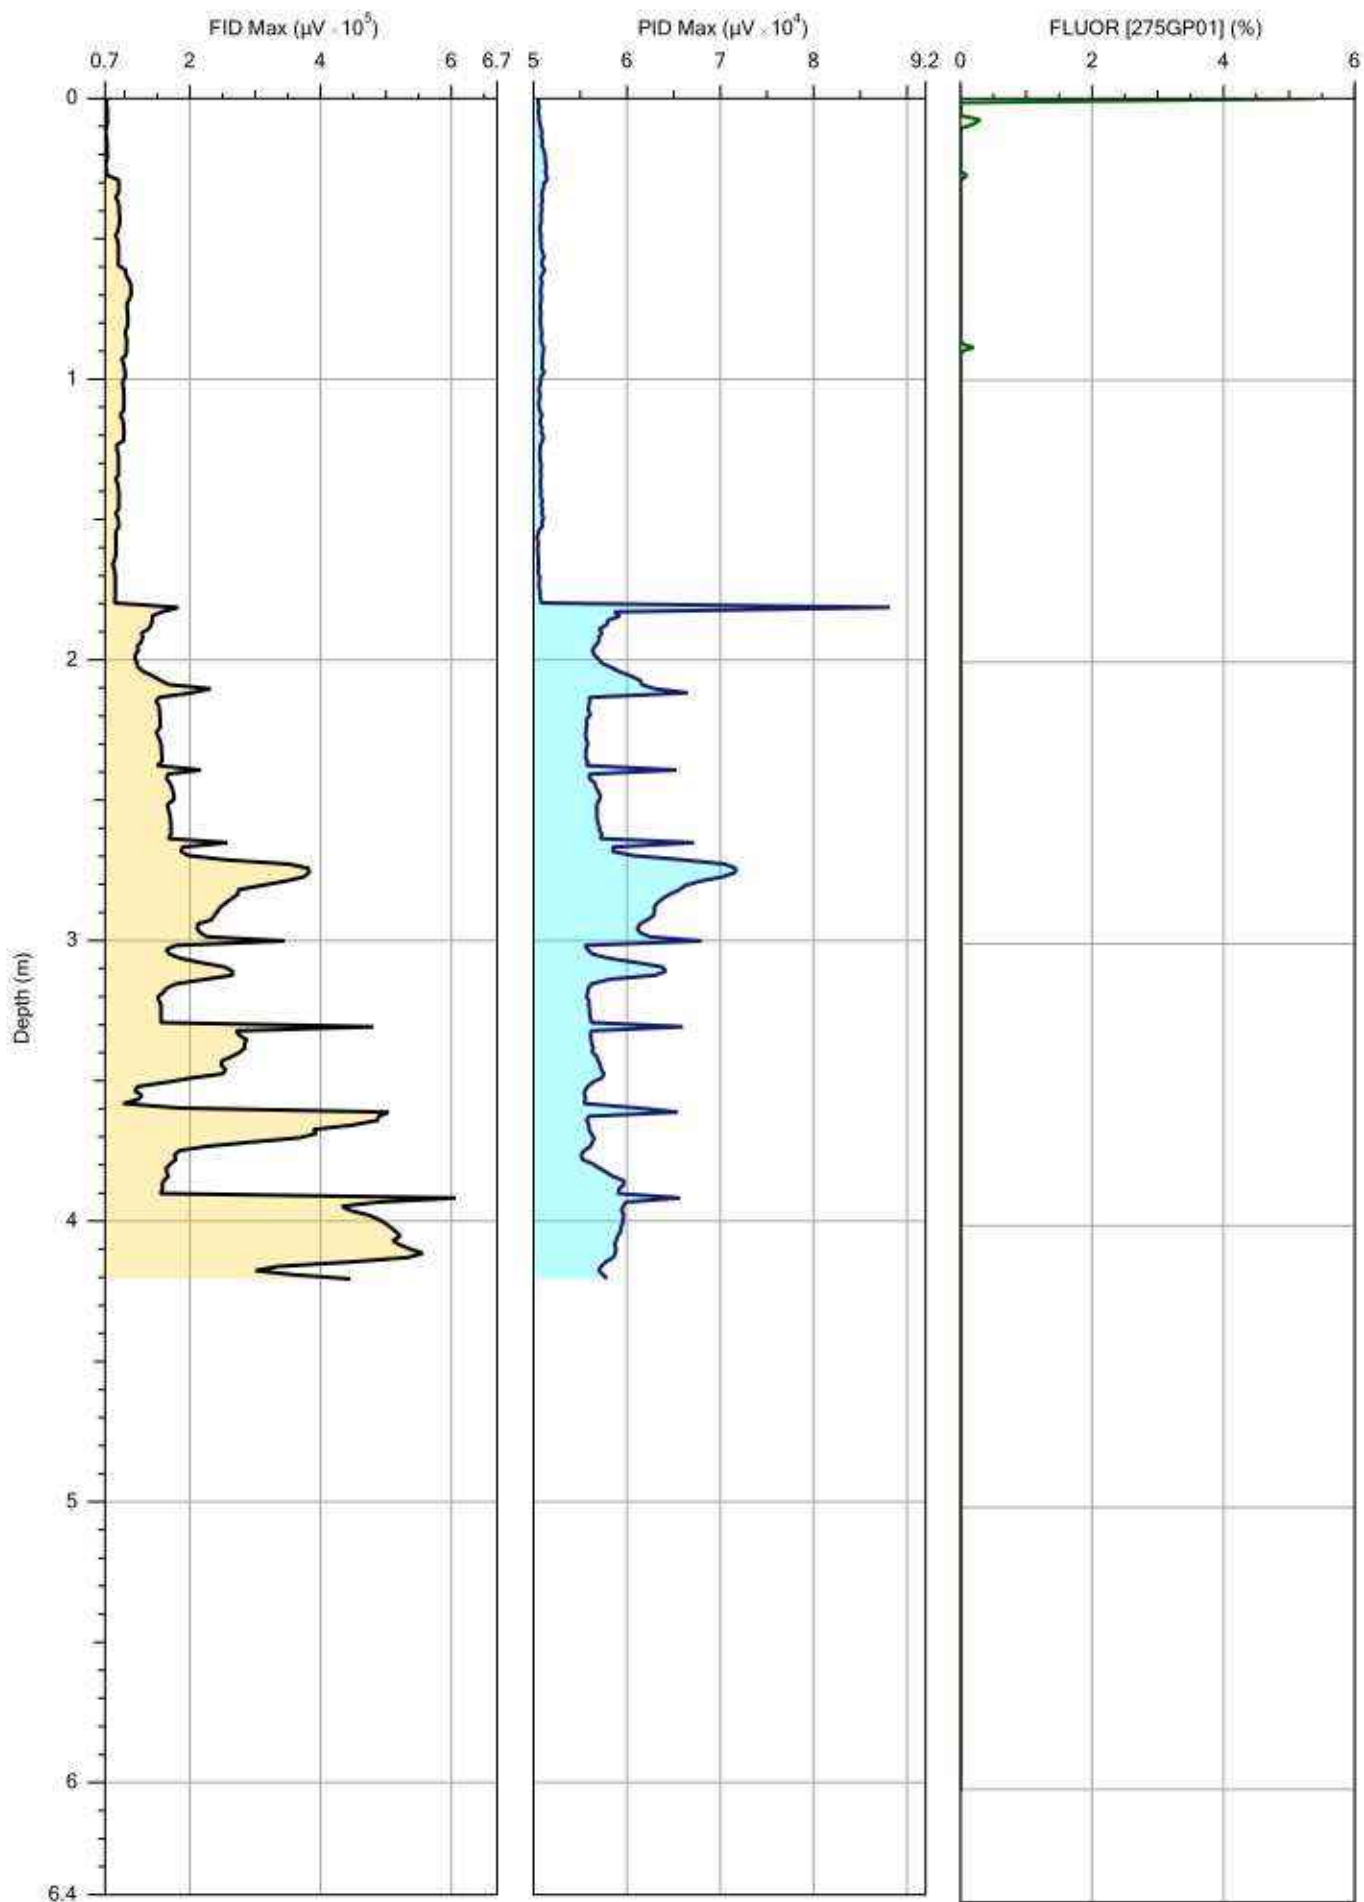
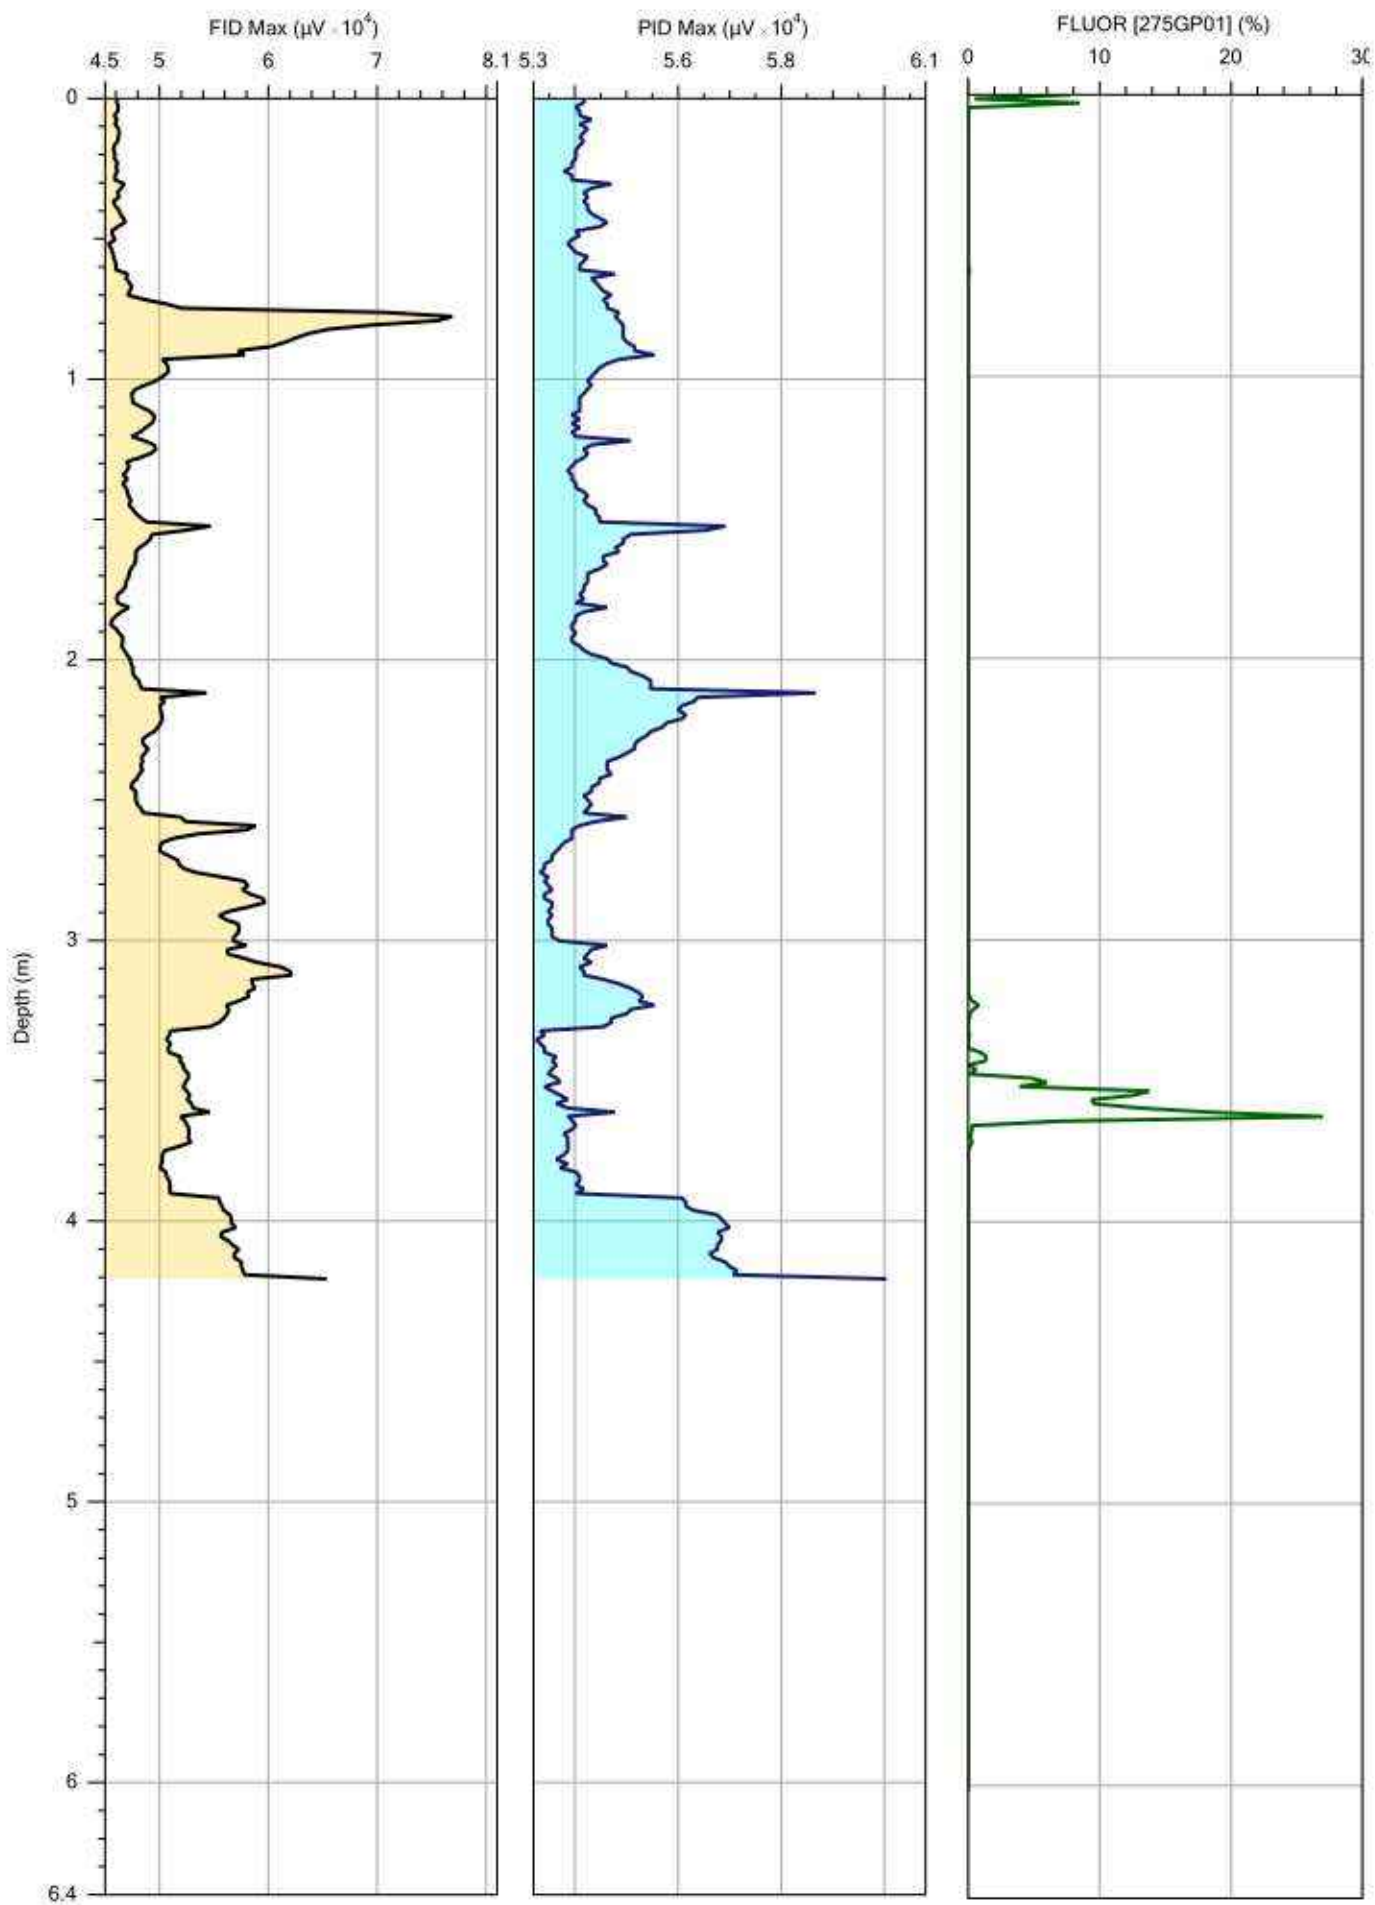
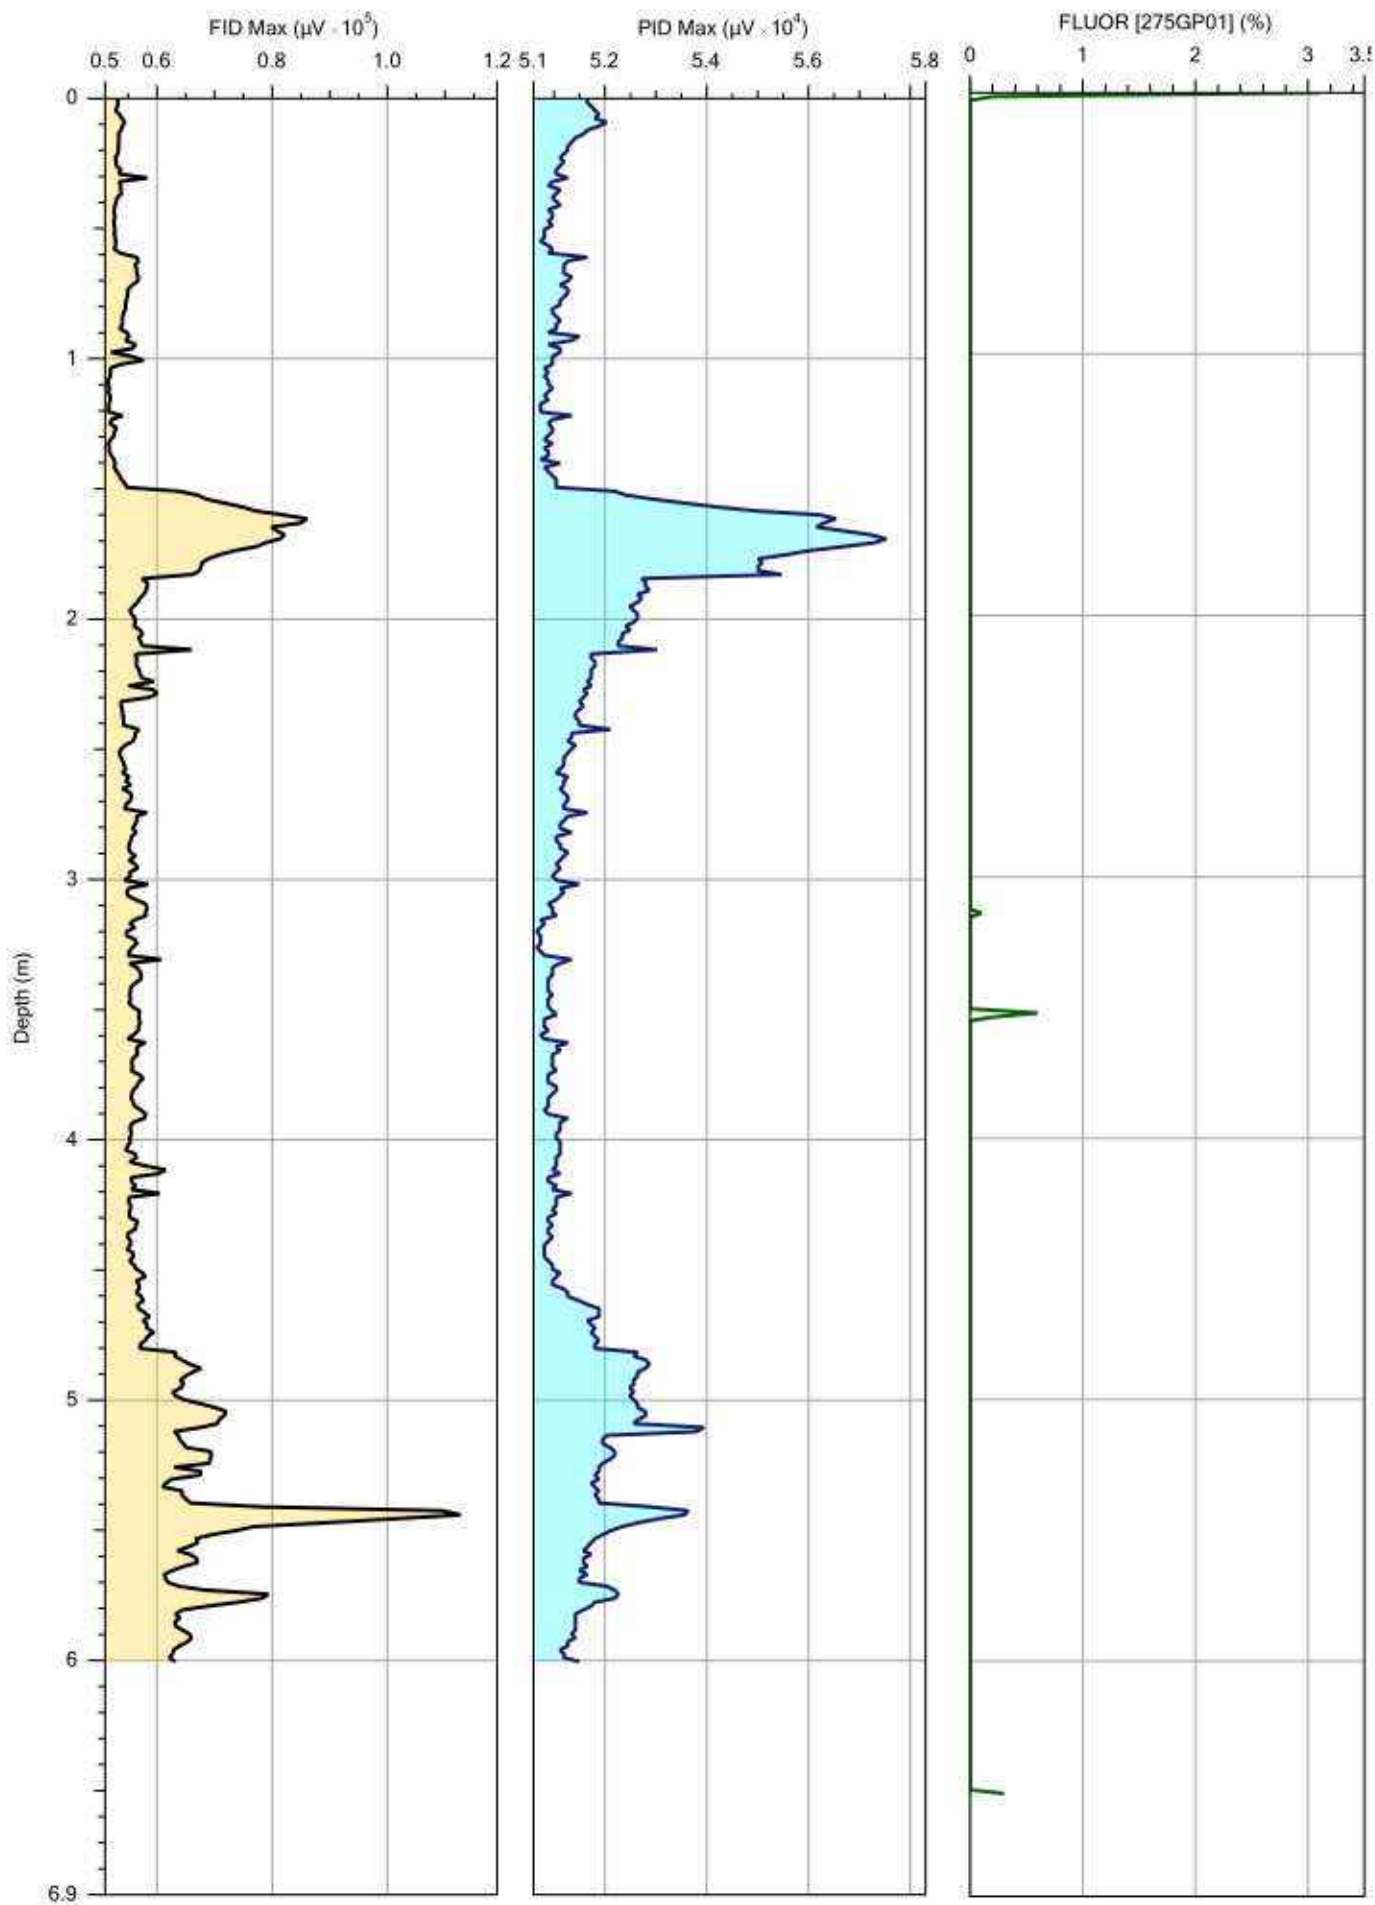
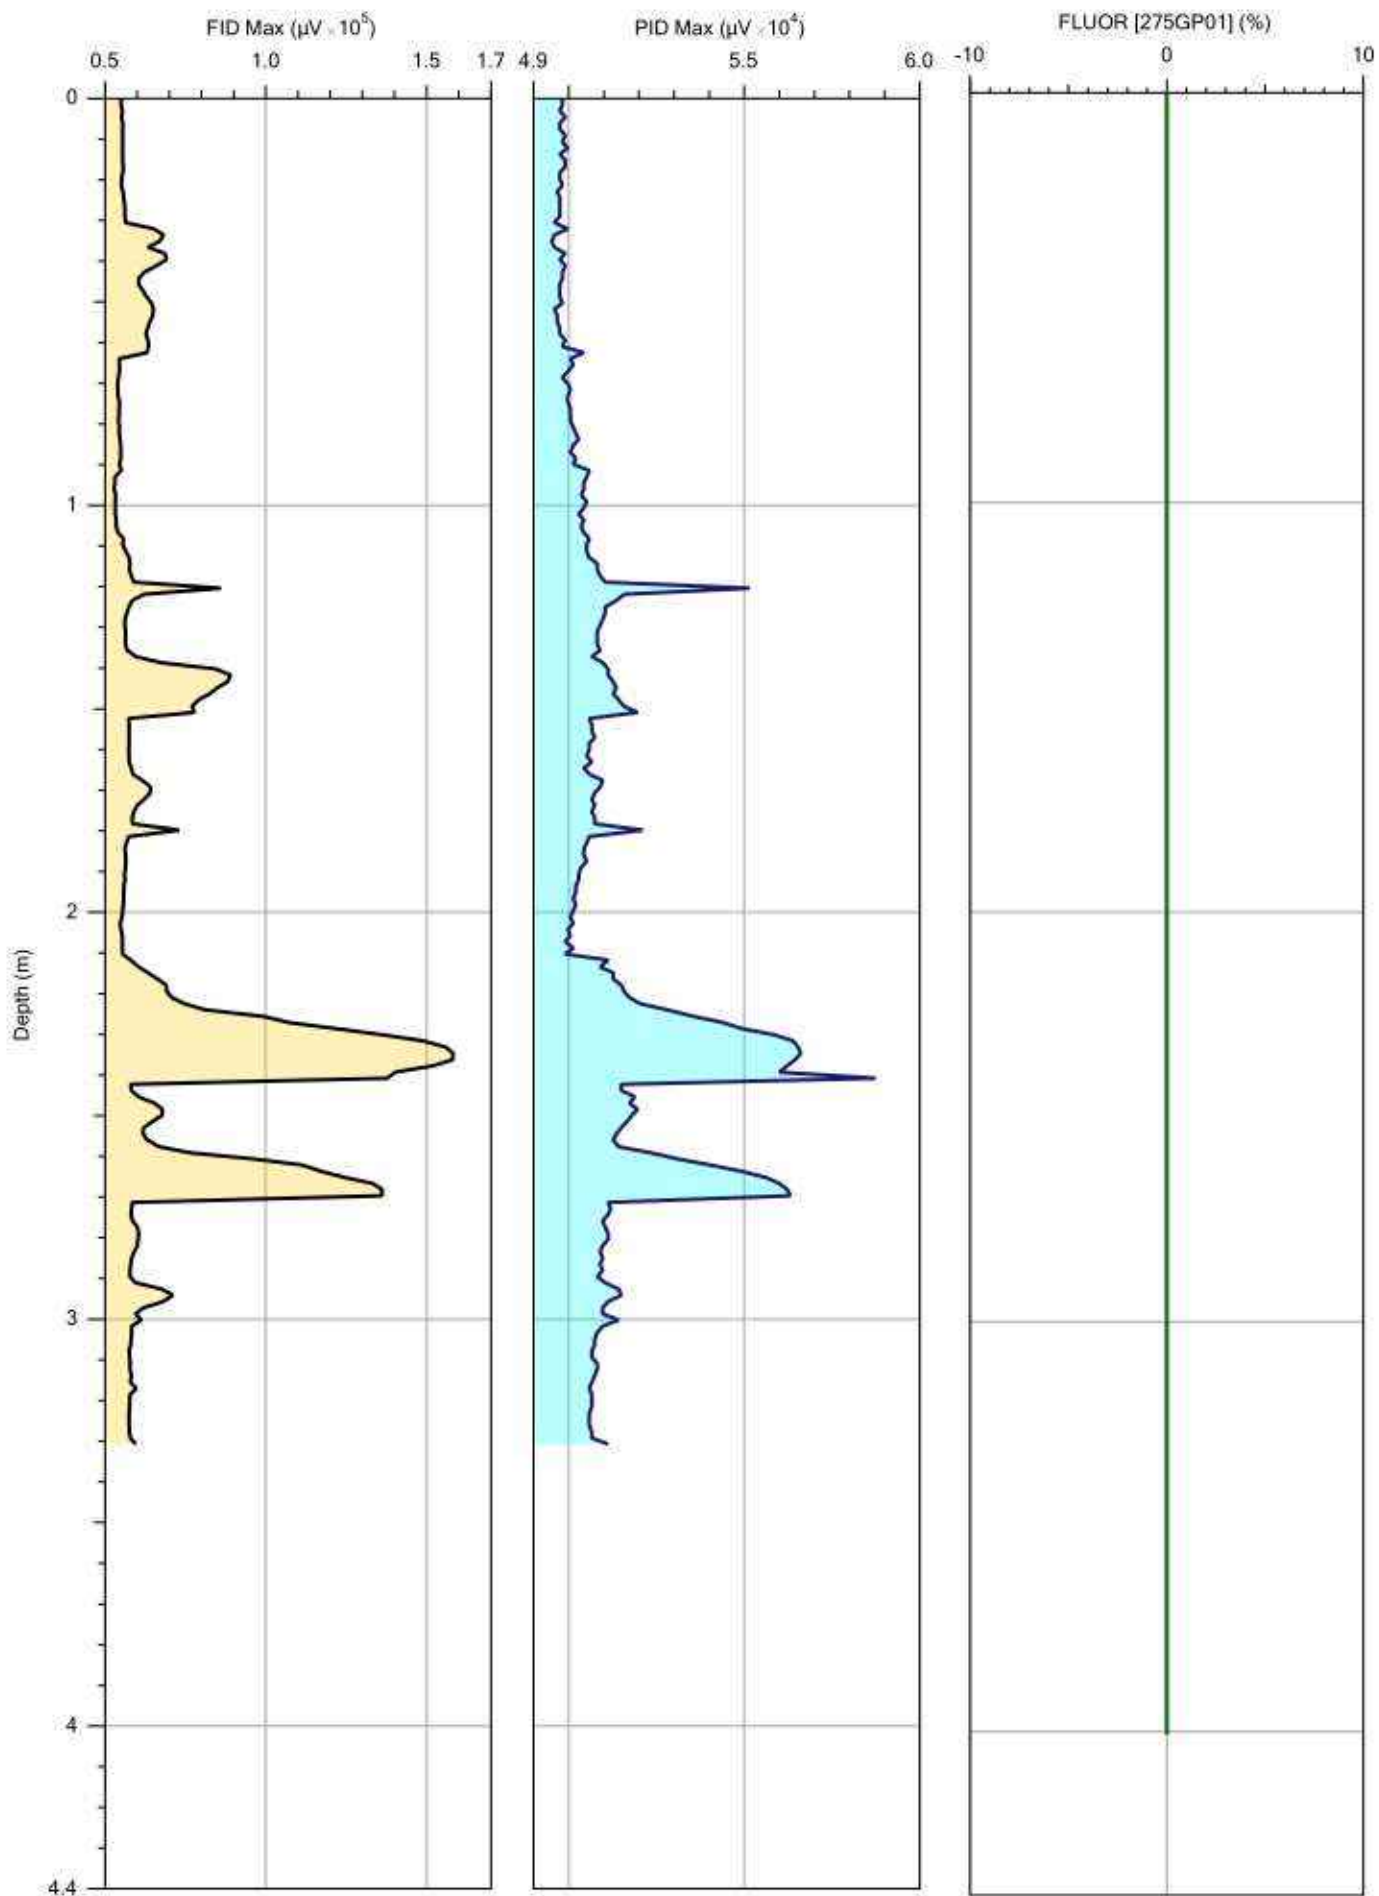
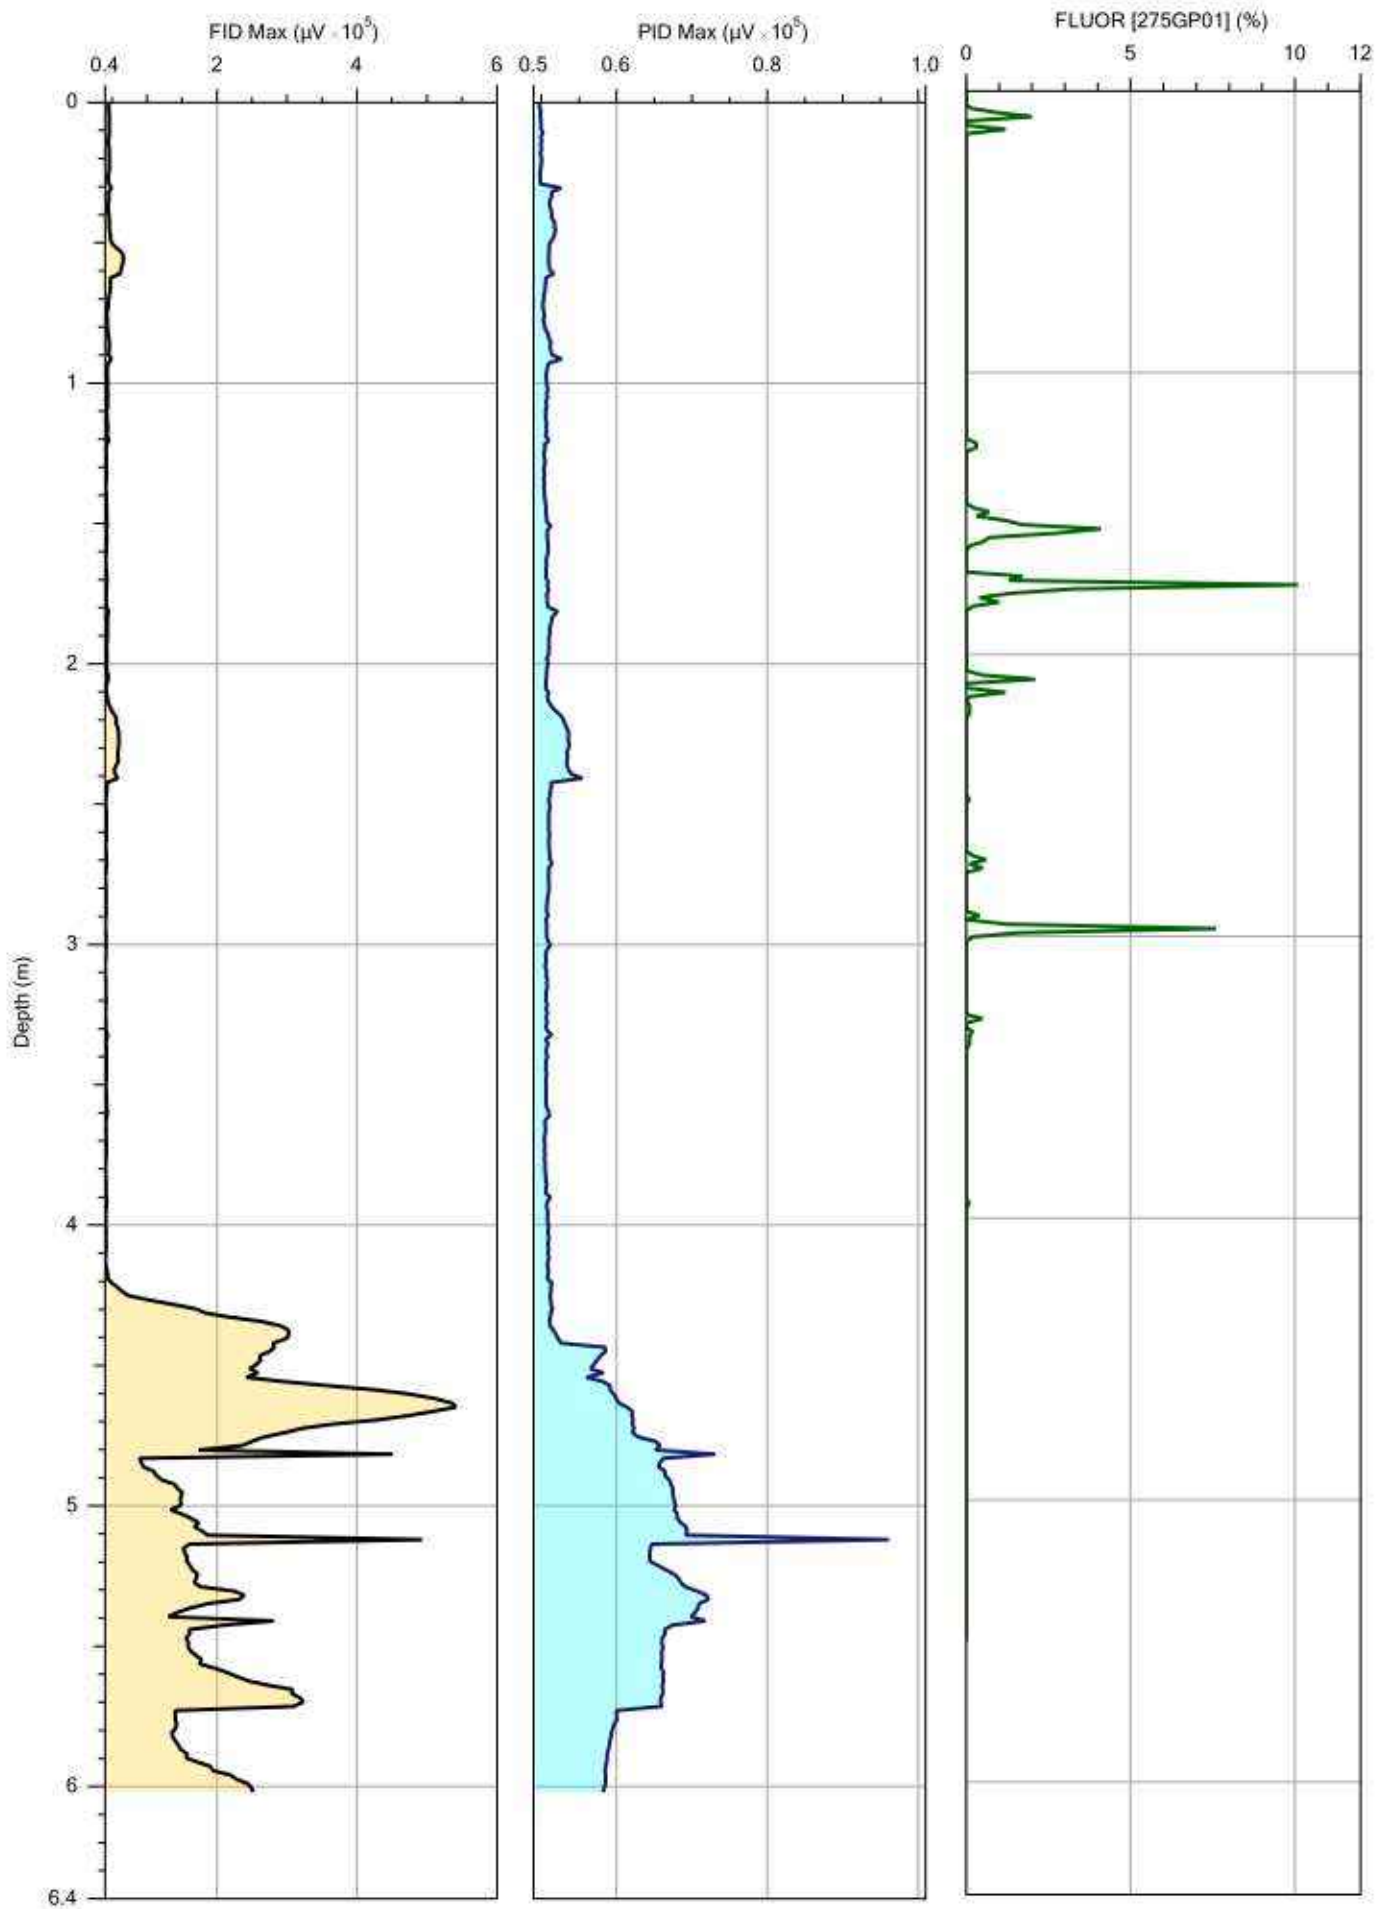
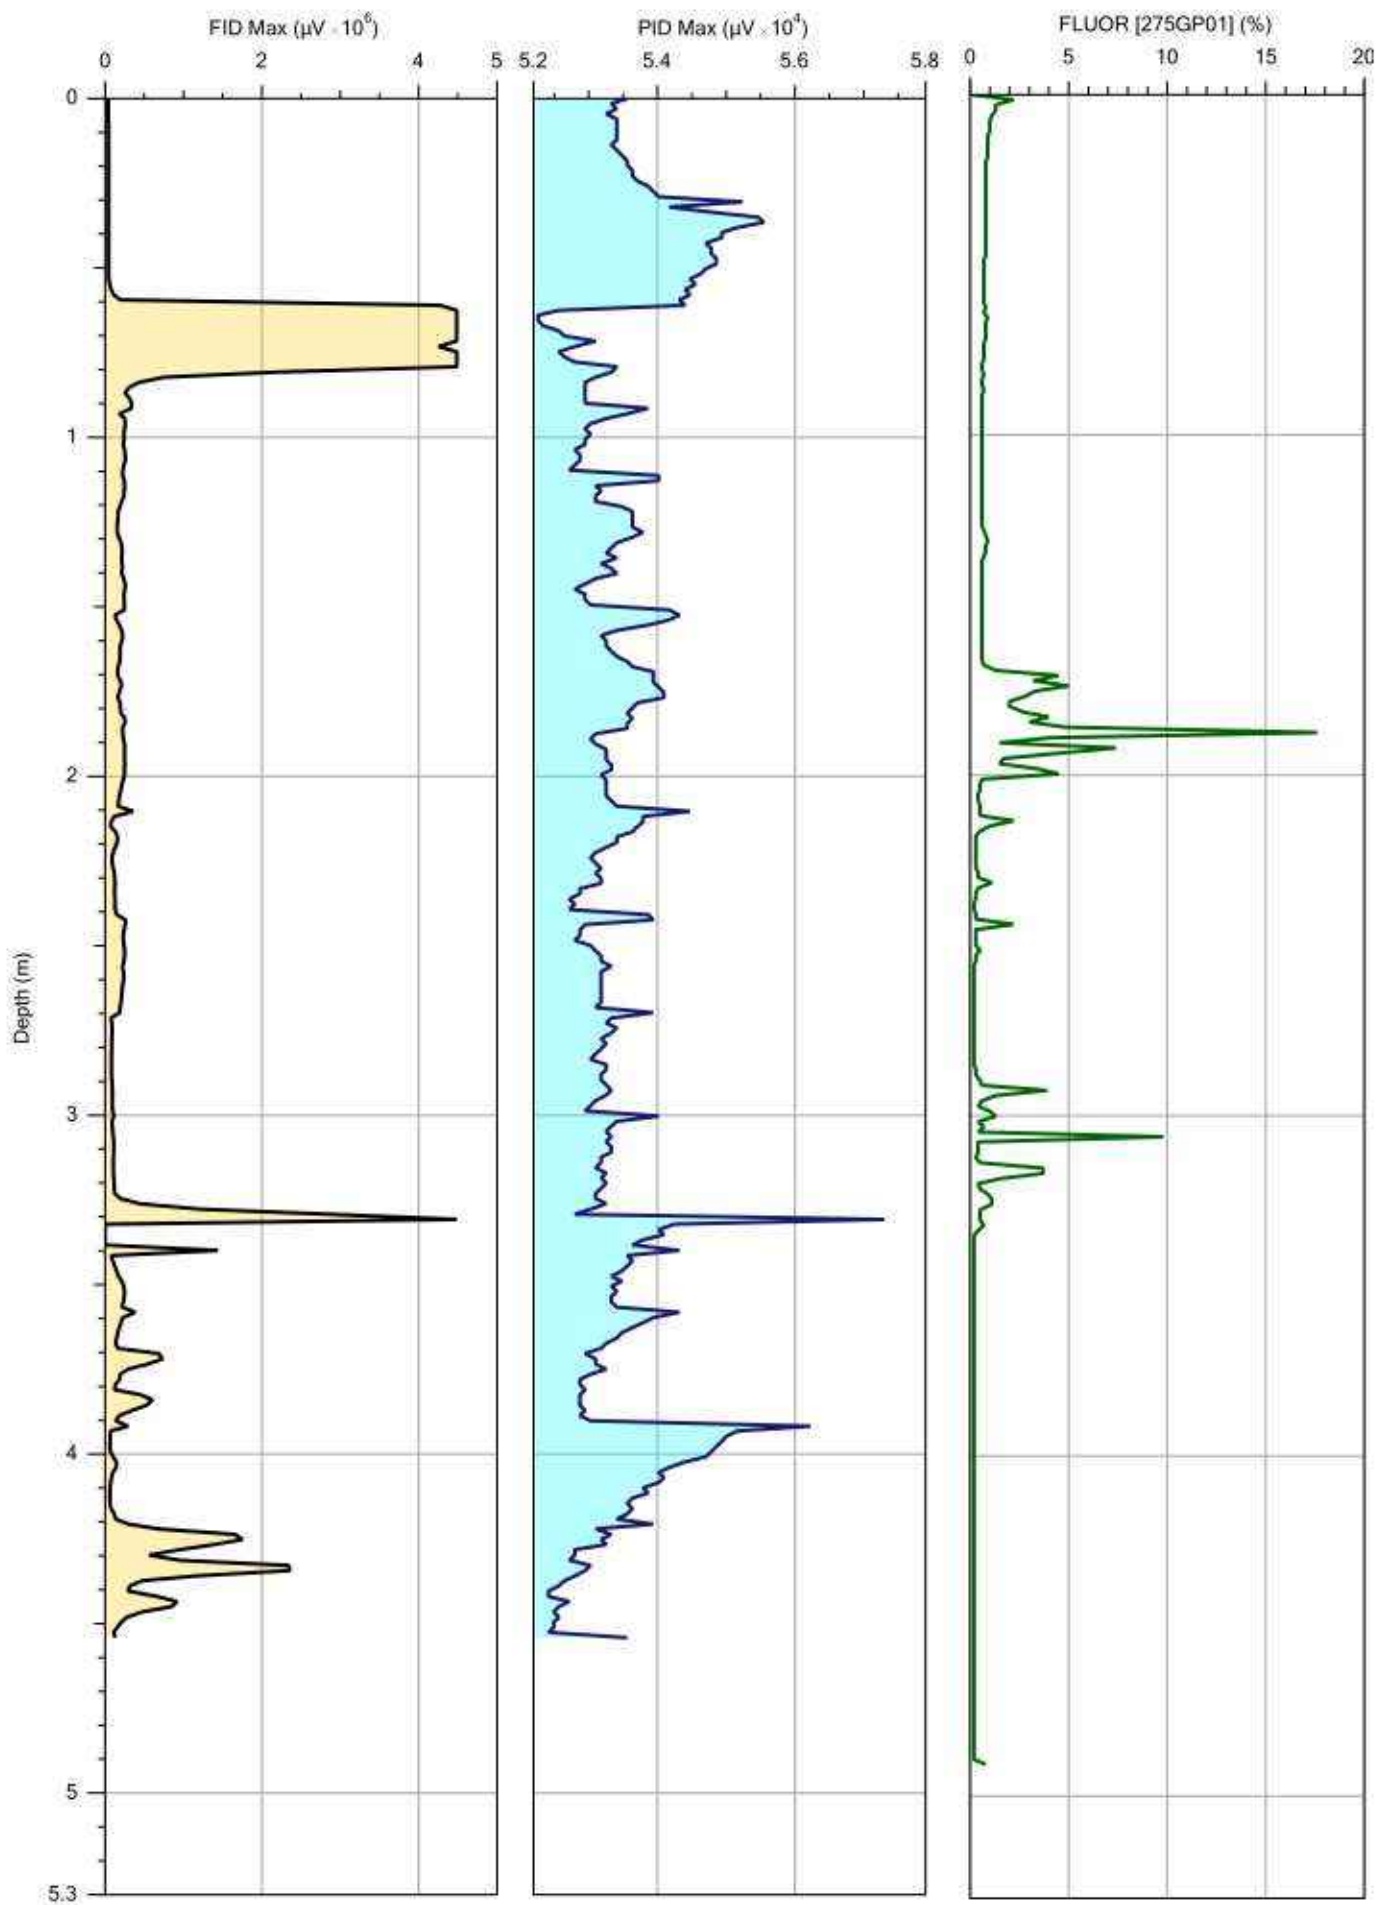
## 10.0 MIP/OIP DETECTOR PLOTS

Where an MIP and OIP log have been performed in the same location detector responses from both probes are shown.
