Our reference: 077873-CUR-00-XX-RP-GE-038-V01

**Re: Phase 2 Geo-Environmental and Geotechnical Report for Varey Street, Project 500 Sites**

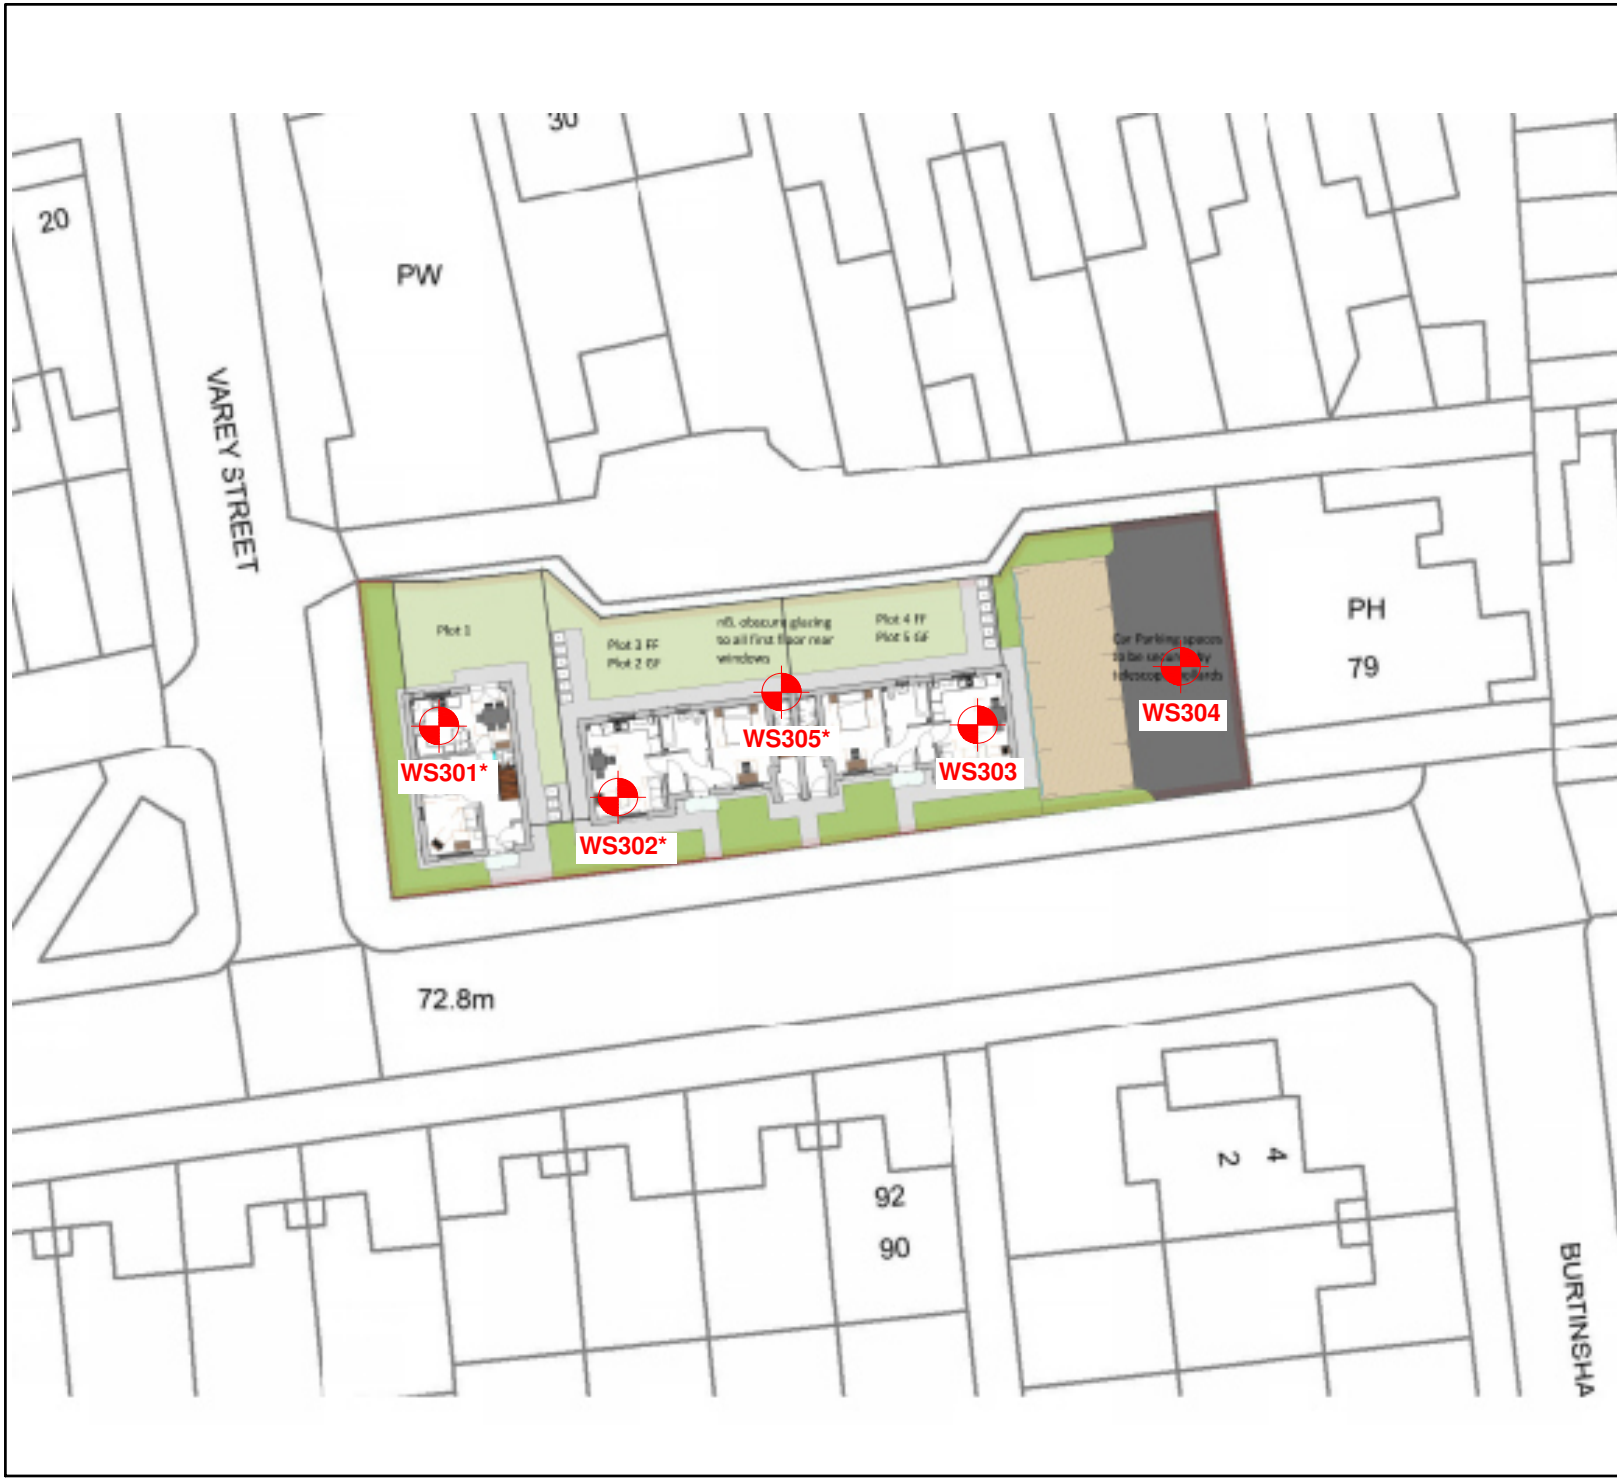
| 077873-CUR-00-XX-DR-GE-00004 | P01 |

The site works consisted of five window sample boreholes, WS301 to WS305 advanced to between 4.00m to 5.45m bgl. In-situ testing, including Standard Penetration Tests (SPTs) were undertaken at, generally, 1m intervals within the superficial soils.

An exploratory hole plan is included at the end of this report, Ref. 077873-CUR-00-XX-DR-GE-00004-P01.
