# Gorton Phase 2 Car Park

## Phase 2 Ground Investigation (Pre-Demolition)

Curtins Ref: 070452-CUR-00-XX-RP-GE-002

Site Address: Gorton Library, Garratt Way, Manchester, M18 8HE

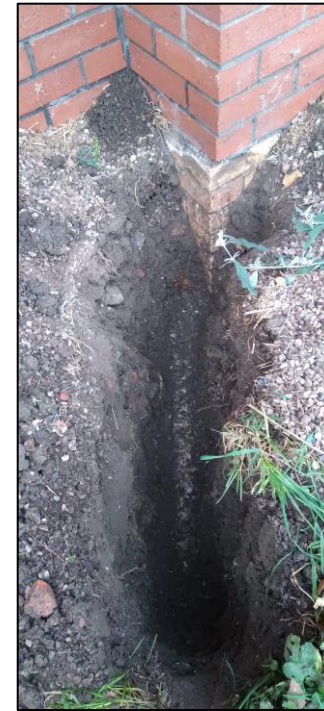
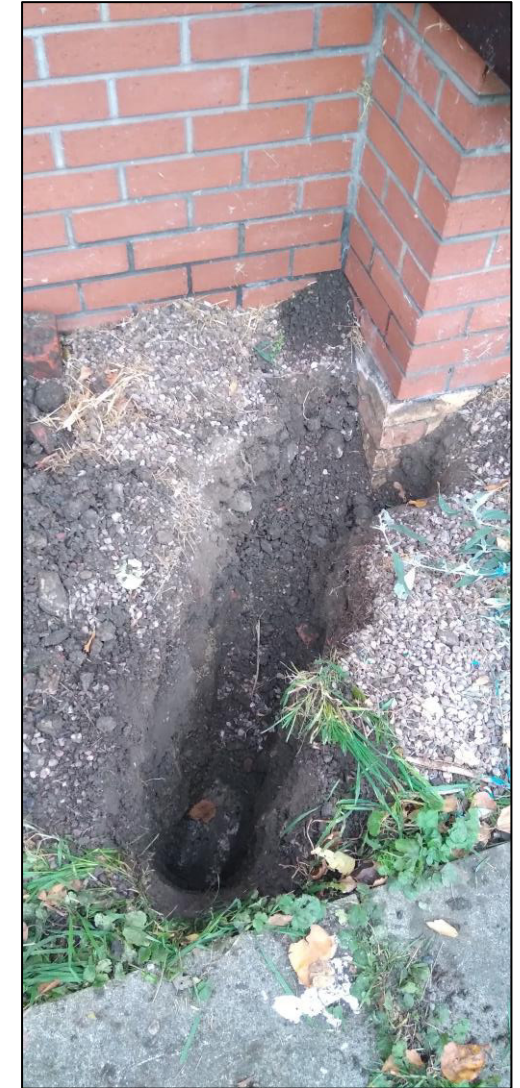
| Hand Pit Location | Purpose of Hand Pit Location | Foundation Encountered |
|---|---|---|
| HP01 | Identify type and extent of foundations on the Eastern side of existing library building | Concrete foundation encountered at 0.60m bgl projects more than 1.20m from the wall. Thickness of the foundation and edge of foundation was not able to be found due to access limitations. |

- Hand pit terminated at 0.60m bgl on concrete.
- Groundwater not encountered.
- Concrete foundation encountered at 0.60m bgl.
- Concrete foundation extends more than 1.20m away from building (measured from face of wall, not face of column).
- Base/thickness of concrete foundation not identified due to restrictions preventing extension of trial pit.
- Further detailed information in log HP01.

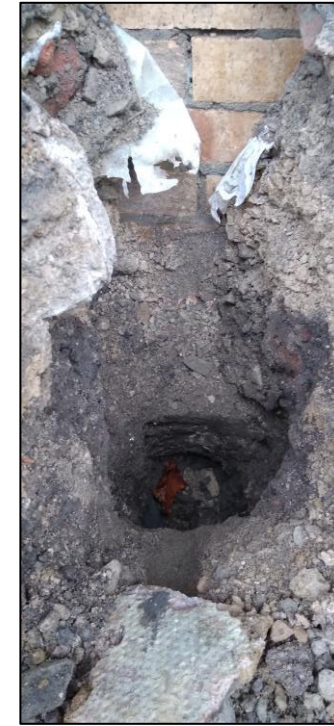
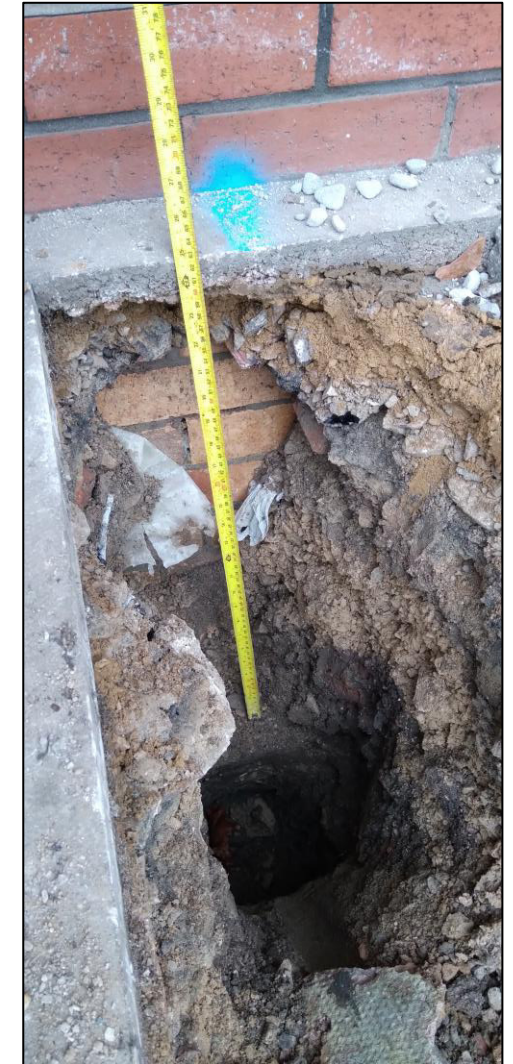
| Hand Pit Location | Purpose of Hand Pit Location | Foundation Encountered |
|---|---|---|
| HP02 | Identify type and extent of foundations on Northern side of existing library building | Concrete foundation encountered 0.60m bgl to 0.80m bgl with a thickness of 0.20m. The foundation projects 0.15m from the wall. |

- Hand pit terminated at 1.05m bgl in natural clay.
- Groundwater not encountered.
- Concrete foundation extends 0.15m away from building wall.
- Concrete foundation encountered at 0.60m bgl and the base of concrete slab identified at 0.80m bgl with a thickness of 0.20m.
- Further detailed information in log HP02.

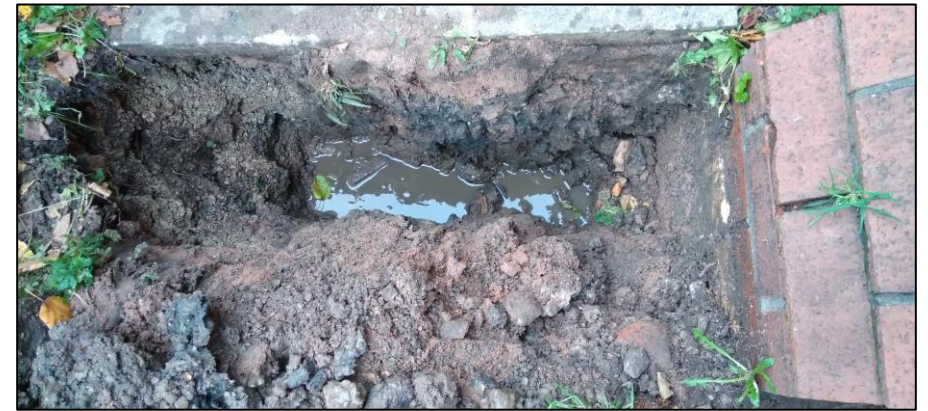
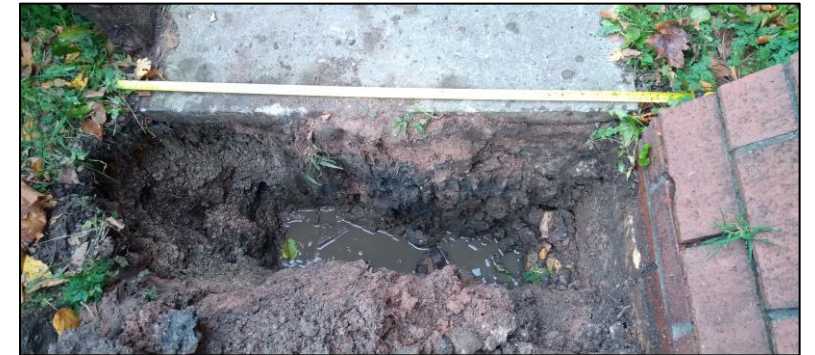
| Hand Pit Location | Purpose of Hand Pit Location | Foundation Encountered |
|---|---|---|
| HP03 | Identify type and extent of foundations on the Southern side of existing library building | Concrete foundation encountered at 0.60m bgl and projects 0.69m from the wall. Thickness of the foundation is more than 0.17m thick, unable to confirm the base of the foundation due to water ingress in the hand pit. |

- Hand pit terminated at 0.77m bgl in Made Ground due to water in the base of hand pit.
- Groundwater was encountered at 0.60m bgl.
- Concrete foundation projects 0.69m from building wall.
- Concrete foundation encountered at 0.60m bgl and the base of concrete foundation identified at 0.77m bgl with a thickness of 0.17m bgl.
- Further detailed information in log HP03.

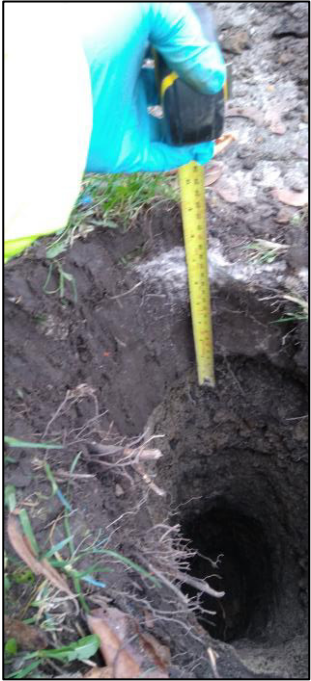
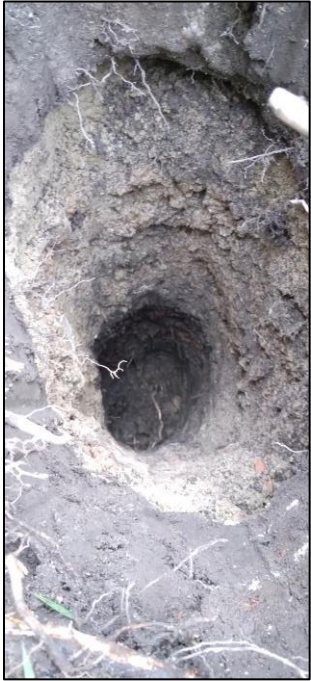
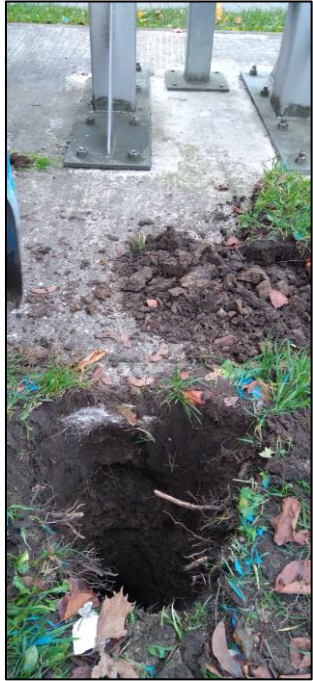
| Hand Pit Location | Purpose of Hand Pit Location | Foundation Encountered |
|---|---|---|
| HP04 | Identify type and extent of foundations on the Northern side of existing monument | Concrete foundation encountered from the surface to 0.20m bgl. The foundation is underlined by a Made Ground gravel to 0.90m bgl and then natural clay from 0.90m bgl. |

- Hand pit terminated at 1.00m bgl in natural clay.
- Groundwater not encountered.
- Concrete foundation encountered at ground level, extending to 0.20m bgl, formed on Made Ground.
- Further detailed information in log HP04.
