# Circle Square, Building 3

## Phase 2 Ground Investigation

Ref: CS3-CUR-03-XX-RP-G-0002

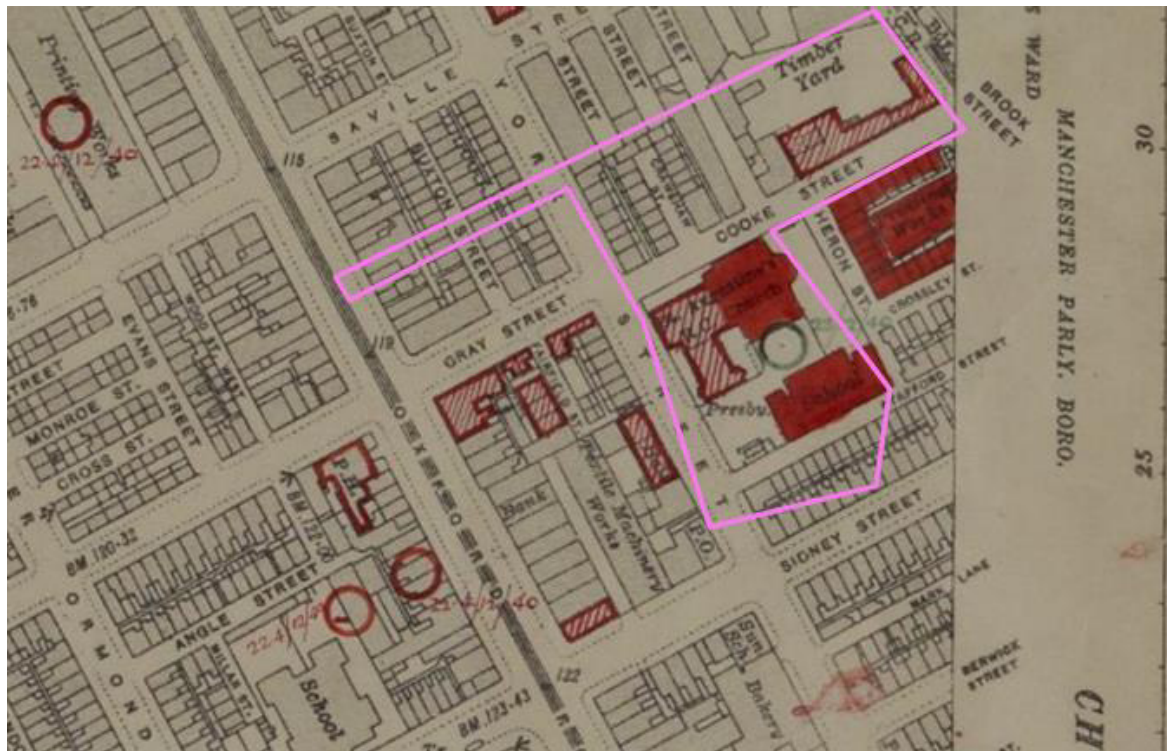
A review of historical mapping and available online bomb damage mapping (Ref. 2) for Manchester has indicated that bomb damage was incurred in the south of the site and terraced properties immediately south of the site were demolished. A fire bomb was recorded approximately 120m north west of the site.

The buildings in the south of the site are shaded pink which indicates they encountered damage during WWII, confirmed by historical mapping which indicates the presence of Medlock Works in their place. The terraced properties and St Augustine's Roman Catholic Church to the south boundary of the site are shaded red indicating they were demolished during WWII.
