Phase II Contaminated Land Risk Assessment

Monet Lodge, Cavendish Road, Didsbury

Site Ref: 6103/VMD-CLRA v1.00

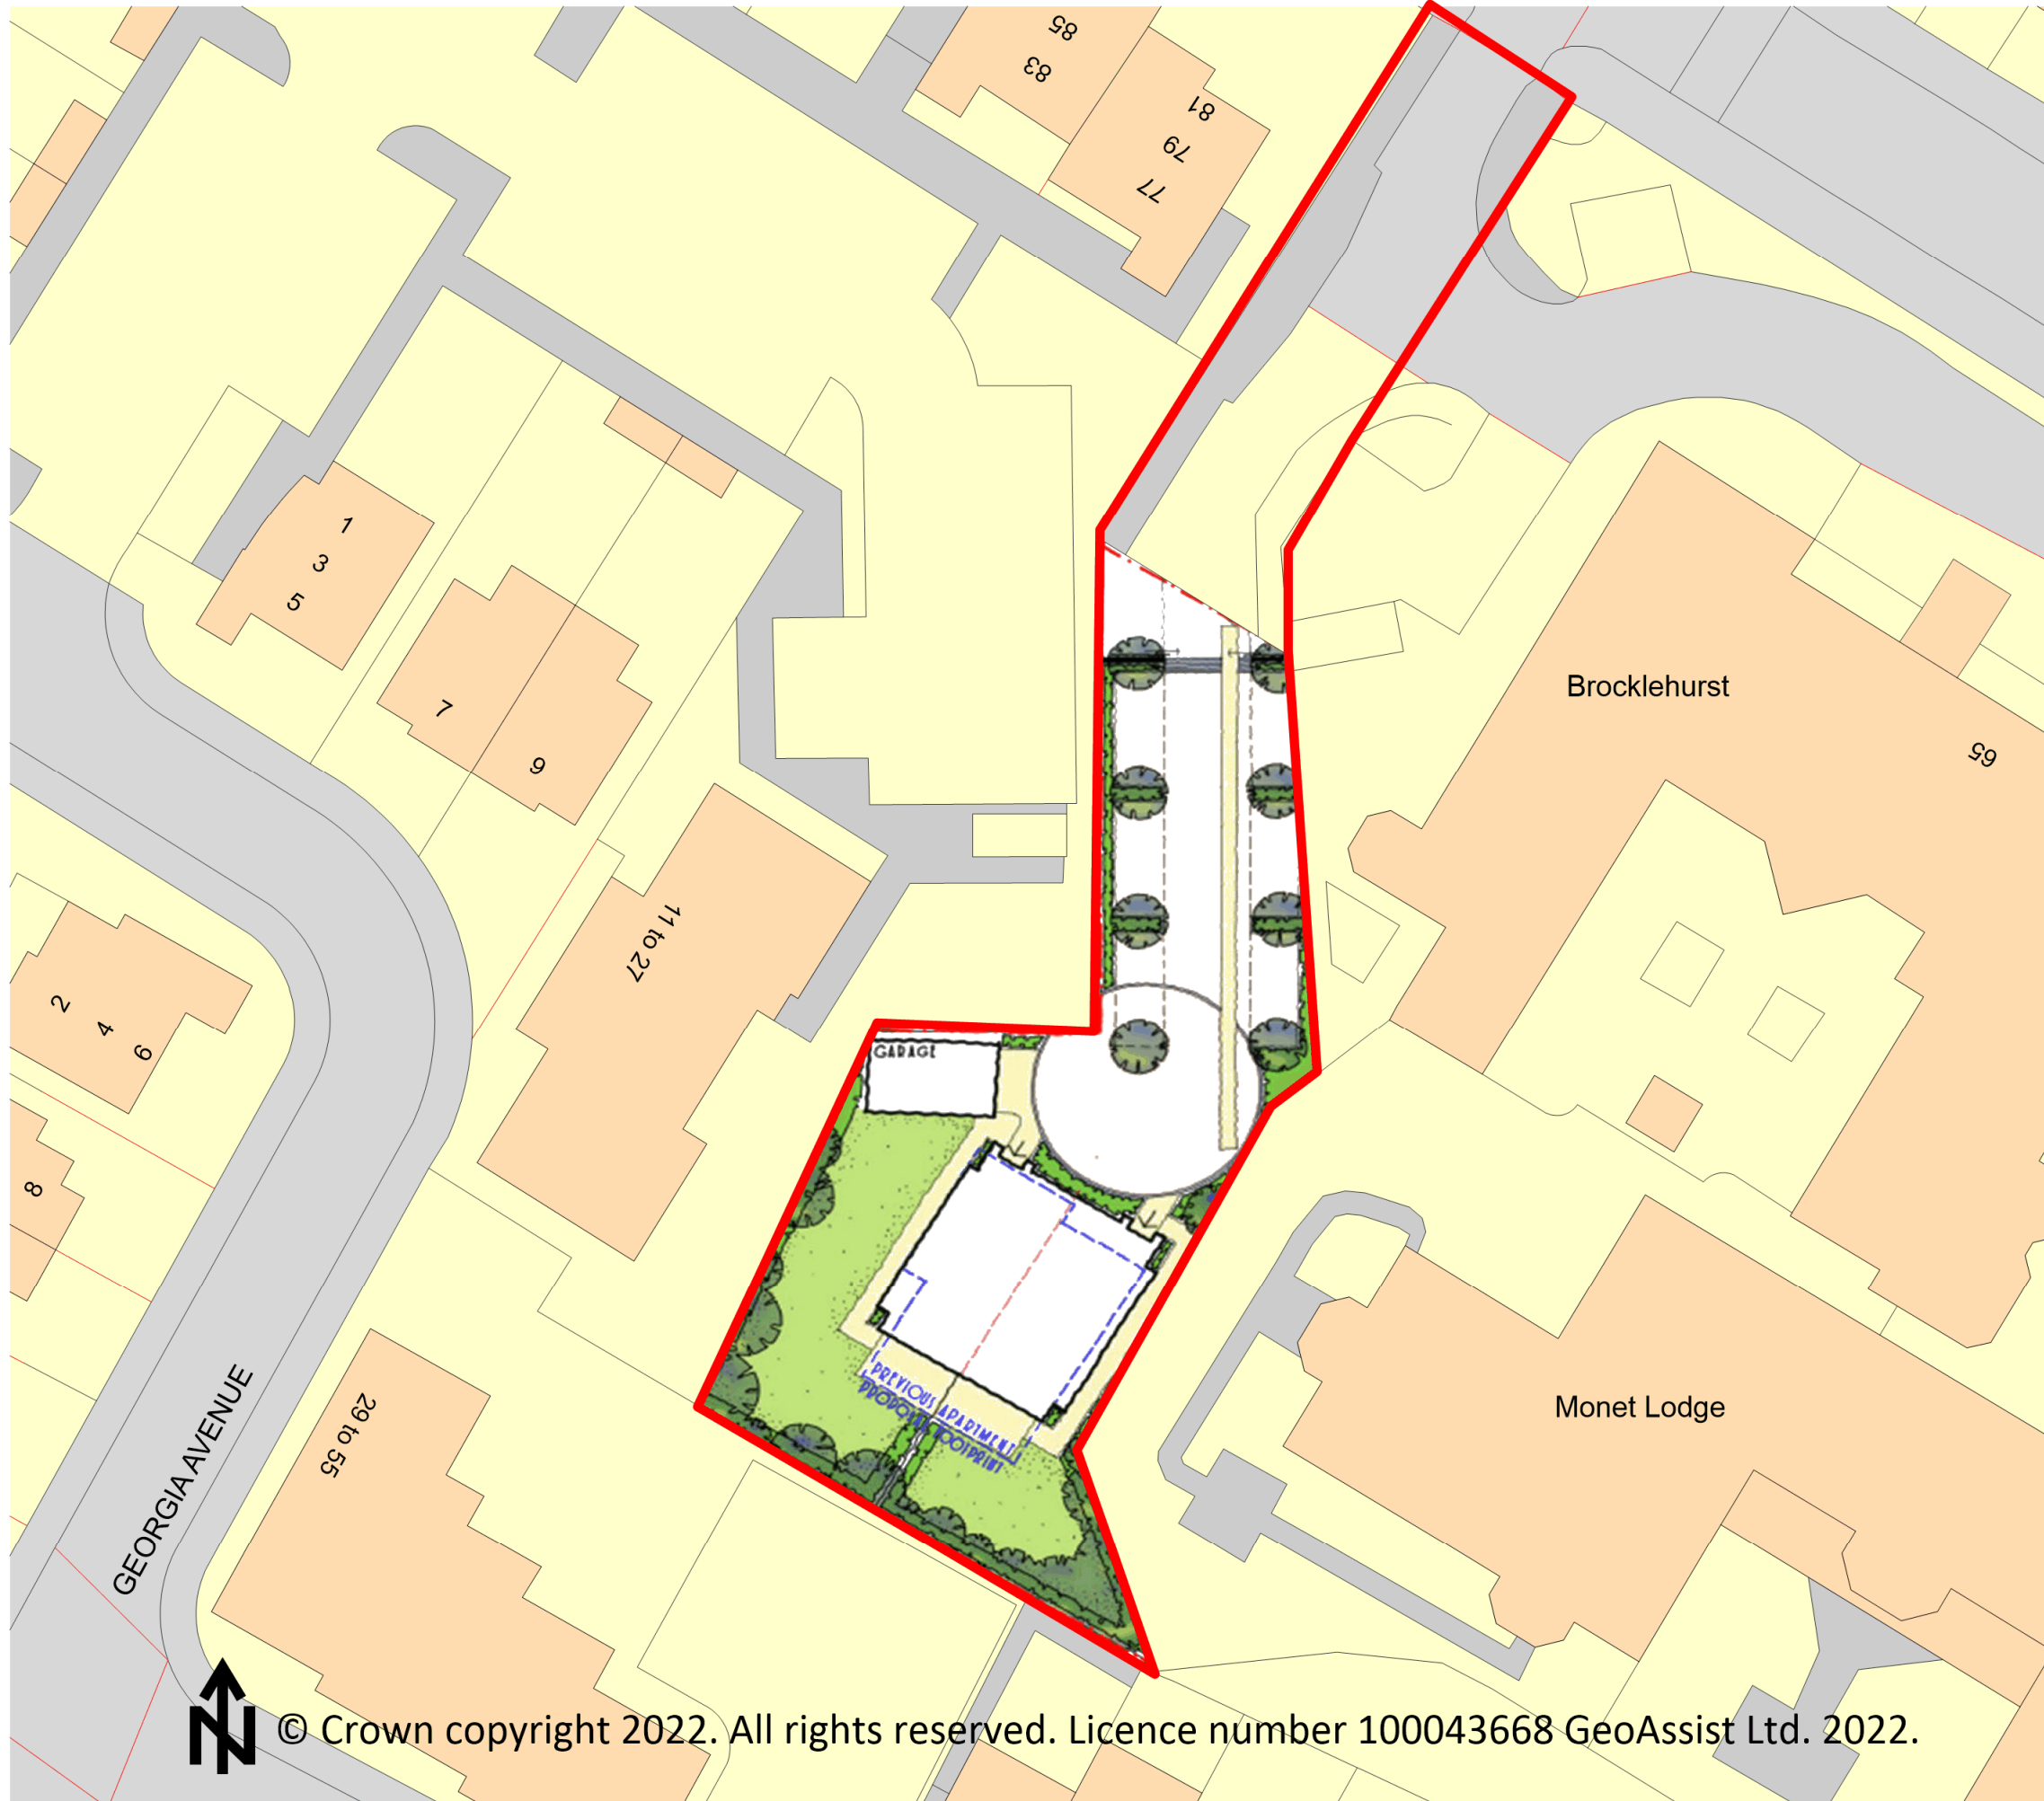
The approximate grid reference for the centre of the site is 383750, 392600 and the total area of the site is approximately 1,200m<sup>2</sup>. The area of the site scheduled for investigation is outlined with a solid red line on the site plan in Appendix A1. The positions of exploratory holes are also indicated on the plan. The proposed development plan is shown in appendix A2.
