# DAYTIME BAT SURVEY & NESTING BIRD SURVEY

FRASER HOUSE, 36 CHARLOTTE  
STREET, MANCHESTER

NOVEMBER 2022

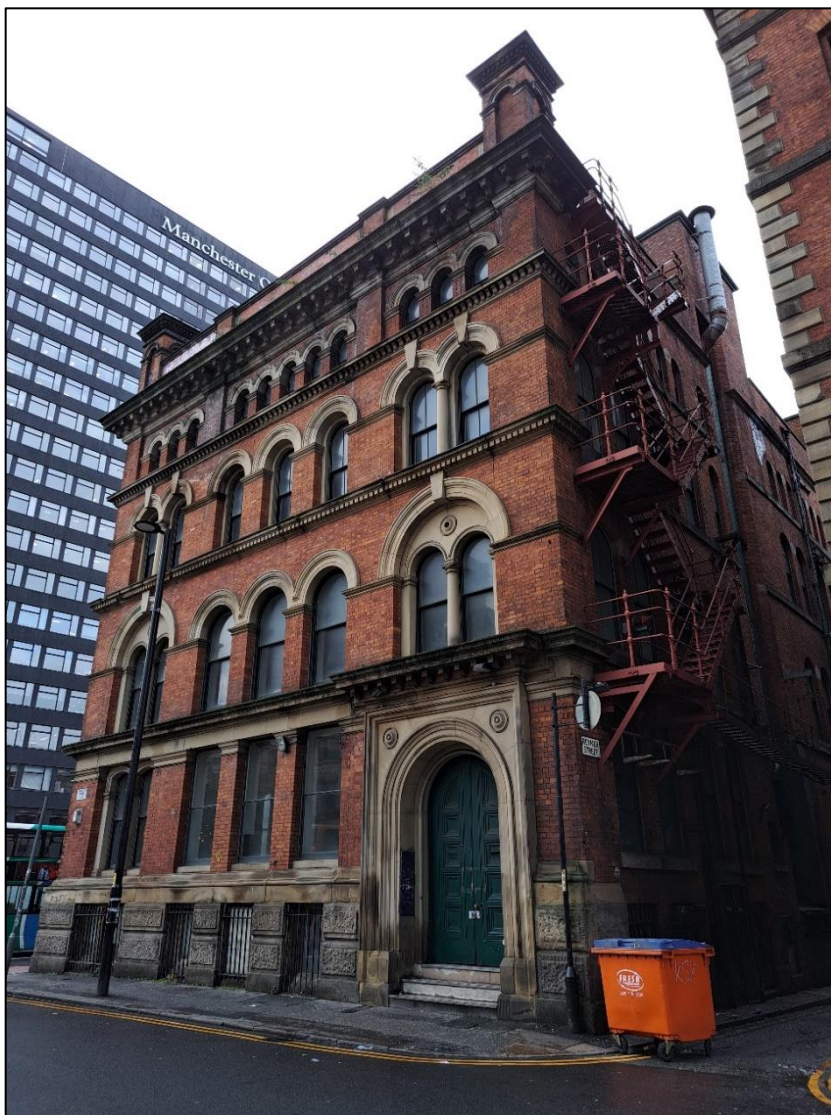
- 3.1 Fraser House is a large, multi-story 1850s commercial warehouse building sitting within Manchester city centre (see Photograph 1). The building is constructed from brick with a stone dressing, with arched windows on the elevations that stretch across Portland Street and Charlotte Street and loading bays across Rayner Street. The hipped roof has three rows of windows across the centre and a tall, panelled parapet extending around the edge of the building. The building extends five stories from ground level and extends across several lower basement levels.

*Photograph 1 showing the building from the corner of Charlotte St and Portland St*

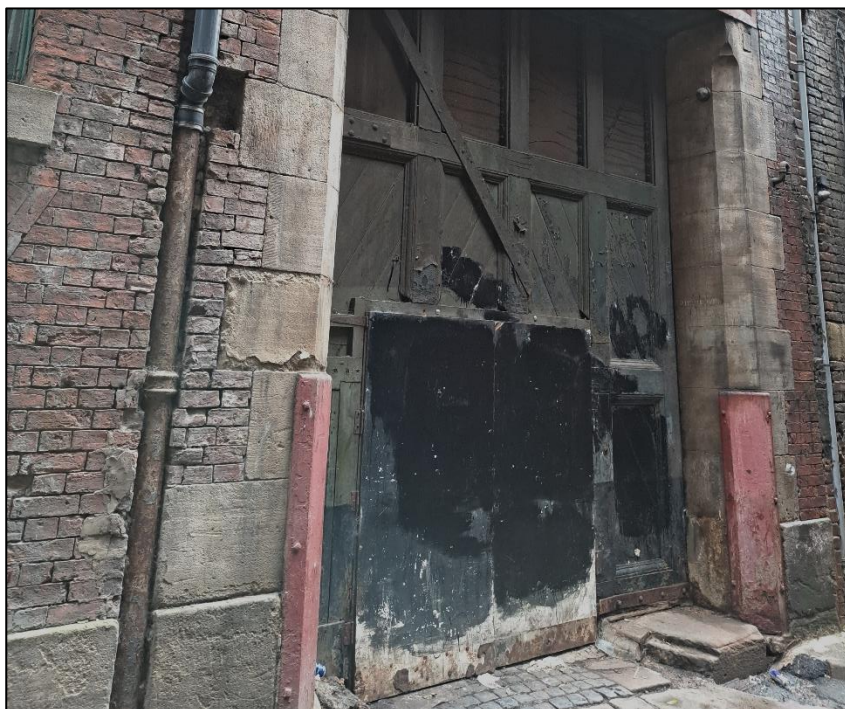
- 3.2 The brickwork and stone dressing appear in fair condition overall. There are however some holes in the brickwork that lead into the internal spaces. There are also gaps on the main front door and gaps on the doors of the loading bays that provide opportunities for bats to enter the building, albeit at lower levels. Photograph 2 shows the brickwork condition and loading bay entrance towards the rear of the property.

*Photograph 2 showing condition of the external brickwork*

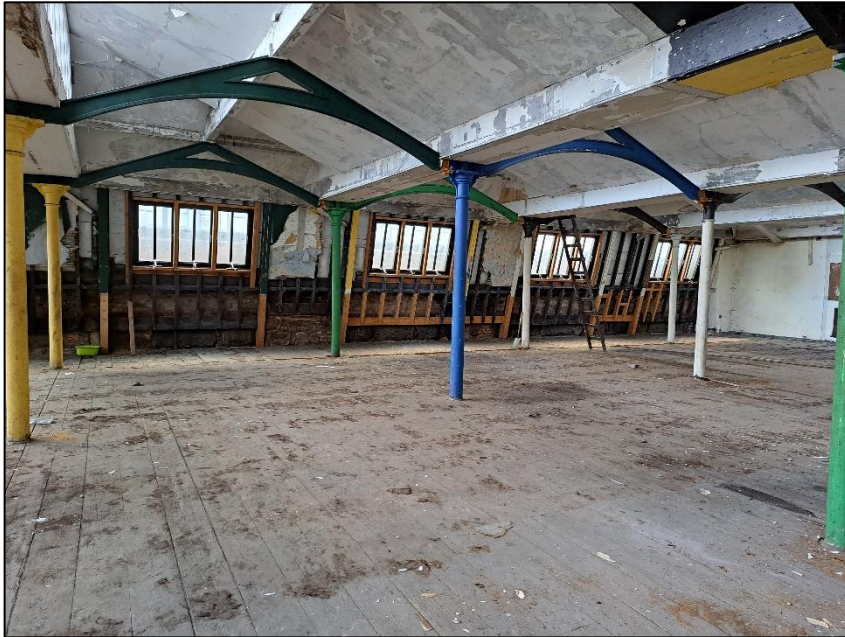
- 3.5 The uppermost floor of the property is open to the roof (see Photograph 4). The iron frame and wooden beams are exposed and show no cracks or crevices. The beams have been well maintained with several areas having been replaced (see Photograph 5). The space is well-lit by the skylights in the roof.

*Photograph 4 showing the uppermost floor of the property*

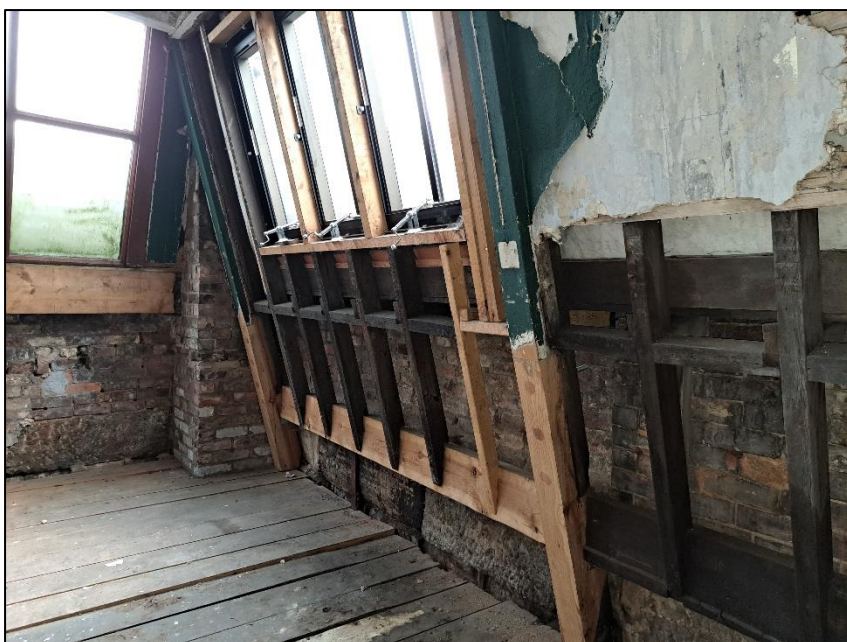
*Photograph 5 showing replaced beams*

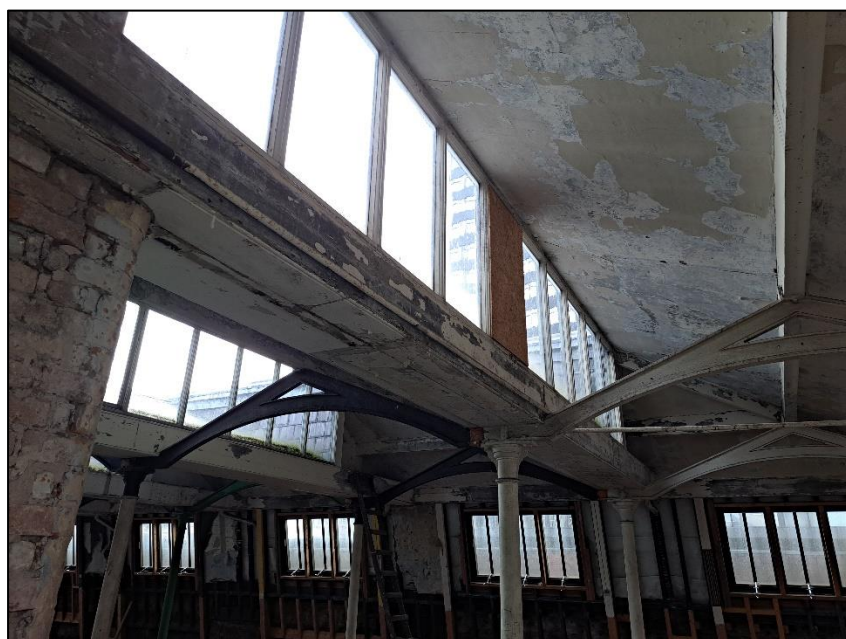
- 3.6 The skylights and windows are single glazed, most are well sealed (see Photograph 6). Three skylights are missing glass and are boarded with wood, these are not well sealed, and gaps are visible that lead directly outside (see Photograph 7). A hole was also identified in the door that leads to the exterior stairs (see Photograph 8).

*Photograph 6 showing the skylights and windows of the upper floor*

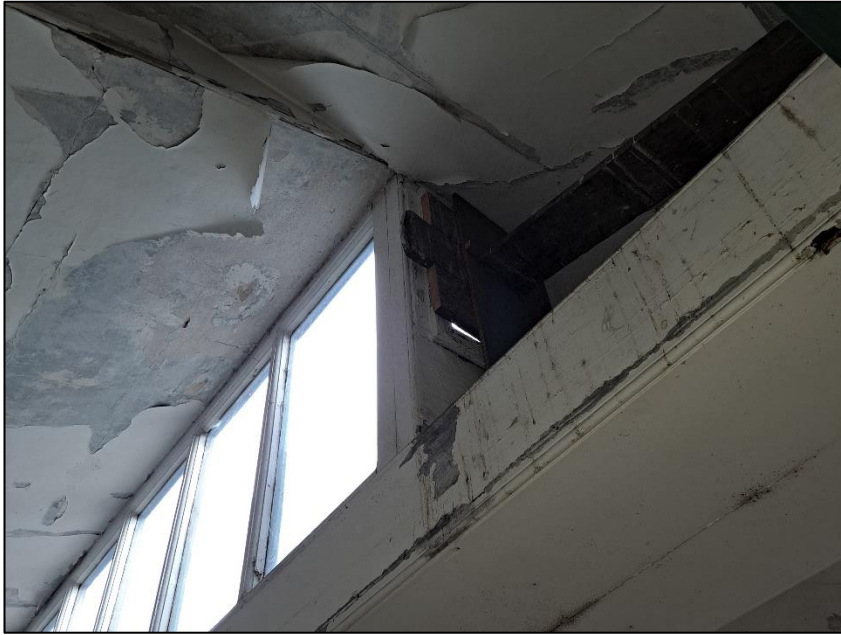
*Photograph 7 showing a gap leading to the exterior*

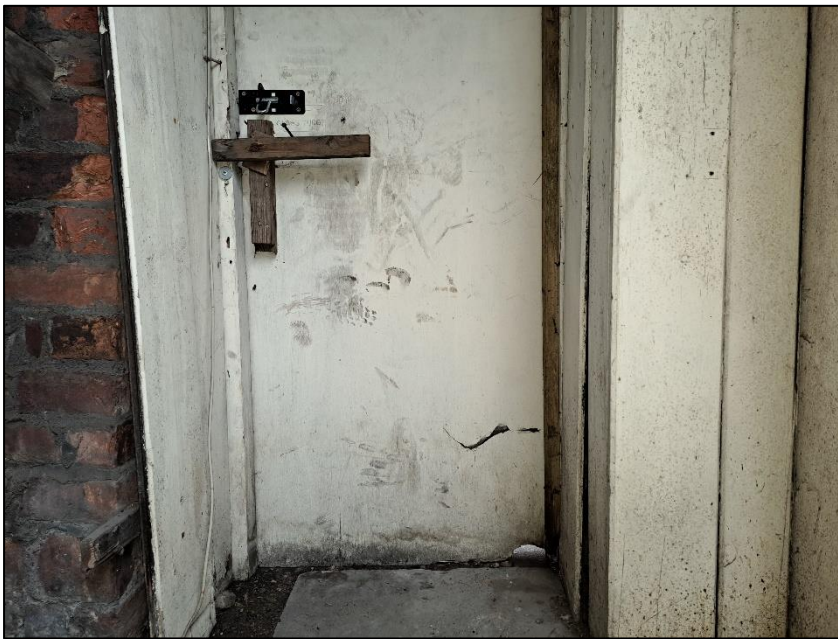
*Photograph 8 showing a hole in the door that leads to the external staircase*

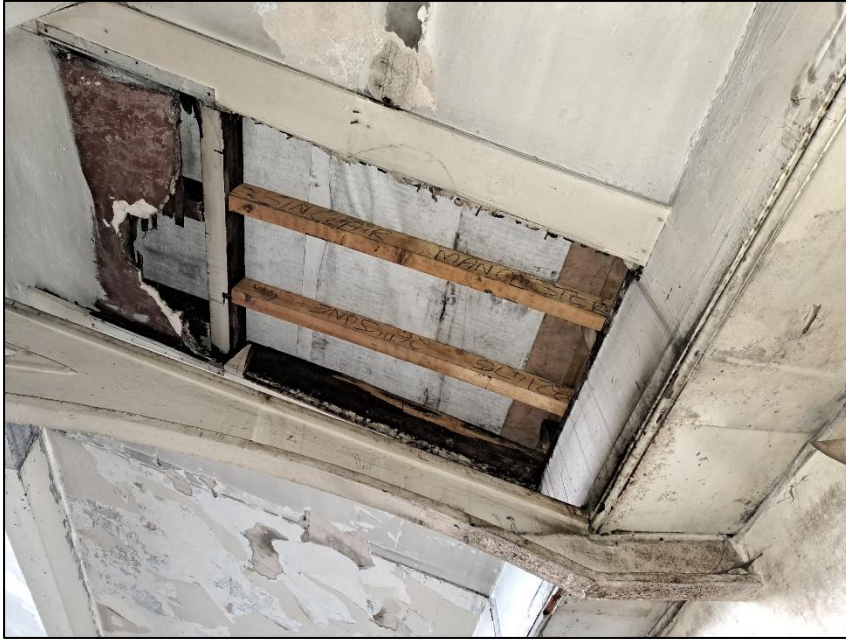
- 3.7 A false ceiling is present within the hipped roof sections of the roof, that leads to a small roof void (see Photographs 9 & 10). The void was too small for the surveyors to access and assess but sections of ceiling are missing where wood has rotted and a number of large potential bat entry points were identified. Where visible, the roof lining is in place and in good condition.

*Photograph 9 showing the roof void of the hipped roof*

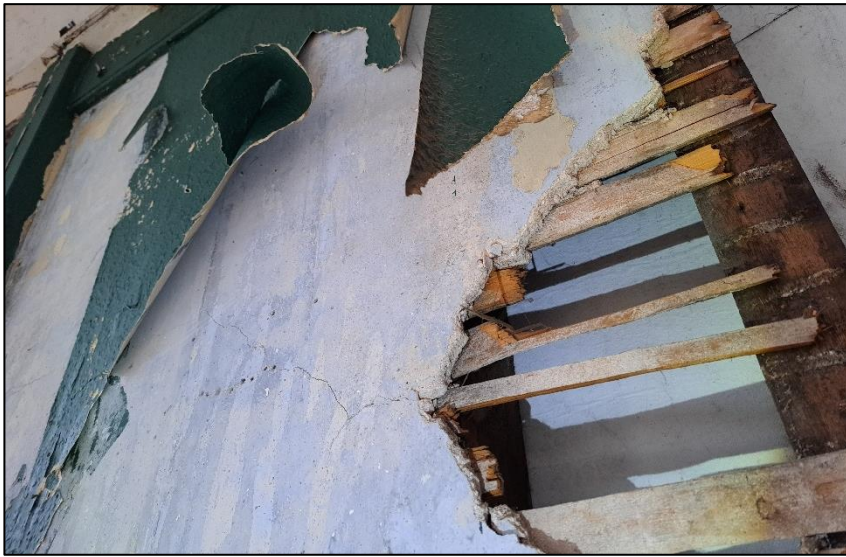
- 3.8 The internal brickwork and walls of the upper floor are in a poor and derelict condition (see Photograph 11). There are significant areas of missing mortar and large gaps that lead to crevices where bats could roost (see Photograph 12). Numerous gaps in the brickwork provide access to the cavity wall (see Photograph 13). Gaps were identified along the wooden floor beams that provide direct access to the lower stories.

*Photograph 11 showing damage to the wall (the cavity wall can be seen)*

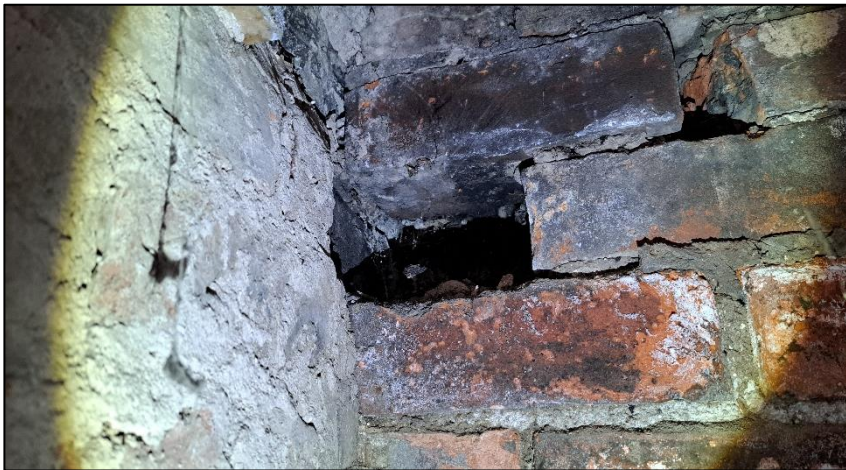
*Photograph 12 showing a missing brick*

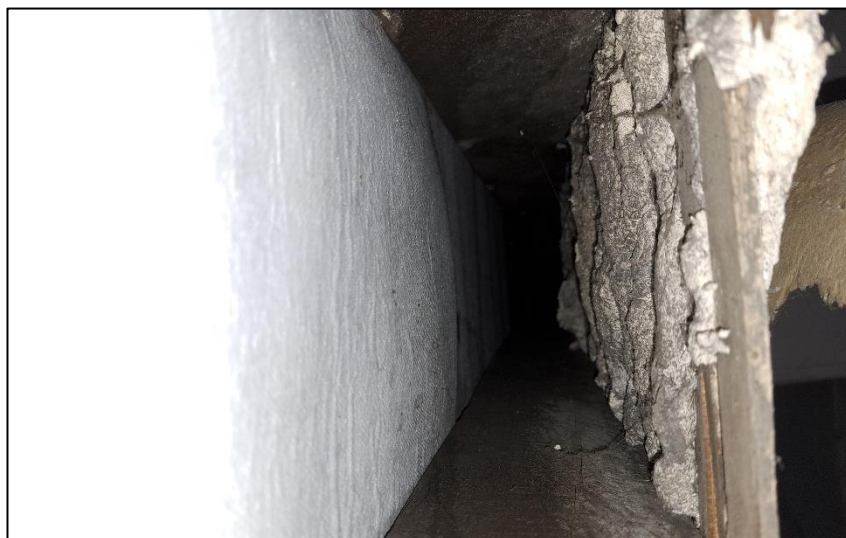
*Photograph 13 showing a gap leading to a significant cavity*

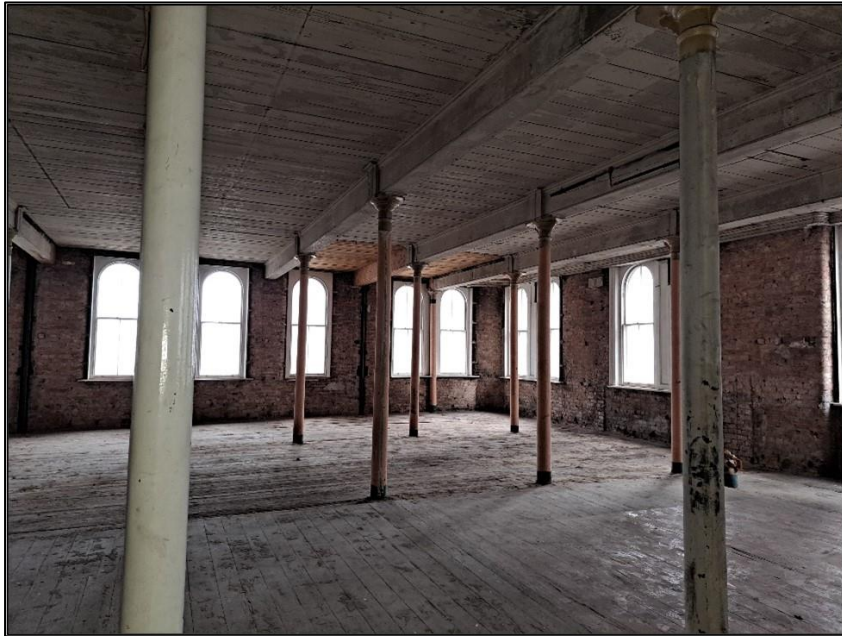
- 3.9 The floors below are in similar condition (see Photograph 14). Gap exist within the brickwork that lead directly to the exterior with significant gaps leading to the cavity wall. On the 4<sup>th</sup> floor, several holes are present in one of the walls which lead to the exterior (see Photograph 15).

*Photograph 14 showing the internal area of the 4<sup>th</sup> floor*

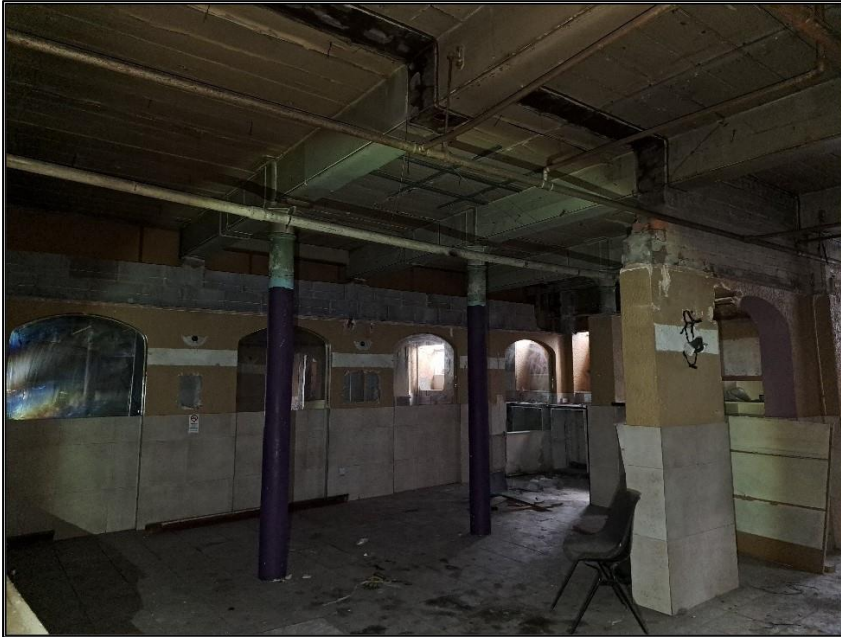
- 3.10 The basement of the property consisted of several rooms (see Photographs 17 and 18), across several levels. These spaces were in a derelict condition, with large amounts of building waste with areas of missing brickwork offering voids and crevices.

*Photograph 17 showing one of the basement rooms*

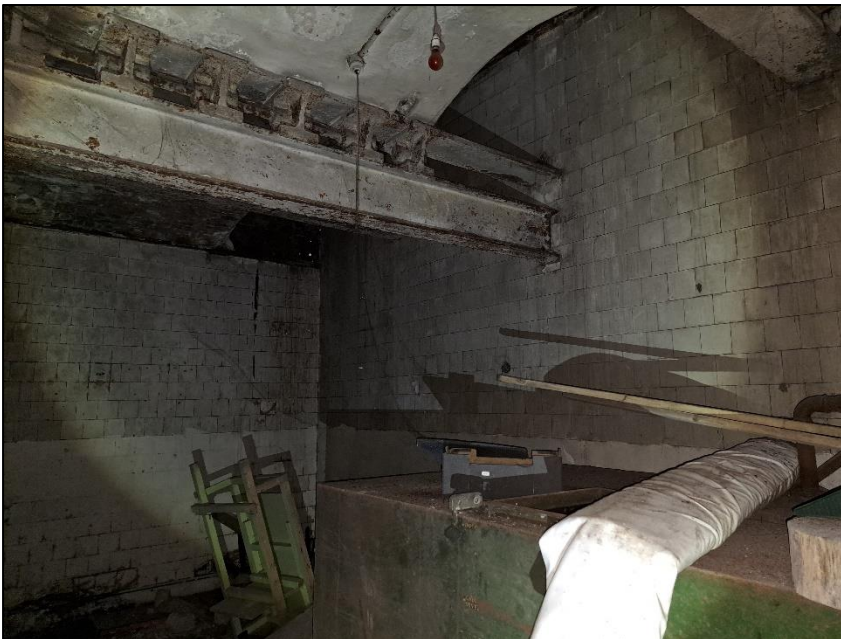
*Photograph 18 showing one of the basement rooms*

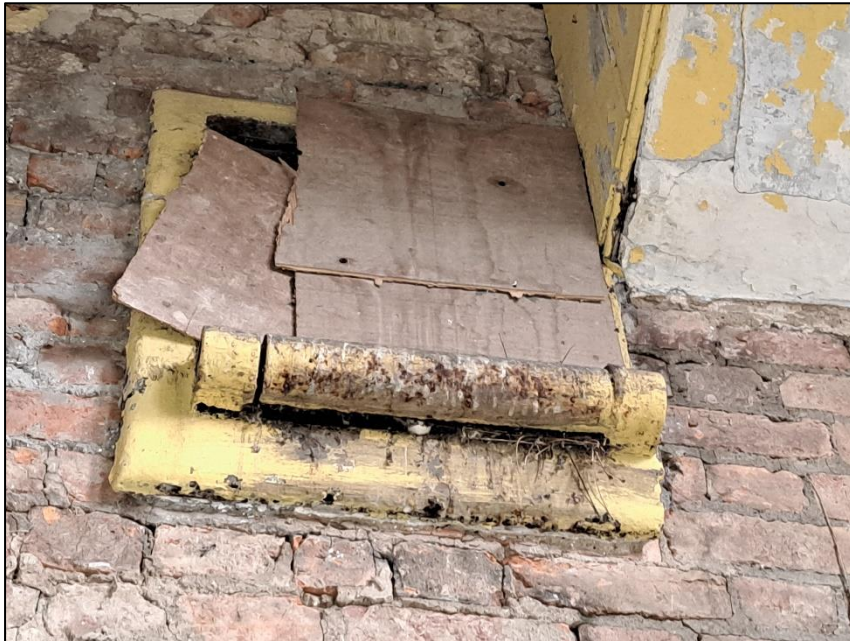
- 3.12 Evidence of bird nesting activity was identified within the upper floors. This included feathers, droppings, and an old nest with a broken egg (see Photograph 19). The owner of the site provided anecdotal evidence that Feral Pigeons are commonly seen within the building.

*Photograph 19 showing an old bird nest*

- Site personnel should not handle bats.
- 4.5 Evidence of nesting birds was identified during the visit. If any work is to proceed to the building within the bird nesting season (which is generally March-August), then a nesting bird check will be required immediately prior to any work. This should be carried out by a suitably experienced ecologist.
