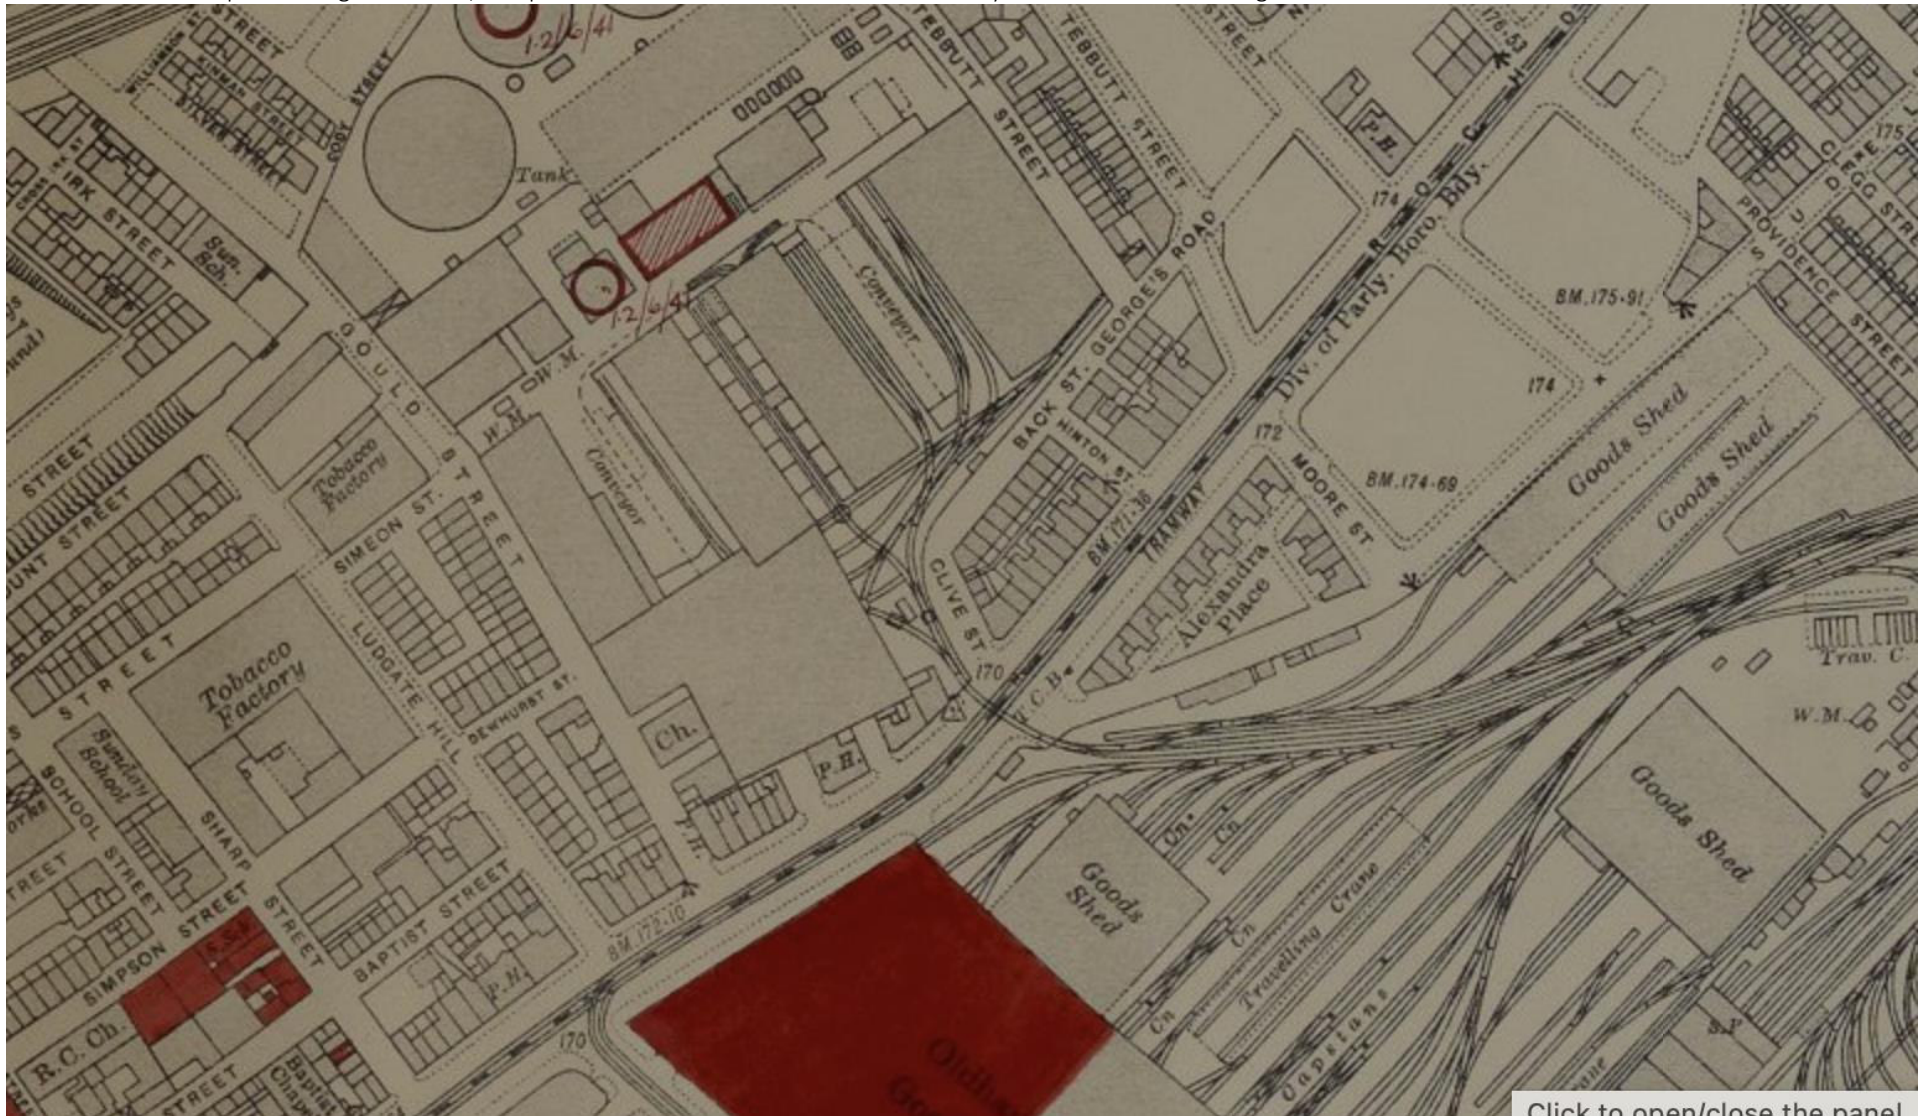
**PHOTO D-2:** This map shows a greater area, compared to other areas within Manchester City centre the bomb damage could be considered Low.

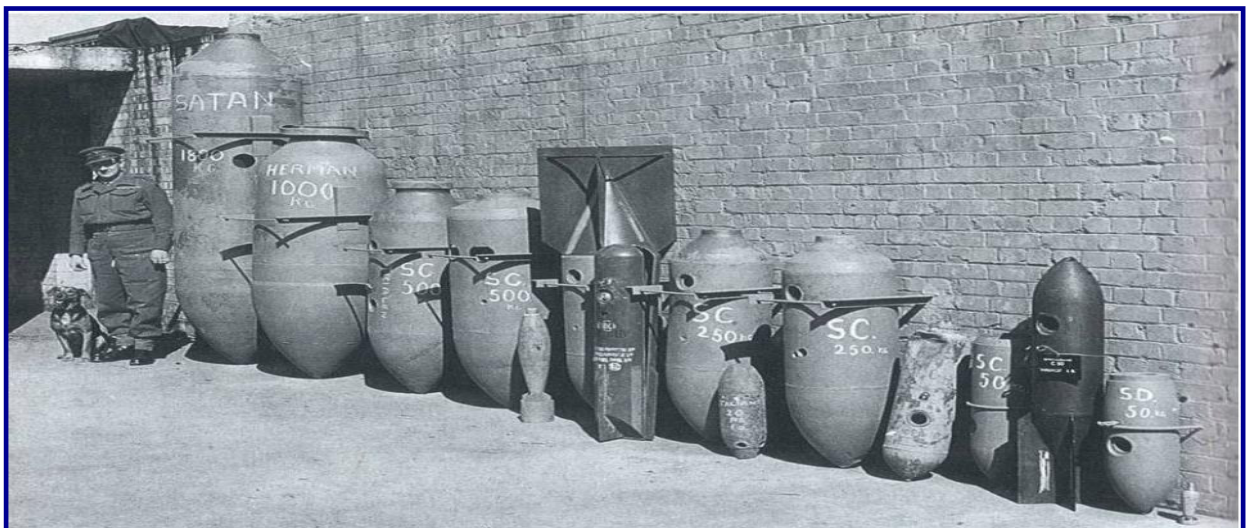
**FIGURE 3:** Range of HE bombs dropped on the United Kingdom.

**NOTE:** The smaller sub-munitions (Bomblets) seen to the right, ranged in size between 1 and 3kg, were dropped in large numbers and were intended as incendiary bombs, anti-personnel bombs or as bombs filling both roles. The smaller bomblets were dropped in larger container bombs designed to hold between 360 and 620 of the bomblets. The containers were designed to burst open at a predetermined height above ground level, dispersing the bomblets over a wide area. Air raid damage was far greater by using both incendiary, and HE bombs on a single raid. The fires

**High Explosive (HE) Bomb.** Some of the most common type of ordnance to be dropped on the United Kingdom, HE bombs are often the type encountered as UXBs. Relatively thick cased, they are still recovered in remarkably good condition. Ranging in size from 50 to 1700 kg, their typical release height (1,500m) allowed them to penetrate deep into the ground as a result of design or flaw. Towards the end of the bombing campaign, as steel became scarce the German Engineers produced a range of bombs that used steel reinforced concrete as the bomb body. Figure 6.3 shows the range of steel HE bombs dropped on the UK.

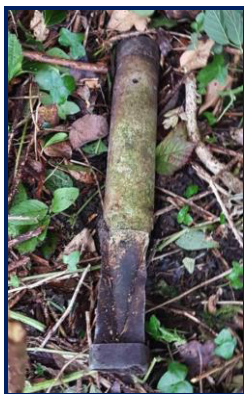
**FIGURE 4:** Incendiary Bombs.

Left, 1kg incendiary bomblet, and right a 50kg incendiary bomb containing bottles of white phosphorus.

**NOTE:** Incendiary bomblets were made of a flammable alloy similar in appearance to aluminium, which resists corrosion well. The tail unit was made of thin tin-plate steel and is more prone to have rusted away. Some Incendiary models were fitted with a High Explosive (HE) steel nose. With the tail and explosive nose attached the bomb was 480mm long.

**Incendiary Bomb.** The larger incendiary bombs, containing bottles of white phosphorus and an incendiary mixture contained within a thin steel case were designed to burst on contact with the ground. A fixed dispenser on the aircraft delivered the smaller type of bomb or 'Bomblet' to the target area in container bombs or both types of container would open dispersing the smaller Incendiary bombs. Relatively small and light they were unlikely to penetrate the ground to any significant depth. However, once concealed in bomb damage rubble or below water they were easily missed and are still unearthed today from in-fill and drained land. Later versions of the incendiary bomb contained an additional explosive charge used as a short delay "Booby Trap" device that contained a significant amount of high explosive. The Booby Trap component was designed to kill or injure fire fighters and hinder the damage control. See Figure 4.

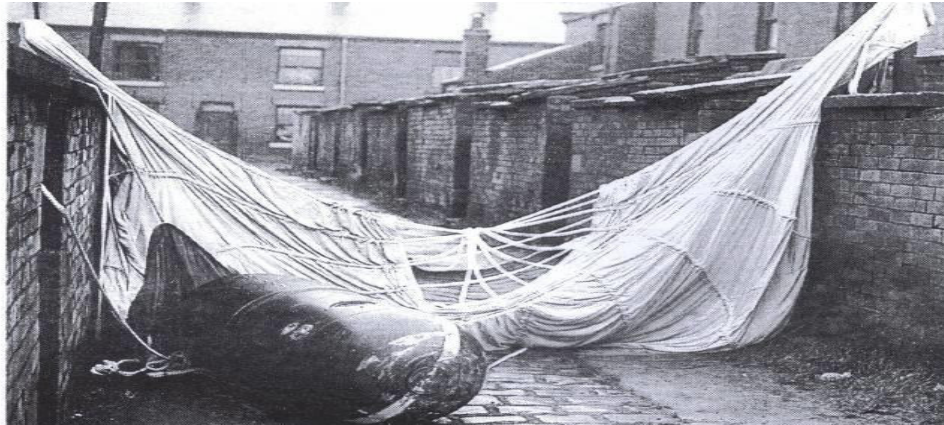
**FIGURE 5:** Common Airdropped Mines.

**NOTE:** all mine fuzes were designed to arm after deployment from the ship, submarine or aircraft, some fuze designs incorporated anti-removal booby traps. Unexploded mines found today are the result of a failure within the arming mechanism or procedure whereby the mine never fully armed. Sudden shock or jarring of a weapon in this state has the potential to complete the arming sequence and could result in the mine detonating with lethal consequences.

increases significantly on projects over water or in marshland. Thicker cased versions however will survive impact and pose a significant risk regardless of the local ground conditions. (See Figure 5)

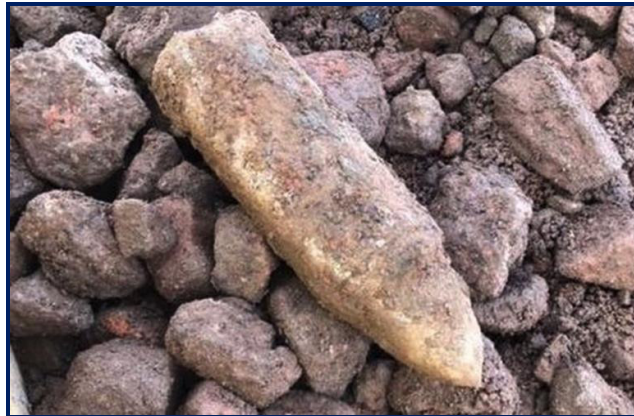
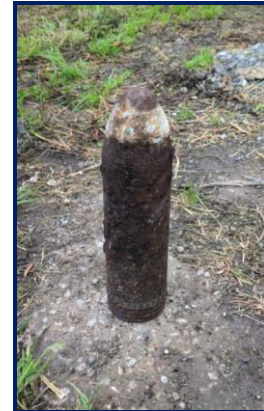
**FIGURE 6: Generic Shell Design**

Generic High Explosive (HE) Shells (recent finds on site around the UK)
