# DAYTIME BAT SURVEY & NESTING BIRD SURVEY

FRASER HOUSE, 36 CHARLOTTE  
STREET, MANCHESTER

NOVEMBER 2022

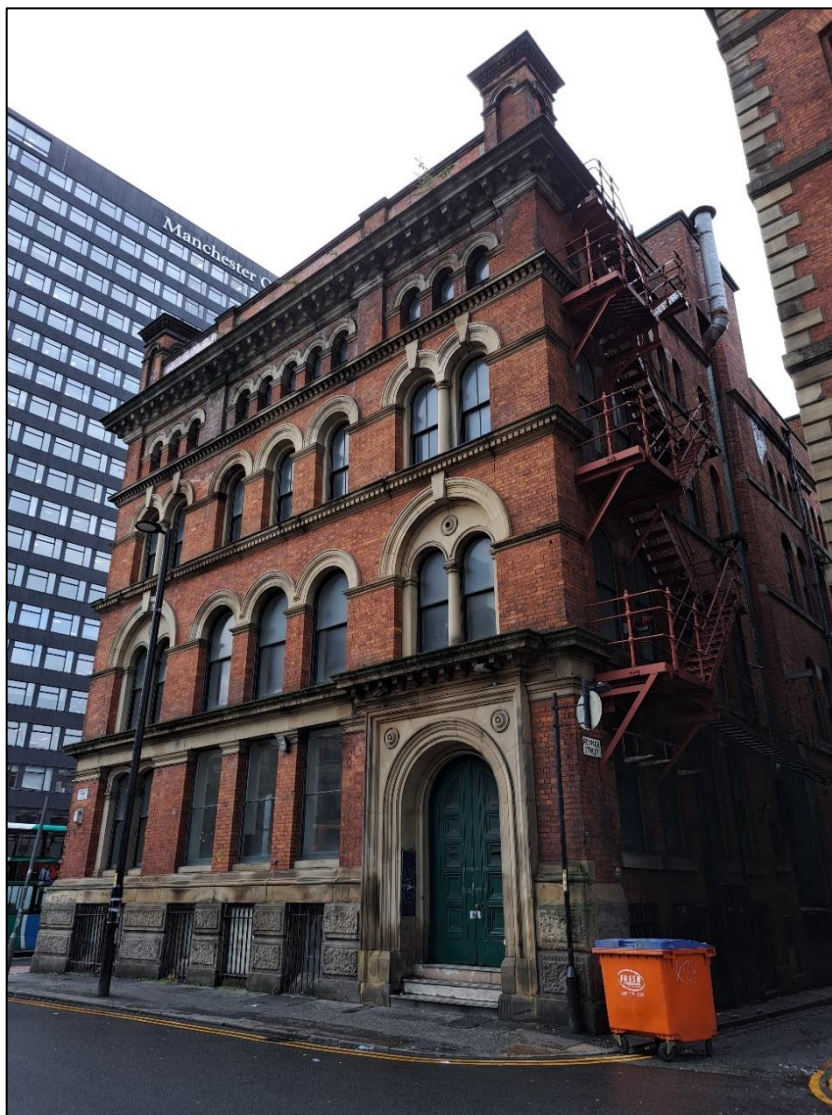
- 3.1 Fraser House is a large, multi-story 1850s commercial warehouse building sitting within Manchester city centre (see Photograph 1). The building is constructed from brick with a stone dressing, with arched windows on the elevations that stretch across Portland Street and Charlotte Street and loading bays across Rayner Street. The hipped roof has three rows of windows across the centre and a tall, panelled parapet extending around the edge of the building. The building extends five stories from ground level and extends across several lower basement levels.

*Photograph 1 showing the building from the corner of Charlotte St and Portland St*

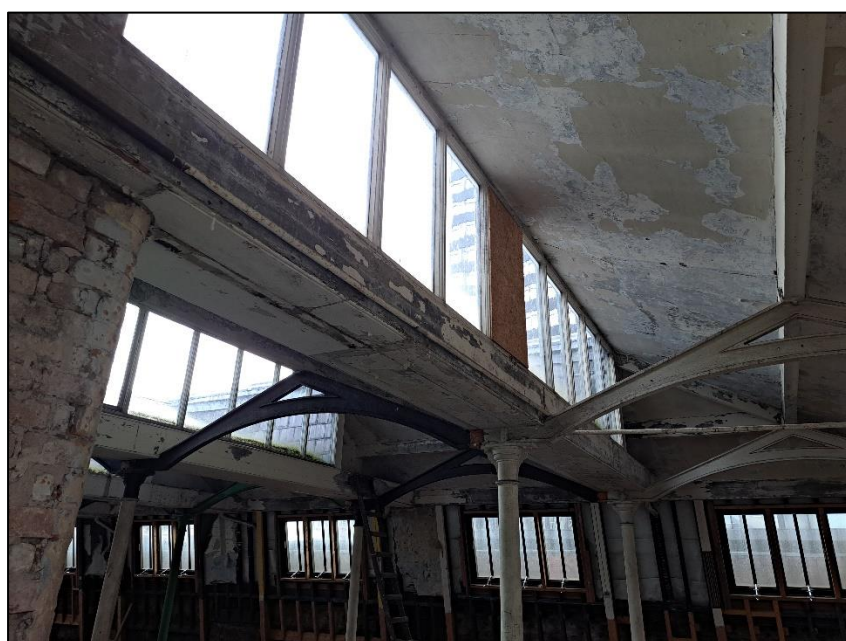
*Photograph 6 showing the skylights and windows of the upper floor*
