# VICTORIA PARK PROBATION CENTRE

## PHASE 1: PRELIMINARY RISK ASSESSMENT

**Job Number:** LKC 21 1679  
**Date:** August 2022  
**Client:** Britannia Victoria Ltd

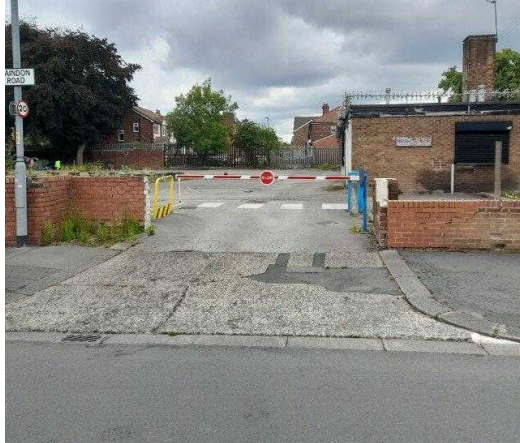
| <p><b>Photograph 1:</b> View of site entrance at W, looking E.</p> | <p><b>Photograph 2:</b> View of E of Probation Centre, from SW, looking N.</p> |

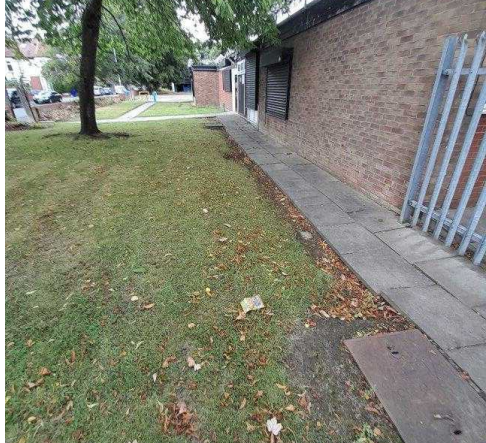
- The two-storey brick Probation Centre in the south of the site is in good condition with several windows smashed. The area to the south, and the centre's tarmacadamed (good condition) yard is fenced off with metal palisade fencing and inaccessible at the time of the walkover. Anecdotal evidence from the landowner indicates the building has no basement, and suggests the building is currently occupied by squatters.

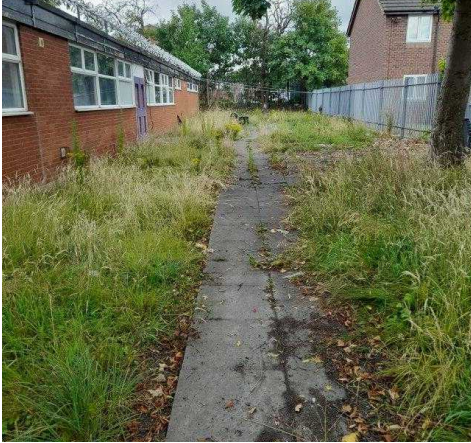
| <p><b>Photograph 3:</b> View of S of Probation Centre, from SW of site, looking E.</p> | <p><b>Photograph 4:</b> View of fire damaged building, from centre of site, looking NW.</p> |

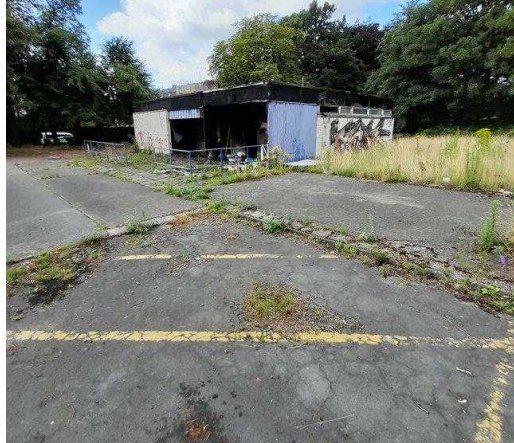
- The other building on site is a small, one storey building in poor condition due to fire damage. Anecdotal evidence from the landowner suggests it was previously occupied by homeless people.

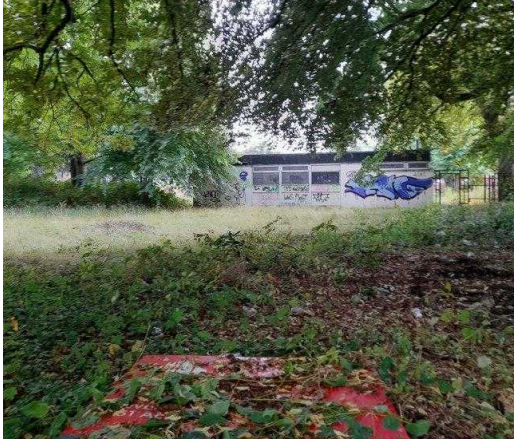
| <p><b>Photograph 5:</b> View of NW of site and rear of fire damaged building from N, looking S.</p> | <p><b>Photograph 6:</b> View along N face of building from E, looking W.</p> |

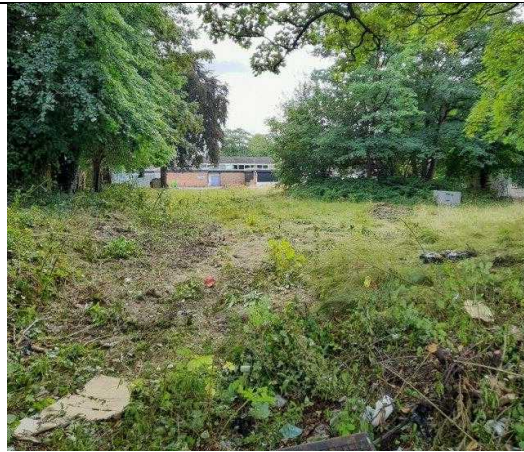
- The vegetated area in the north of the site was noted to be slightly hummocky. A broken gate (approximated 1.5m wide) is noted in the northeast of the site which could provide an alternate access route to this area of the site. A small homeless camp was noted in this area to the east.

**Photograph 7:** View of NE of site from N, looking S.

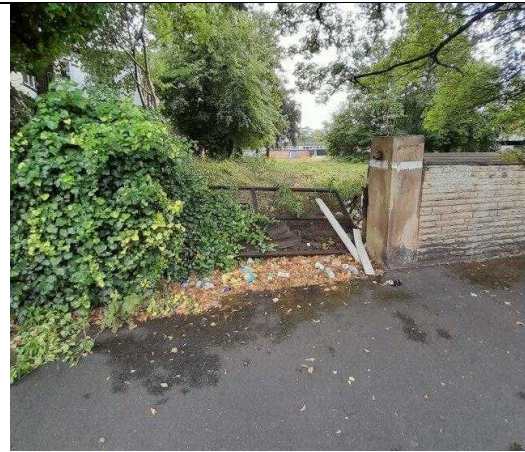
**Photograph 8:** View of possible alternative entrance in NE of site.

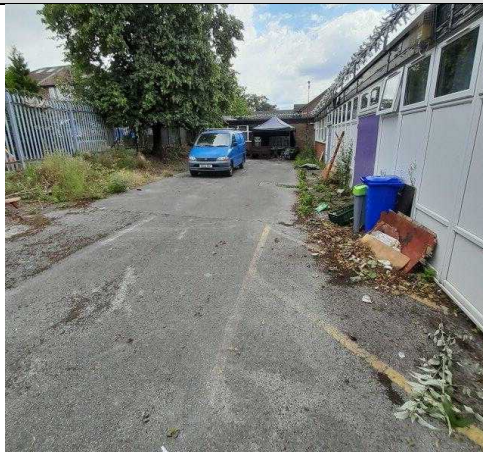
**Photograph 9:** View of yard of Probation Centre from centre of site, looking S

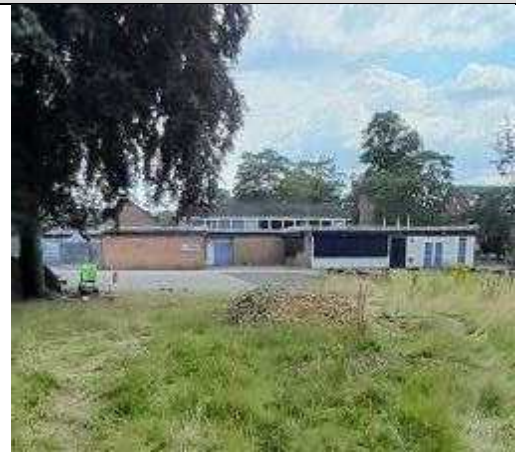
**Photograph 10:** View of Probation Centre from centre of site, looking S.

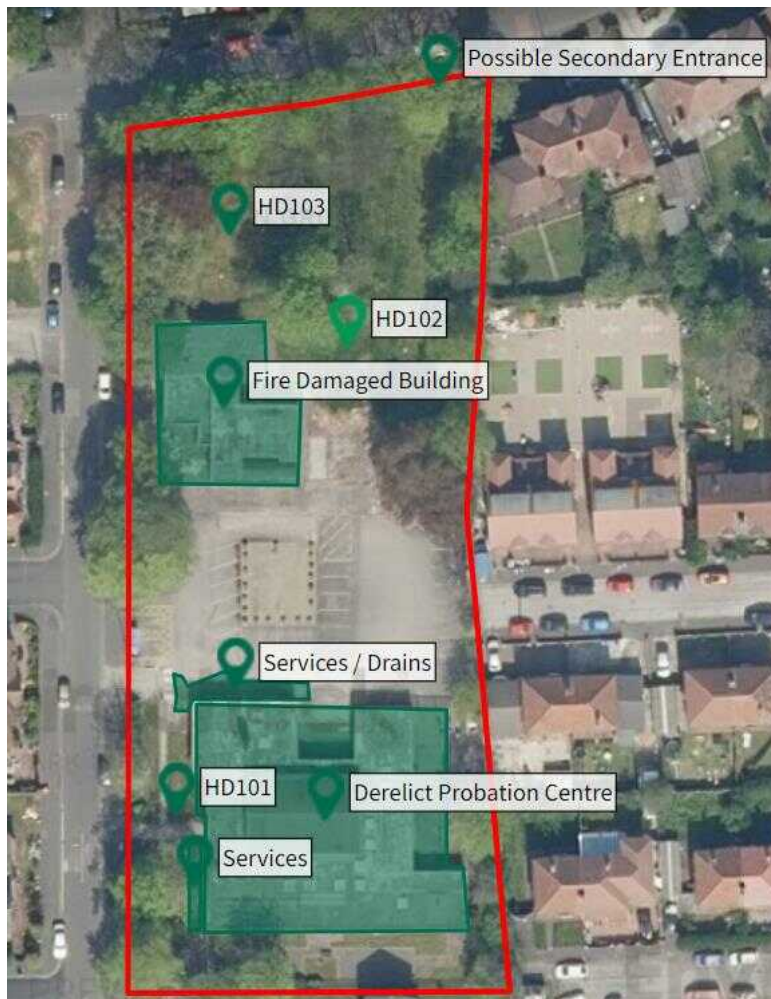
Plate 4-3: Plan showing relevant site walkover features.

Relevant features are also shown on Plate 4-3.
