# RAMADA - MANCHESTER

Kitchen Survey

Tuesday, 5 April 2022

Prepared For Acorn Catering Equipment

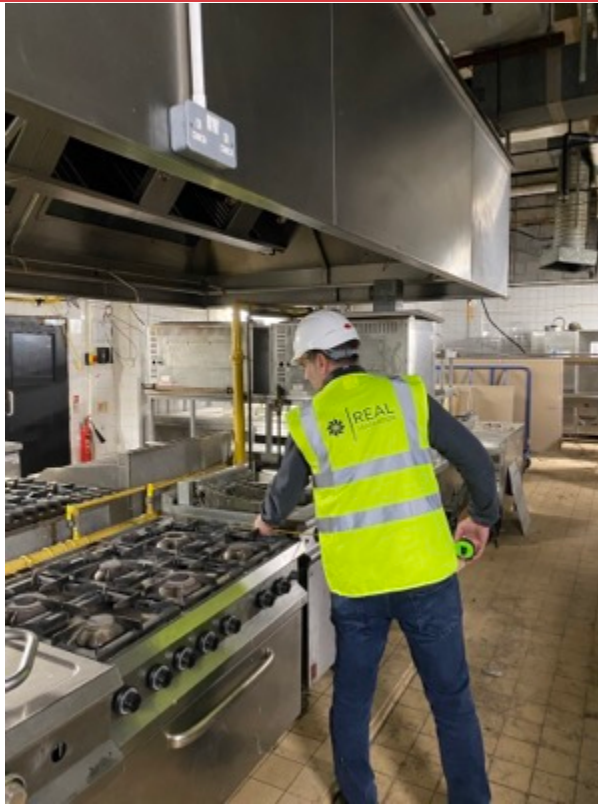
## **GROUND FLOOR KITCHEN**

Existing catering equipment:-

Bratt Pan - Gas - 900 x 860

Open Top - Gas - 900 x 770

Open Top - Gas - 900 x 860

Chargrill - Gas - 900 x 810

Salamander X 2 - Gas - 900 x 560

Fryer - Elec - 600 x 765

Open Top - Gas - 1100 x 730

Boiling Kettle - Gas - 900 x 900 -

**DISCONNECTED**

10 Grid Combi - Gas 850 x 770

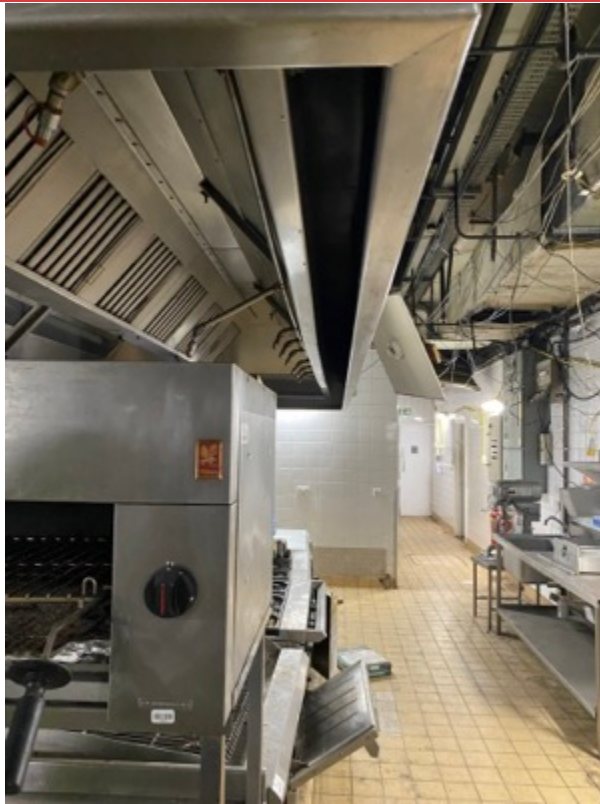
## **GROUND FLOOR KITCHEN - INDUCTION CANOPY**

The ground floor canopy is manufactured from stainless steel and is of an outdated design with a secondary skin allowing for introduction of large quantities of fresh air (induction canopy).

This particular hood design currently does not offer the correct overhang for the equipment underneath and contains a significant grease trap that is inaccessible for cleaning and maintenance.

The latest HVAC design is removing the fresh air duct from the connections of the hood.

Size:- 5407 x 2505

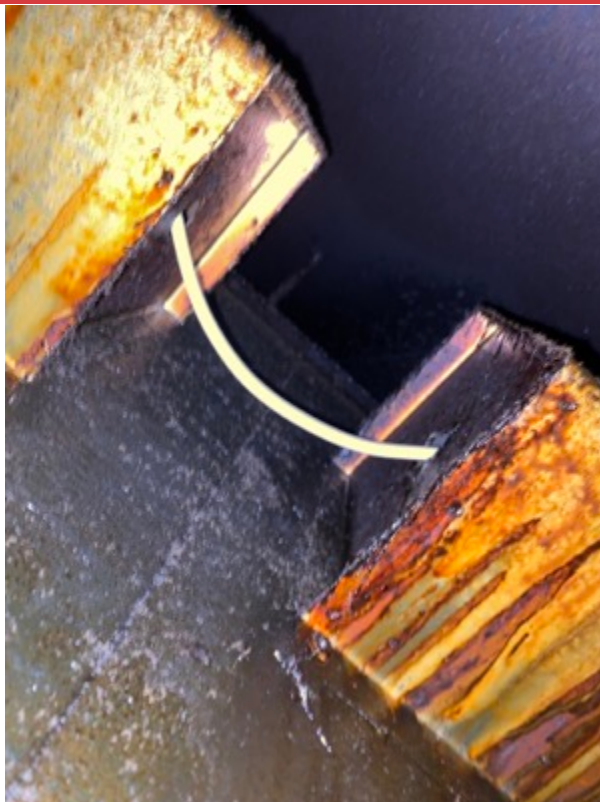
**GROUND FLOOR KITCHEN -  
HAZARD**

Inner skin of ground floor extract hood is inaccessible for cleaning which has allowed grease to accumulate during previous operation.

This is a fire and a health hazard.

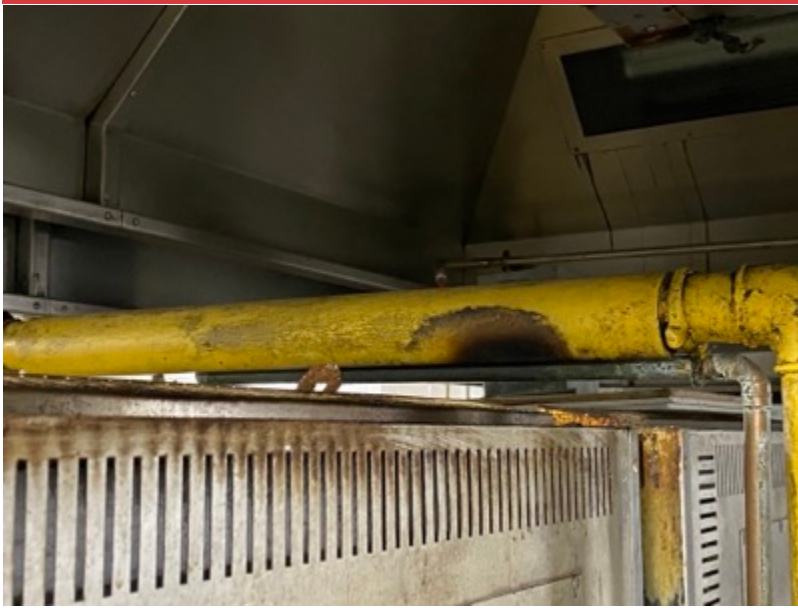
### **GROUND FLOOR KITCHEN**

Gas pipe passes within 50mm of the high temperature flue outlet for the salamander.

Evidence of the heat expelled within this area is shown by discolouration on the gas pipe.

This hazard must be rectified.

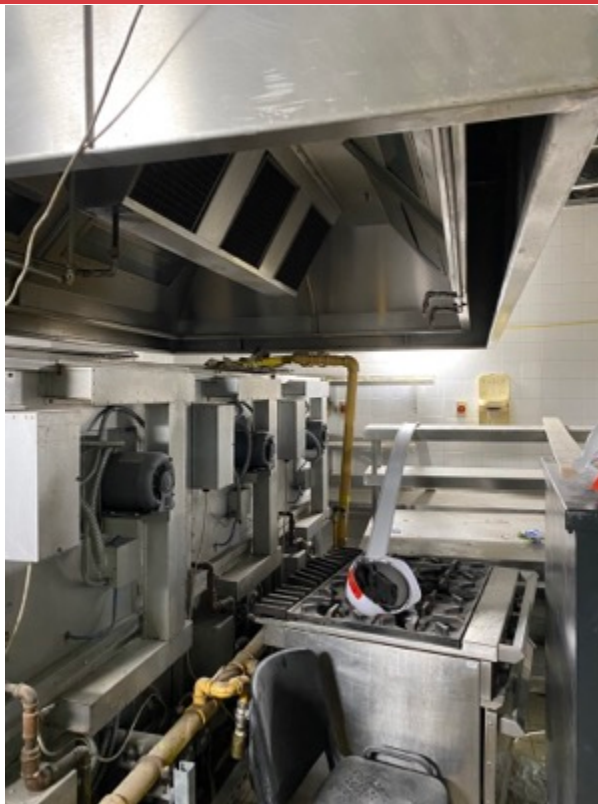
### **MEZ FLOOR KITCHEN**

A stainless reel fabricated canopy complete with double skin. Same induction style design as the ground floor.

Overhangs to ovens are acceptable but lack of overhang to open top range will cause an issue during recommissioning.

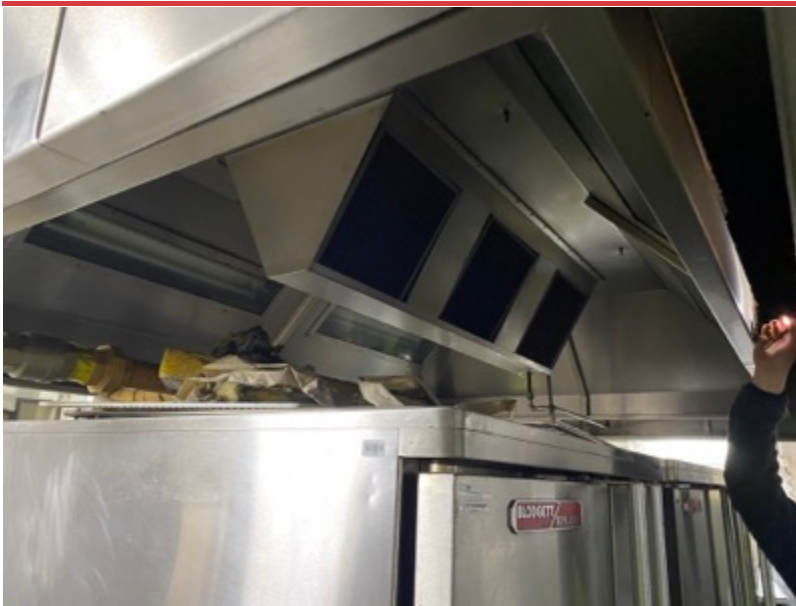
### **MEZ FLOOR KITCHEN - BAFFLE FILTERS**

The extract hood in the mez floor kitchen contain unlisted baffle filters which appear to have been retro-fitted likely in place of mesh filters.

These bespoke made “baffle” filters offer no fire protection and it is suggested lack grease removal capability - it is possible to see through the baffle filters as shown in the photograph.

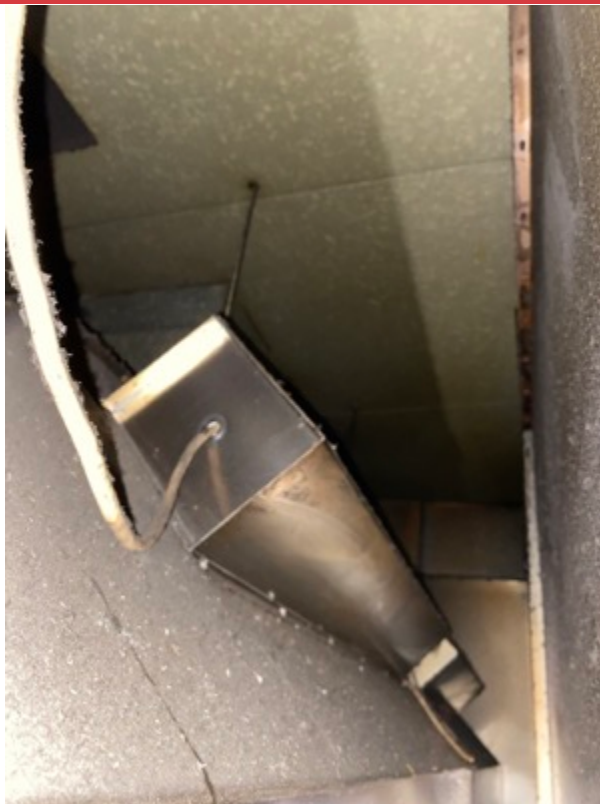
### **MEZ FLOOR - INTERNAL SKIN OF HOOD**

A different cooking style than that on the ground floor has resulted in less grease build-up in the inaccessible sections of the extract hood. Grease is still present in the void and still represents a potential fire hazard.

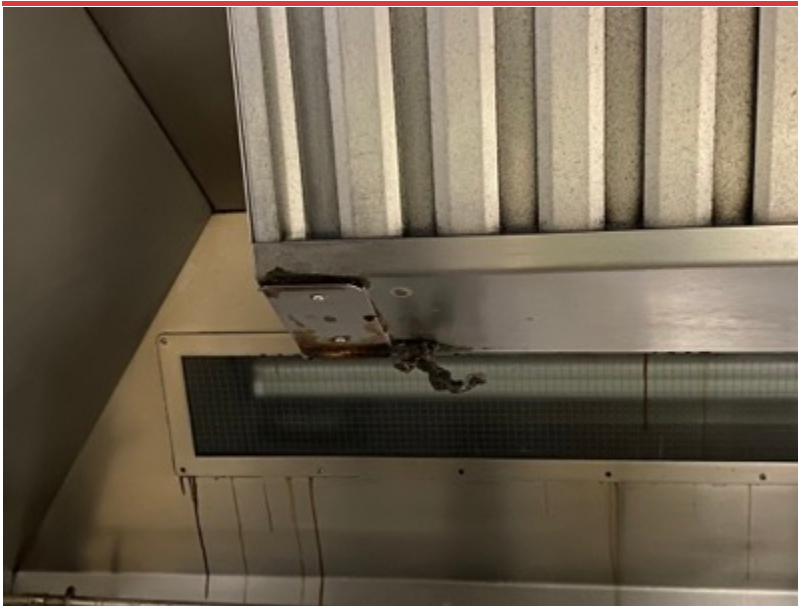
### **MEZ FLOOR - GREASE DRAWERS MISSING**

Grease drawers missing from underside of grease collection channel. Grease leaking from light fitting.
