# REDBY STREET, MANCHESTER

## PHASE 1: PRELIMINARY RISK ASSESSMENT

**Job Number:** LKC 22 1260

| <b>LK Consult</b> | | | |
|---|---|---|---|
| <b>Report Title</b> | Phase 1: Preliminary Risk Assessment | | |

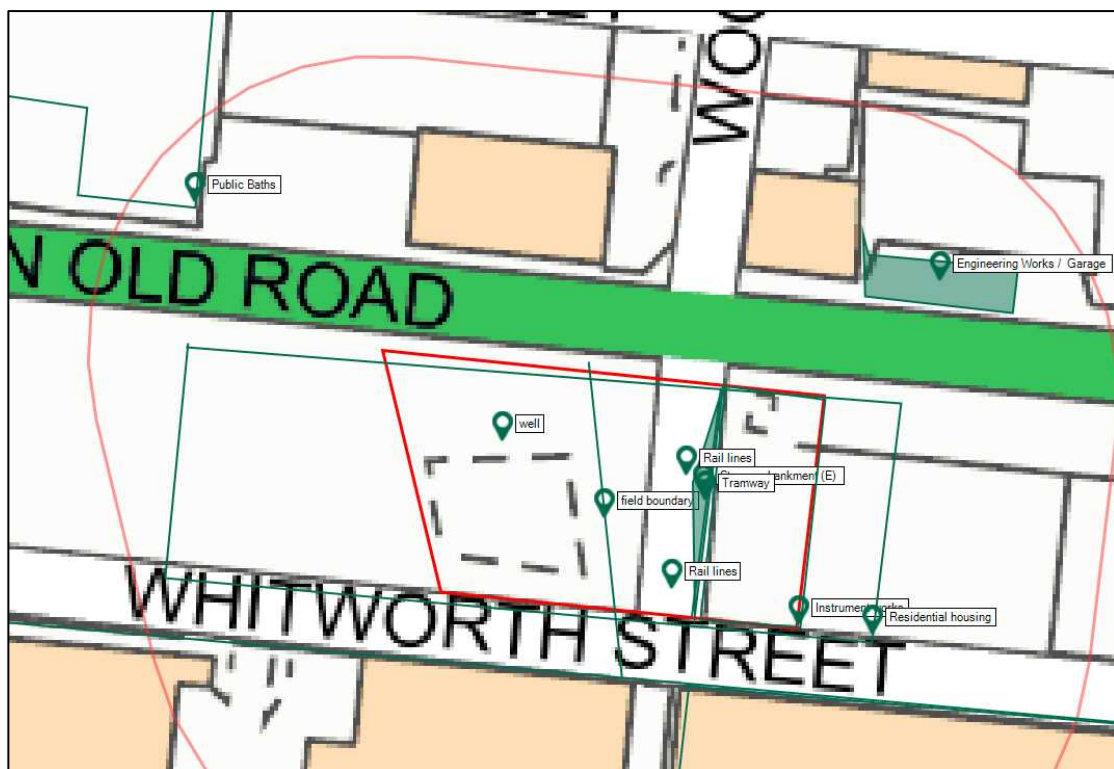
Plate 2-1: Historical features.

Plate 2-1 shows the features noted in Table 2-1 and some of the features in Table 2-2.

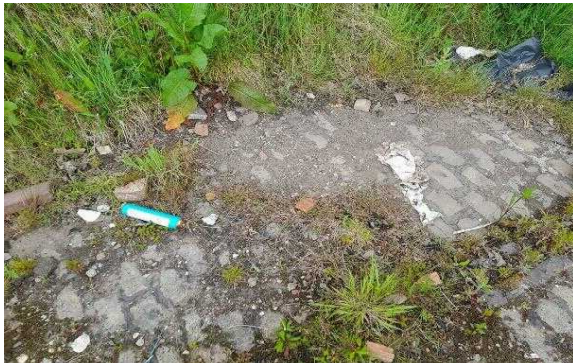
| <b>Photograph 1:</b> View from Redby Street looking south, fly tipping. | <b>Photograph 2:</b> View of Redby Street and rail lines looking north. |

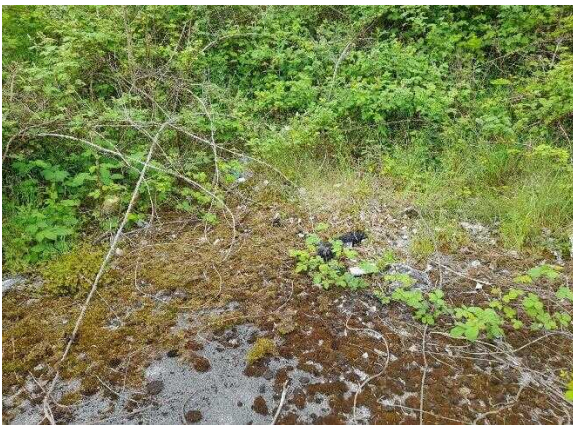
| <b>Photograph 3:</b> Carpark (on site) looking west. | <b>Photograph 4:</b> View of overgrown site with brambles, east of site looking south. |

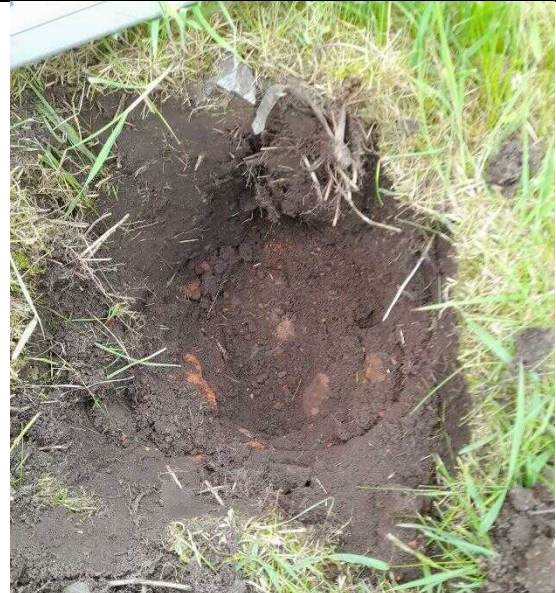
| <b>Photograph 5:</b> Hand dug 101 to the East of the site next to the advertisement sign. | <b>Photograph 6:</b> View of Redby Street, Embankments and bund looking to the south boundary. |

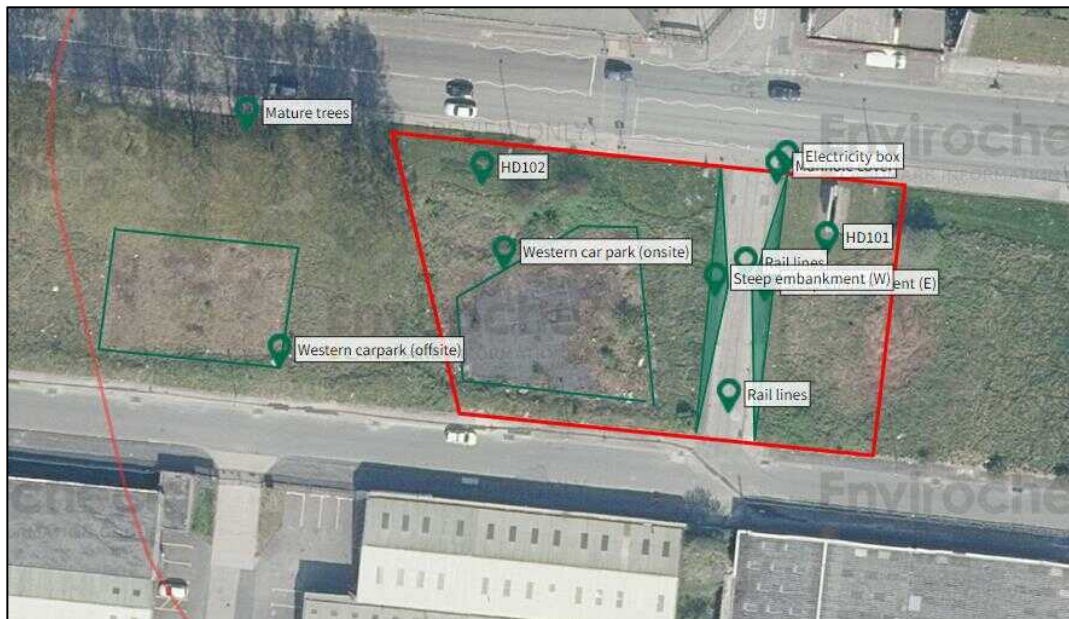
Plate 4-3: Plan showing relevant site walkover features.

Relevant features are also shown on Plate 4-3.

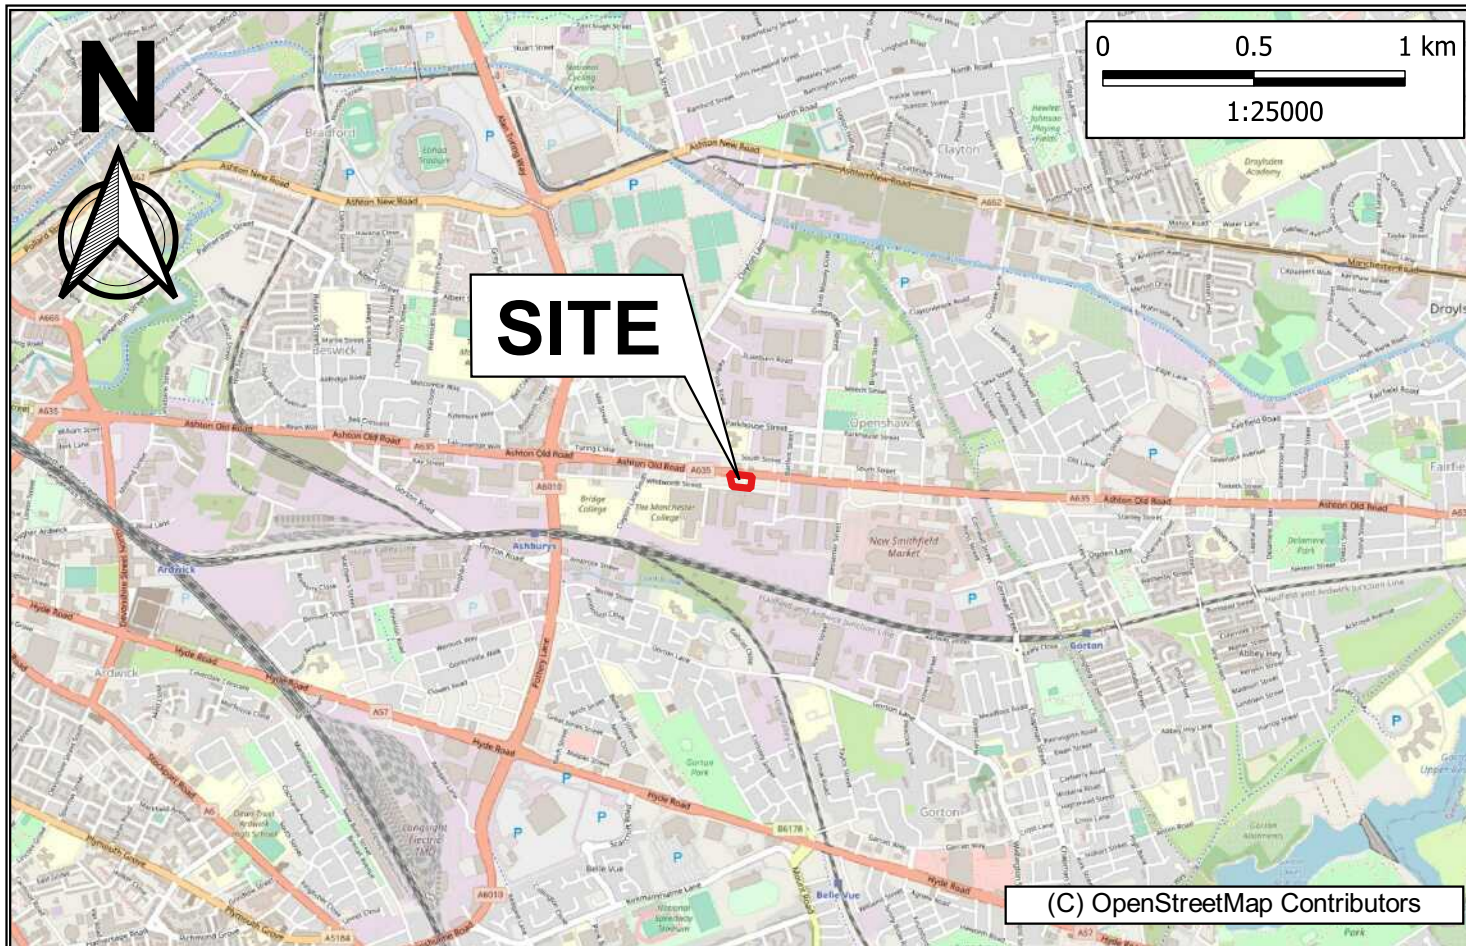
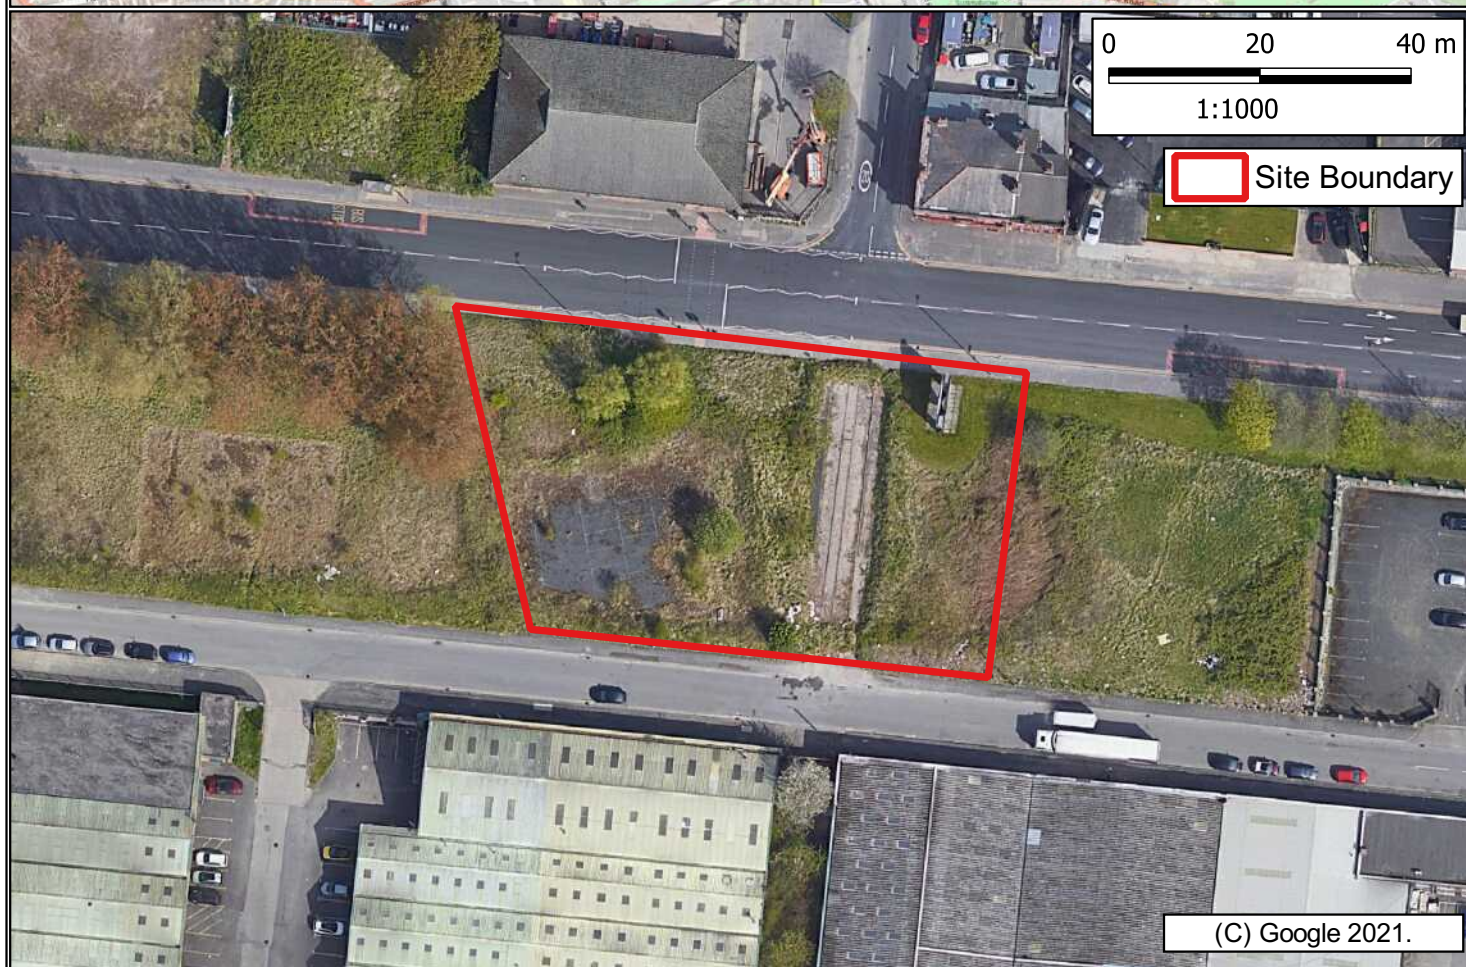
| Job No.:<br>LKC 22 1260 | Drawn By:<br>JW | Checked By:<br>EK | Drawn:<br>May 2022 | Figure:<br>1 | Revision: | | |

| Client:<br><br>Create It Studio Architects | | | | Title:<br><br>Site Location &<br>Boundary Plan | | | |
