PRELIMINARY GEOTECHNICAL AND  
ENVIRONMENTAL ASSESSMENT

# JACKSON'S ROW

PRELIMINARY GEOTECHNICAL &  
ENVIRONMENTAL ASSESSMENT

Project no: 70010925

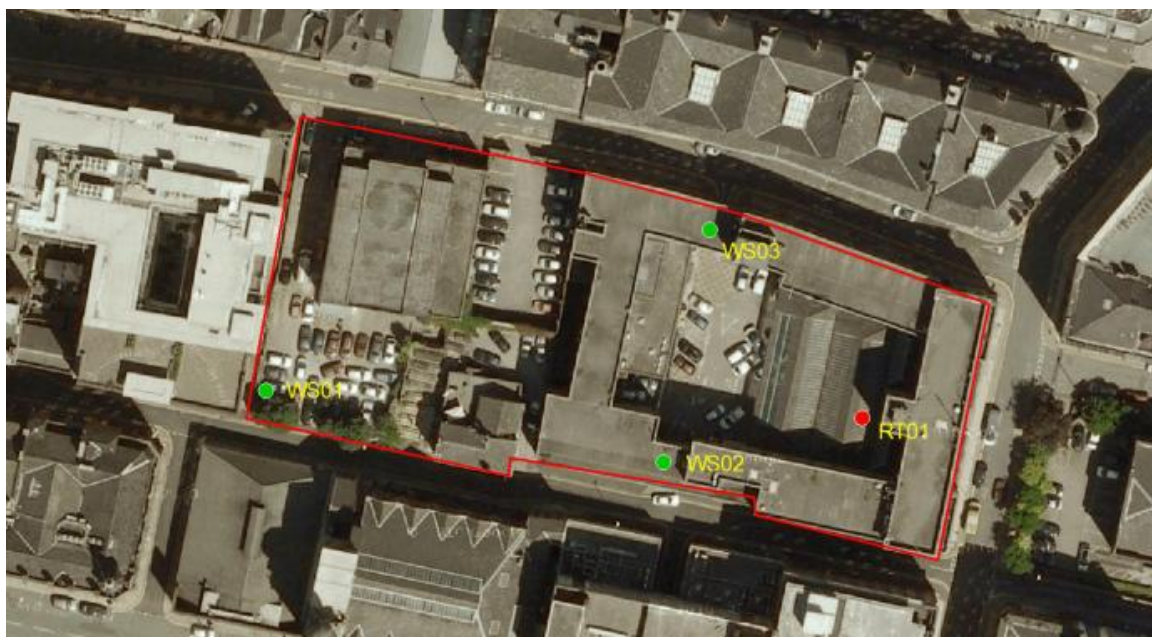
**Figure 2.1 – Exploratory Hole Locations**

Borehole locations are shown on **Figure 2.1** below.

WS02 and WS03 were located underneath the arches leading to the central courtyard of the former Bootle Street Police Station.

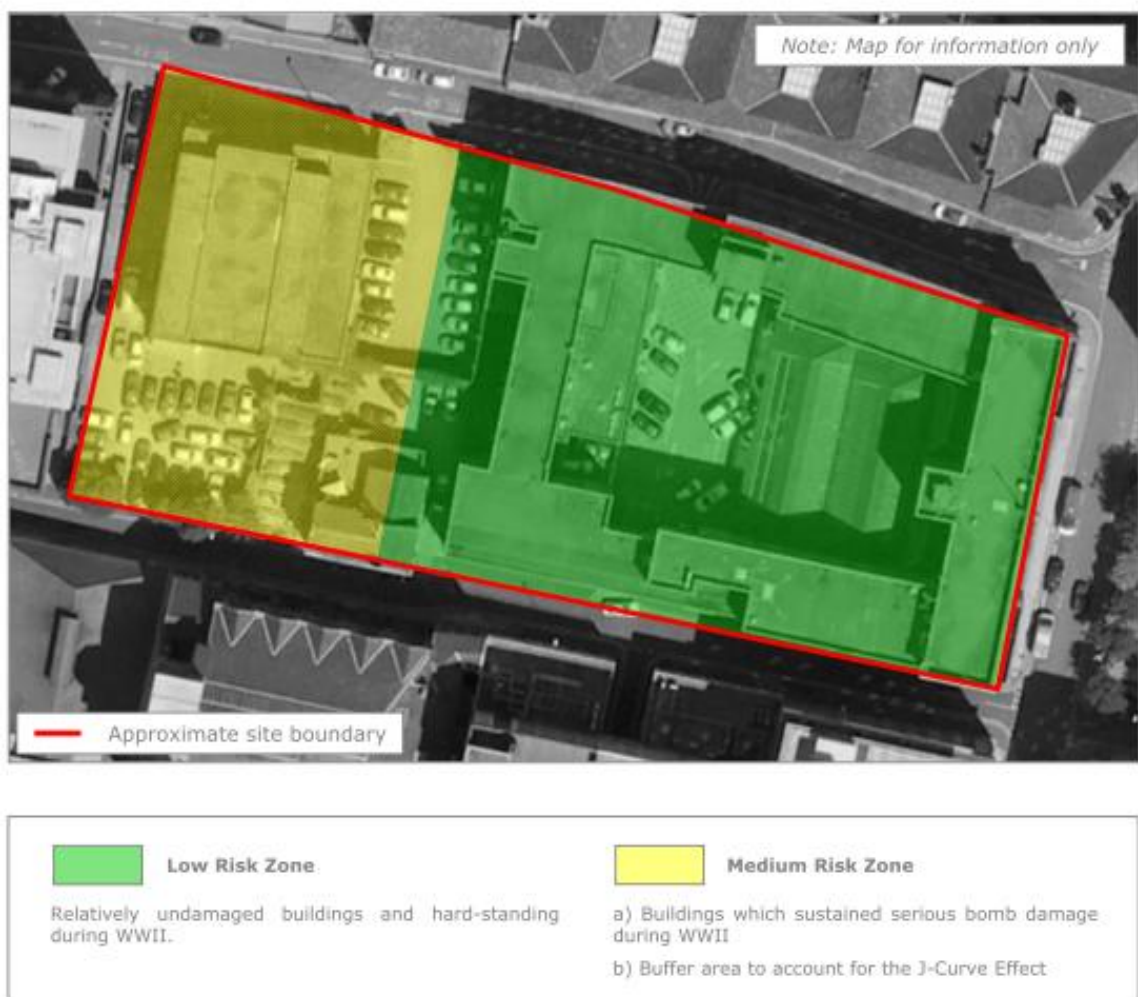
As discussed in the Phase I report, the site has been divided by Dynasafe BACTEC into a Low Risk Zone and a Medium Risk Zone (see extract below).

The following risk mitigation measures are recommended by Dynasafe BACTEC to support the proposed works:
