# Plots 2, 3 and 5, Angel Meadow, Manchester: DRAFT 2 Archaeological Excavation Report

**Client: Orion Heritage Ltd**

OA Reference No: L11148

# Plots 2, 3 and 5, Angel Meadow, Manchester

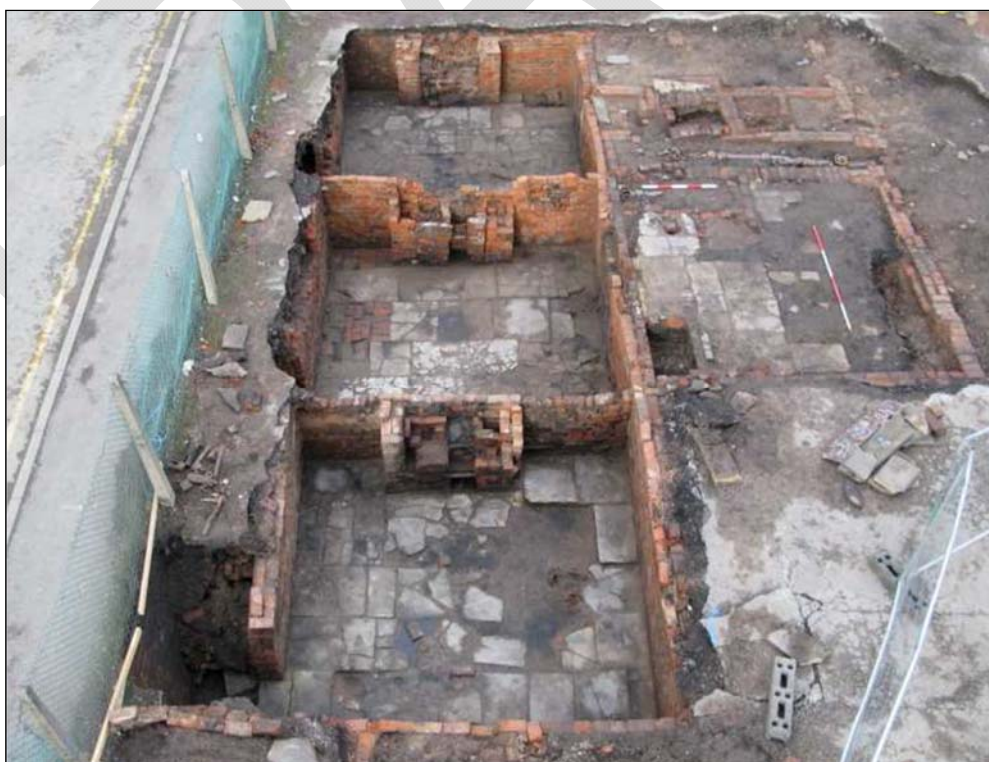
- 1.4.2 In addition to this assessment work, the extreme southern portion of Plot 2 had also been previously excavated. This excavation was completed as a prelude to road-widening works along Angel Street and Aspin Lane in 2012, as part of the adjacent NOMA project (OA North 2013a; Miller and Wild 2015). Significantly, the excavation revealed the well-preserved remains of back-to-back cellars (Plate 6), built in the 1820s, which fronted New Blakeley Street, and a small courtyard area (marked as No 1 Court on historical mapping; *Section 3.2.3 below*). Some of the cellars had evidently been abandoned and infilled during the later nineteenth century, and improved sanitation was installed. The footprints of houses on the eastern side of the court were also excavated, although the foundations of these uncellared properties were fragmentary, and yielded little significant information.

Plate 6: Remains of early nineteenth-century cellars in the southern portion of Plot 2, excavated in 2012

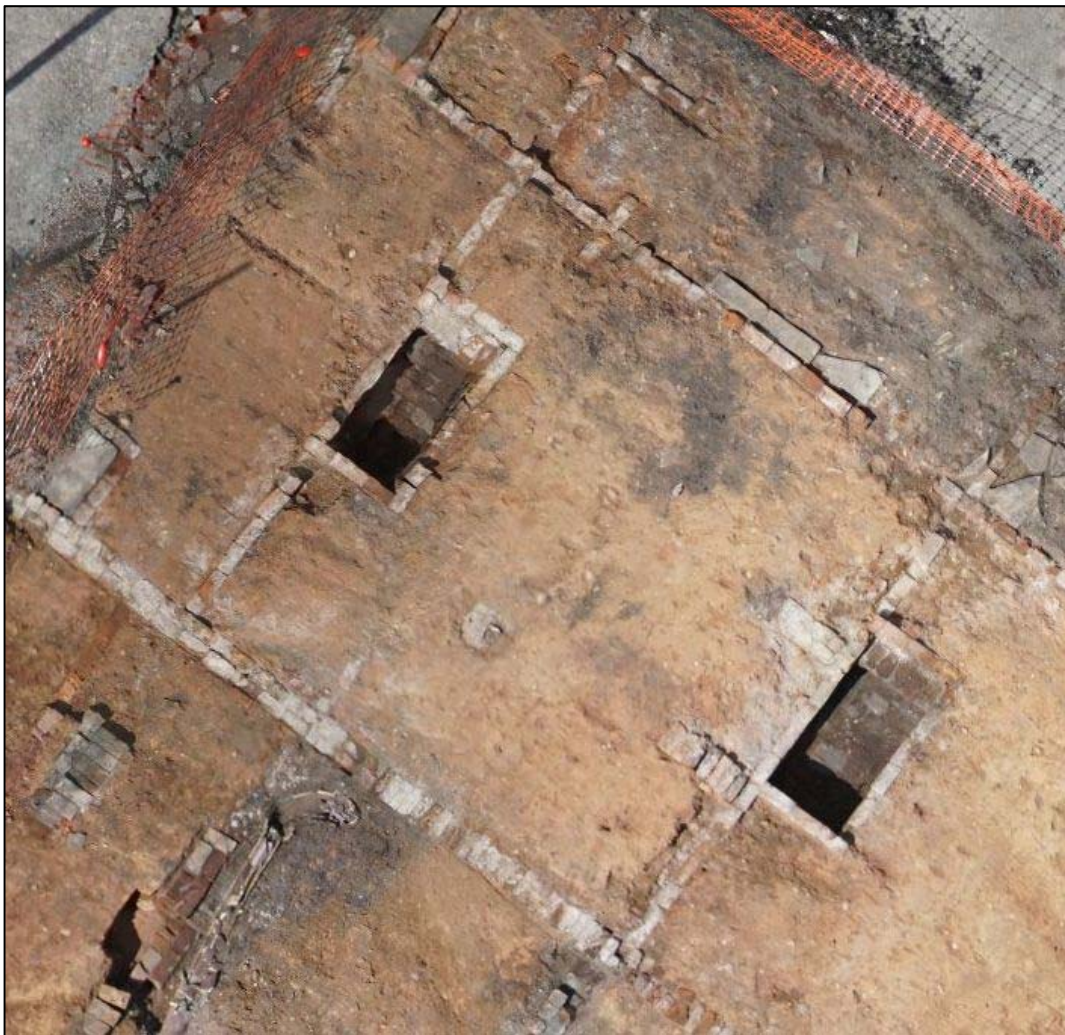
Plate 14: Aerial view of **R17**

3.2.23 Several brick-built structures were present in the interiors of the back-to-back properties, and their positioning and general similarity suggested that each of these dwellings contained an identical 'set' of internal features, at ground-floor level. These, however, were most apparent in one of the dwellings (**R17**) fronting Nelson Court (Plate 14). On its eastern wall were two brick walls that projected for a distance of 0.55m. These were one full-brick thick, were spaced 0.95m apart, and formed the remains of a fireplace that was positioned centrally on the eastern side of the dwelling. Directly opposite this fireplace, tied into the western wall, was a rectangular handmade-brick structure. This measured 1.55 x 0.75m and was a single-skin construction, four courses high, with a brick floor and course of header bricks forming a step. It is probable that this supported a staircase that allowed access to a first-floor level, with perhaps a storage area beneath. Within **R17** two other, single-skin, projecting brick walls were also identified. One of these, which was one-brick (0.23m) long, was positioned on the northern (rear) wall of the dwelling, set some 0.75m from the western wall. It is possible that this feature related to a doorway, which led to the stairs. The other projecting wall was located on the southern (front) wall. This extended for a distance of 0.6m and was set 1.1m from the west wall, and might have defined a small partitioned area in the corner of the room.

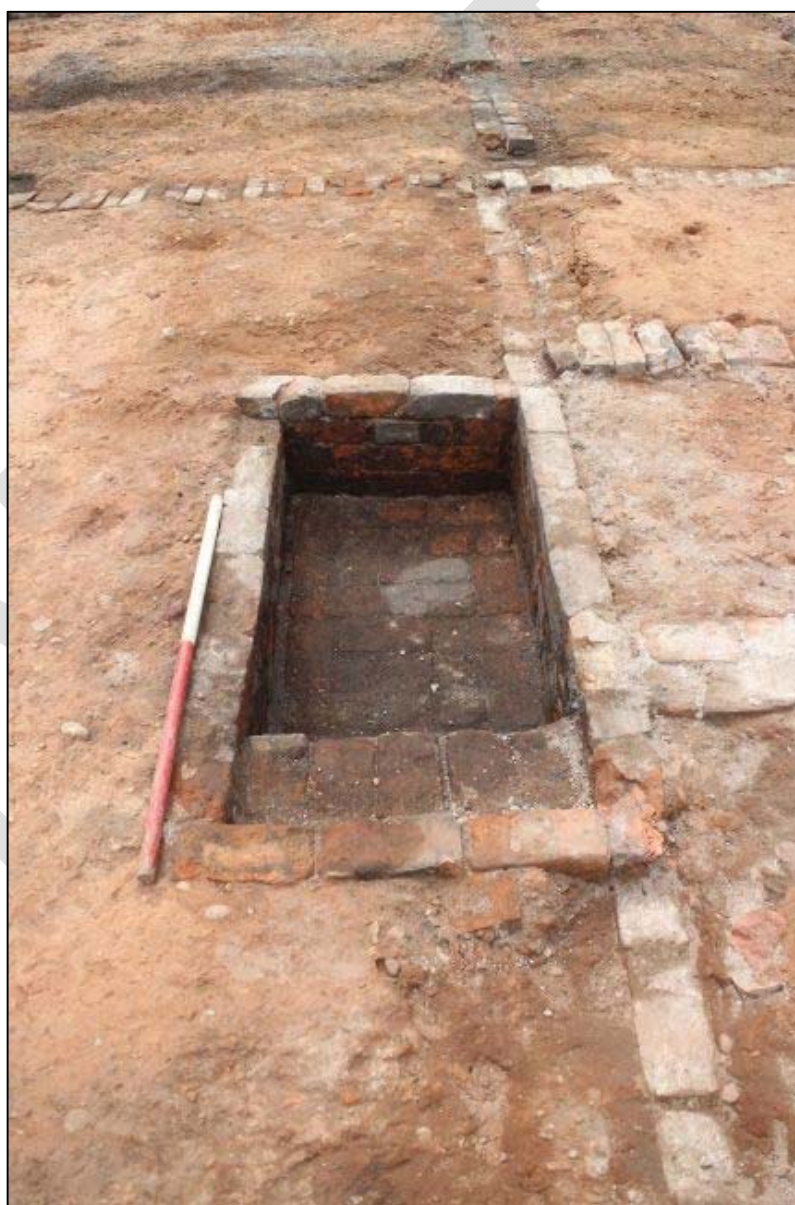
3.2.24 The positioning of these internal features was probably replicated in the other dwellings that fronted Nelson Court and Nelson Street. For instance, the staircase, positioned on the western party wall, survived in eight of these dwellings (Plate 15). The partial remains of a fireplace, on the opposing eastern party wall, was also apparent in one of these dwellings (**R15**), whilst the wall stub possibly relating to a doorway leading to the stairs was also present in two of the dwellings (**R18** and **R22**). These internal features were also seemingly present in the two dwellings (**R19** and **R20**) at the western end of the back-to-back range, that fronted New Blakeley Street. In contrast, though, the location of these features was rotated 90 degrees anti-clockwise, with the fireplaces and staircases being on the northern and southern walls respectively. However, this is to be expected given that access into these properties was would have been from the west, from the New Blakeley Street frontage.

*Plate 15: Staircase in **R15**, looking south-west*

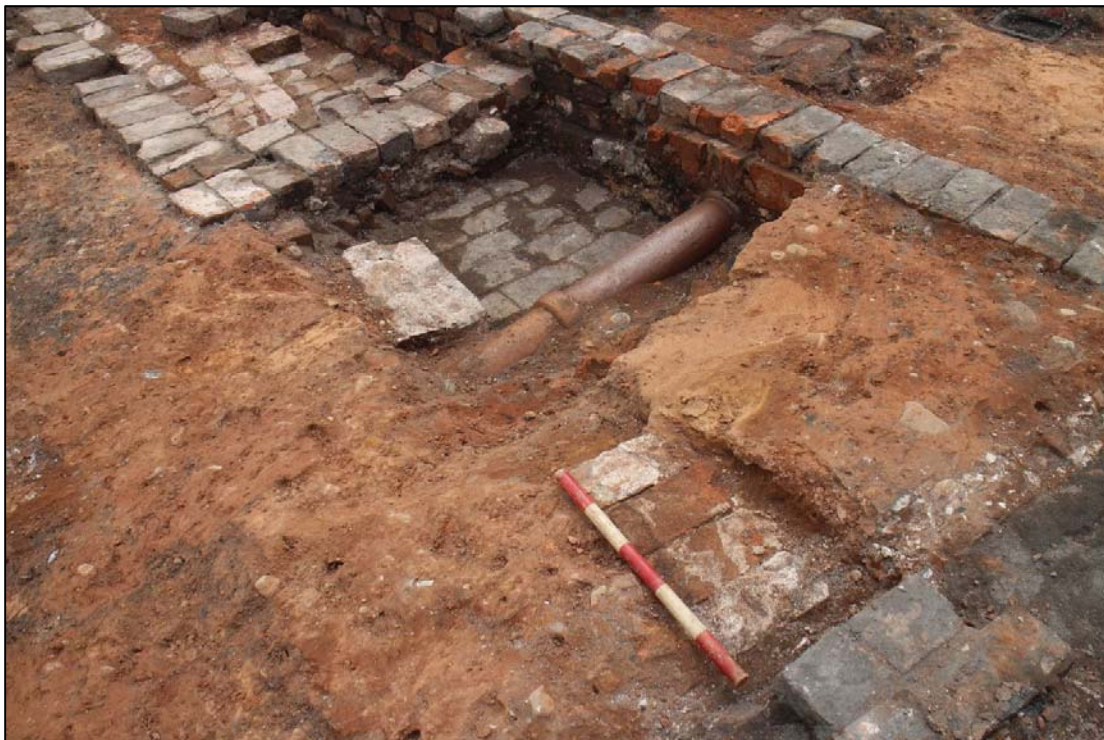
- 3.2.26 The structures included a right-angled length of handmade brick walling (**2005**), which was one full-brick thick and had been laid in a stretch bond (Plate 16). This wall had been heavily truncated during the late nineteenth/early twentieth-century remodelling of Nelson Court (*Section 3.2.49*), but it seemed to represent the exterior wall of an early building. Moreover, its position seems to suggest that it related to the more northerly of the double-depth properties in this area, though intriguingly it does not equate with any wall lines plotted on the detailed mid-nineteenth-century mapping. One possibility, therefore, is that it represents the corner of an outshut that was demolished in the earlier part of the nineteenth century. Another structure (**2006**) was also associated with this northern property. This was rectangular in plan, c 1m wide, though its length could not be determined as it extended outside of the excavation area. However, its form suggested that it formed the base of a staircase, which was probably in the front room of the property.

Plate 16: Structure **2005**, beneath Privy **P7**, looking south-east

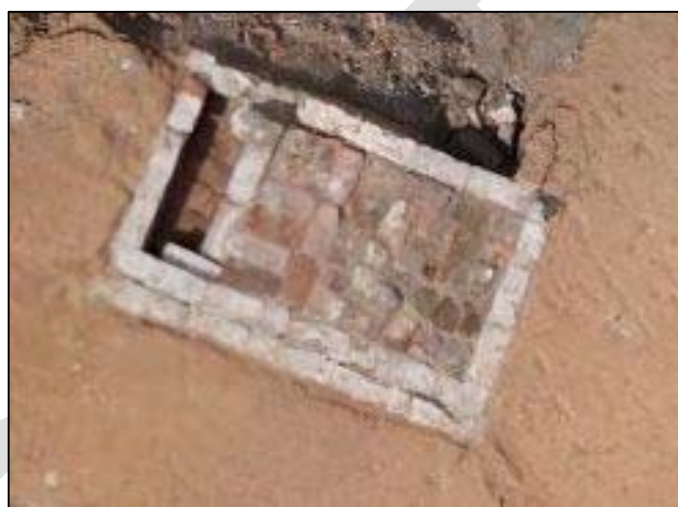
- 3.2.27 Two structures lay to the south and appear to have been associated with the more southernmost of the double-depth properties. One of these (**2007**; Plate 17) was a rectangular handmade brick structure, measuring 1.6 x 1.02m, with a brick floor, which was defined on its northern, eastern and western sides by a single-skin wall. Its southern side, however, was defined by a double-skin wall that probably represented the only surviving element of the wall which formed the southern side of the dwelling; the historical mapping indicates that this also defined the northern side of a covered

passage allowing access into No 3 Court. As with structure **2006** (*Section 3.2.26 above*), the form of structure **2007** suggests that it supported the stairs running to an upper floor, and its position indicates that these were placed in the rear room of the double-depth dwelling. Historical mapping indicates that the other structure associated with this property was located in its outshut (**P3**; Plate 18). Although it had been truncated by a later drain, it was evident that it formed a rectangular brick-built chamber, measuring 2.1 x 1.62m, with an outer two course-thick brick wall, bonded with lime mortar. The chamber was divided into two compartments by a two-course thick wall, each of which had brick floors. It also had a brick-built drain running out from its eastern side, then along its southern side, though it is unclear whether this represents an original, or later, feature. The form of the structure, however, suggest that it was an early privy.

Plate 17: Aerial view of **2007**

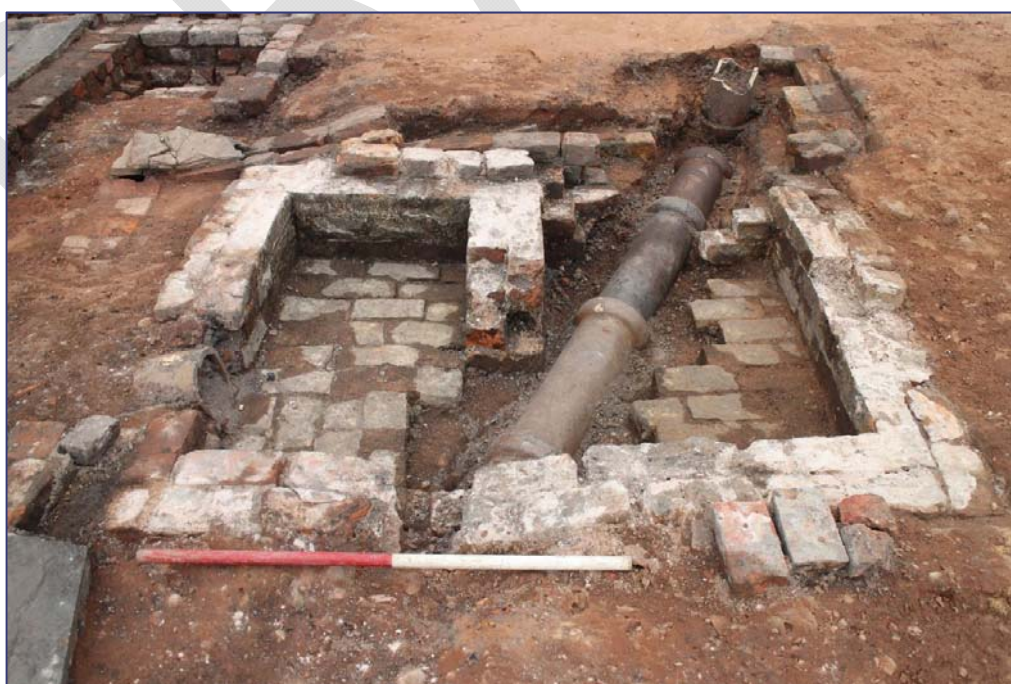
Plate 18: **P3**, looking south-west

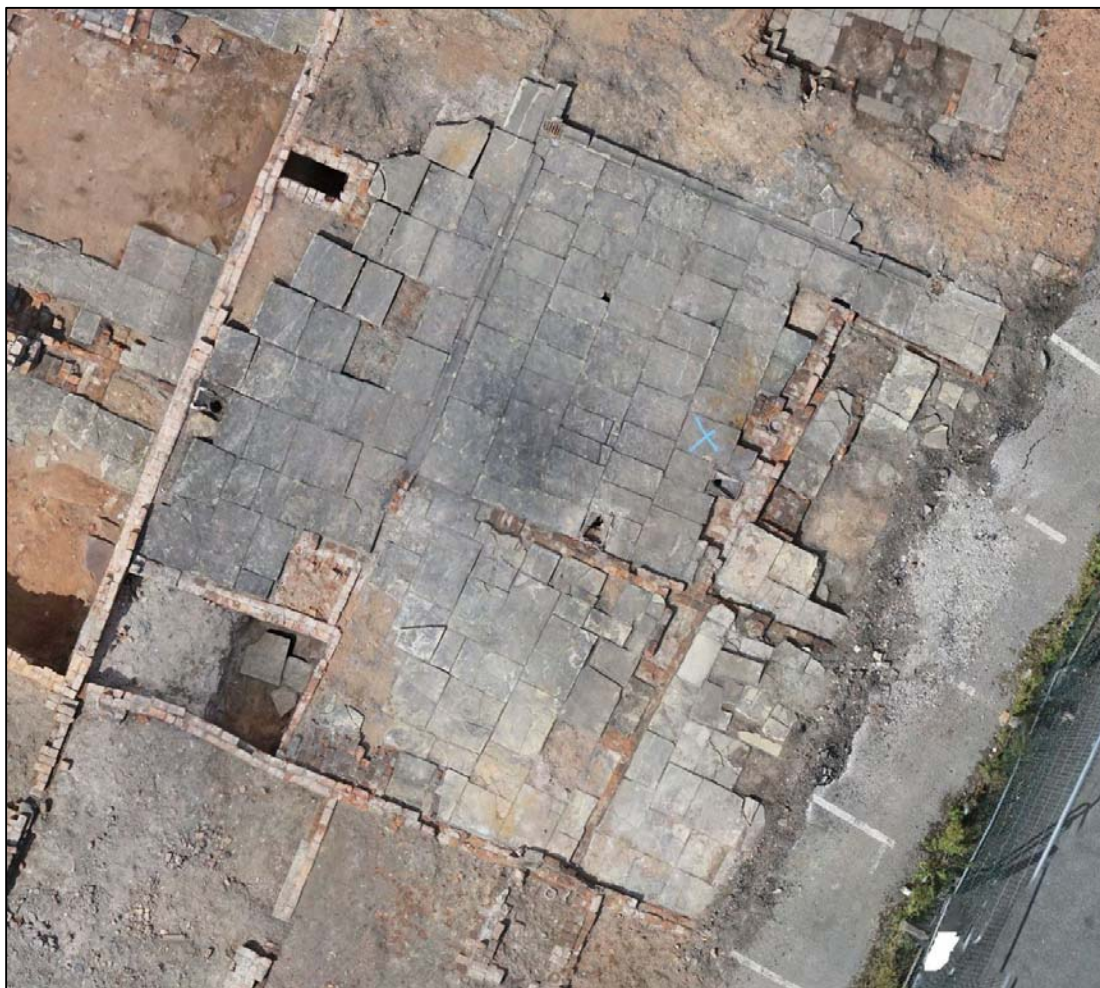
- 3.2.31 To the south, the surface of **Court 3** survived, composed of sandstone flags, containing four small drains, as did the remains of two buildings (defined by **R5-7**) dating to the 1820s on the southern side of this courtyard, which fronted Ashley Lane (Plate 19). Cartographic evidence indicates that one of these latter buildings (**R7**) formed a blind-back that was positioned immediately south of the covered passage leading to the courtyard. This building was 4.1m wide and its rear portion lay within the excavation area. Its northern side was defined by a single-skin brick wall, whilst its western gable wall was double-skinned, and had been rebuilt at a later date (*Section 3.2.54*). A c 0.6m-wide doorway was also present on its western gable wall, at the north-western corner of the building. Two areas of *in-situ* sandstone flags were present within, forming the original flooring. Immediately south of the doorway, butted against the gable wall, was a rectangular brick structure, defined by two single-skin walls, parallel with this side of the building, which contained an area of flagged and brick flooring. This structure measured 0.54m across and had a length of 1.29m, and defined the position of a narrow staircase.

Plate 19: Aerial view showing the flagged surface of **Court 3**, and the remains of **R5** (centre), **R6** and **R7** (right and centre), and **C9** (left)

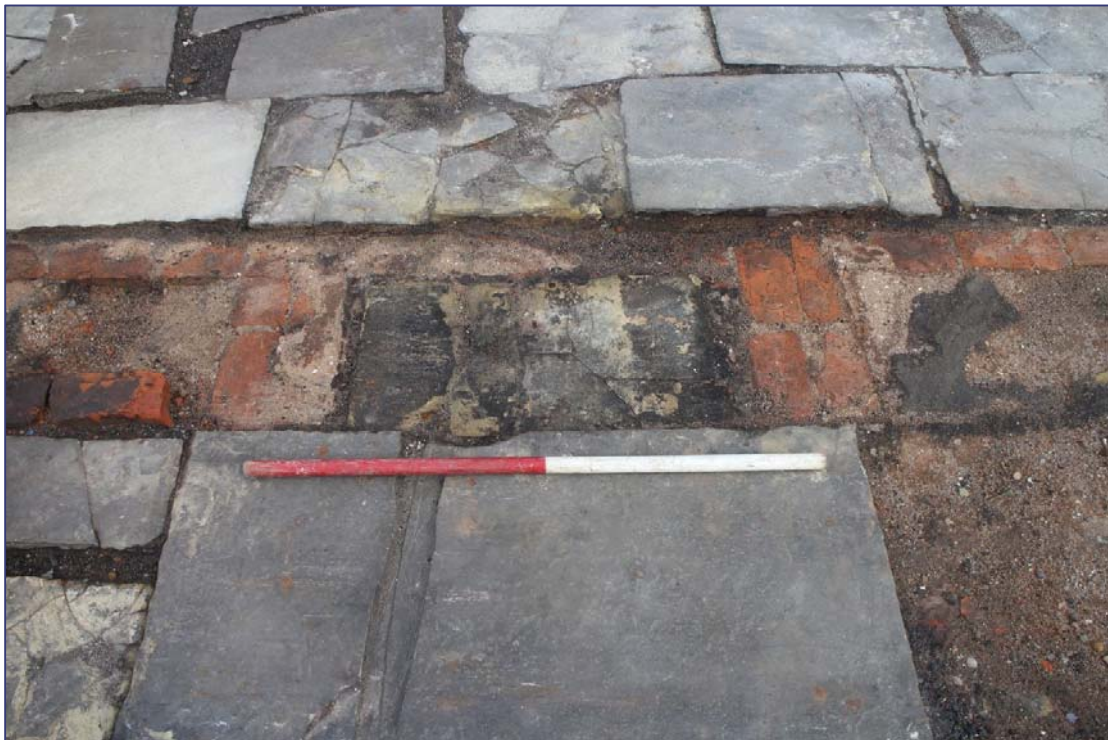
*Plate 20: Fireplace in R5, looking east*

- 3.2.34 Within the interior of the dwelling were two rooms. One of these (**R5**) formed the rear room of the original double-depth property, measuring 3.95 x 4.25m, which latterly formed a separate dwelling. The complete area of this room was exposed and contained a flagged floor, apart from a rectangular area of brick flooring (measuring 1.4 x 0.7m) at the south-western corner of the room. It seems quite possible that this denotes the position of a staircase, as similar areas of brick flooring were associated with other staircase positions excavated within this plot. Another internal feature comprised the remains of a 0.8m-wide fireplace situated just off-centre on the eastern wall of the room (Plate 20). The sides of this were composed of two full-brick width (0.23m) walls, projecting for a distance of 0.39m into the room. A stretch of single-skin walling also extended from the northern side of the fireplace, parallel with the party wall, which could represent the setting for a range or pot boiler. Only the rear elements of the adjacent room (**R6**) were present in the excavated area, and this was of identical width to its counterpart, and also similarly contained a flagged floor.

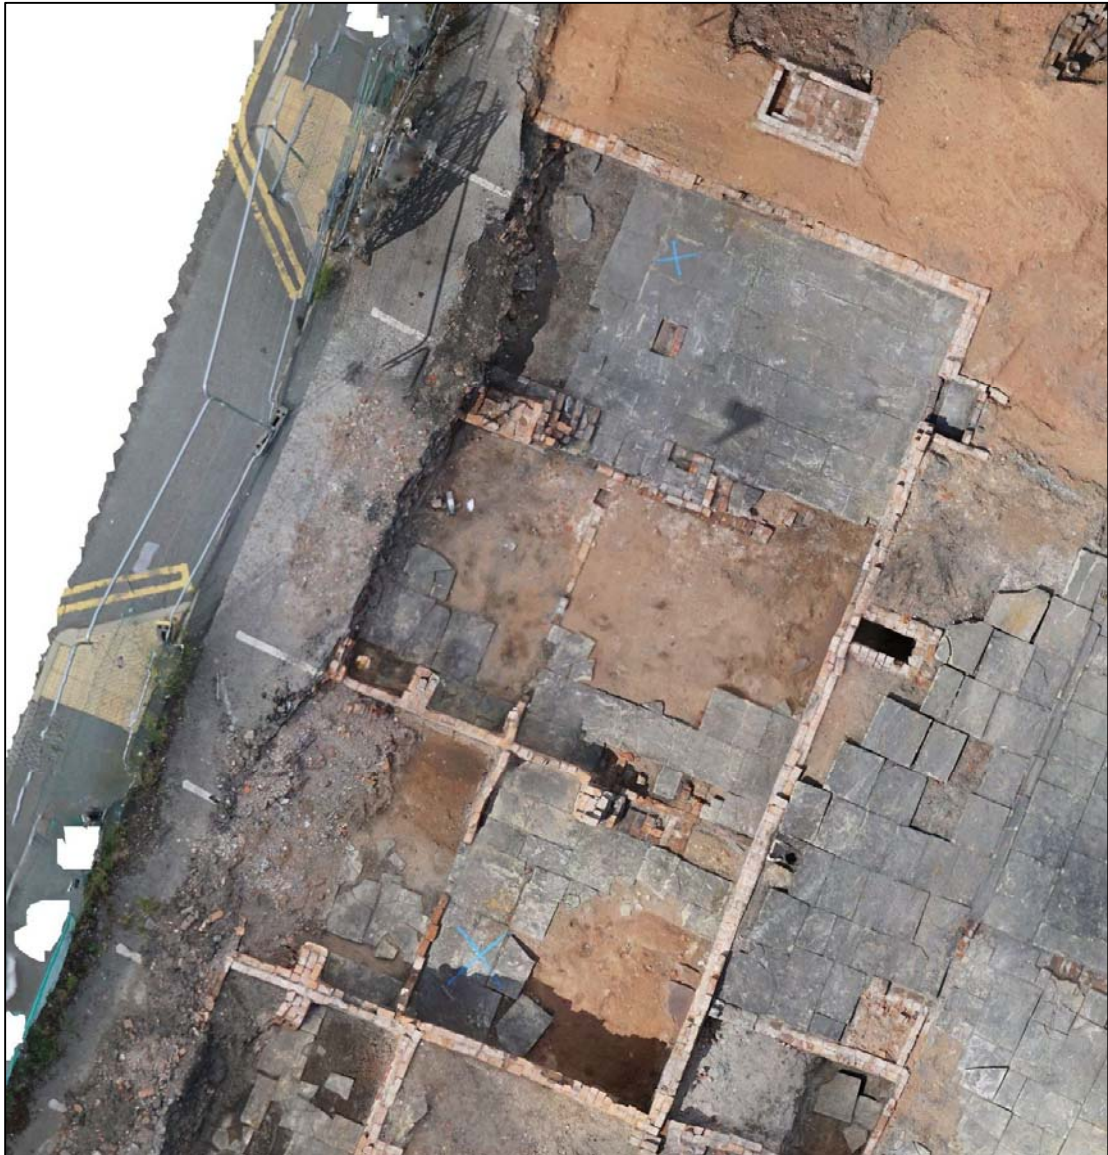
*Plate 21: Aerial view of C4-8*

- 3.2.36 Although this range's street frontage lay beyond the excavated area, the archaeological remains did indicate that its exterior walls, and also the party wall, which divided the range from those properties associated with **Court 2**, was of double-skinned construction, being one full brick in width, laid in an English Garden Wall bond. Within the range, five cellars were present (**C4-8**; Plate 21). These were half-basements, and the largest (**C8**) was at the northern end of the range. This was a single cellar, with a c 4m width and a flagged floor, of a type that invariably lay beneath one double-depth property or two back-to-back dwellings. Perhaps significantly, there was no obvious dividing wall within the cellar that equated with the position of the back-to-backs' party wall, as depicted on historical mapping. Instead, it appears that this internal wall was 'floating' and was supported by a brick-built pillar, measuring 0.38 x 0.47m in plan, the remains of which were located at the centre of the cellar floor. The cellar could be accessed from **Court 3**, via a c 1m-wide stairwell, that had single-skin walls, and flagstone treads, supported on a brick base.

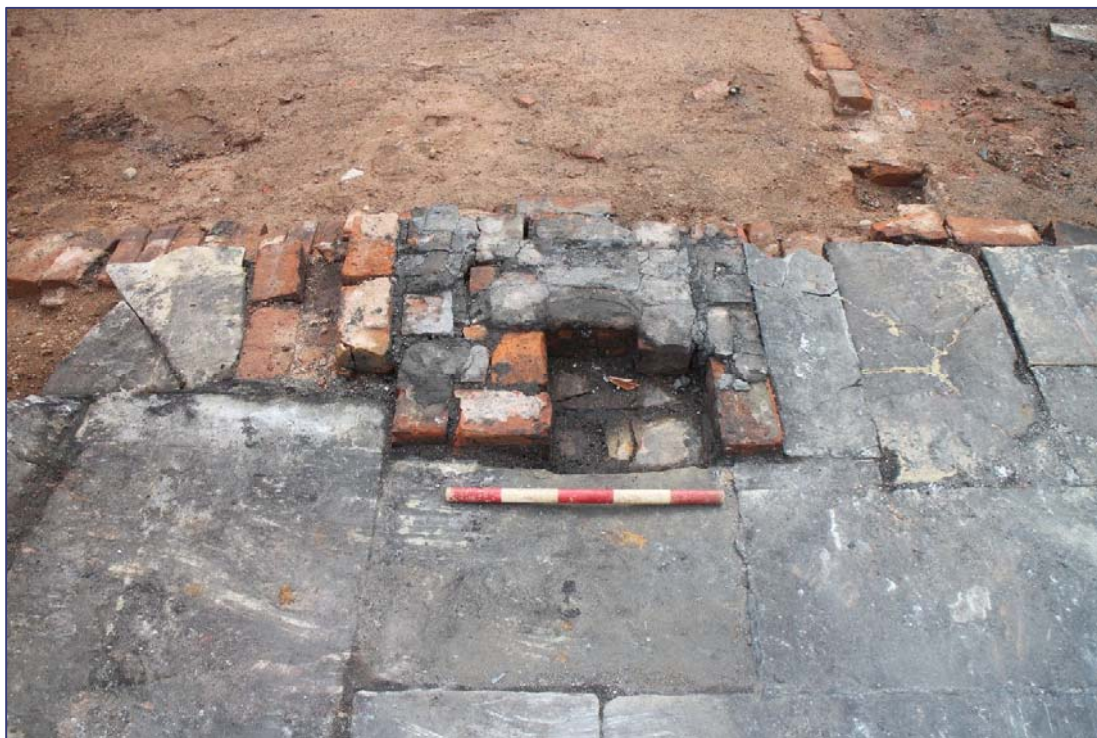
*Plate 22: Remains of the fireplaces in **C8**, looking west*

3.2.37 **Cellar C8** also contained two brick-built fireplaces/chimney stacks on the southern wall, positioned beneath, and supporting, the fireplaces in the two upper rooms of the double-depth/back-to-back property. Only one side of the fireplace in the western part of the cellar lay within the excavated area, though both sides of the fireplace were present in the eastern part of the cellar (Plate 22). This fireplace was formed of two brick piers, that were three-bricks thick. These were spaced 0.9m apart and the fireplace also had a sandstone base.

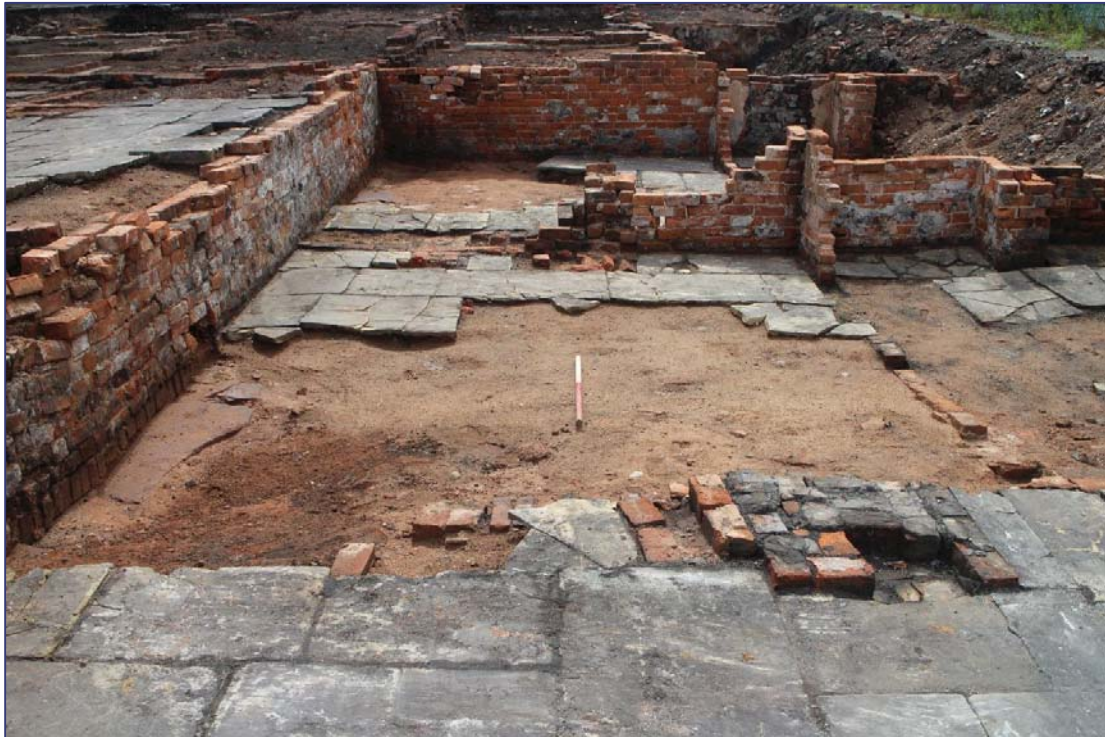
Plate 23: **C7**, looking south

- 3.2.39 The complete extent of **C7** was uncovered (Plate 23), and this measured c 3.8 x 4.1m; it seems highly likely that the adjacent **C6** was of identical size. Both of the cellars were also provided with fireplaces/chimney stacks that were situated in the southern walls, and these were of identical design and size to those in **C8** (Section 3.2.36). Another brick-built structure was also associated with **C7**, which butted onto the external face of its eastern wall. This sunken structure had one-brick-thick walls, measured 1.2 x 0.9m, and probably represents the base of steps that led to the raised ground-floor of the property.

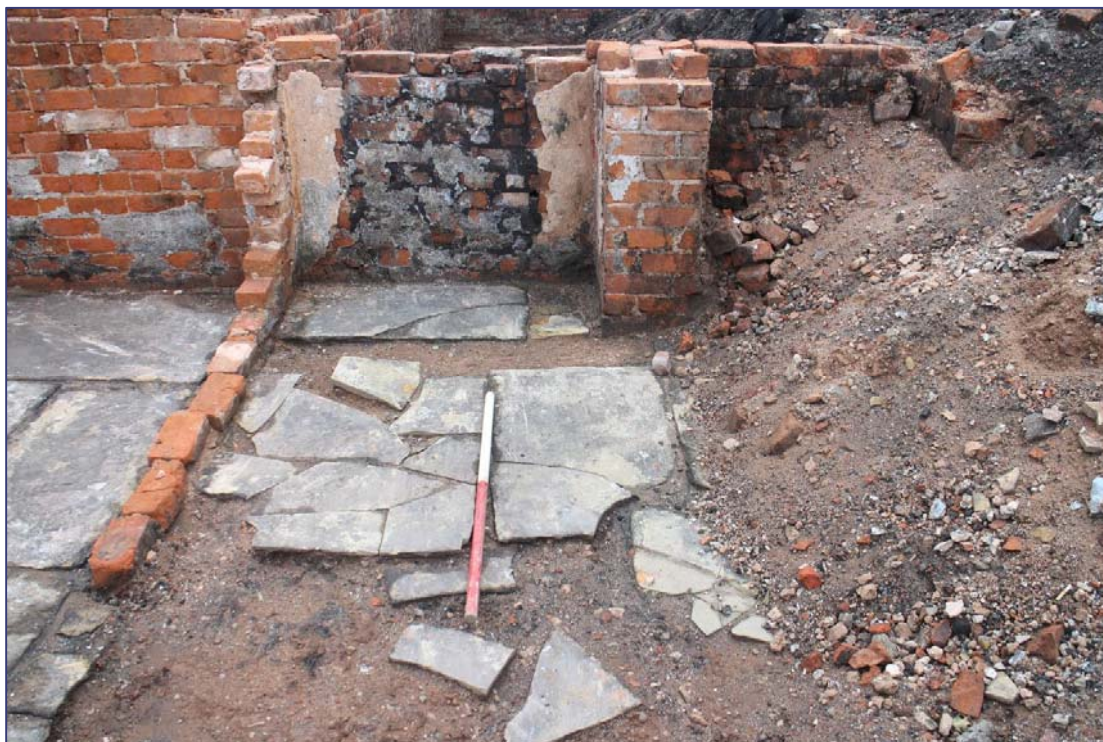
3.2.40 **C4** and **C5** were south of **C6** and **C7**, and lay beneath the southernmost of the double-depth/back-to-back property in this range. They were identical in size to **C6** and **C7** (Section 3.2.38), contained elements of *in-situ* flagged flooring, and patches of lime plaster were also observed, indicating that originally the cellar walls were rendered (Plate 24). These cellars were divided by a single-skin wall that had a centrally placed 0.8m-wide, doorway, allowing access between them. Significantly, though, the northern part of this wall, beyond the doorway, was a later addition, suggesting that originally the two cellars formed one large cellar, containing a short southern partition wall. It is therefore conceivable that the two separate cellars, with shared access from New Blakeley Street, were created when the double-depth property was ‘converted’ into a back-to-back dwelling (Section 3.2.35). This division may also imply that the cellar was divided to form two separate cellar dwellings.

*Plate 24: Southern elevation of **C4**, with patches of surviving lime plaster*

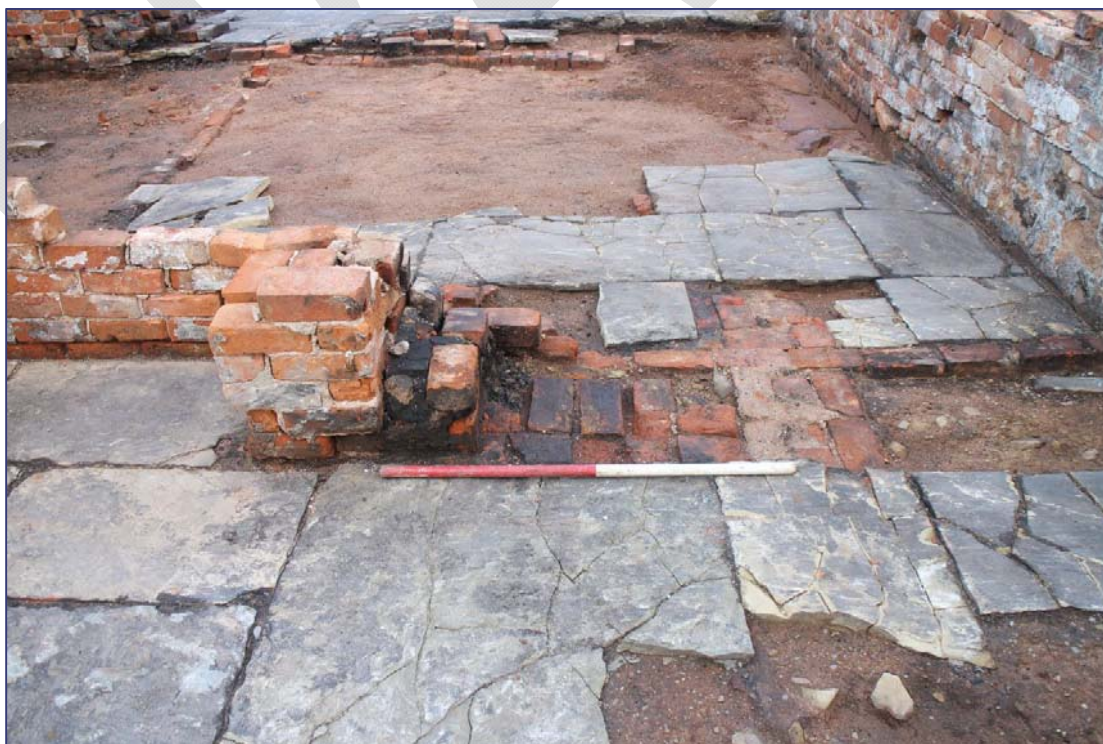
3.2.41 Both **C4** and **C5** contained fireplaces/chimney stacks, which were identical in size and design to those found in the other cellars in this range (*Sections 3.2.36 and 3.2.38*). Similarly, that in **C4** was placed on the southern side of the cellar, though that in **C5** was on the northern wall (Plate 25), mirroring the fireplace in adjacent **C7**.

*Plate 25: Fireplace (and later pot boiler) in **C5**, looking north*

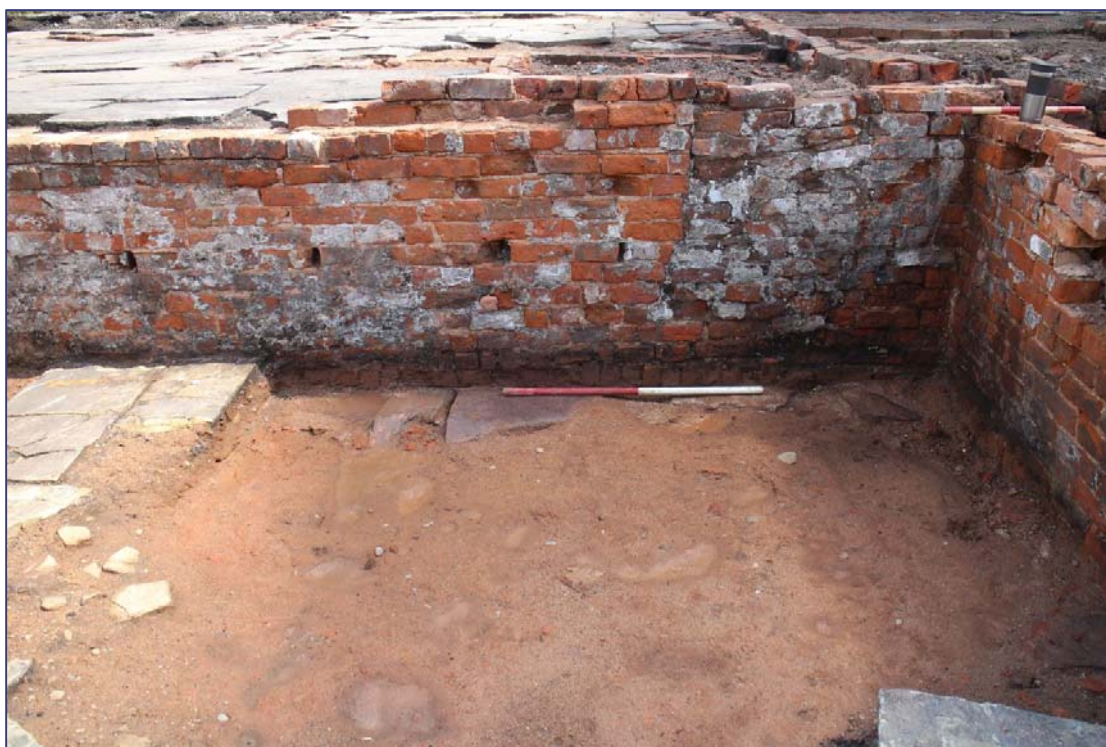
3.2.42 One further feature associated with **C5** was a 0.7m-wide doorway, on its eastern wall, which had been blocked with a handmade brick wall at some stage (Plate 26). This doorway originally led into a cellared outshut (**C9**) that in the early part of the nineteenth century formed an element of the double-depth property that existed at this end of the building range. The north wall of the outshut was of double-skin construction, and contained a doorway 0.7m-wide adjacent to the rear wall of the double-depth property, allowing access into **Court 3**. Although this wall had been blocked with handmade brick, its presence suggests that, originally, steps may have led from it down into the cellared outshut; however, it was not possible to determine this with certainty, as this part of the cellar was not cleared of demolition rubble. The eastern wall of the outshut was single-skinned and this abutted the northern wall of the adjacent blind-back dwellings, lining **Court 2** (Section 3.2.45 below); this also formed a party wall with **R5**, associated with the adjacent double-depth property that fronted Ashley Lane (Section 3.2.23 above). The eastern half of the cellared outshut was excavated, exposing remnants of a flagged floor. Immediately above the floor level was a 0.5m-thick layer composed of tin-plate fragments. There was also a small square brick-built 'annexe' on the northern side of the outshut; however, the purpose of this feature is not particularly clear.

Plate 26: Blocked doorway originally providing access between **C5** and **C9**, looking east

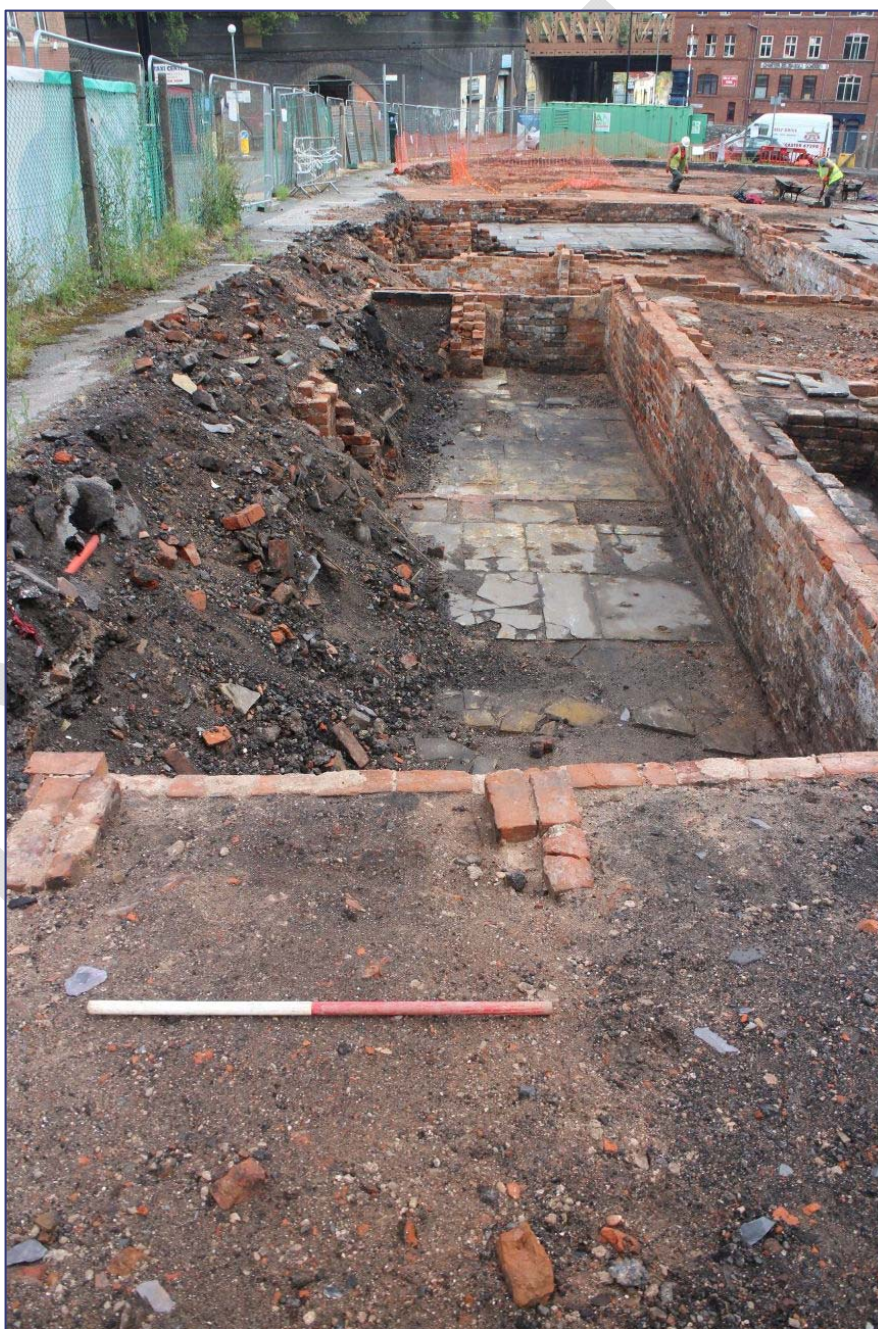
The excavated remains from the 1820s that were recorded did, however, indicate that these later properties were cellared (**C1-3**; Plate 27), and were constructed at exactly the same time as the cellared properties fronting New Blakeley Street, in the **Court 3** area (**C4-8**). This was particularly evident, as the shared rearward double-skinned external wall (with an English Garden Wall bond) of **C1-3** was tied into the southern wall of an adjacent double-depth/back-to-back property (defined by **C4** and **C5**) in the **Court 3** area (Section 3.2.40). Surprisingly, it was also clear that, originally, there was access between **C3** in the **Court 2** area and **C4** in the **Court 3** area, as a 0.65m-wide doorway had once existed that allowed for movement between the two cellars, which were associated with two seemingly separate properties.

Plate 27: **C1-3**, looking north, with a blocked doorway visible on the northern elevation of **C3**

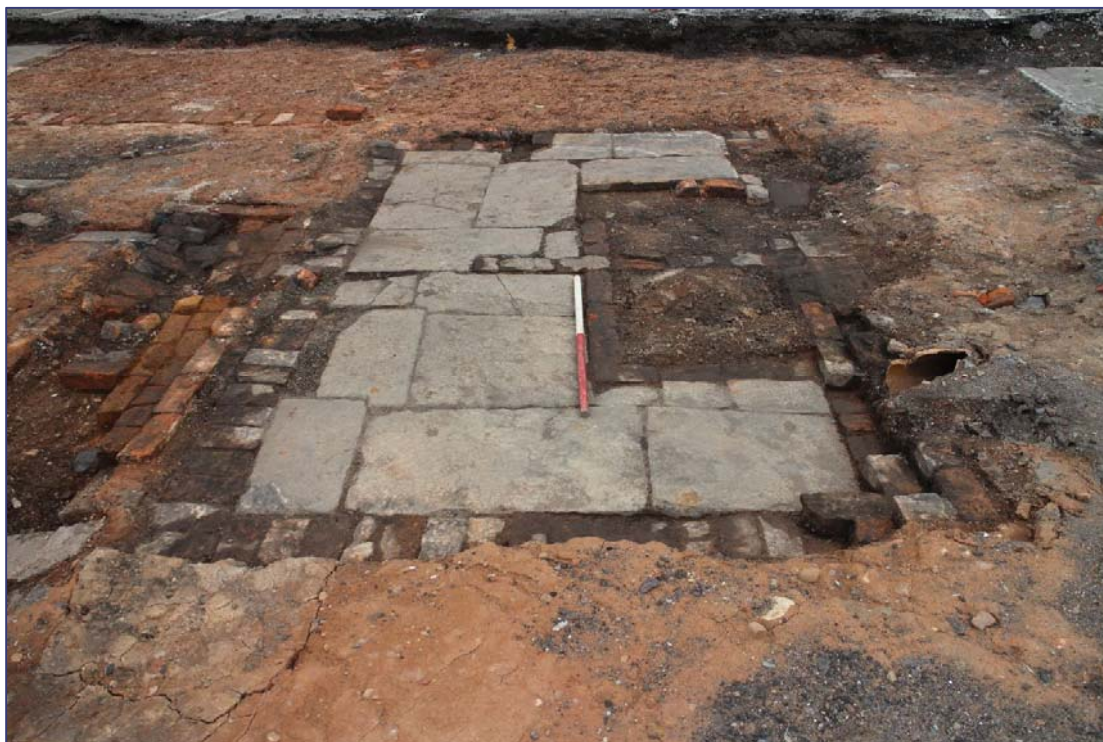
Plate 28: **P1**, looking east

- 3.2.46 **Phase 4 (1848-88)**: one structure was present in **Court 3** that can be dated by the cartographic evidence to the mid-/late nineteenth century (Fig 4). Significantly, this butted on to the rear of an earlier single-depth property fronting Ashley Lane (**R23**; Section 3.2.30; Fig 3) and it was clearly associated with improving the living conditions for those occupying this property, since it formed a small outshut functioning as a privy block (**P1**; Plate 28); its construction also entailed the demolition of an early nineteenth-century dwelling, of which no remains survived (Section 3.2.30). The privy block measured 2.91 x 1.88m, was constructed of handmade brick, bonded with a grey/brown sandy mortar, and it could be accessed from its 'parent' property (**R23**) through a 0.9m-wide doorway close to its south-eastern corner. The external walls were one-full brick thick and it was divided in half by a single-skin wall, to form two small rooms, with access between each being through a doorway at the northern end of the dividing wall. An *in-situ* flagged floor was also present in both rooms, along with 0.75m square brick-lined chambers.

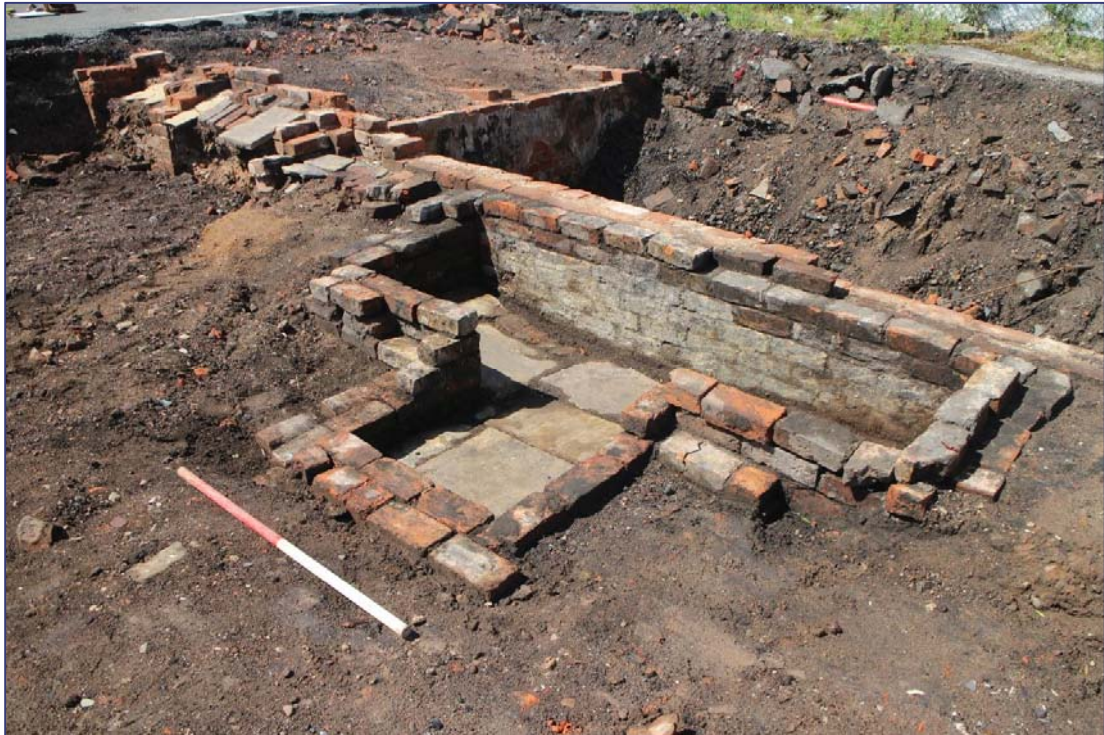
Plate 29: R2, looking south-west

3.2.47 To the south-west, another outshut, of sorts, was present in the **Court 2** area. This butted onto the rear wall of the early nineteenth-century blind-back (defined by **C2**), and, as such, would have been positioned at the far end of the courtyard. It formed a T-shaped structure (**R2**), with maximum dimensions of 3 x 2m, with a double-skin brick wall, bonded with a dark grey mortar, and a flagged floor (Plate 29). The exact purpose of the structure is not entirely clear, though given its position at the end of the courtyard it is quite likely that it was a privy. Indeed, the large-scale OS map of 1891 depicts a probable small privy block in this area, containing three separate compartments, with a 'corridor' to the rear, parallel with the blind-back property. It seems likely, therefore, that the T-shaped structure relates to this corridor and the central compartment in the block.

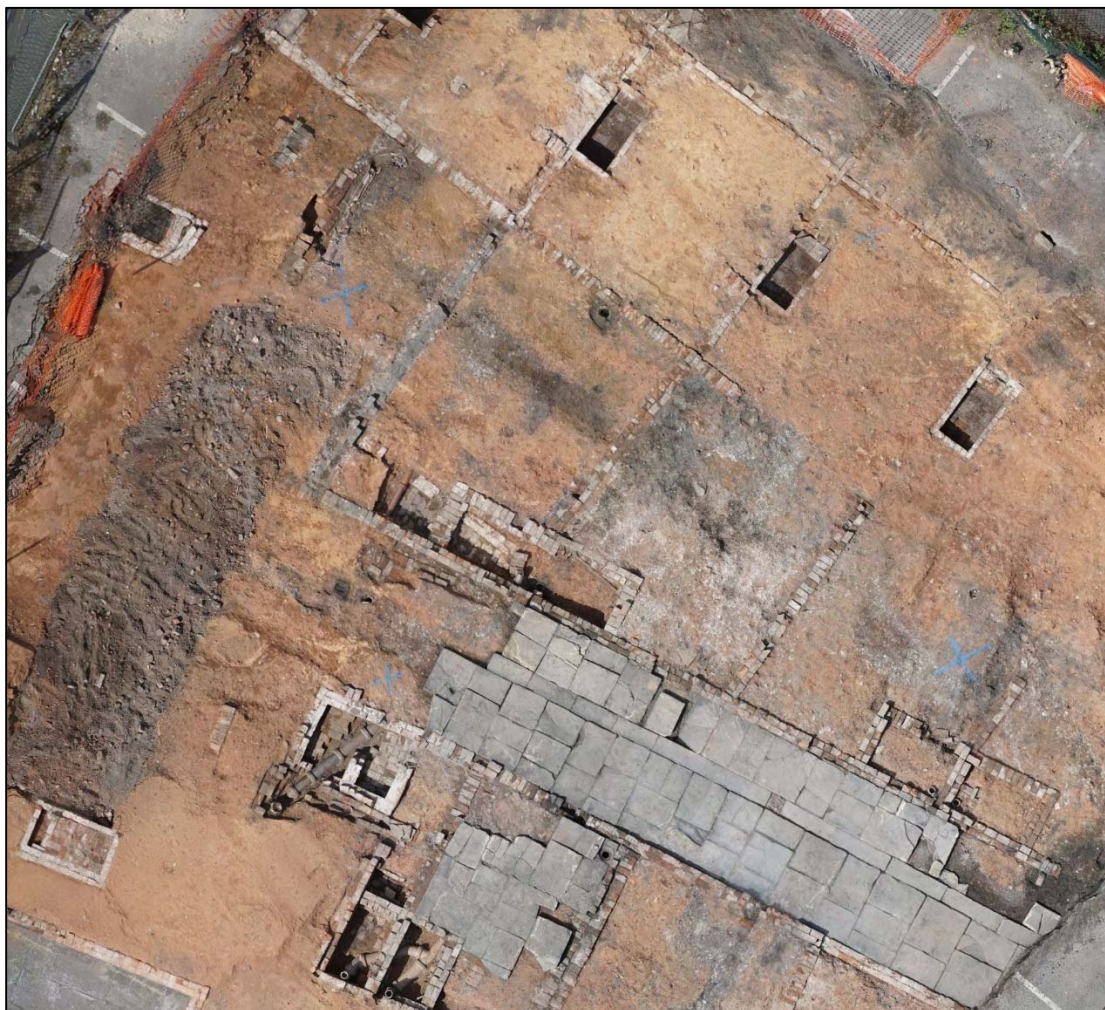
- 3.2.49 **Nelson Court area**: at the northern end of the plot, this phase of improvement was readily apparent in the modifications that were made to the row of 12 early nineteenth-century (Phase 2) back-to-backs that partially fronted Nelson Street/Nelson Court (*Section 3.2.20*). The cartographic evidence indicates that these were knocked through to form six larger double-depth dwellings, which were each provided with yards and privies that covered much of the area formerly contained in Nelson Court. This later court was therefore transformed into a much narrower ginnel. The remains of the yards, privies and ginnel were all present in the excavated area (Plate 30).

*Plate 30: Aerial view of the Phase 5 yards, privies, and ginnel in the Nelson Court area*

- 3.2.50 The yard areas (**Y1-5**) progressively narrowed in size from west (**Y5**) to east (**Y1**) and were defined by double-skin wall foundations bonded with a dark grey mortar. Within each of the yard areas, directly adjacent to the rear of the properties, the up-spout of a ceramic drain was present, which fed into a drainage system, which was partly uncovered in **Y5**. These drains were presumably inserted during the construction of the yards as a means of carrying away both rain and grey water.

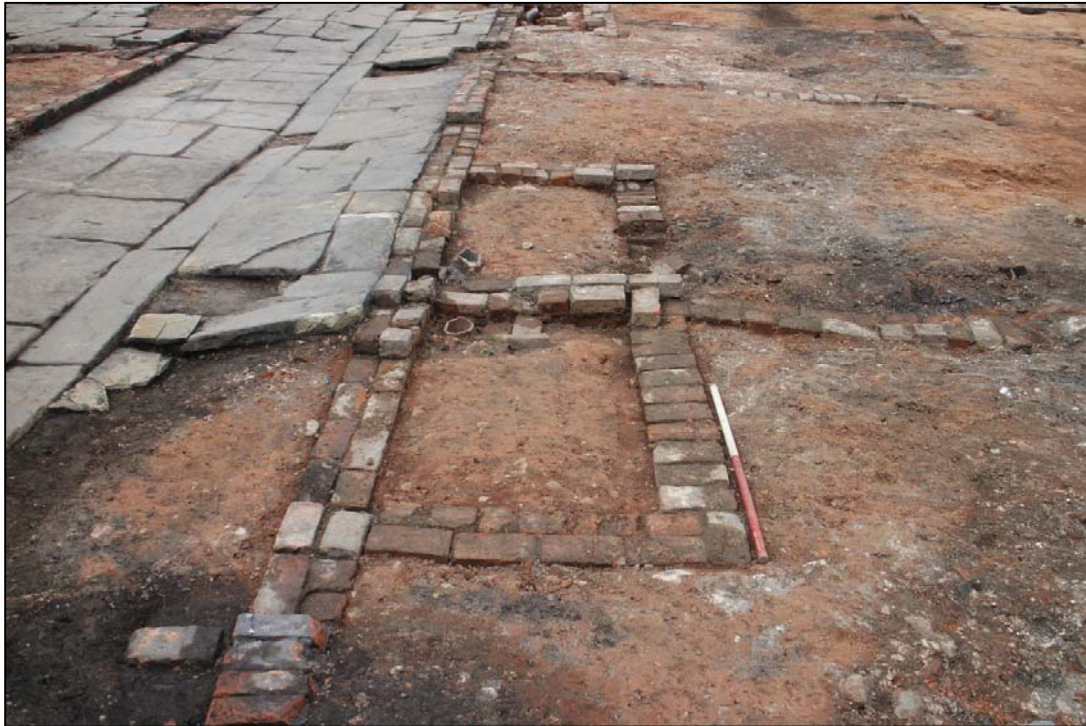
Plate 31: **P4**, looking north-west

- 3.2.51 Butted onto the rear yard wall were two privy blocks (**P4** and **P7**), one of which (**P7**) served the properties associated with **Y3** and **Y4**, the other (**P4**; Plate 31) serving the properties associated with **Y1** and **Y2**. Both were of identical design and construction, being composed of an outer double-skin wall, and also an interior, one full-brick wide, wall (which only survived in **P4**) that divided the block into two separate toilets, served by *in-situ* soil pipes, indicating that they were flushable, provided with a water supply. **P7** measured 3.7 x 1.15m, whilst **P4** was nearly identical in size, measuring 3.5 x 1.15m, with the separate toilet cubicles measuring c 1.4m across.
