# Plots 2, 3 and 5, Angel Meadow, Manchester: DRAFT 2 Archaeological Excavation Report

**Client: Orion Heritage Ltd**

OA Reference No: L11148

# Plots 2, 3 and 5, Angel Meadow, Manchester

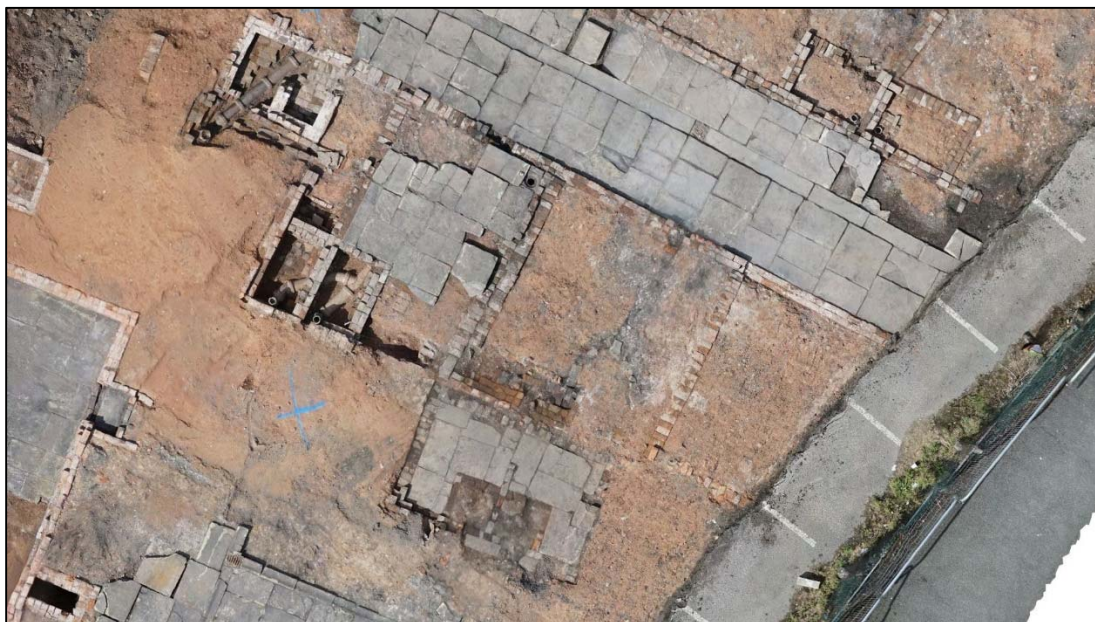
Plate 32: Aerial view of **R12-14** and **P1-3**

- 3.2.53 To the south of this ginnel, on the southern side of Nelson Court, the cartographic evidence also hints that the early nineteenth-century properties in this area were also modified between 1889 and 1908 (Plate 32). This seems to have involved the conversion of two blind-back dwellings (**R12** and **R13**; *Section 3.2.29*) into a double-depth property fronting Ashley Lane, and the demolition of another blind-back property (**R14**; *Section 3.2.29*) to the rear of this, the footprint of which then acted as a small walled yard area. Structural remains relating to these modifications were apparent, indicating that the process of the conversion of the blind-backs into a double-depth property entailed the complete rebuilding of the western end of the blind-back (**R13**), which now formed the back room of the reconfigured property. The associated yard was also defined by a 'newly' constructed wall, that sat above the wall lines of the earlier property (**R14**). Another structure that was contemporary with the yard was a privy block (**P2**). This straddled the yard wall, measured c 2.4 x 2 m, with a one full-brick thick wall, and was internally divided into two separate compartments, each provided with a soil pipe, that would have served a flush toilet. One of the toilets served the property fronting Ashley Lane, whilst the other served an early nineteenth-century double-depth property fronting New Blakeley Street (*Section 3.2.27*); this privy probably also replaced an earlier privy (**P3**; *Section 3.2.27*) associated with this property.

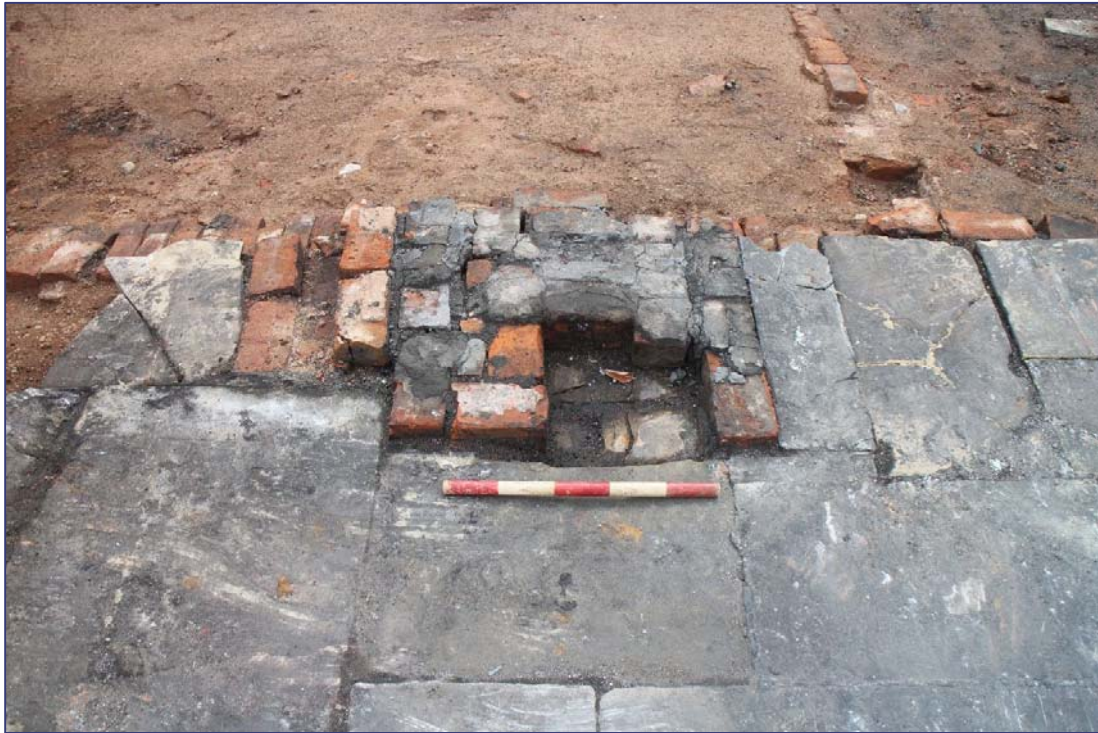
*Plate 33: Base of a pot-boiler associated with the eastern fireplace in **C8**, looking south*

3.2.54 *No 3 Court area*: the only structures associated within the central part of the plot that probably date to Phase 5 were located in **C8** (Section 3.2.36) and **C5** (Section 3.2.40), associated with a blind-back dwelling fronting Ashley Lane (**R7**; Section 3.2.31). The features in **C8** comprised the bases of two pot-boilers, that would have held a large metal pot, heated from below, used for cooking or washing laundry, that butted up against the two fireplaces in this cellar (Plate 33). The bases were composed of (reused?) handmade bricks, bonded with a hard grey cement, and they both measured c 0.8 x 0.7m. The remains of a similar pot boiler were associated with the fireplace in **C5**. The Phase 5 remains associated with the **R7** dwelling indicated that its rear wall had been rebuilt in the late nineteenth/early twentieth century, with a double-skin wall. This wall was also associated with the up-spout of a ceramic drain, designed to carry rain/grey water from the property.

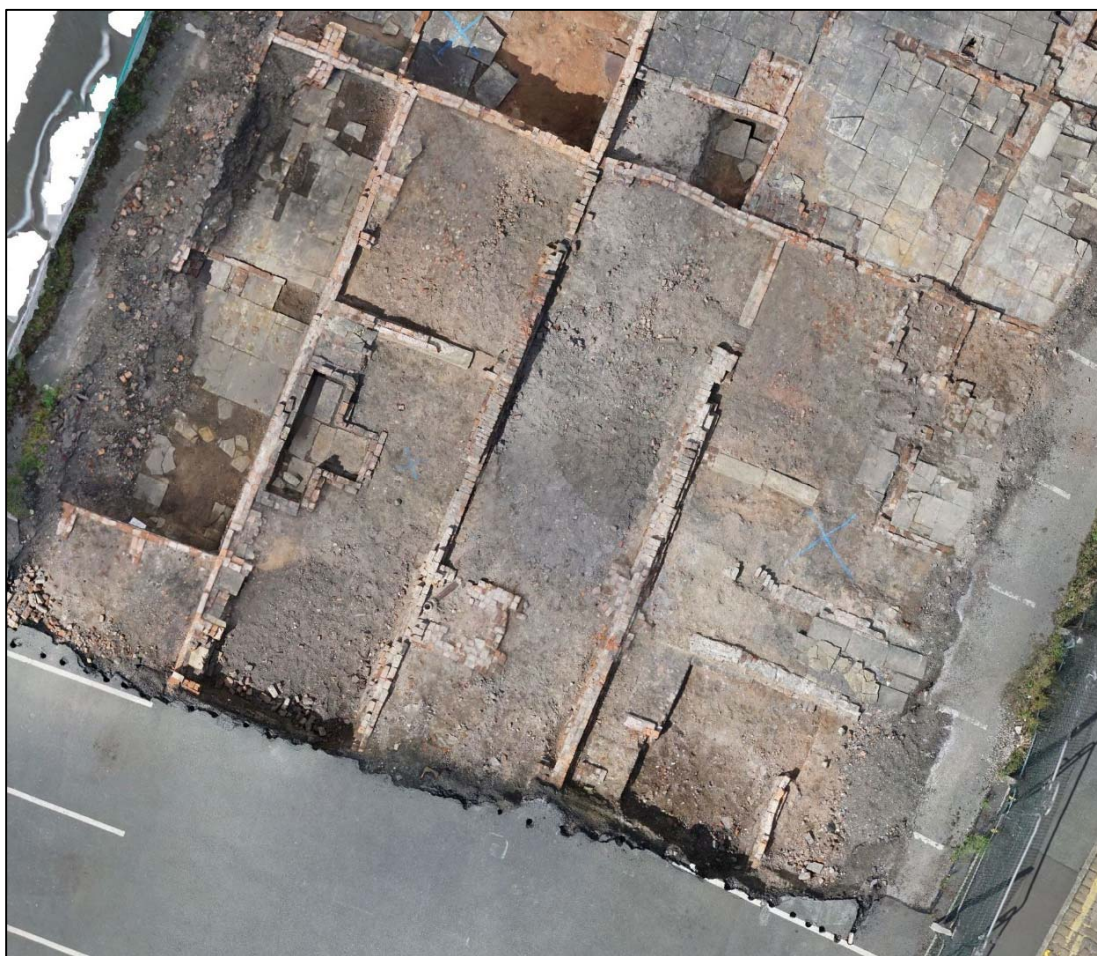
- 3.2.56 The excavated remains indicated that this programme of modification entailed the complete rebuilding of the (presumably originally single-skinned) side walls of the blind-back dwellings, that formerly fronted **Court 2**, by a single wall that extended between these former dwellings, across **Court 2**, and that also acted as the rearward extension of the former blind-back (**C2**) that fronted New Blakeley Street (Plate 34). This wall was double-skinned and was composed of reused handmade brick, bonded with a hard grey cement mortar. The extension of the property defined by **C2** effectively created a backroom (**R1**) in this now enlarged, double-depth, property, and the construction of this room would also have entailed the demolition of the Phase 4 privy block (**R2**; *Section 3.2.47*) that was positioned at the far western end of **Court 2**. Although no flooring survived in the extended room, it is quite likely that the footings of the former privy block were covered by the 'new' floor surface that was contained within this room.

Plate 34: Aerial view of modified **Court 2**, and Phase 5 **R1**, **R9**, and **R10**, and **P5** and **P6**

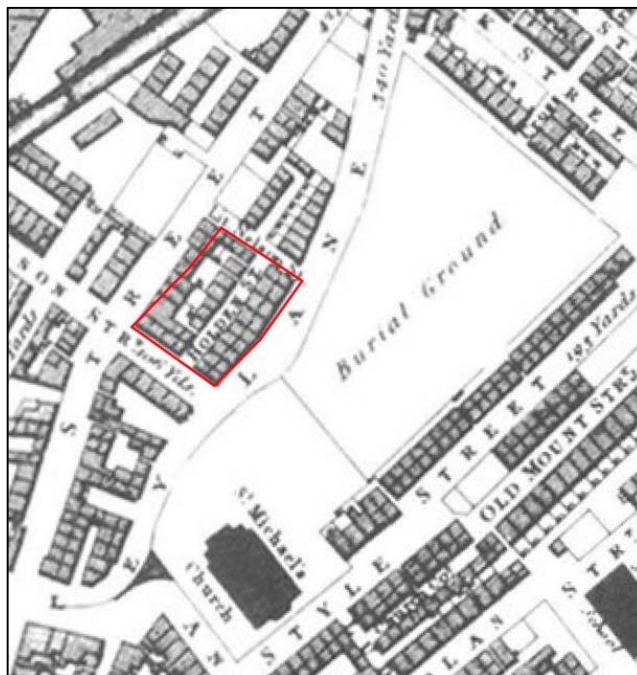
Plate 36: An extract from Bancks & Co's map of 1831, with the location of Plot 3 highlighted

- 3.3.2 Further development evidently occurred shortly after Johnson's survey, as Swire's map of 1824 shows Plot 3 to have been developed almost entirely, with buildings positioned on either side of a small north-east/south-west-aligned street running through the centre of the plot, named Holden Street on later maps. The form and character of these buildings is apparent on Bancks & Co's map of 1831 (Plate 36). This indicates that the small block of back-to-back housing at the corner of Little Nelson Street and Ashley Lane (*Section 3.3.1*) had been extended, and together these now formed a block of 18 back-to-back properties, which could be accessed from Ashley Lane and Holden Street.

- 3.3.3 On the other side of Holden Street, contained in the north-western corner of Plot 3, Bancks & Co's map depicts a C-shaped block of properties, surrounding a courtyard, which could be accessed from Holden Street, via a covered passageway. These properties consisted of a row of five blind-backs fronting Little Nelson Street, a back-to-back dwelling fronting New Blakeley Street and the courtyard, and a large single-depth property facing Holden Street, that stood next to the covered passage. Similarly, in the far south-western corner of Plot 3, Bancks & Co's map plots a row of four blind-back dwellings fronting Nelson Street. The area between this latter row of blind-backs and the C-shaped block to the north-east contained a selection of buildings of varying sizes, with three separate courtyard areas to the rear. These buildings included blind-back dwellings fronting Holden Street, whilst New Blakeley Street was fronted by a range that contained, from south-west to north-east, a fairly large building, with an outshut to the rear, two double-depth properties, and two large single-depth properties.

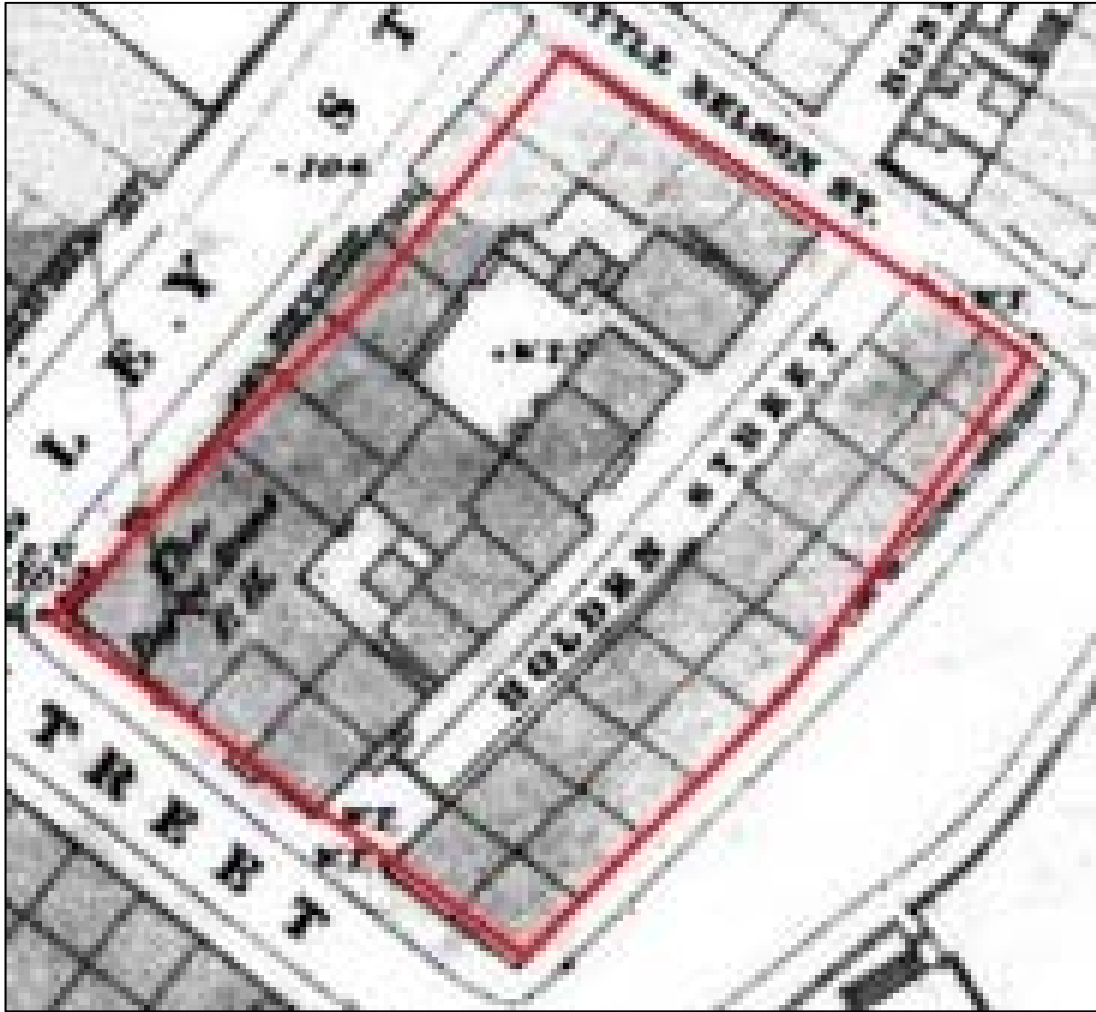
*Plate 37: An extract from the 5ft:1mile OS map of 1850, with the location of Plot 3 highlighted*

- 3.3.4 The buildings depicted on the OS 5ft:1mile maps of 1850 (surveyed in 1848; Plate 37) and Adshead's map of 1850, show several modifications/additions to those depicted on Bancks & Co's map (Section 3.3.3). By the middle of the nineteenth century, a blind-back dwelling had been built across one of the courtyard areas, infilling that open area that was formerly positioned to the rear of the double-depth properties fronting New Blakeley Street and the blind-backs fronting Holden Street. These maps also indicate that two of the blind-backs at the north-western end of Little Nelson Street, and the adjoining back-to-back dwelling, had both been combined to form two double-depth properties fronting New Blakeley Street. Similarly, two of the blind-backs fronting Nelson Street, along with the large building fronting Nelson Street, had been combined into one large property, which functioned as a public house, named 'The Derby Arms' on the OS map of 1850.

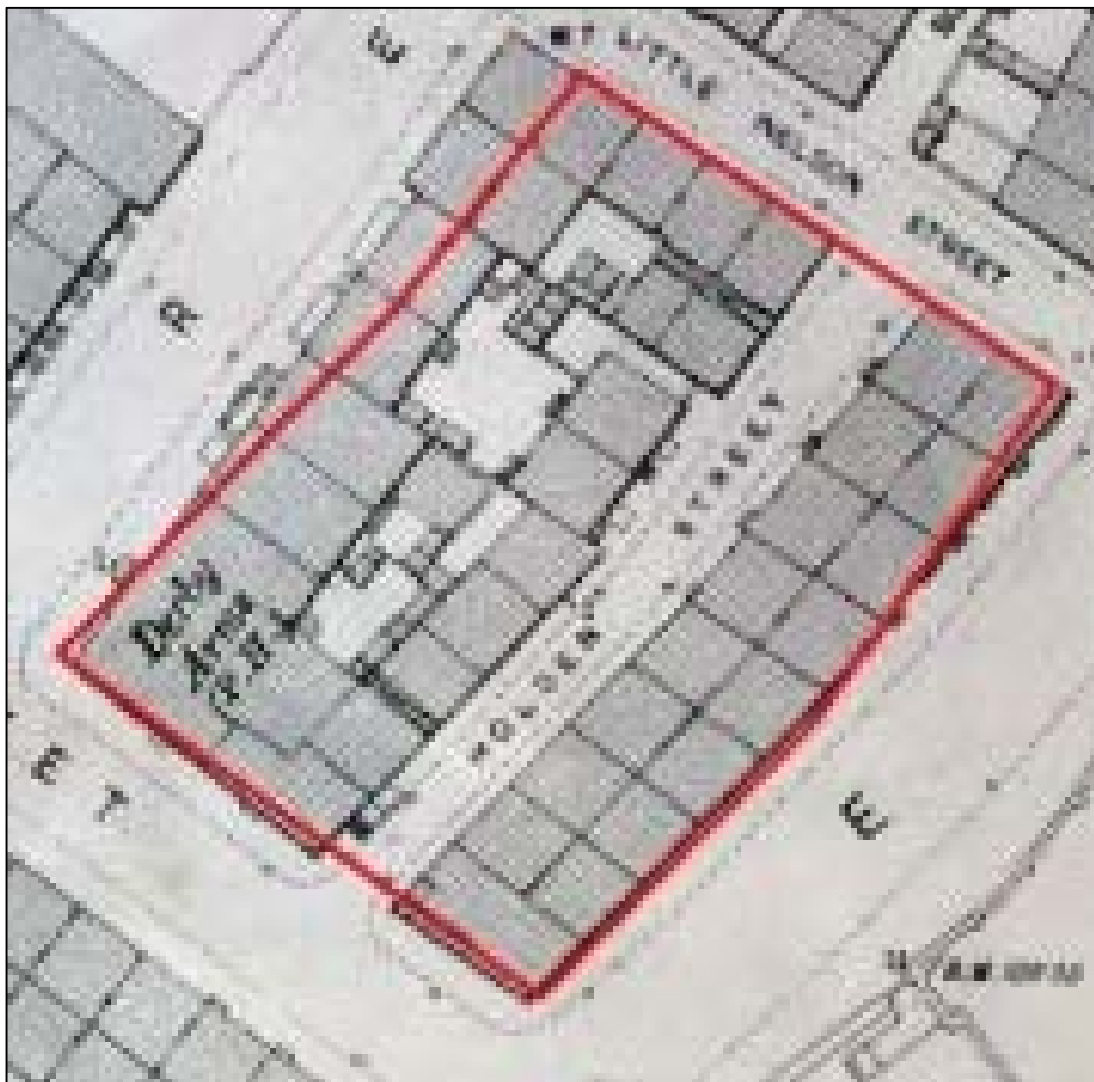
*Plate 38: An extract from the 10ft:1mile OS map of 1891, with the location of Plot 3 highlighted*

- 3.3.5 The OS maps of 1891 (Plate 38) and 1893 reveal an essentially similar layout of properties to that shown on the earlier mapping. One of the few slight differences is the probable replacement of a mid-nineteenth-century building, constructed in one of the early nineteenth-century courtyards, with a structure that probably functioned as an outshut for one of the double-depth properties fronting New Blakeley Street, along with the construction of a yard area to the rear of one of the blind-backs fronting Holden Street. Extending from the oushut, around the corner of the yard in a dog-leg, was a privy block. A small privy block had also been constructed in the large courtyard area to the north-east, that could be accessed from Holden Street. Other modifications were the conversion of the southernmost of the back-to-backs fronting Holden Street/Ashley Lane into a double-depth property, the removal of a covered passageway, adjacent to a large single-depth building at the north-eastern end of Holden Street (*Section 3.3.3*), and division of this property into two smaller units. Intriguingly, the 1891 and 1893 maps also indicate that the two properties at the corner of New Blakeley Street and Little Nelson Street had been reconfigured back into their original early nineteenth-century guises, as four separate tenements.

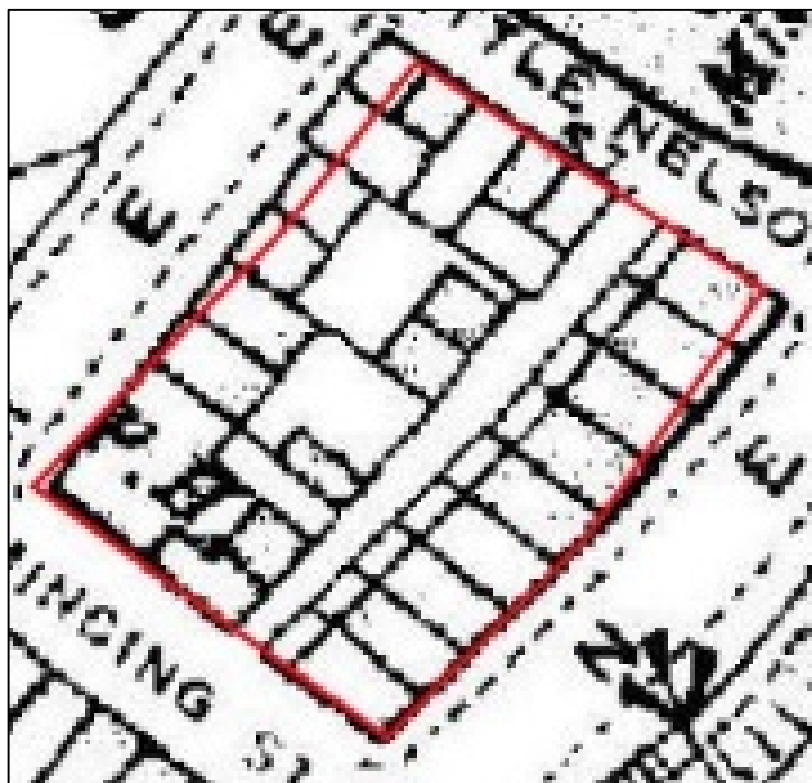
Plate 39: An extract from the 25inch:1mile OS map of 1908, with the location of Plot 3 highlighted

- 3.3.6 The next edition of OS mapping, published in 1908 (Plate 39), shows some changes to Plot 3. In particular, the early nineteenth-century back-to-backs (*Section 3.3.2*) fronting Ashley Lane/Holden Street were remodelled, which entailed their conversion into double-depth properties with small yards to the rear (though see *Section 3.3.4*). Three of the blind-back houses on Holden Street and one fronting Little Nelson Street also appear to have been demolished by 1908, presumably in an attempt to improve the natural lighting and ventilation of the area by removing the worst dwellings, and these were replaced by a courtyard and a narrow building. Similarly, one of the blind-backs on Little Nelson Street had been demolished, to allow better access and ventilation into a courtyard to the rear. The same layout is shown on the Ordnance Survey maps of 1922 and 1933, although the entire plot is shown to have been cleared of all buildings on subsequent editions of OS mapping.

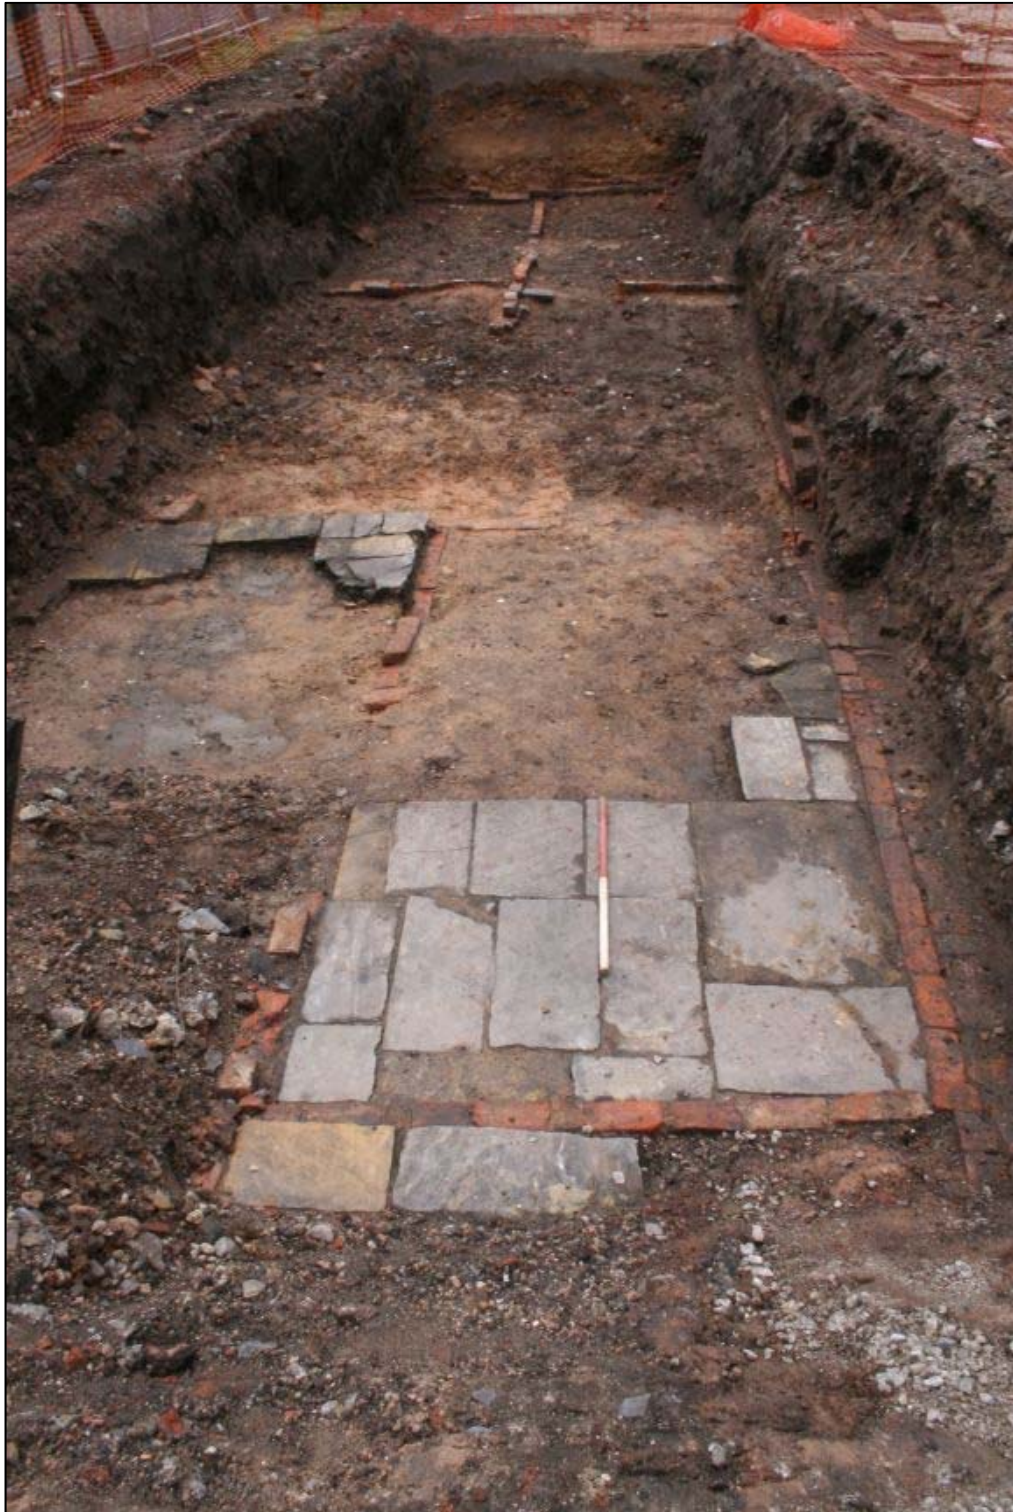
- 3.3.12 **Phase 2 (1809-18/19)**: Johnson's map of 1818/19 indicates that by this date a block of buildings had been constructed in the north-eastern portion of Plot 3, at the corner of Little Nelson Street and Ashley Lane, and these most probably formed back-to-backs, based on the evidence of later mapping (*Section 3.3.1*). These formed a discrete block of six early nineteenth-century back-to-backs and are most probably those depicted on Johnson's survey, along with two further back-to-backs to the north, which lay largely beyond the excavated area (Fig 5). All of these dwellings were cellared, though there was poor survival of these, due to later truncation, with **C4-6** respectively defining the cellared areas beneath two of the opposing back-to-back dwellings (Plate 40). Where it survived, the external wall of this block of back-to-backs was of double-skin construction, whilst the internal party walls were single skinned.

Plate 40: **C4-6**, looking south-west, with **C6** in the foreground

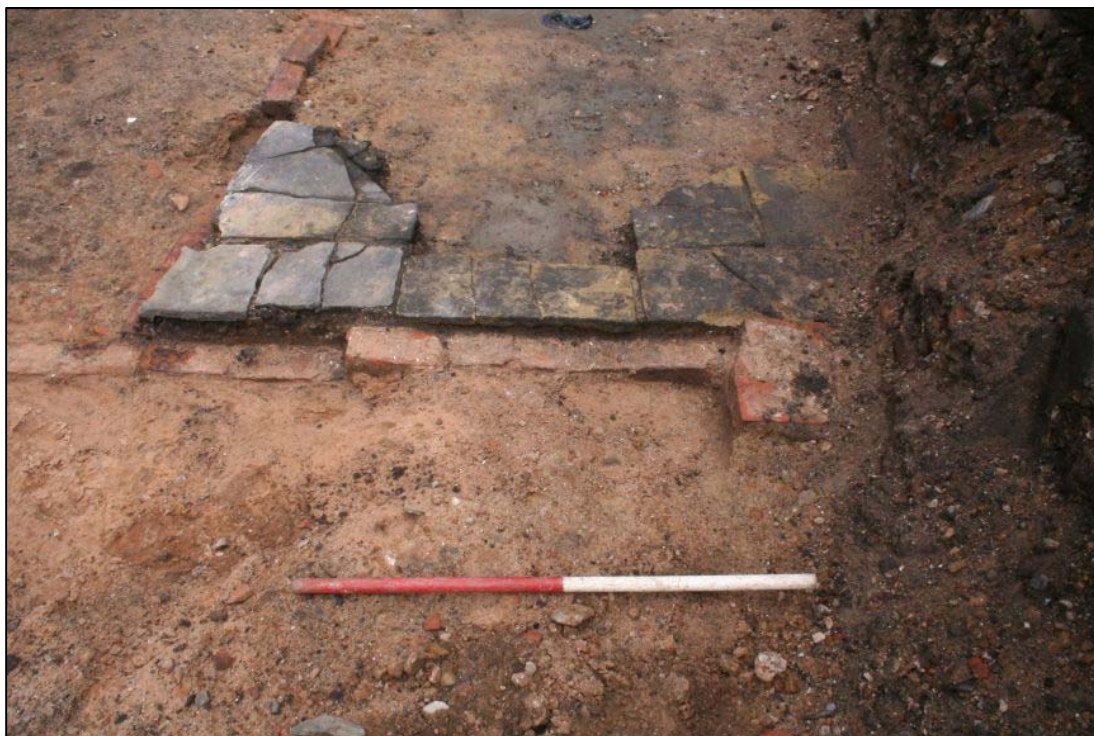
(Plate 41), and originally these would have been found in each of the cellars that lay beneath the back-to-backs.

Plate 41: Remains of a fireplace in C5, looking north-east

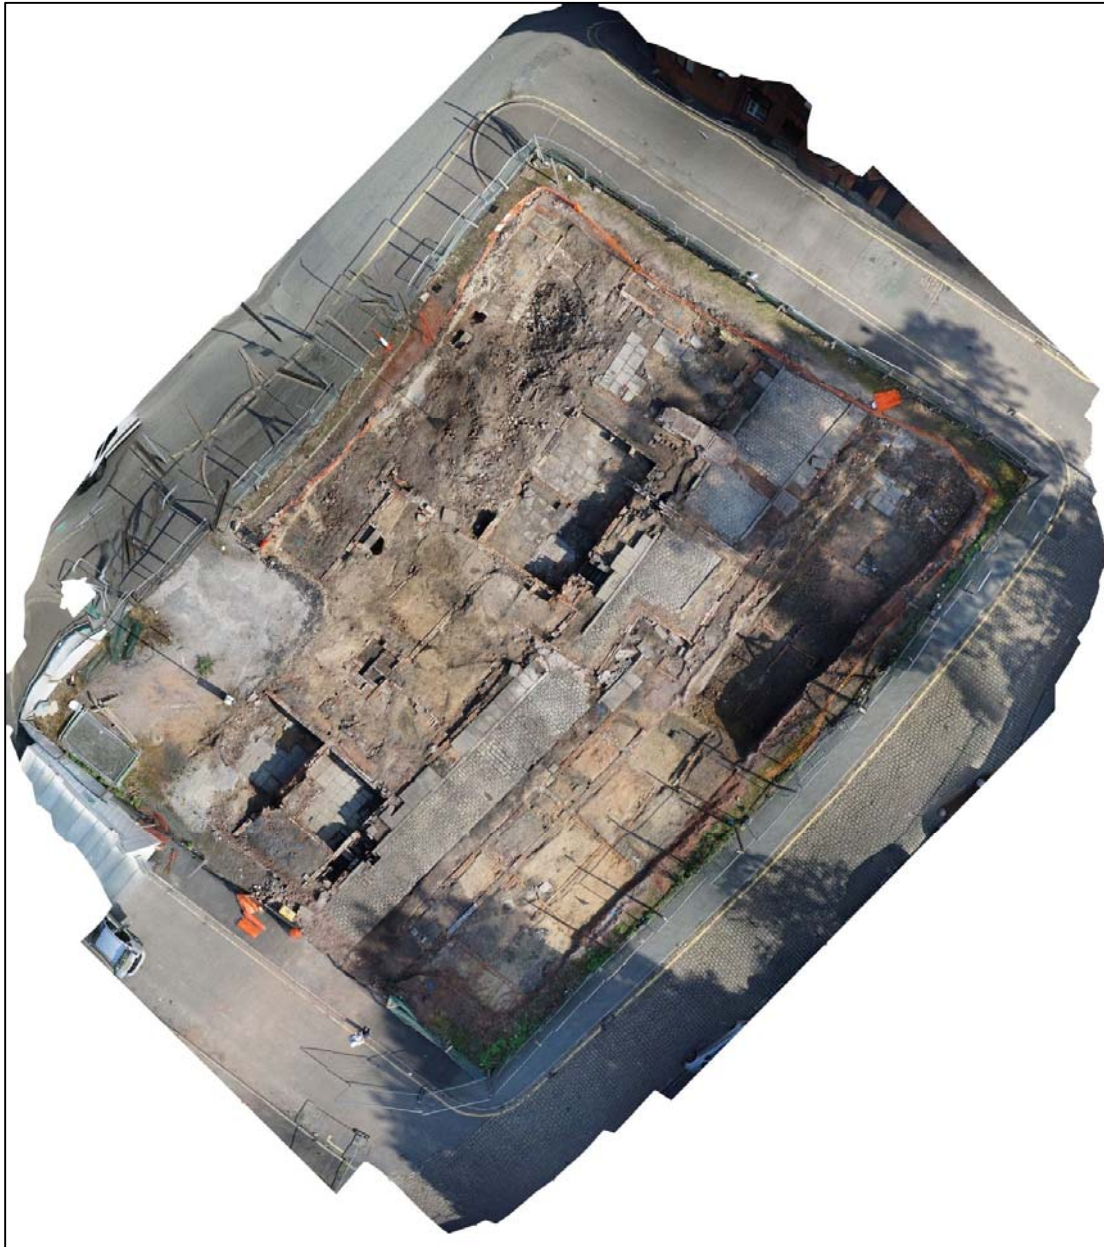
- 3.3.15 **Holden Street**: the *in-situ* remains of Holden Street (**3003**; Fig 5) were very well-preserved and, in fact, this street formed the most prominent feature in the excavated area (Plate 42). Indeed, much of its surface was present, and it had only been disturbed in four places, during the construction of a late twentieth-century building (Section 3.3.35). It was evident that, in the excavation area, the street was wider at its north-eastern end, at 3.7m across, narrowing to 2.5m at its far south-western end. Its surface was composed of cobble setts, with average dimensions of 0.22 x 0.12 x 0.1m, set on a black silty bedding layer. The road surface was bounded by kerb stones, which were present in several areas, behind which was a flagstone pavement, measuring c 0.8m wide. *In-situ* remains of this pavement were present along the north-eastern and south-western parts of the street, with better survival on its eastern side.

*Plate 42: Aerial view of Plot 3, highlighting the well-preserved remains of Holden Street*

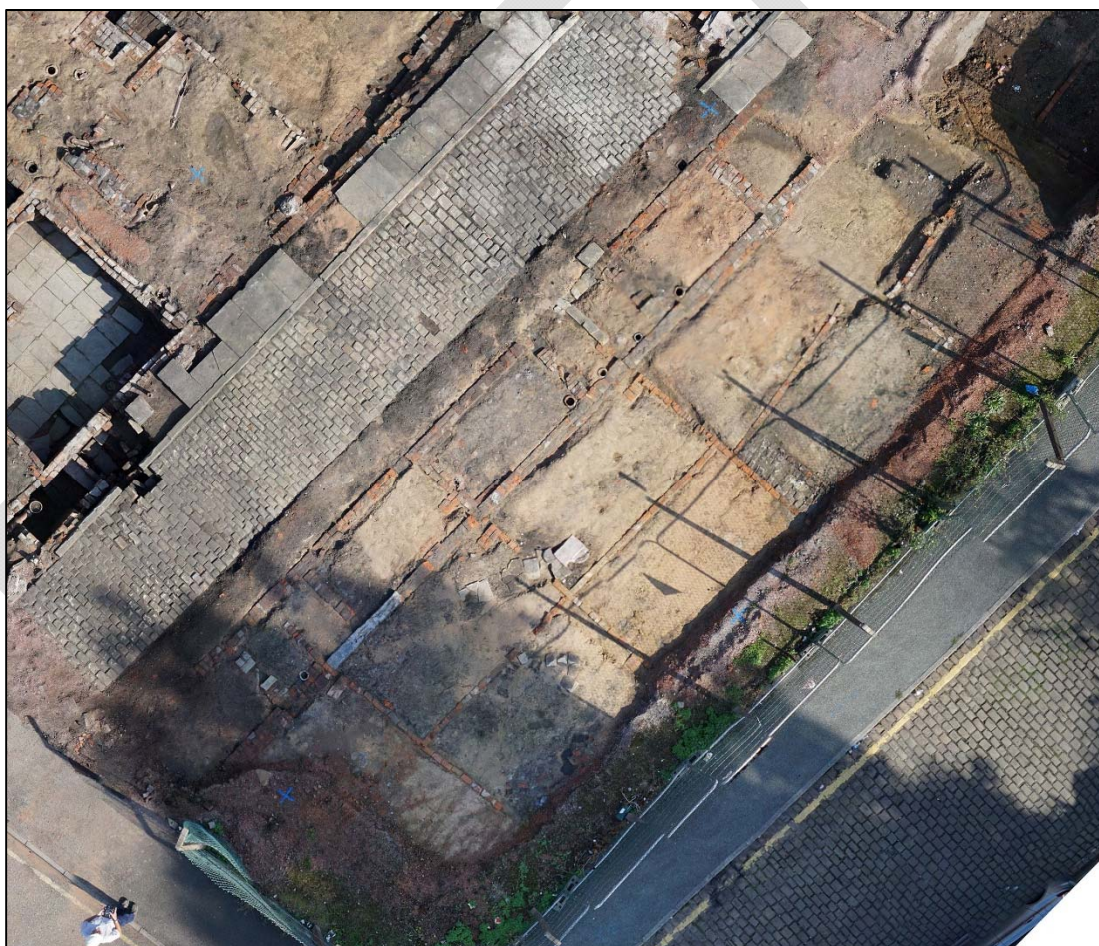
Plate 43: Aerial view of **R1-5**

fragmentary and no floor surfaces survived. In addition, only the area covering the complete ground-floor footprint of four of the dwellings (the western portions of **R2-5**) was present in the excavation area. These dwellings fronted Holden Street and two (in **R2** and **R3**) measured 3.7m square. The remains of fireplaces were also present on the north-eastern walls of these dwellings. It is likely that the adjacent dwellings fronting Ashley Lane were of comparable size and the remains of one side of a fireplace, again on the north-eastern wall, was present in the easterly **R3** dwelling. The back-to-backs to the north-east of these (in **R4** and **R5**) were more irregular in morphology, with those fronting Holden Street having trapezoidal plans. Both measured 3.7m across, but their depth ranged between 4.2m and 3.7m. It is likely, however, that these also had fireplaces on their north-eastern walls, particularly as one side of a fireplace was present on the north-eastern party wall of the **R4** back-to-back that would have fronted Ashley Lane. Within this dwelling, a 0.85m-wide brick base was also present, butting against its south-western party wall, which marked the position of a staircase leading to the first-floor of the property.

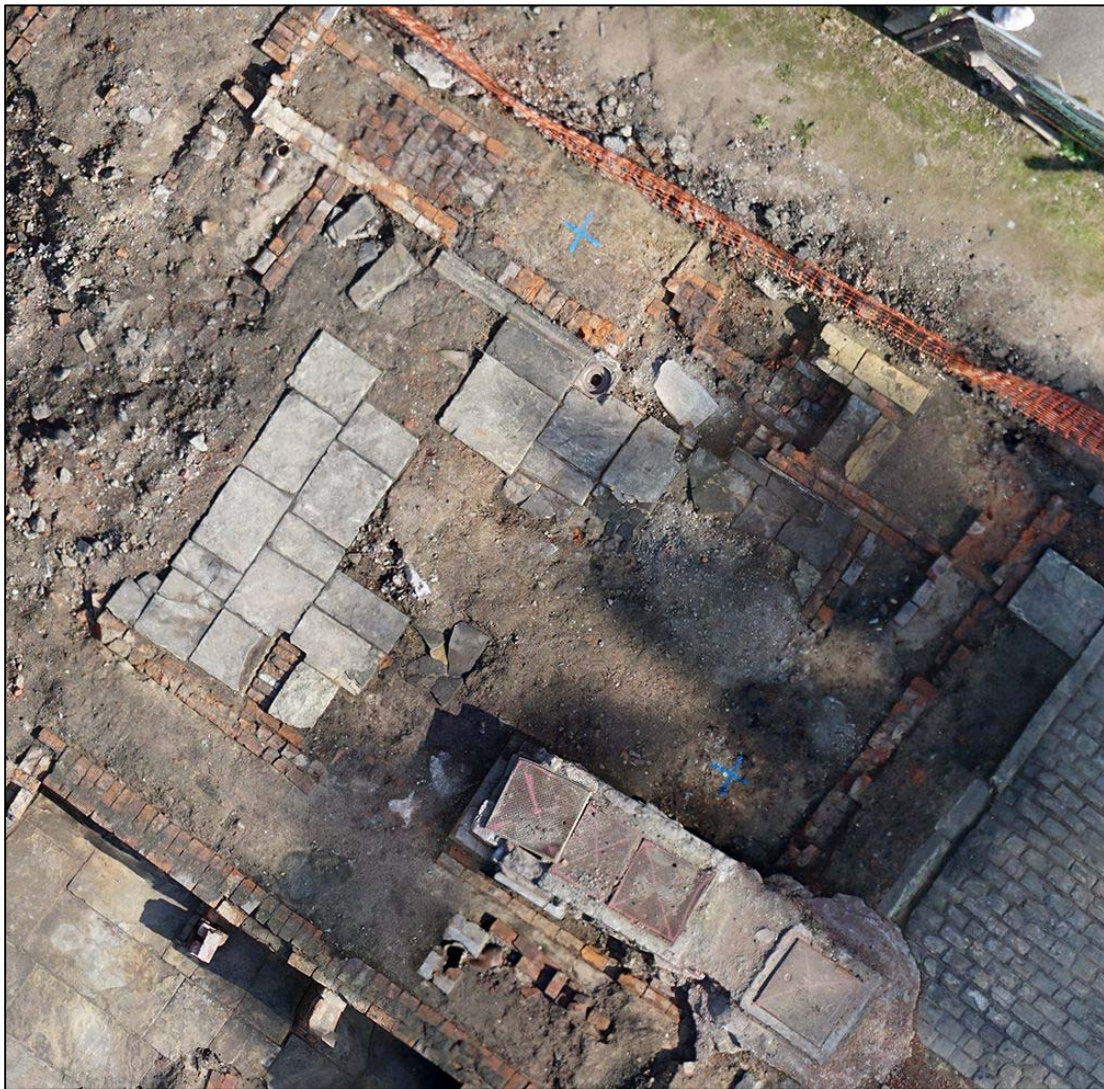
Plate 44: Aerial view of **R15**

cartographic evidence indicates originally had a covered passage on its northern side, that led to a courtyard area to its rear (*Section 3.3.3*). The remains of this building and the adjacent passageway were, however, fairly fragmentary due to later modifications (*Section 3.3.29*) and truncation (*Section 3.3.35*). Therefore, the surviving elements merely consisted of parts of the south-western and eastern external walls of a single-depth dwelling, which were double-skinned, being one-full-brick thick. The position of the passageway was denoted by later blocking walls (*Section 3.3.20*).

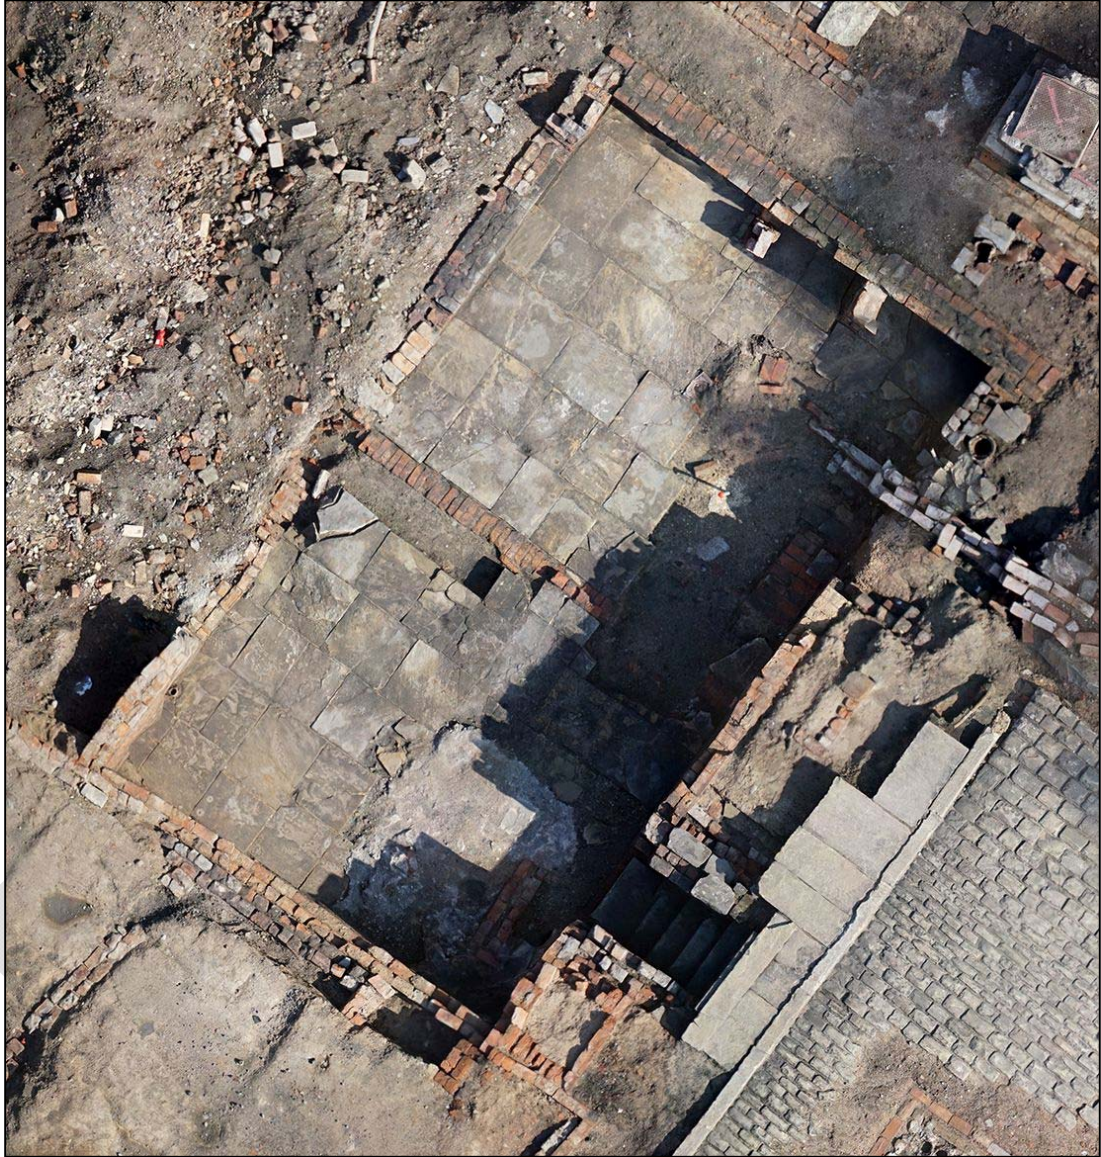
*Plate 45: Aerial view of C7 and C8*

3.3.19 To the south of **R15** were the cellars (**C7** and **C8**; Plate 45) of two adjoining blind-back properties. **C8** was the better preserved, in terms of the early nineteenth-century remains, and this measured 4.39 x 3.76m (Plate 46). The external walls, and also the party wall, were double-skinned and had been laid in an English Garden Wall bond, whilst its floor was composed of stone flags. Access into the cellar was via a flight of steps from Holden Street, though these had been remodelled during the late nineteenth century (*Section 3.3.32*). The original walls of the stairs did, however, survive, butting the building's eastern elevation, indicating that this entrance was c 1.5m wide. A brick-built, 0.8m-square, structure also stood on the Holden Street

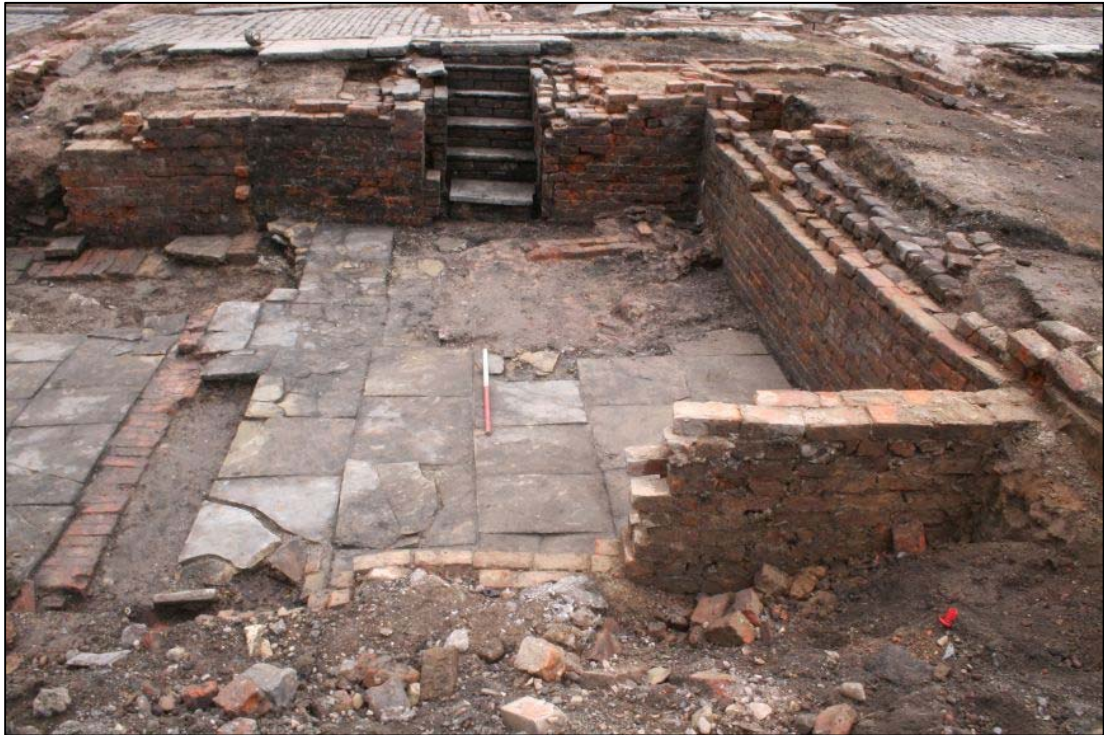
Plate 46: **C8**, looking south-east

frontage, close to the western corner of the cellar, which probably formed the base of stairs leading to the raised ground-floor of the building. Perhaps significantly, there was no clear evidence for a fireplace within the cellar. Indeed, the only internal remains comprised a short length of walling; this was adjacent to the cellar entrance and might have formed elements of the original cellar stairs.

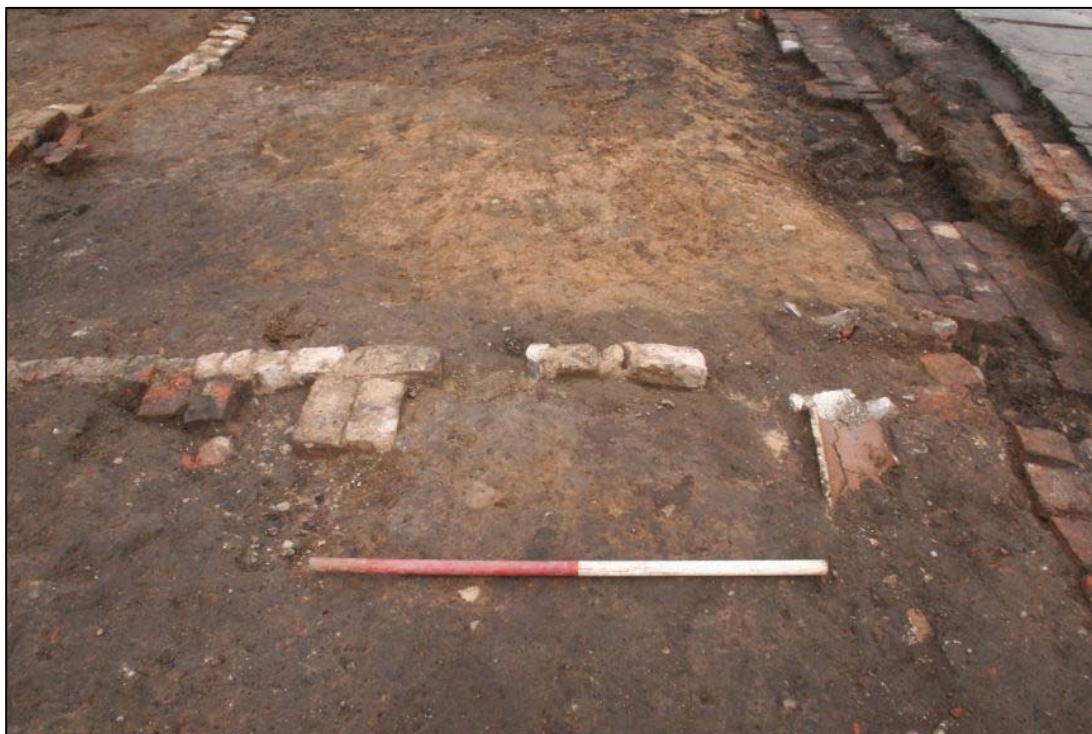
*Plate 47: Remains of a fireplace in **R14**, looking north-east*

- 3.3.21 To south-east of **C7** and **C8**, several Phase 3 walls were recorded, relating to three blind-back properties (defined by **R12-14**) depicted on historical mapping (*Section 3.3.3*). Again, these remains were piecemeal, as some had been subjected to later rebuilding (*Section 3.3.31*) and truncation, though those present did indicate that the buildings had an average width of 4m, with double-skinned external walls and single-skin party walls. No floor levels survived, and the only internal features present were a 0.78m-wide fireplace on the north-eastern party wall of **R14** (Plate 46), and a 0.83m-wide fireplace on the north-eastern wall of **R12**. Both of these were defined by projecting brick piers.

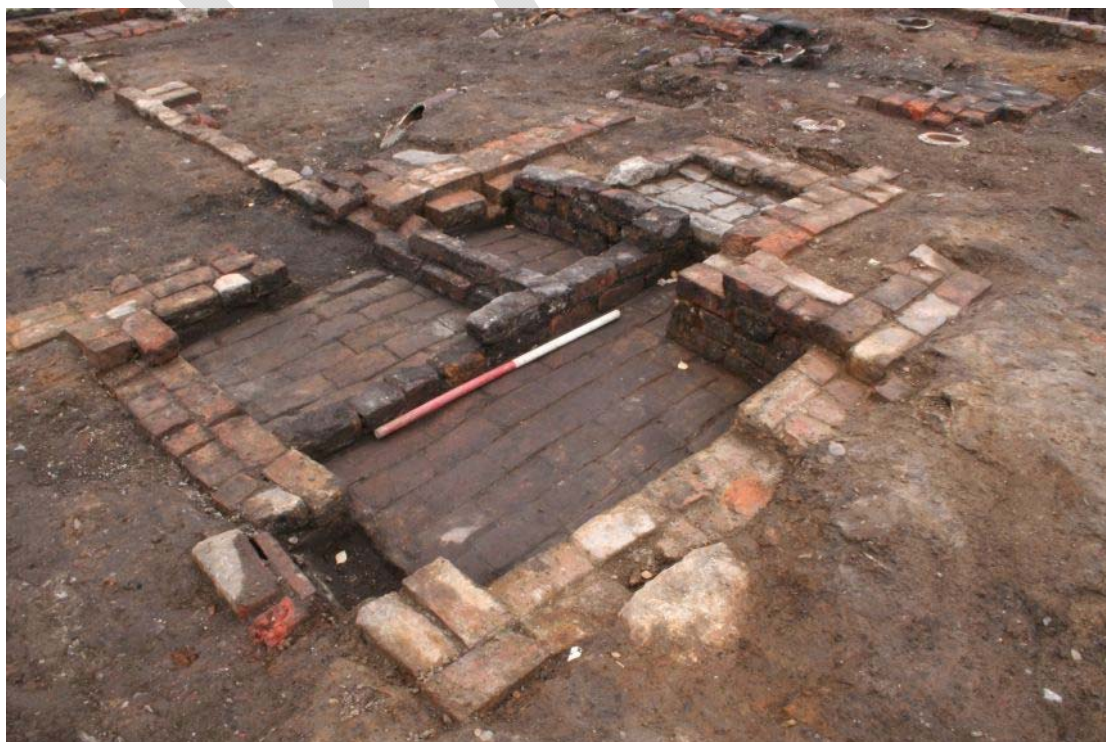
*Plate 48: Outshut **3004**, looking south-east*

3.3.22 The best-preserved, and most coherent, structure in this area was a brick-built outshut (**3004**), which was accessed from the blind-back defined by **R13** (Section 3.3.21). This structure had a T-shaped plan, covering an area measuring approximately 2.5m square, with a double-skin external wall and internal brick floor (Plate 48). At a later date, a wall had been inserted into its interior (Section 3.3.31).

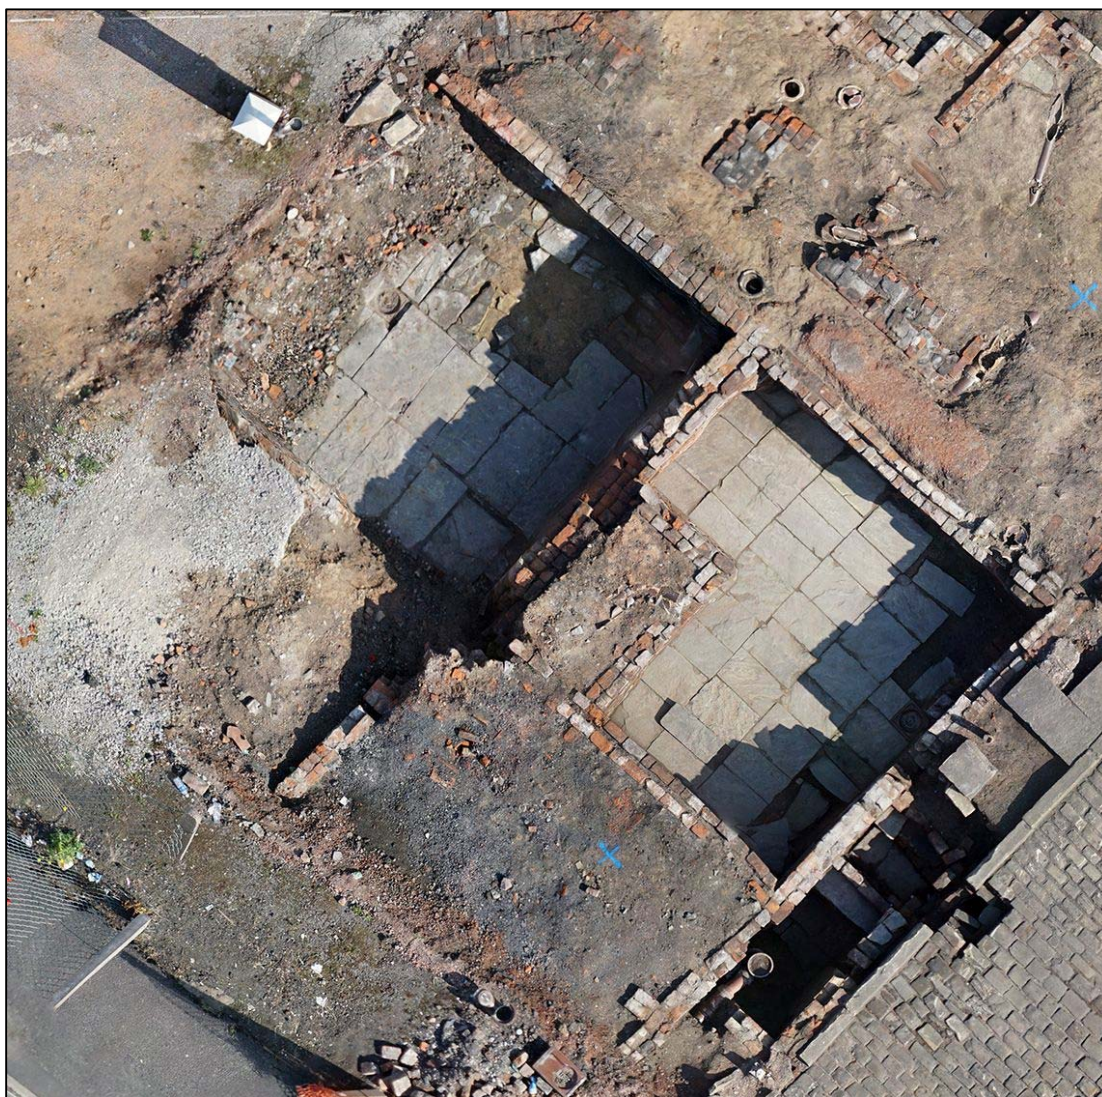
Plate 49: Aerial view of **C1-3**

3.3.23 The last early nineteenth-century building remains were to the south-west, on the western side of Holden Street. These comprised three cellars (**C1-3**), the backfill from two of which (**C1** and **C2**) was emptied in order to expose their floor levels (Plate 49). **C2** and **C3** were associated with two blind-back properties, one (containing **C2**) fronting Holden Street, the other (**C3**) Nelson Street, and their external walls were one-full brick thick, laid in an English Garden Wall bond, whilst the original party wall shared by these two dwellings was of single-skin construction.

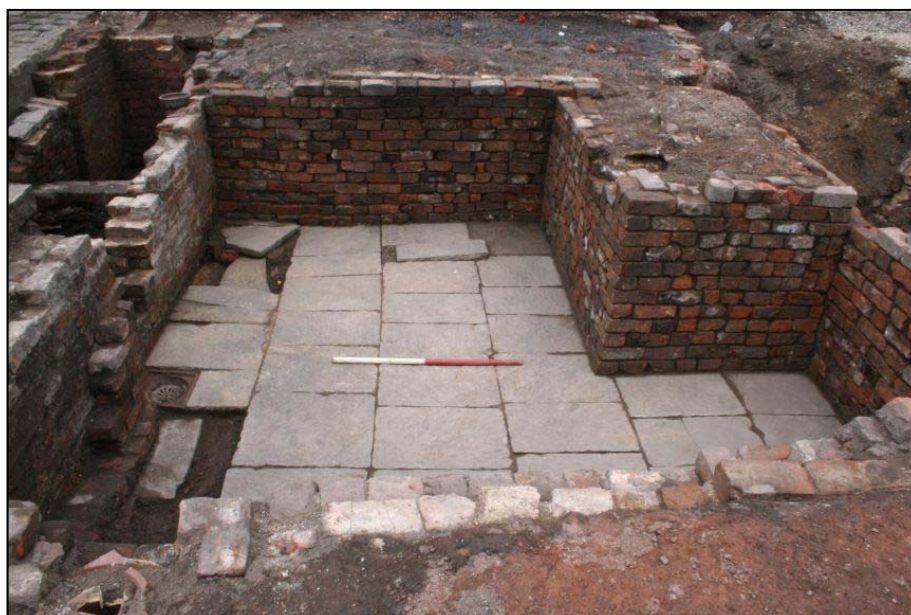
Plate 50: **C2**, looking south-west

3.3.24 The interior of **C2** was fully exposed, measuring 3.78 x 3.57m, which revealed its floor, composed of stone flags, which also contained a small ceramic drain positioned against its eastern wall (Plate 50); several later additions were also apparent (*Section 3.3.32*). Originally, access into this cellar was from Holden Street through a 1.1m-wide doorway (blocked at a later date; *Section 3.3.31*), connected to a stairwell. The partial remains of the side walls of this stairwell were apparent, though these had been disturbed by a later drain.
