# Plots 2, 3 and 5, Angel Meadow, Manchester: DRAFT 2 Archaeological Excavation Report

**Client: Orion Heritage Ltd**

OA Reference No: L11148

# Plots 2, 3 and 5, Angel Meadow, Manchester

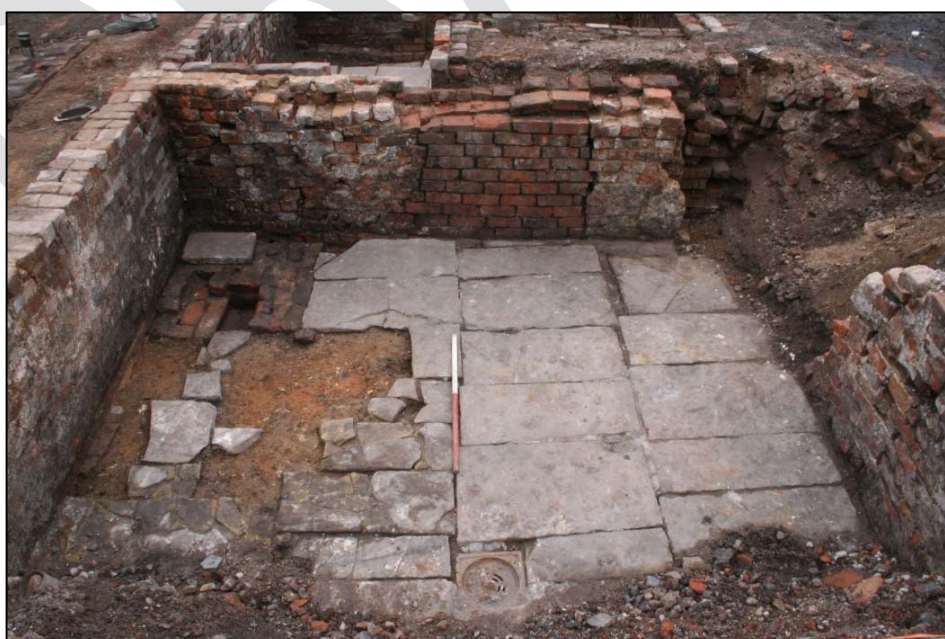
Plate 51: **C1**, looking south-east

3.3.25 **C1**, to the west of **C2**, was of similar size (3.9 x 3.55m) and construction, and contained a flagged floor (Plate 51). Set within this floor were also two ceramic drains, one on its eastern and other on its western side. In addition, an area of brick flooring in its north-eastern corner probably marks the position of a staircase, allowing access into it from the room above. The cartographic evidence indicates that this cellar and the room above formed an outshut for a large building, which, by at least the mid-nineteenth century, functioned as The Derby Arms public house (Section 3.3.4). Interestingly, though, access between this cellar and the adjacent cellar (**C2**; Section 3.2.24), beneath the blind-back dwelling, was possible through a c 1.1m-wide doorway, which was blocked at a later date (Section 3.3.32).

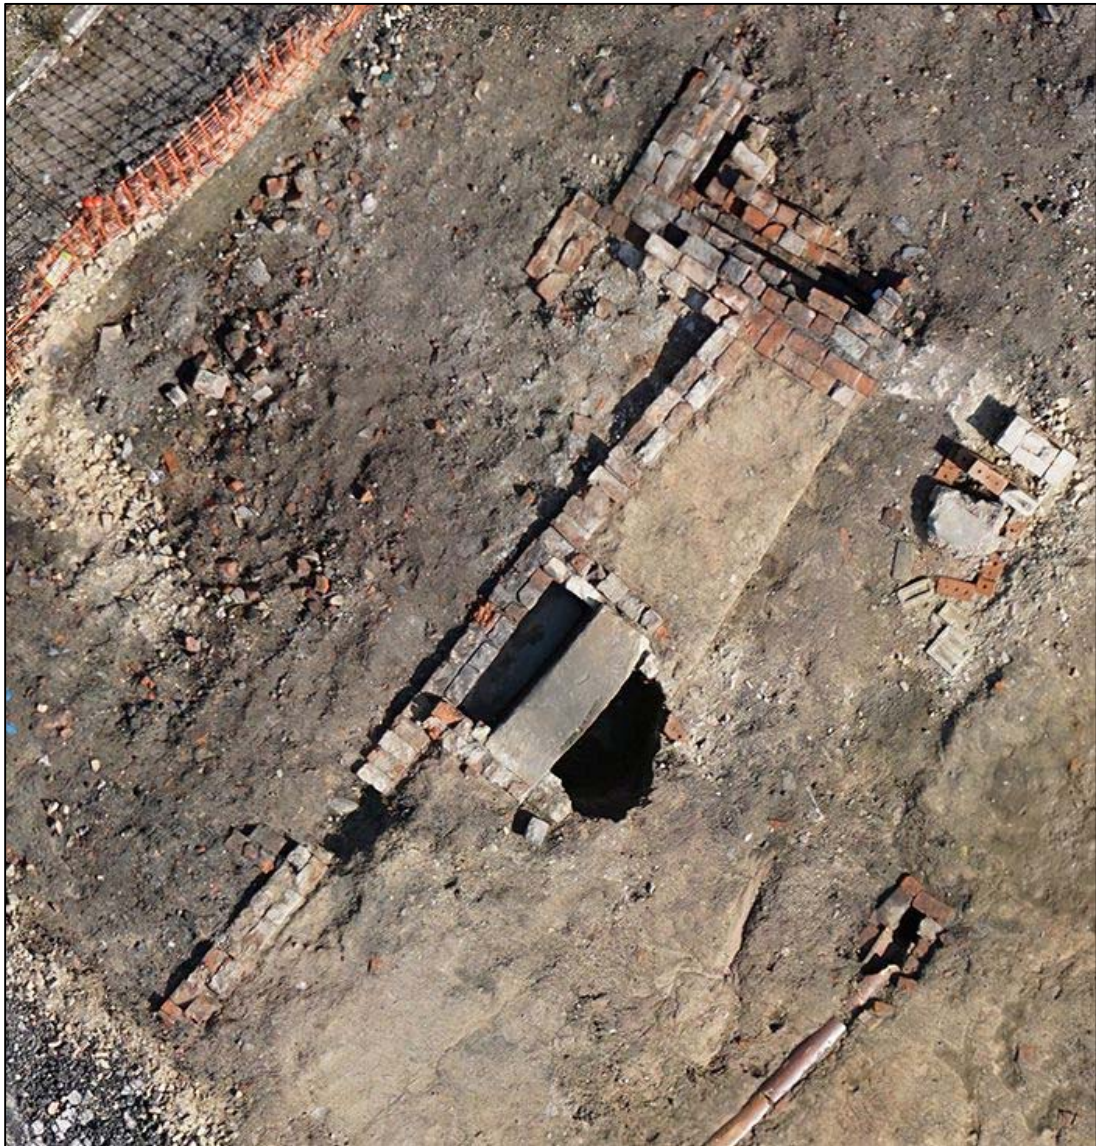
Plate 52: Aerial view of **R11**

3.3.26 *Buildings fronting New Blakeley Street*: some limited early nineteenth-century building remains were present on the eastern side of Plot 3, associated with two double-depth properties that fronted New Blakeley Street (*Section 3.3.3*). The remains comprised lengths of double-skin walling, and although these were fragmentary, they appear to relate to the rear portions of the double-depth buildings (defined as **R11**; Plate 52). They included elements of the rear external wall of the properties, and also a small part of the side wall of the more north-easterly of the dwellings, with evidence for a perpendicular projecting wall, probably forming one side of a fireplace/chimney stack. Another recognisable feature was a 1.1m-wide stairwell, providing access into the cellar that lay beneath the north-easternmost of the dwellings. The side walls of this were present, though it had been blocked up and sealed by a stone flag at a later date. The cartographic evidence suggests, however, that this may have occurred in the early-to mid-nineteenth century, and was perhaps related to the construction of a blind-back building immediately to the rear of the double-depth property (*Section 3.3.4*).

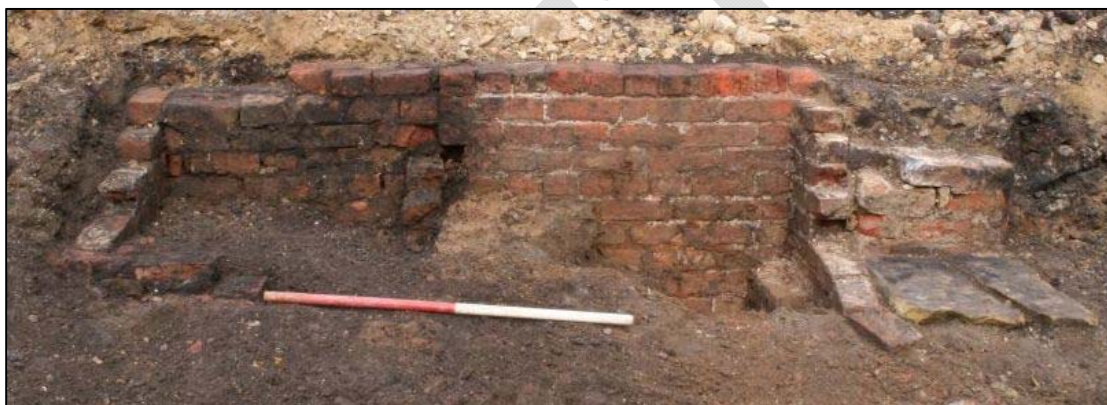
Plate 53: Blocked cellar light, **R10**, looking north-west

3.3.27 To the north-east of **R11** was another fragmentary group of remains, which formed elements of a large single-depth property (**R10**) and a double-depth dwelling (**R9**) fronting New Blakeley Street, forming an element of the C-shaped block of properties that surrounded the courtyard there (*Section 3.3.3*). This property began life as a back-to-back, but had been converted into a double-depth property at some stage between 1831 and 1848 (*Section 3.3.3*). The elements relating to the large single-depth property (**R10**) merely included portions of its double-skinned rear wall, and evidence for a cellar within the property was the presence of a 1m-square cellar light, that had been blocked at a later date (Plate 53). Slightly more remained of the adjacent property (**R9**), including its single-skinned side walls and its double-skinned rear wall. Together, these indicate that the building was 4.4m wide. It is also clear that this property was not cellared, as two *in-situ* flags were present next to its south-western side wall, forming elements of the ground-floor floor surface. These flags also lay next to a brick pier, forming one side of a fireplace.

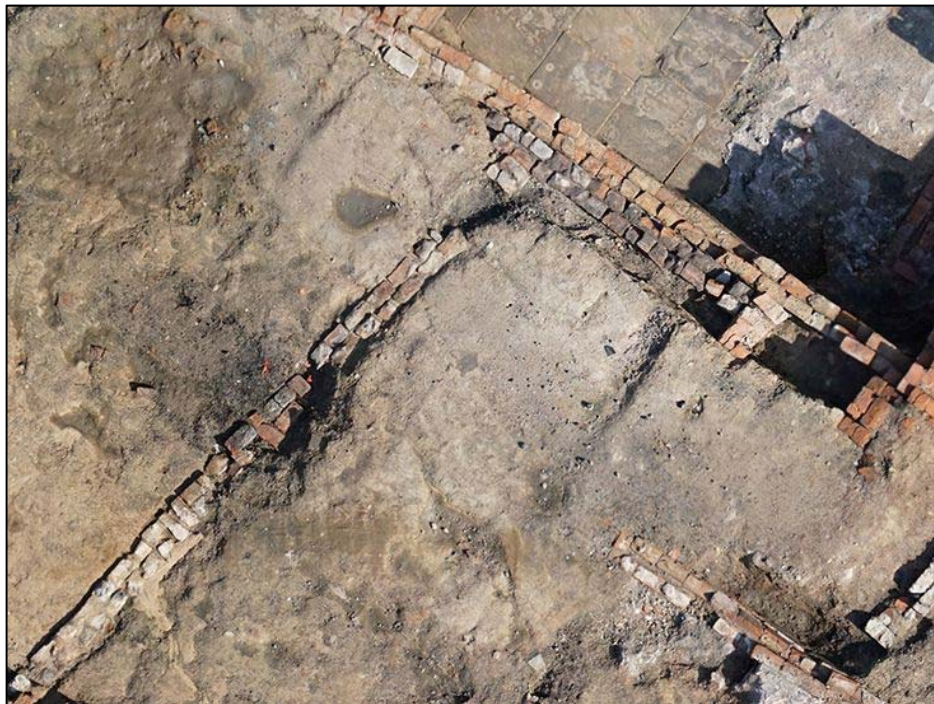
Plate 54: Aerial view of the rebuilt northern corner of **R12**

- 3.3.31 The only other Phase 4 modifications related to those buildings on the western side of Holden Street. One of these modifications involved the complete rebuilding of the northern corner of one of the blind-back dwellings (**R12**; *Section 3.3.21*). This entailed the construction of a right-angled double-skinned wall, which abutted the north-western side of the early nineteenth-century fireplace in this dwelling (Plate 54). The cartographic evidence (*Section 3.3.5*) indicates that this relates to the construction of a yard area to the rear of the property. At the far south-western end of the plot, it also appears that the street-front entrance into **C2** (*Section 3.2.24*) was blocked with a handmade brick wall bonded with a sandy mortar. Finally, within outshot **3004** (*Section 3.3.22*), walling was inserted to create a 0.86m-square compartment; it is possible that this was the remains of a privy.

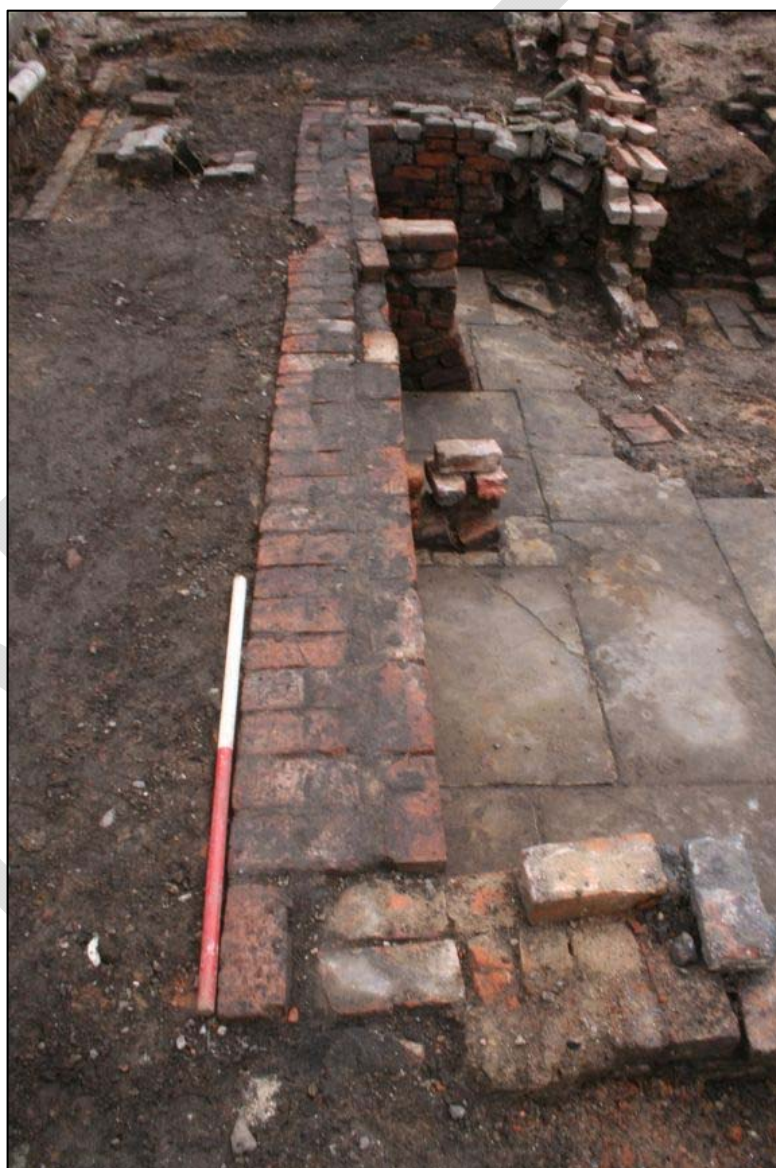
Plate 55: Rebuilt wall of **C7**, looking south-east

instance, in **C2** (Section 3.2.24), an entrance between this and adjacent **C1** (Section 3.3.25) was blocked and a rectangular structure was built in its western corner, which had double-skin walls. The structure measured 1.89 x 1.18m and was associated with a large ceramic pipe, suggesting that it related to the construction of a privy that lay at the rear of The Derby Arms public house. To the north-east, the northern corner of **C7** (Section 3.3.20), associated with a large single-depth property, was also completely rebuilt with a 'new' double-skinned wall, though this seems to have respected the position of an earlier fireplace (Plate 55). This scheme of rebuilding might also have involved the insertion of a 'new' stairwell and staircase (Plate 56), allowing access into **C8** (Section 3.3.19), associated with an adjoining property. This new stairwell measured 1.26 x 1.23m, and was of brick construction with stone steps.

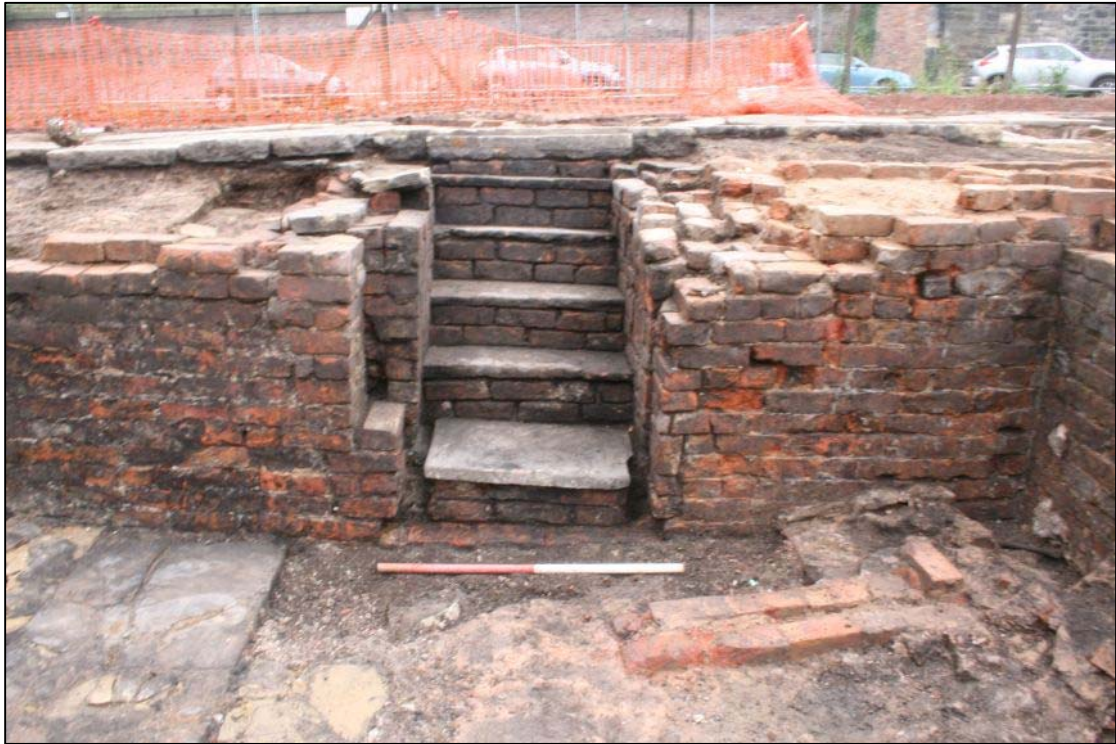
*Plate 56: Remodelled cellar steps, associated with **C8**, looking south-east*

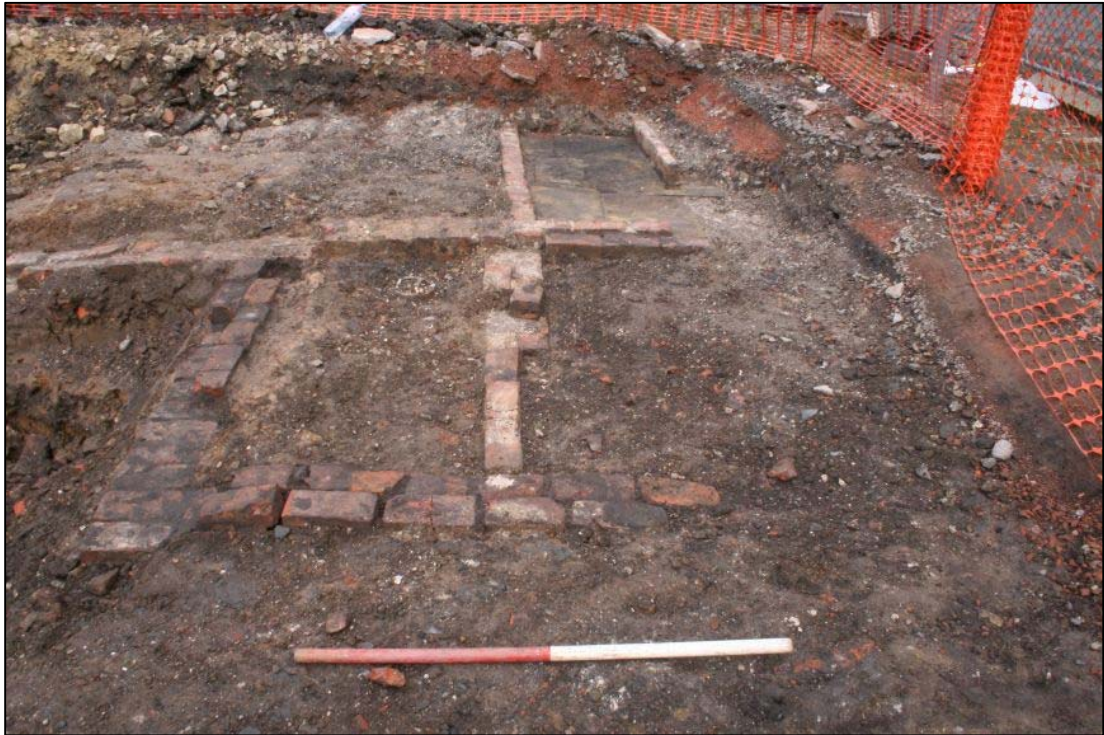
Plate 57: **P2**, looking north-west

3.3.33 The cartographic evidence (Section 3.3.6) indicates that several buildings were demolished to the south and north of **C7** and **C8**, to improve the natural light and ventilation. Demolition to the south resulted in the removal of a block of three blind-back buildings (**R12-14**; Section 3.3.21), which were subsequently replaced by a narrow building and a courtyard area. Several lengths of fragmentary Phase 5 walling in this area probably relate to these structures. The demolition to the north involved the removal of a blind-back on Little Nelson Street, which created an open area (**Y7**). It is evident from the archaeological remains in this area that part of this improvement entailed the construction of two privies (**P1** and **P2**), both of which contained *in-situ* soil pipes (and hence flush toilets). One (**P1**) measured 1m square and had been tagged onto the rear of the large single-depth building (**R15**) that had been remodelled in Phase 4 (Section 3.3.29), whilst the other (**P2**) had been attached to the rear of the double-depth property (**R9**; Section 3.3.27) fronting New Blakeley Street. This latter privy had double-skin walls and measured 1.5 x 0.75m (Plate 57).

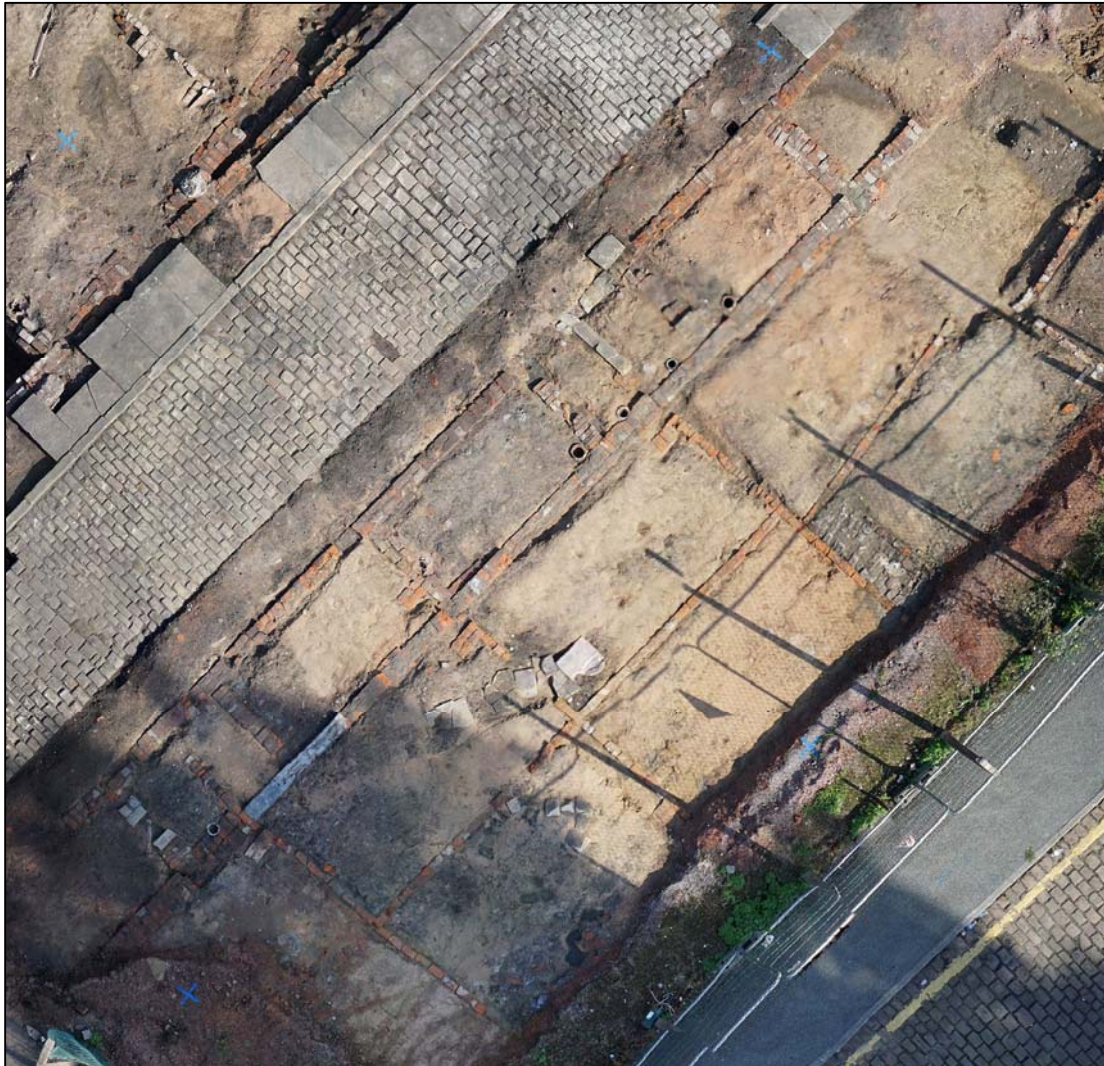
3.3.34 The most dramatic late nineteenth/early twentieth modifications occurred on the eastern side of Holden Street. The cartographic evidence indicates that the row of back-to-back properties in this area was knocked through, to create double-depth properties, and provided with small yards backing onto Holden Street. There was very clear archaeological evidence for this conversion, as it actually entailed the construction of a completely new rear wall for all of these properties. Significantly, this double-skinned wall did not respect the external wall of the earlier properties (as the historical mapping suggested; *Section 3.3.6*), but instead sliced through the back-to-back dwellings that fronted Holden Street, and hence created one-and-half-unit dwellings, with a single-depth room at the front and a smaller room to the rear. The small yard areas to the rear (**Y1-5**) did, however, respect the wall lines of the front portions of the earlier back-to-backs fronting Holden Street, and it is probable that the bases of the demolished early nineteenth-century walls acted as the footings for the yard walls (Plate 58). Several of these yards also contained ceramic up spouts, which would have carried rain and grey water from the remodelled properties.

*Plate 58: Aerial view of Y1-5, adjacent to Holden Street*

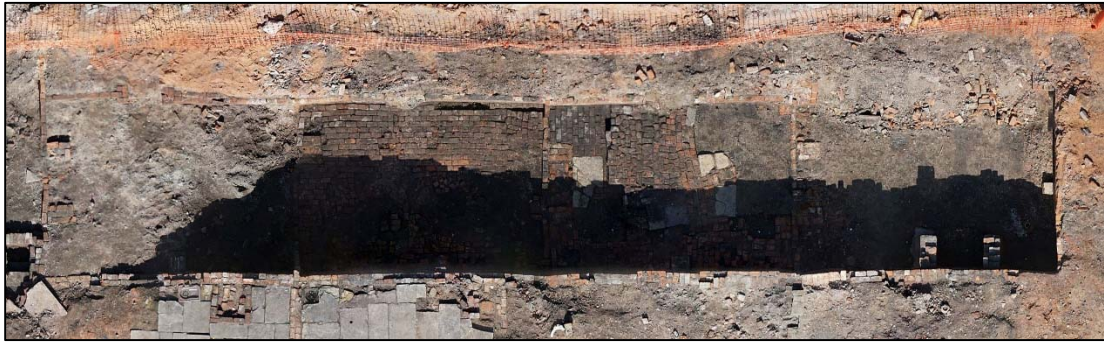
- 3.4.14 *Double-depth properties at north-eastern end of Old Mount Street:* the larger of the late eighteenth-century properties in the range were positioned at the north-eastern end of Plot 5, the remains of four of these lay within the excavation area, and indicated that they were cellared (**C8-11**; Plate 65). Although all of these had been subjected to later rebuilds and modifications (in Phases 4 and 5), and one of the cellars (**C8**) was not completely emptied for reasons of access, the basic form and construction of the late eighteenth-century constructions could be determined (Plate 66). It is apparent, for instance, that these buildings had a double-skin external wall (*ie* the wall that defined the rear of the buildings), whilst the north-east/south-west party walls were single-skin constructions.

Plate 65: Aerial view of **C8-11** (from left to right)

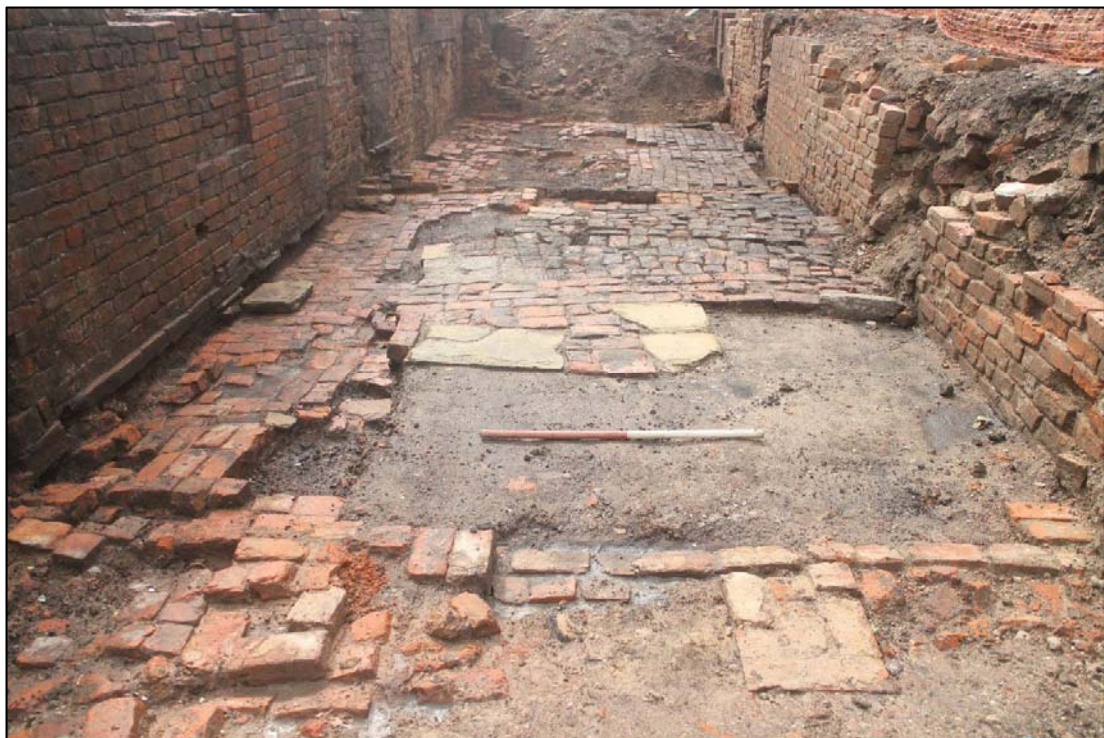
Plate 66: **C8-11**, with the fireplace for **C11** in the foreground, looking south-west

3.4.15 Internally, each of the cellars had a fireplace/chimney stack on their south-western party walls, each c 1m wide. The remains of *in-situ* flooring survived in two of the cellars (**C9** and **C10**), which in one (**C9**) consisted solely of handmade brick (Plate 67), whilst the other was composed of handmade brick, interspersed with stone flags. All of the cellars also had some evidence of a dividing wall on their western side, which corresponded to the position of the internal wall that would have originally defined the rear room of the double-depth properties. These rooms and the cellars beneath were all similar in size, at c 3.8 x 5.4m. It was apparent, however, that in **C8**, **C9**, and **C11**, these walls either never originally extended across the complete width of the cellar (suggesting the presence of one large cellar beneath the entire building footprint; the outer wall being beyond the area excavated) or had been removed/modified at a later date. An original wall spanning the width of the cellar was, however, present in **C10**, which had a c 1m-wide doorway, allowing access into the cellared area at the front of the property. Therefore, in this instance, it is evident that this property, at least, had two defined cellars beneath its footprint.

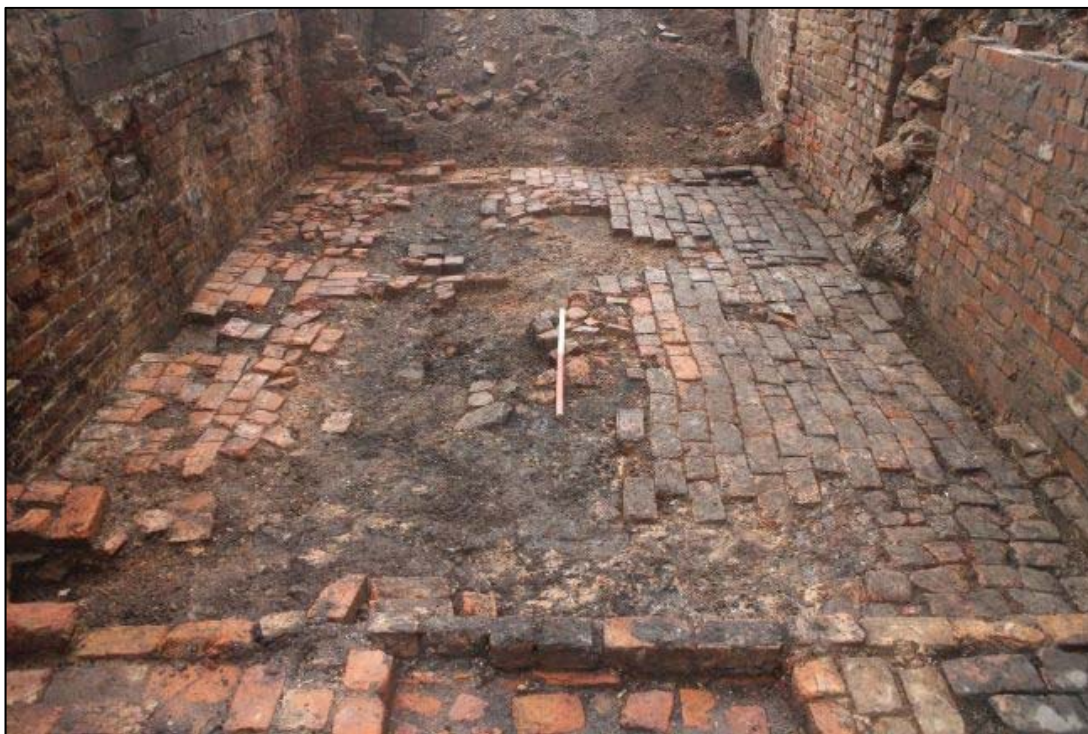
*Plate 67: Handmade brick floor in **C9**, looking south-west*

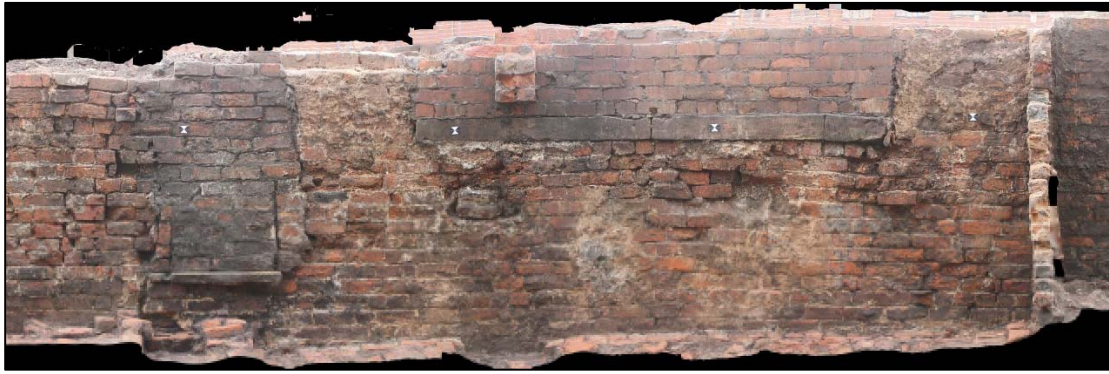
3.4.16 The eastern exterior walls of **C10** and **C11** had been substantially rebuilt at a later date (*Section 3.4.33*); however, some original late eighteenth-century features associated with this wall line were apparent in **C8** and **C9**. These included a stepped entrance leading up from a doorway, positioned at the north-eastern corner of the respective cellars, which in both instances was c 0.8m wide. The south-eastern side walls of both of these steps were similarly defined by c 0.85m-square ‘piers’ protruding from the rear walls of each of the cellars. Green’s map of 1787-94 indicates that originally these stepped entrances would have exited into outshuts to the rear of the properties containing **C8** and **C9**, though these had been demolished by the time of Bancks & Co’s survey of 1831 (*Section 3.4.2*), and access into the cellars would then have then been directly from yard areas to the rear. It was also evident that each of these cellars had a light on the eastern wall, which originally flanked the south-eastern side of the late eighteenth-century outshuts, prior to their demolition. These ‘windows’ were surprisingly large, at c 2.8m wide, and indicate that the cellars were fairly well lit and ventilated. The cellar light in **C9** was completely exposed, and this also suggested that these were fairly well-made features that had been provided with a stone sill (Plate 68; Fig 9).

Plate 68: North-west-facing elevation of **C9**, with the surviving Phase 1 cellar light and door (both later blocked)

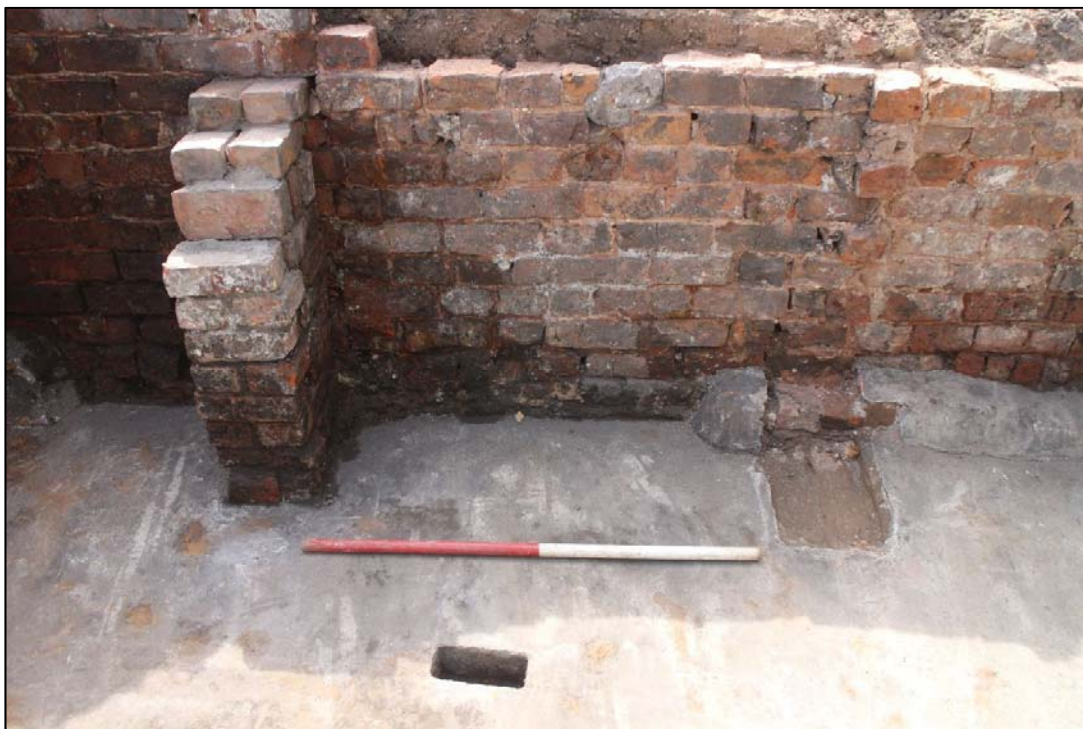
- 3.4.19 Seven cellars (**C1-7**) associated with the rear portions of these properties were either fully or partially excavated. Although these had invariably been subjected to later phases of modification, they were largely similar in terms of construction and design. Hence, the exterior wall, which also defined the rear wall of the properties, was double-skinned, whilst the party walls were single-skinned. Most of the cellars also had evidence for a fireplace/chimney stack on their south-western party wall, defined by projecting brick piers (Plate 69). Where both piers survived, these indicated that these structures were c 0.9m wide.

*Plate 69: Remains of the fireplace in C1, looking south-west*

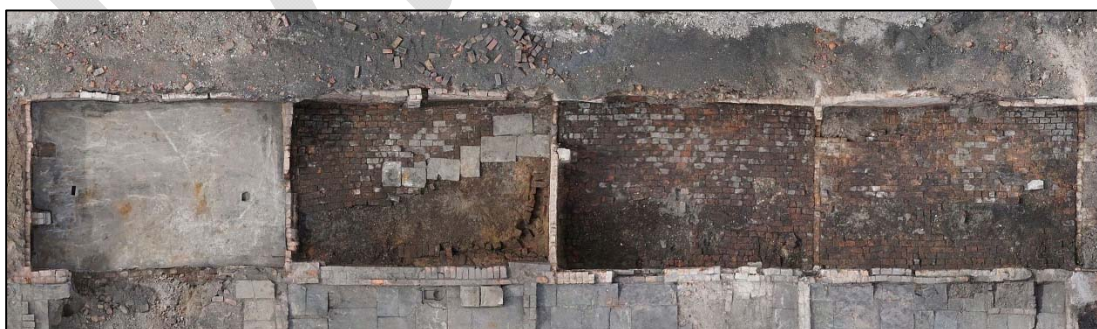
3.4.20 The original brick floor was present in three of the cellars (**C2-4**) and in one of these (**C2**), this was interspersed with stone flags (Plate 70). A curving brick-lined drain was exposed beneath the floor of this cellar, again an original feature that was probably designed to drain water to keep the cellar comparatively dry (Plate 71). Most of the cellars could be accessed through a doorway at their north-eastern corner, via a flight of steps that led from the yard areas at the rear of the properties; one of the stairways (in **C6**) was fully exposed, and comprised six stone treads supported by brick walling. In contrast, **C1** did not possess this arrangement, but instead, access into this cellar was originally possible from **C2**, in the adjacent property to the north-east, through a doorway in the party wall, and also from the cellar that was beneath the front room of the property, beyond the excavation area.

*Plate 70: Aerial view of C1-4 (left to right)*

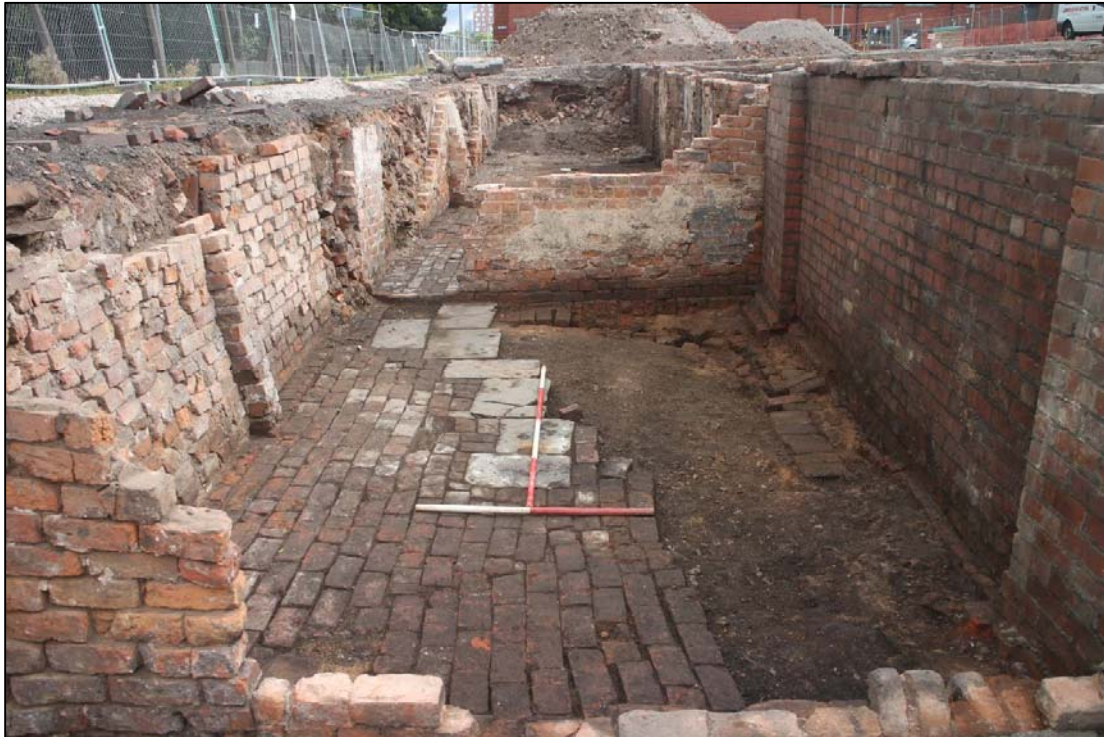
Plate 71: **C2** and its brick-lined drain, looking north-east

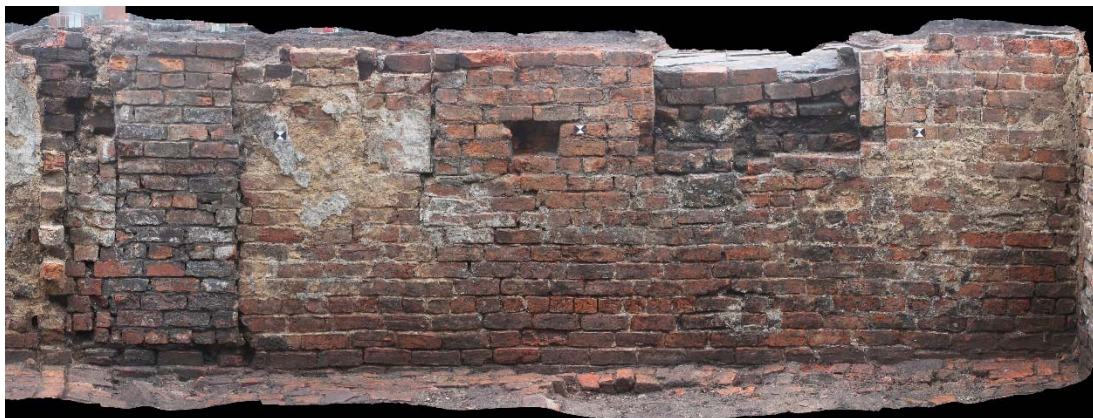
3.4.21 One of the cellars (**C3**) also had a cellar light on its eastern external wall, which was 1m across (Plate 72; Fig 9). It is also quite possible that two of the other cellars had light wells, though these had been modified by later activity; for instance, a protruding section on the outer face of the external wall of **C5** could denote the presence of one such a structure, whilst an original light well in **C4** may have been replaced in the early nineteenth century (Section 3.4.27).

Plate 72: The north-west-facing elevation of **C3**, with the surviving Phase 1 cellar light and door (later blocked)

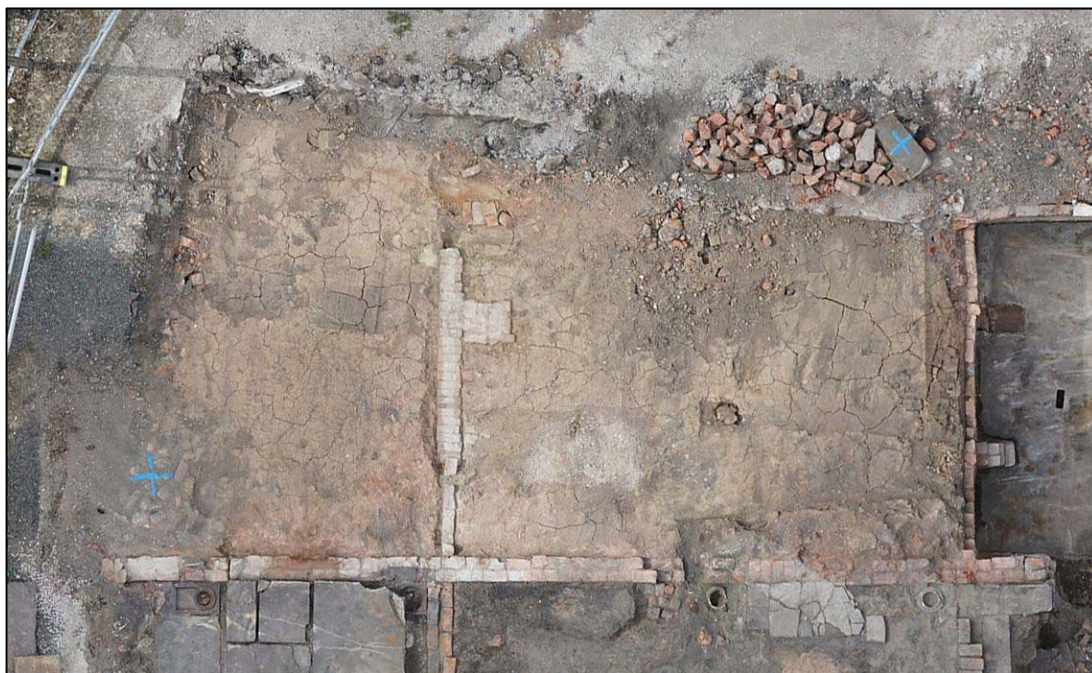
3.4.23 At the far south-eastern end of Plot 5, two of the Old Mount Street properties were not cellared. The remains associated with these (**R6** and **R7**) were double-skin walling defining the eastern external wall of the two properties and also a double-skin dividing wall (Plate 73). However, the party wall between the more north-easternmost of these properties, **R7**, and the adjoining cellared property (containing **C1**; *Section 3.4.19*) was of single-skin construction. The remains of a 0.5m-wide fireplace was also positioned on the south-western party wall of **R7**, mirroring the arrangement seen in all of the other excavated late eighteenth-century properties in Plot 5.

Plate 73: Aerial view of **R6** and **R7**

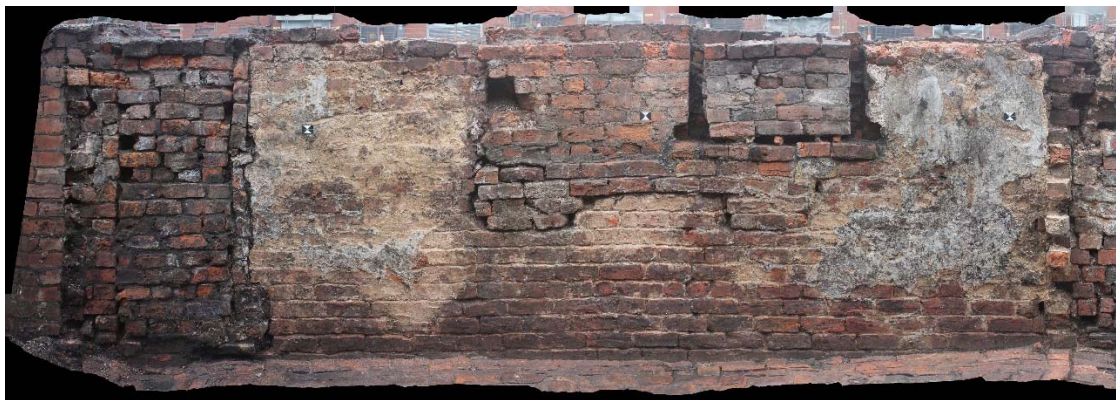
Plate 74: The north-west-facing elevation of **C4**, showing the Phase 1 wall and door, and the Phase 3 cellar light (later blocked)

3.4.27 Other lengths of walling that probably date to this period were present in four of the cellars (**C1**, **C2**, **C4**, and **C5**) associated with the late eighteenth-century double-depth properties fronting Old Mount Street (*Section 3.4.19*). In **C1**, **C2**, and **C5**, these were additions to the north-eastern internal walls of the cellars, which appear to have been designed to divide the rear and front portions in the respective properties (on the edge of the excavated area). This indicates that, during this period, these cellars were partitioned, which might suggest that each was divided into two separate dwellings. Access between these potential dwellings was, however, possible through c 1m-wide doorways on these newly created dividing walls, though one of these doorways (in **C2**) appears to have been blocked shortly after its creation, with an early nineteenth-century blocking wall. In contrast, the Phase 3 walling in **C4** related to the partial rebuilding of its external south-eastern wall, which also involved creating a 0.9m-wide cellar light (Plate 74). It is possible that this light replaced an earlier light well that had collapsed, particularly as a Phase 1 cellar light existed in an adjacent cellar (**C3**; *Section 3.4.21*). It is also likely that a 'new' handmade brick floor was also laid in **C10** (*Section 3.4.15*) during the early nineteenth century, which sealed the late eighteenth-century floor (Plate 75).

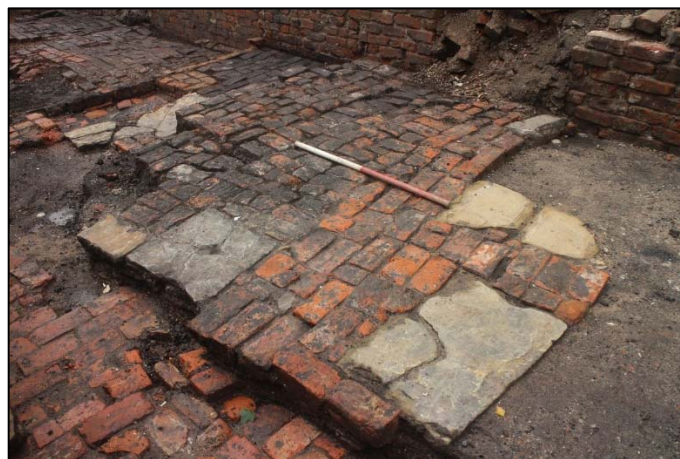
Plate 75: Phase 3 floor in **C10**, looking north-west

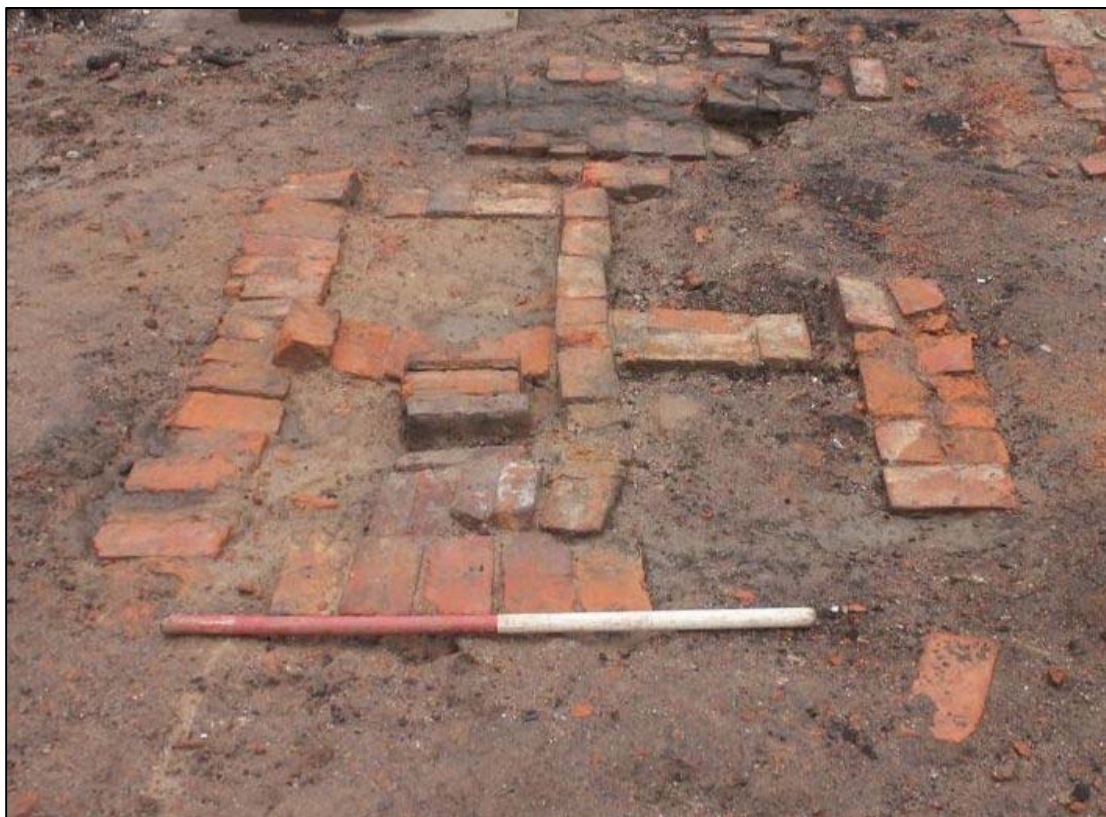
3.4.28 Another Phase 3 structure was an early privy in **Y15**, to the rear of one of the double-depth houses fronting Old Mount Street, the position of which was plotted on Bancks

& Co's map of 1831. This measured 1.9m square and had a one full-brick thick external wall. Internally, it was divided onto four separate compartments (Plate 76).

Plate 76: Early privy in Y15, looking south-west

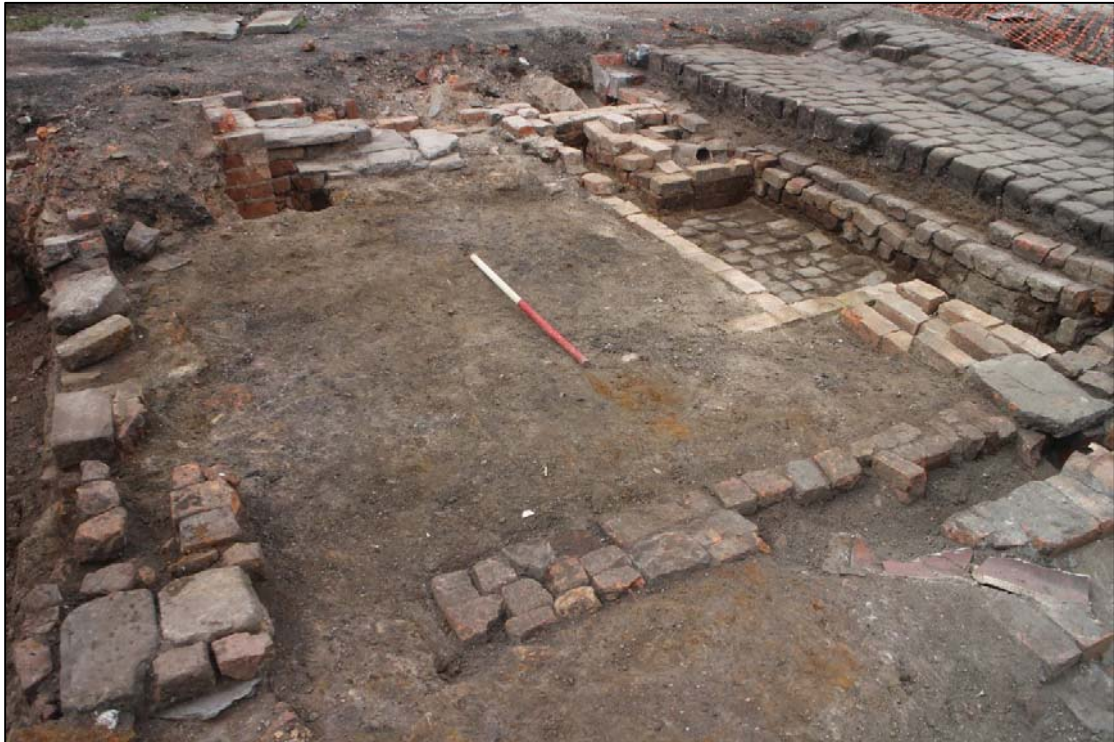
3.4.29 **Phase 3B (mid-nineteenth century)**: it has been possible through a detailed consideration of the historical map sequence to date some of the handmade brick structural remains in Plot 5 to the mid-nineteenth century. At the south-western end of the plot, these define the footprint of a small building (**R1**) that is first depicted on the OS map of 1850 (*Section 3.4.4*), and stood on the eastern side of Back Old Mount Street. Its northern side was formed by a length of double-skinned Phase 3 walling that was originally an element of a walled yard/compound (*Section 3.4.26*), whilst its remaining Phase 3B walls, which defined its eastern, western, and southern sides, were also double-skinned. Together these created a rectangular building that measured 3.5 x 4m, which could be entered through a 0.9m-wide doorway at its north-eastern corner, with a flagged threshold (Plate 77). Adjacent to this doorway were patches of brick flooring, which might originally have extended across the entire interior of the structure. The interior also contained a brick-built partition, parallel with the north-western wall of the building, which was 1.25m wide. Inside the partition was a sunken brick floor and a brick-built drain. The function of this building is slightly perplexing, though the available evidence seems to suggest that it did not form a domestic dwelling.

Plate 77: **R1**, looking west

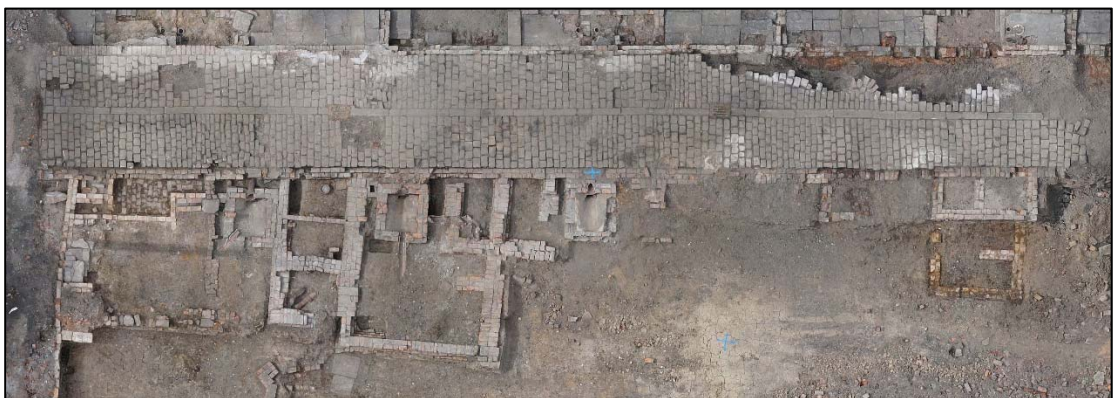
3.4.30 The eastern wall of the **R1** building was tied into a wall that extended along the southern side of Back Old Mount Street for a distance of 23m. Significantly, the surface of this street (**5005**) survived (Plate 78) between this wall and a Phase 1 wall on the opposite side of the street that formed the yard wall for the double-depth properties fronting Old Mount Street (Section 3.4.24). However, as the surface appeared to be contemporary with the Phase 3B wall, this suggests that it was laid in the mid-nineteenth century (though portions would have been lifted and replaced at later dates to insert drains; see Section 3.4.39). The street was 2.7m wide and was composed of stone setts, set on a bed of clinker, and sand and gravel. A drain capped with sandstone slabs also ran down its centre line, which was associated with two cast-iron drain covers. A similar surface was present at the far north-eastern end of the plot, forming another surviving section of Back Old Mount Street.

Plate 78: Aerial view of Back Old Mount Street, with **R1** on the far left-hand side

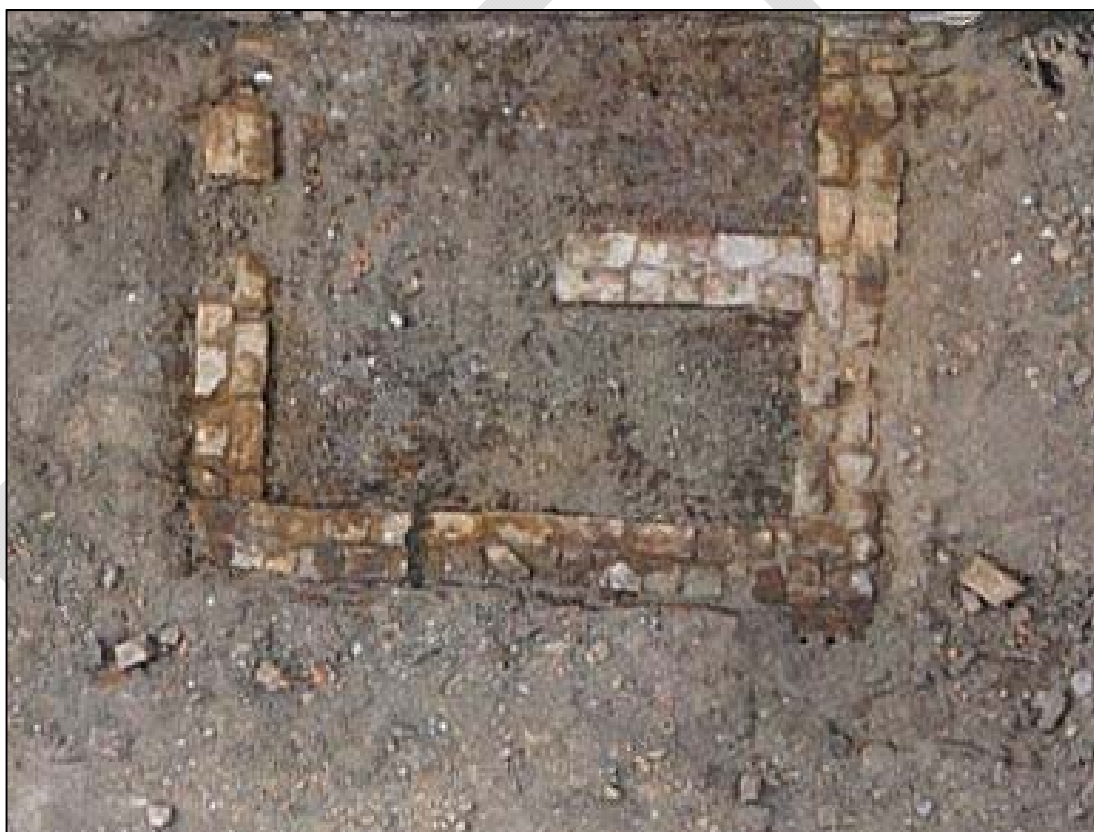
- 3.4.32 To the east of this wall was another Phase 3B structure (**5007**), which is depicted on the OS map of 1850. Although its northern side had been destroyed by a later structure (*Section 3.4.36*), it measured 2.3m wide and had walls that were one-full brick thick (Plate 79). It also had a short internal dividing wall, which created two compartments. The form of the structure indicates that it was an early privy to the rear of the large property fronting Nicholas Street.

Plate 79: Aerial view of structure **5007**

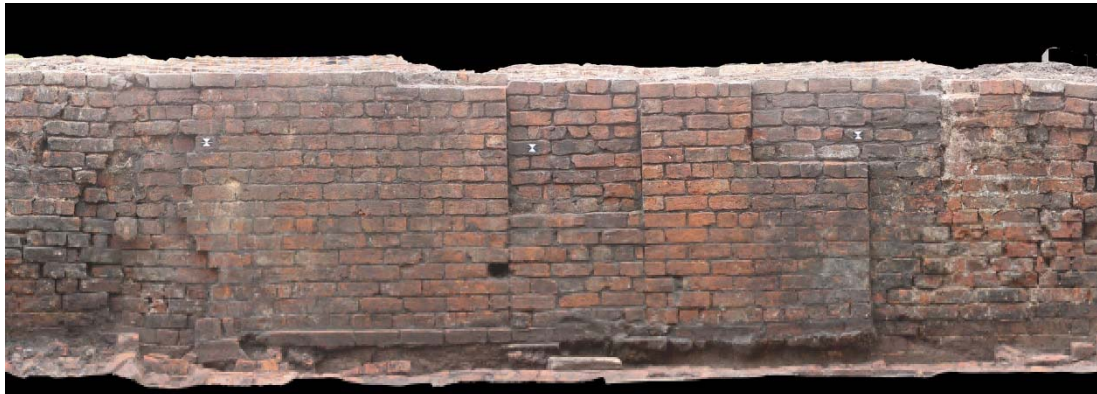
*Plate 80: The north-west-facing elevation of **C10**, showing the rebuilt Phase 4 wall, with cellar light and doorway (later blocked)*
