# Plots 2, 3 and 5, Angel Meadow, Manchester: DRAFT 2 Archaeological Excavation Report

**Client: Orion Heritage Ltd**

OA Reference No: L11148

# Plots 2, 3 and 5, Angel Meadow, Manchester

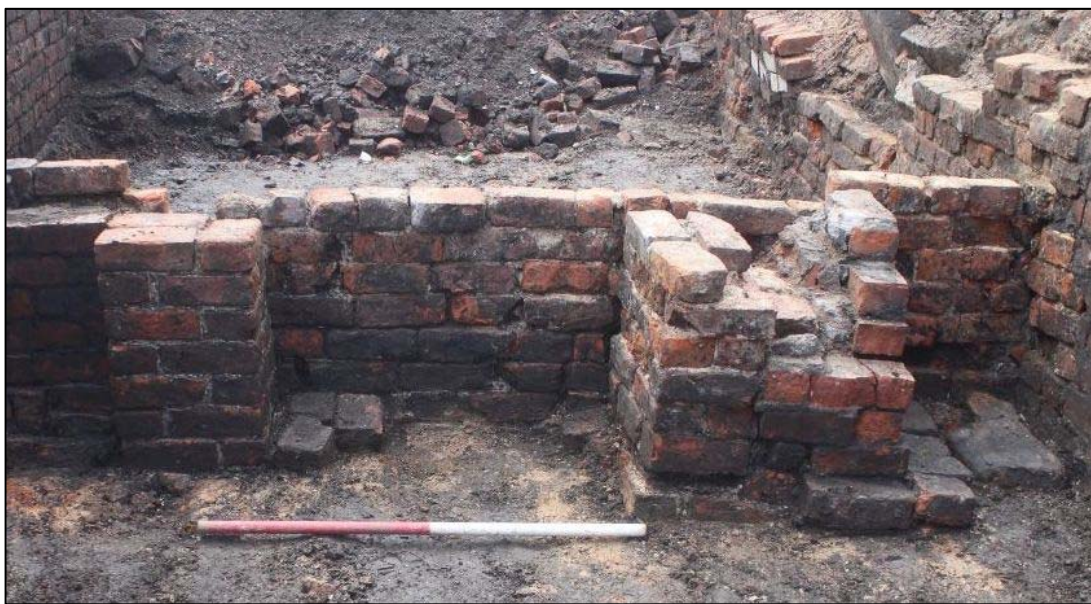
*Plate 81: Remains of the fireplace and pot-boiler (right-hand side) in **C6**, looking south-west*

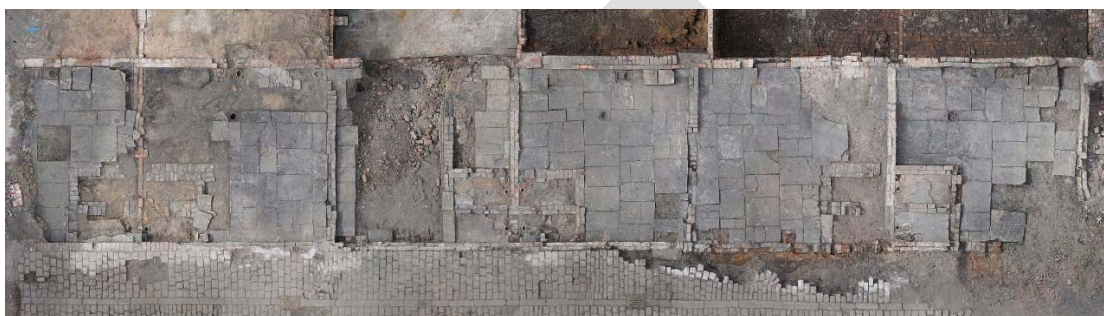
*Plate 82: Aerial view of Y4-9, with Phase 4 paving and privy blocks*

- 3.4.35 The OS maps of 1891 and 1893 indicate that each property by then also had a privy at the rear of the yard, and the remains of these survived in **Y4-9** (Plate 82) and **Y13-16**. They were all comparable in form and had a 'butterfly' arrangement, whereby two rectangular privies were positioned on one side of a yard wall, with the arrangement being mirrored on the opposite side. Each individual privy measured c 0.8 x 1.5m, was of double-skin construction, and associated with a soil pipe, indicating that they were flush toilets, provided with a water supply; one in **Y9** also had the remains of a flagged floor in its interior (Plate 83).

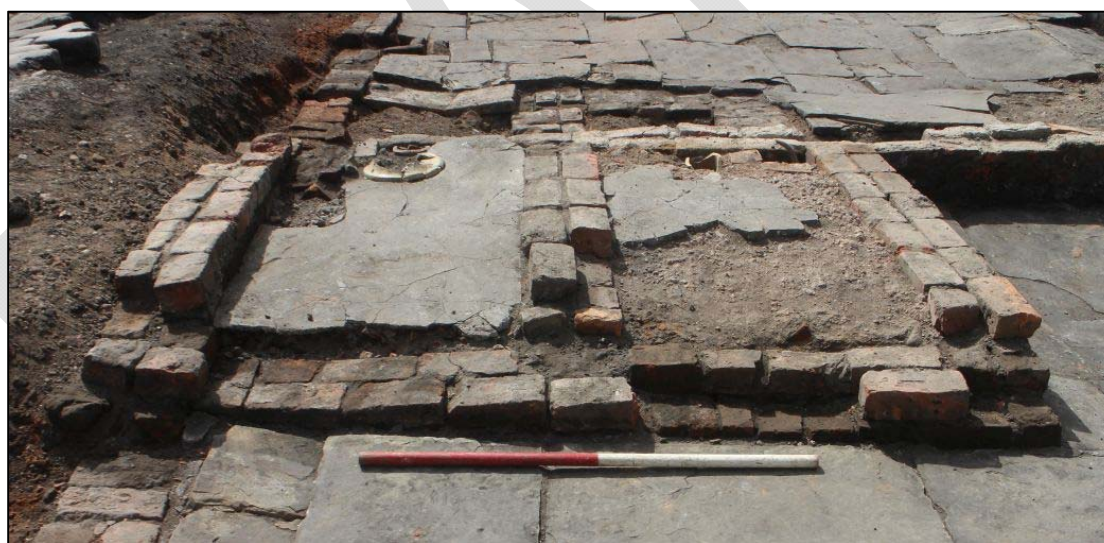
*Plate 83: Privy in Y9, looking south-west*

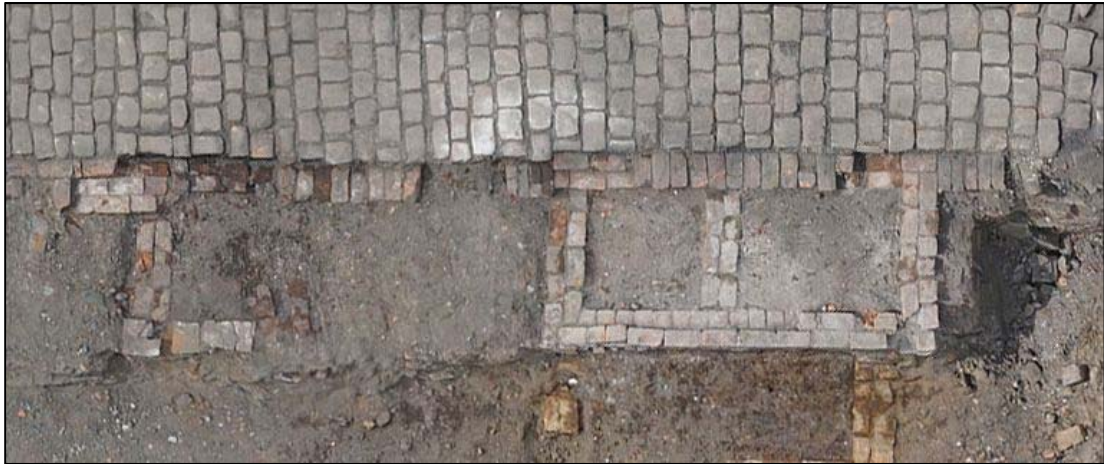
Plate 84: Aerial view of 5004/5006

- 3.4.36 Two Phase 4 privy blocks were also present on the eastern side of Back Old Mount Street. Both were narrow rectangular structures, with double-skin walls, and one (**5004/5006**) measured 5.2 x 1.3m (Plate 84); the large-scale OS map of 1891 indicates that originally it contained five separate privies, two of which (**5006**) survived. The other privy block (spanning the later buildings defined by **R4** and **R5**; *Section 3.4.37*) was c 9m long and had a brick floor (Plate 85). Although no compartments survived within, the map evidence indicates that originally this was associated with three

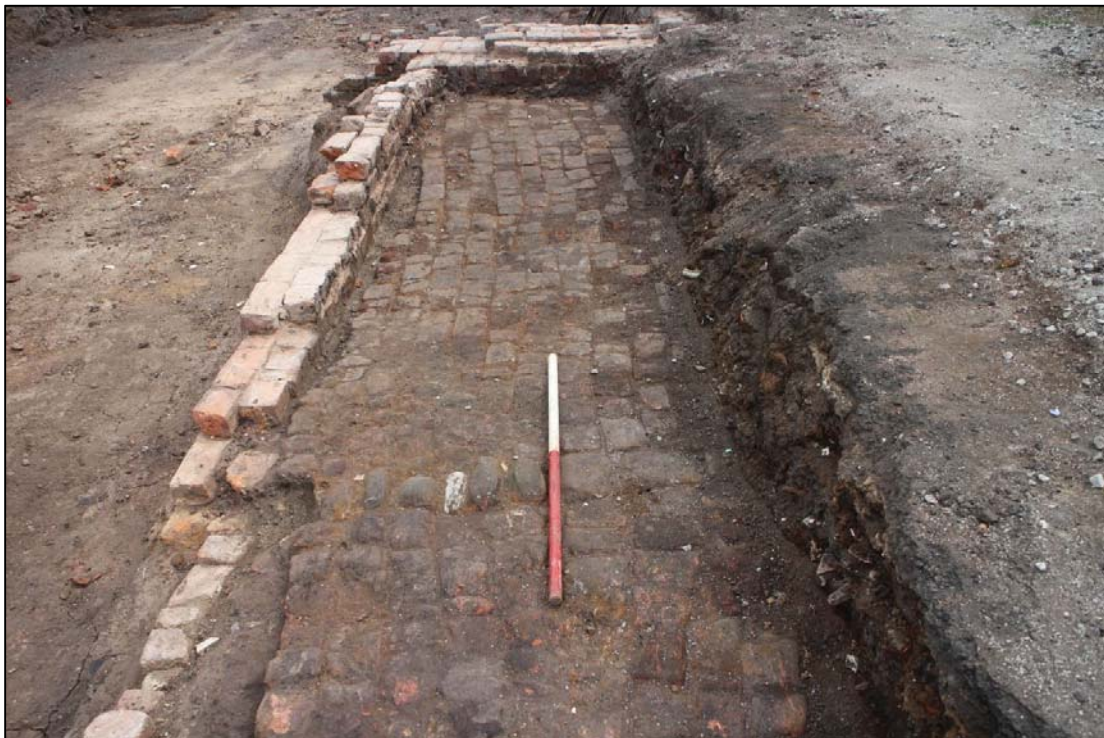
Plate 85: Phase 4 privy block, looking north-east

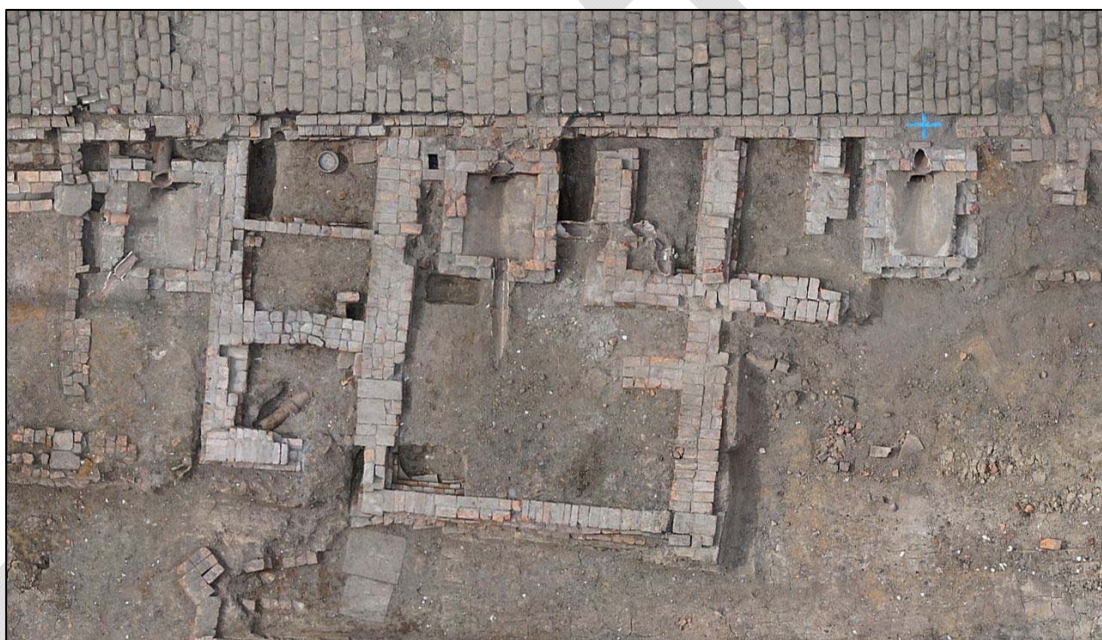
Plate 86: Aerial view of **Y1-3**

- 3.4.38 Other Phase 5 remains in this area included yard walls associated with **Y1** and also two yards (**Y2** and **Y3**) at the rear of **R4** and **R5** (Plate 86). The walls associated with **Y2** and **Y3** were fairly substantial, being three-courses thick in places. Within each of the yard areas were brick-built privies, with those in **Y2** and **Y3** being of identical rectangular form (measuring 1.16 x 1.7m), arranged back-to-back, on either side of the yard wall. Again, these were fairly substantial structures, and in sections were constructed of three-course-thick walls. An *in-situ* soil pipe was also present in the privy within **Y2**, indicating the presence of a flushing toilet. Three privies were present in **Y1**, which together formed a small block, some 3.8m long; the compartments within were 1.4m wide. Once more, these were substantial structures that in places had three-course-thick walling, and soil pipes survived in two of the privies.

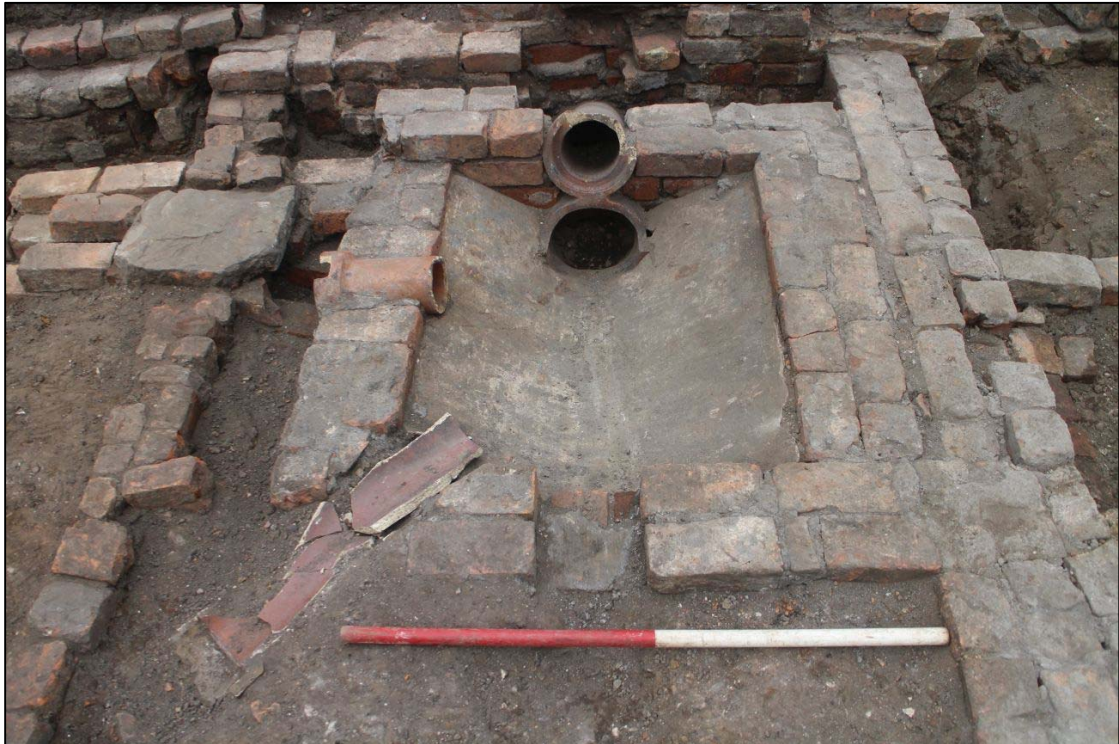
*Plate 87: Sewage/drainage structure in Y1, looking north*

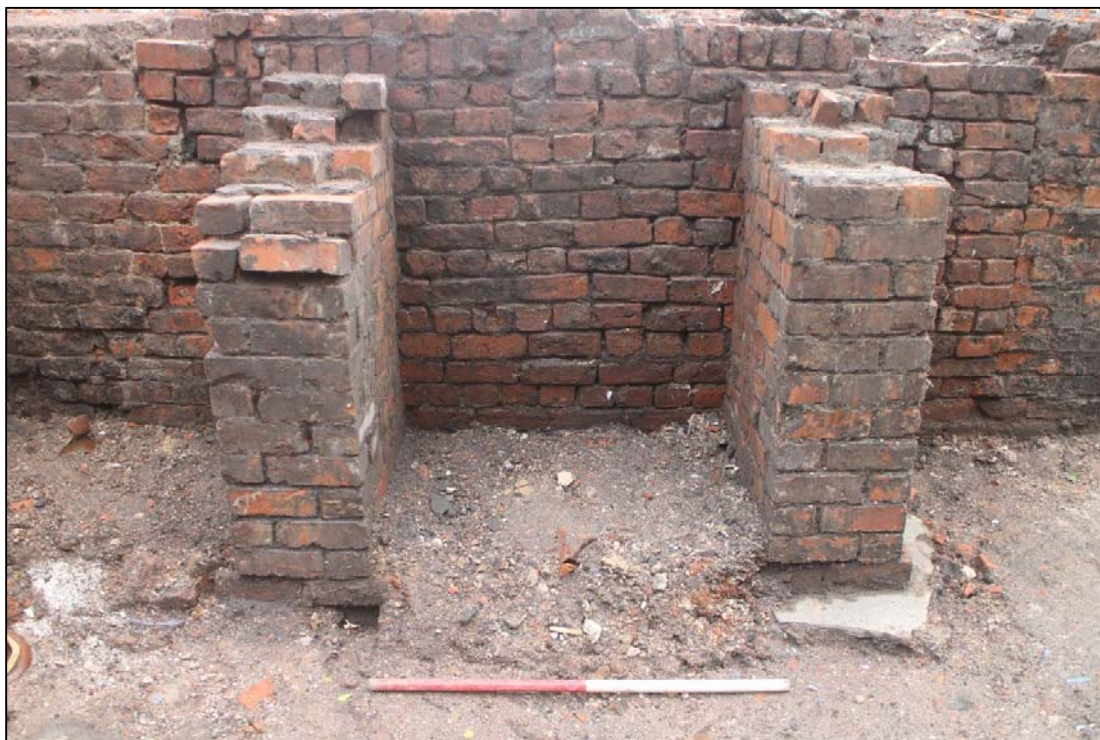
*Plate 88: The remains of the Phase 5 fireplace in C11, looking south-east*

3.4.40 Some limited Phase 5 remains were also present in the cellars of the double-depth properties fronting Old Mount Street, relating to rebuilding and modification. It is evident that the property containing **C2** was subjected to a major scheme of refurbishment, as the rear wall of the cellar was completely rebuilt during this period; this might also have been contemporary with the laying of a concrete floor in the cellar (**C1**) of an adjacent property. The rear wall of **C7** was also strengthened through the construction of an additional skin of walling on its inner face. In addition, it appears that two of the Phase 4 walls used to block the cellar lights in **C8** and **C9** were replaced during Phase 5. This replacement in **C8** probably relates to the construction of a new fireplace in the room above, as one of its supporting checks was evident in this cellar. Similarly, in **C11**, the brick piers for a chimney stack were added to the eastern wall of the cellar (Fig 9: Plate 88). Other modifications included the blocking of an internal doorway in **C5** and the extension/replacement of an internal dividing wall in **C8**.

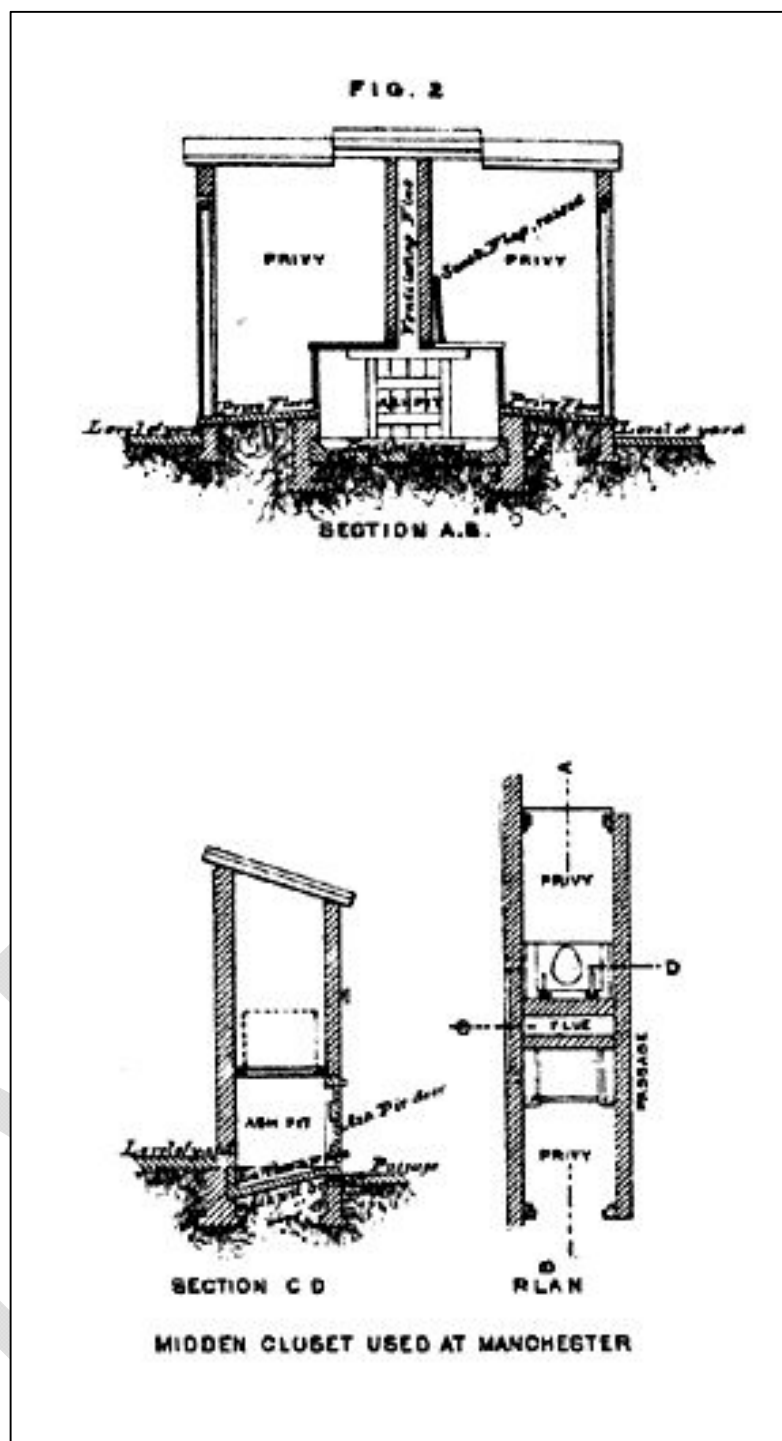
Plate 91: The typical form of a privy midden in use in Manchester in the earlier part of the nineteenth century (from Gray 1884)

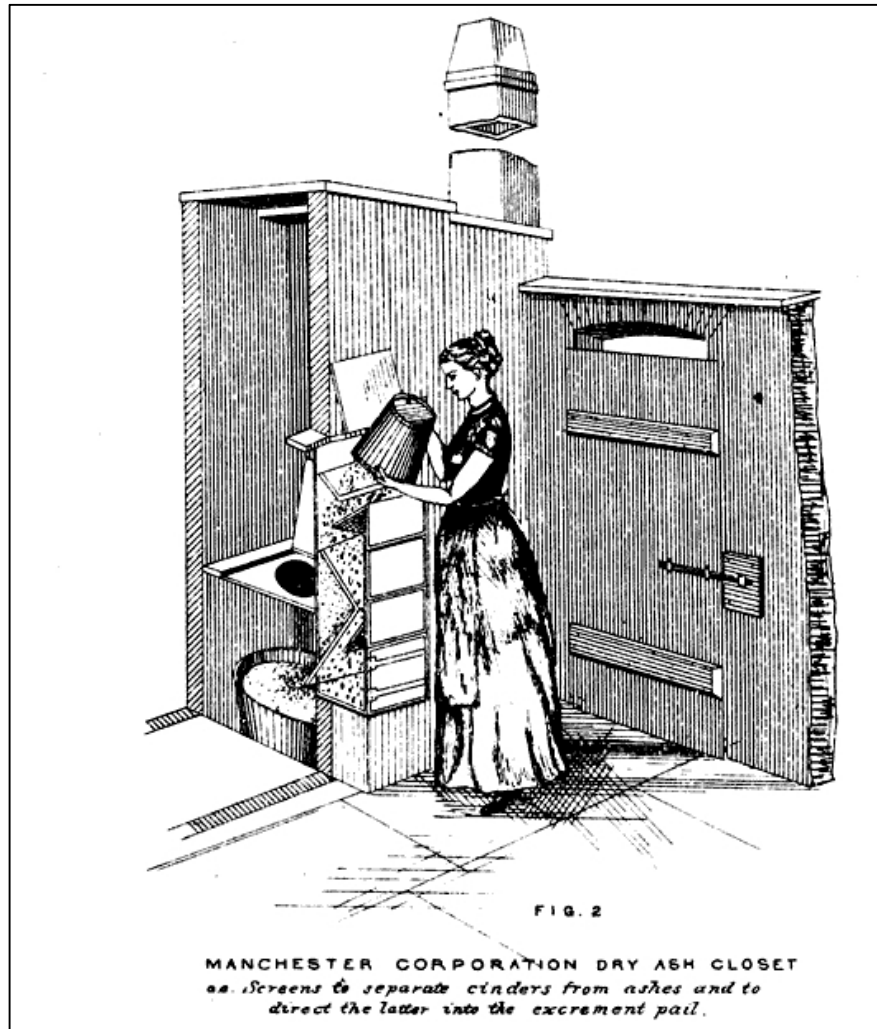
Plate 92: A Manchester ash closet (from Gray 1884)

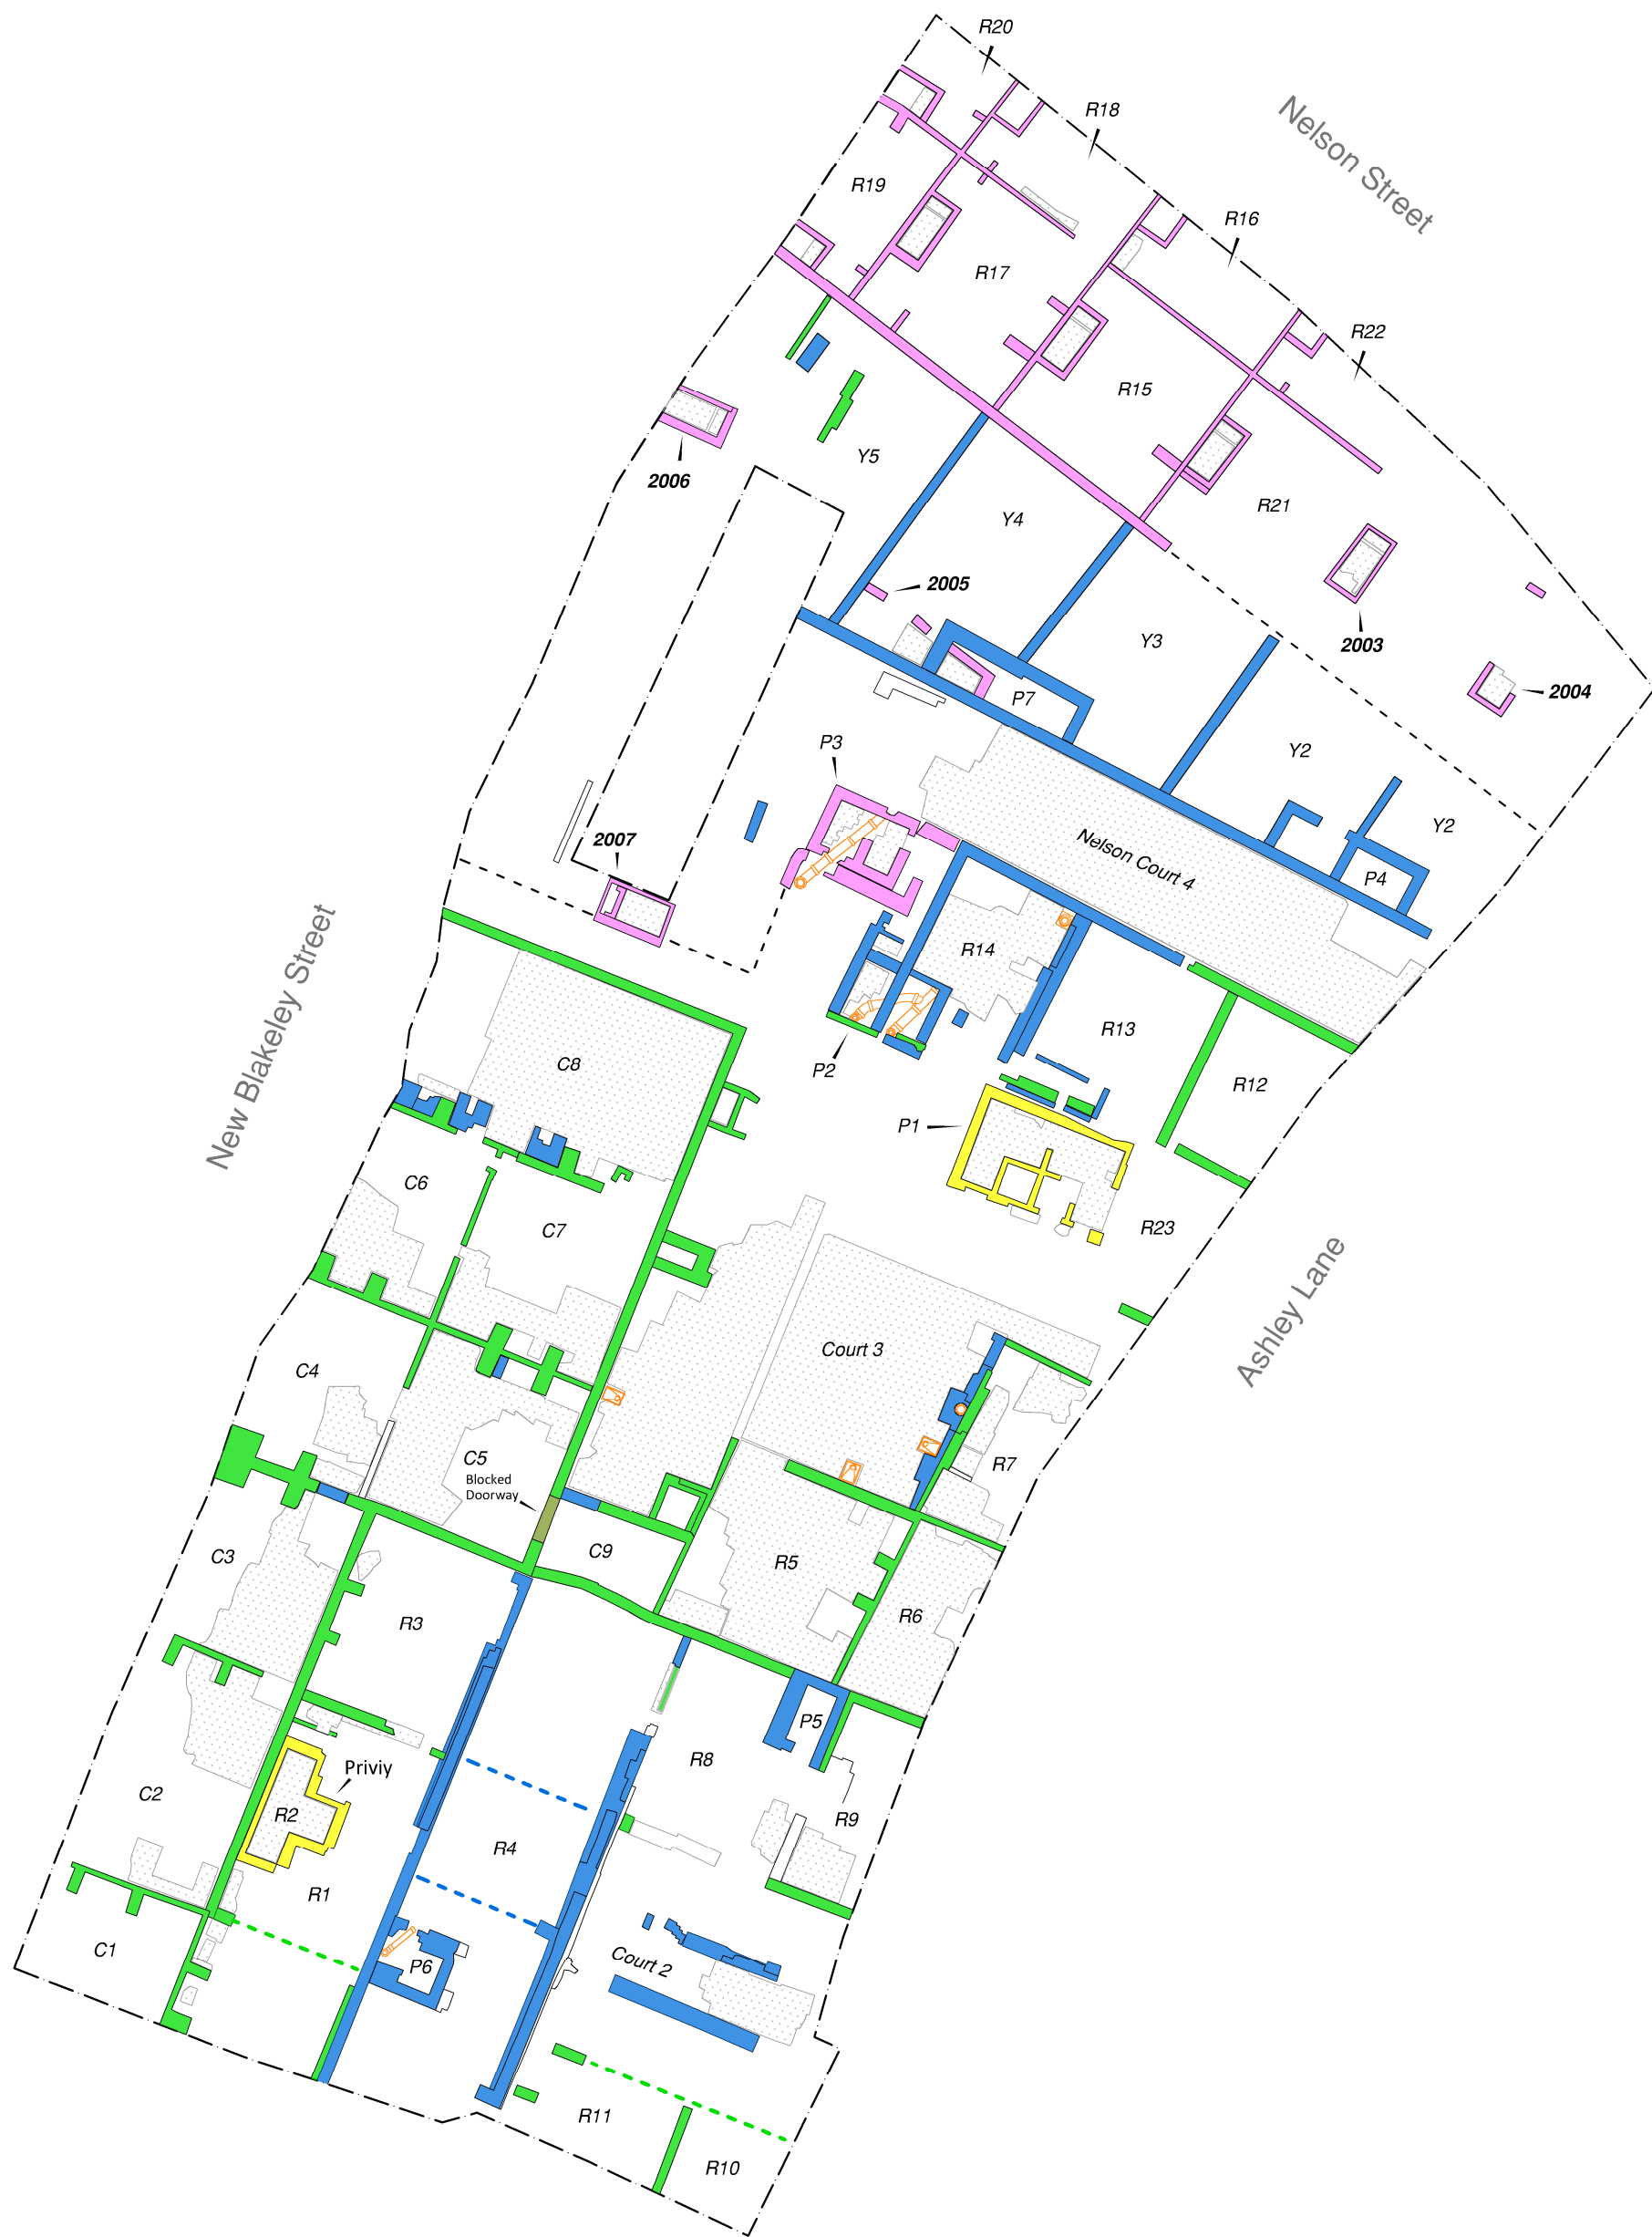
Figure 3: The archaeological remains in Plot 2

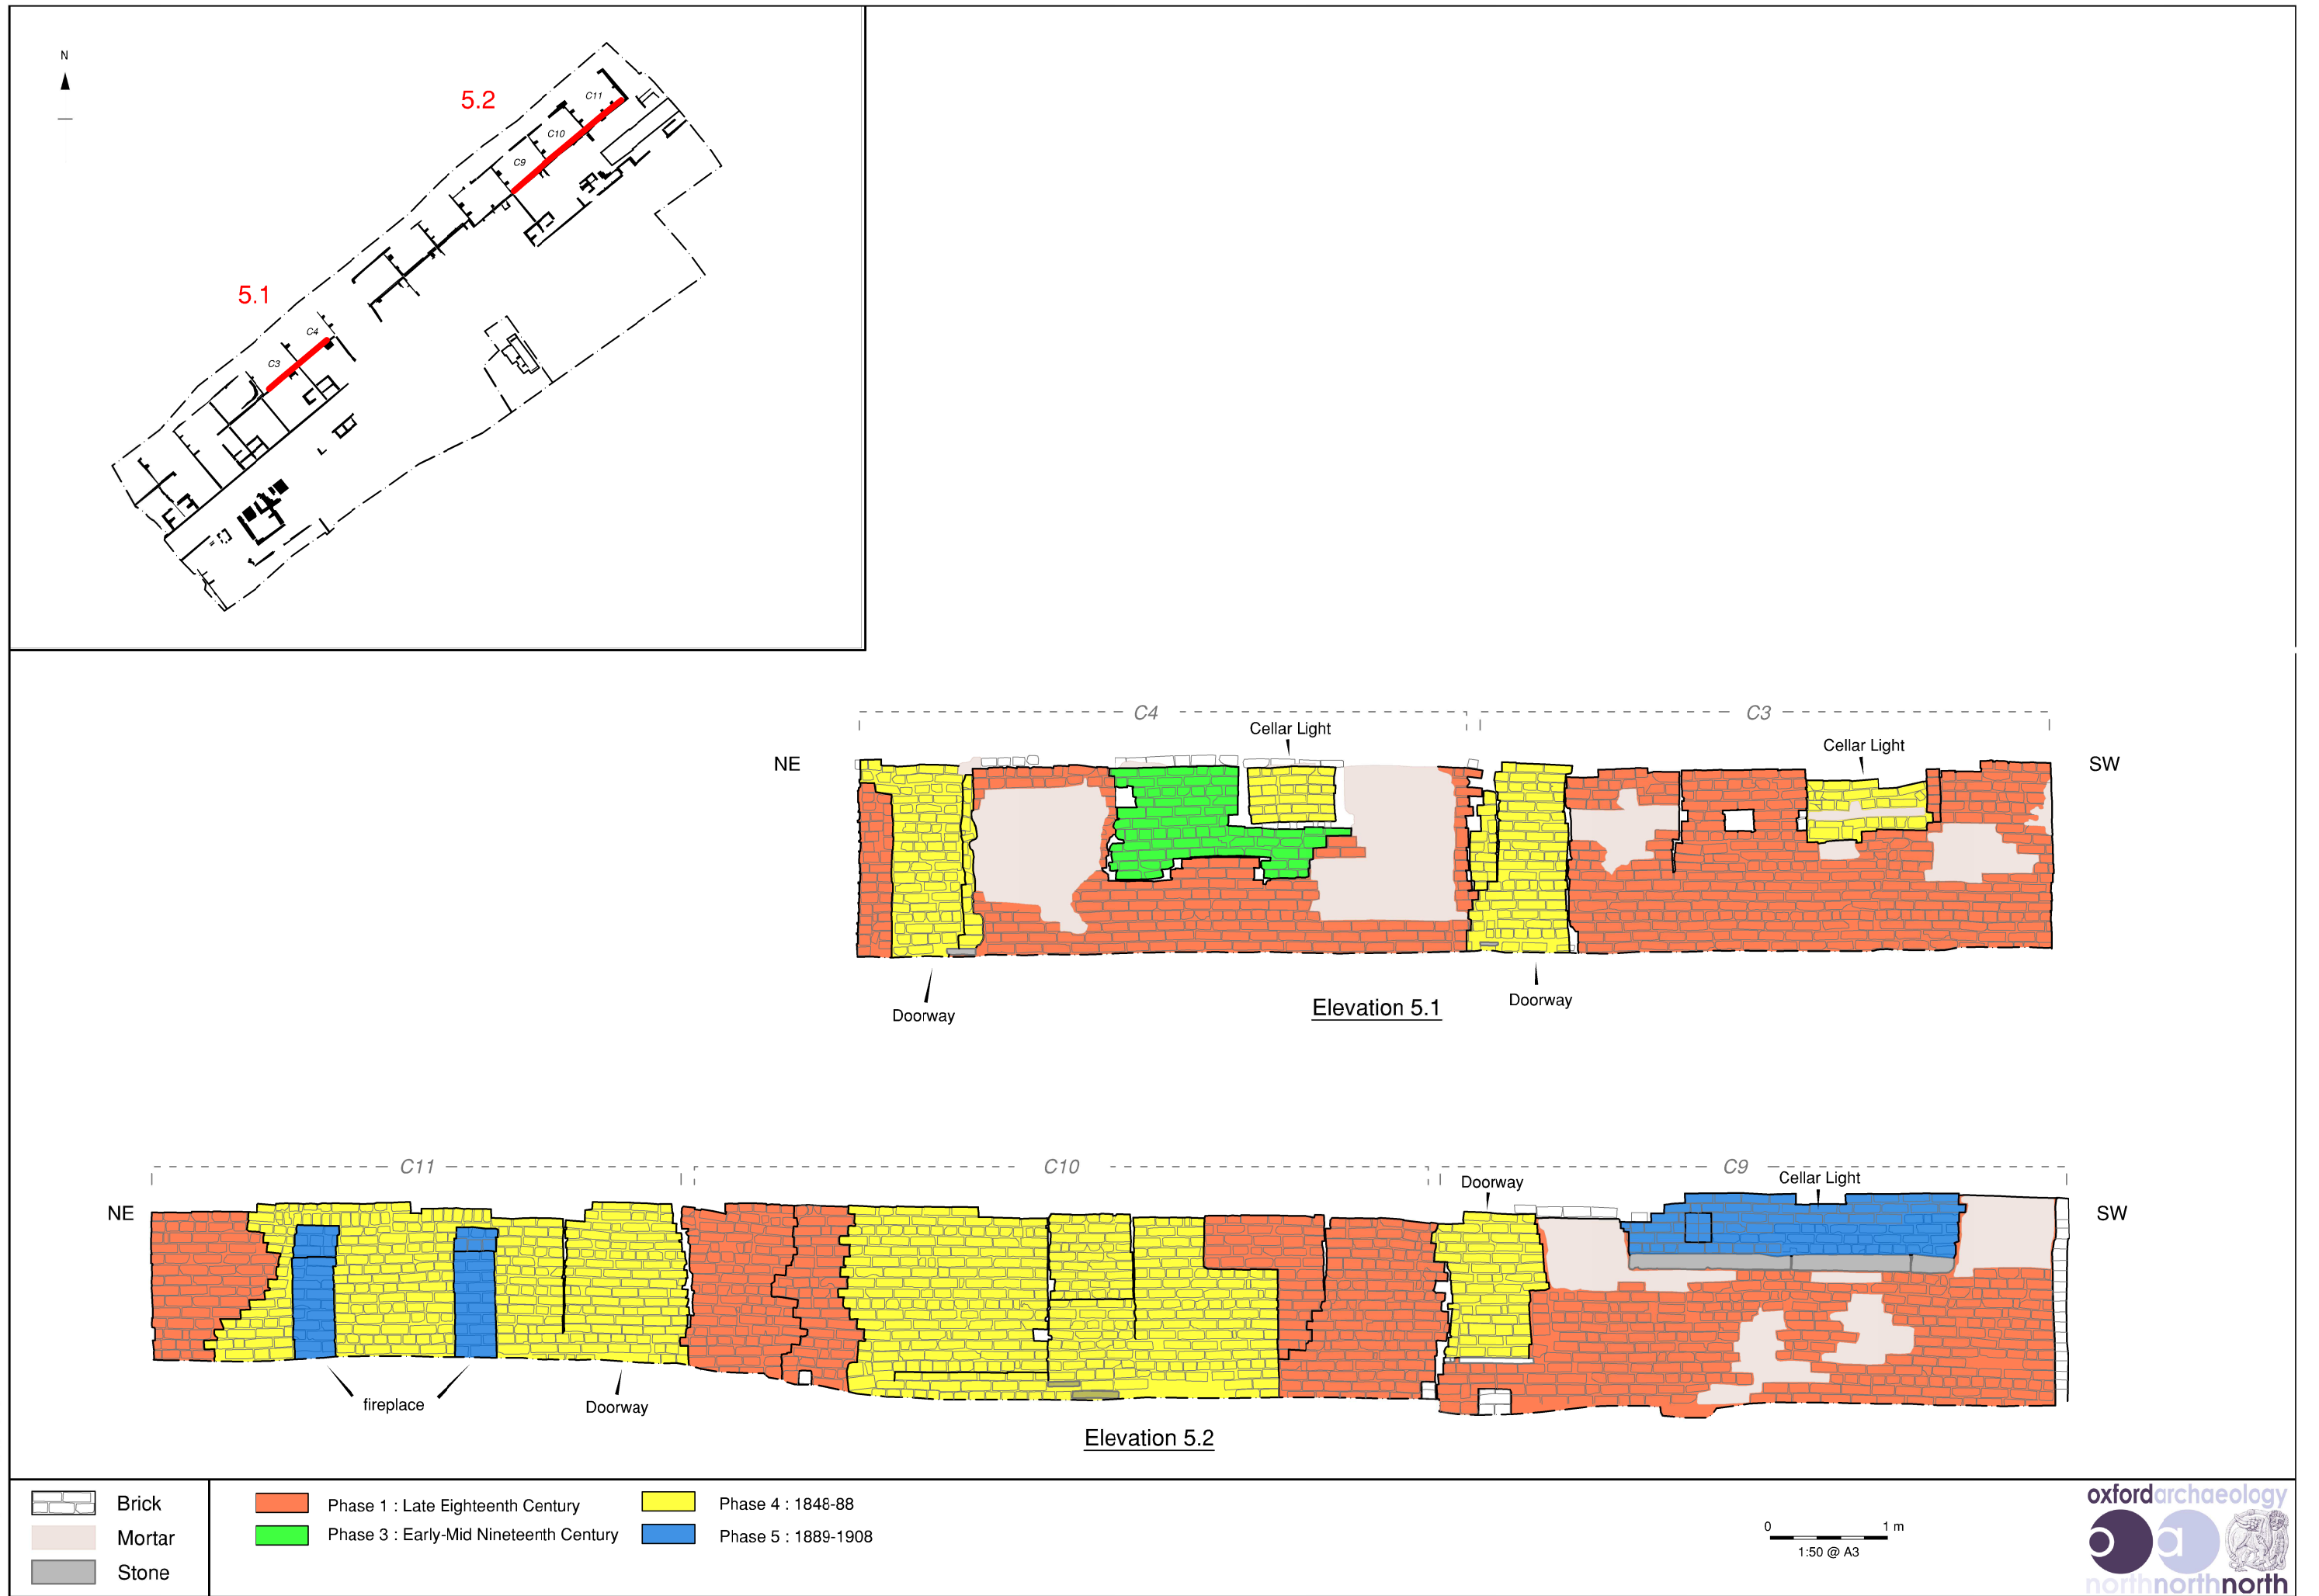
Figure 9: Elevations across the rear wall of Cellars 3 and 4, and 9-11

3.4.21 One of the cellars (**C3**) also had a cellar light on its eastern external wall, which was 1m across (Plate 72; Fig 9). It is also quite possible that two of the other cellars had light wells, though these had been modified by later activity; for instance, a protruding section on the outer face of the external wall of **C5** could denote the presence of one such a structure, whilst an original light well in **C4** may have been replaced in the early nineteenth century (Section 3.4.27).

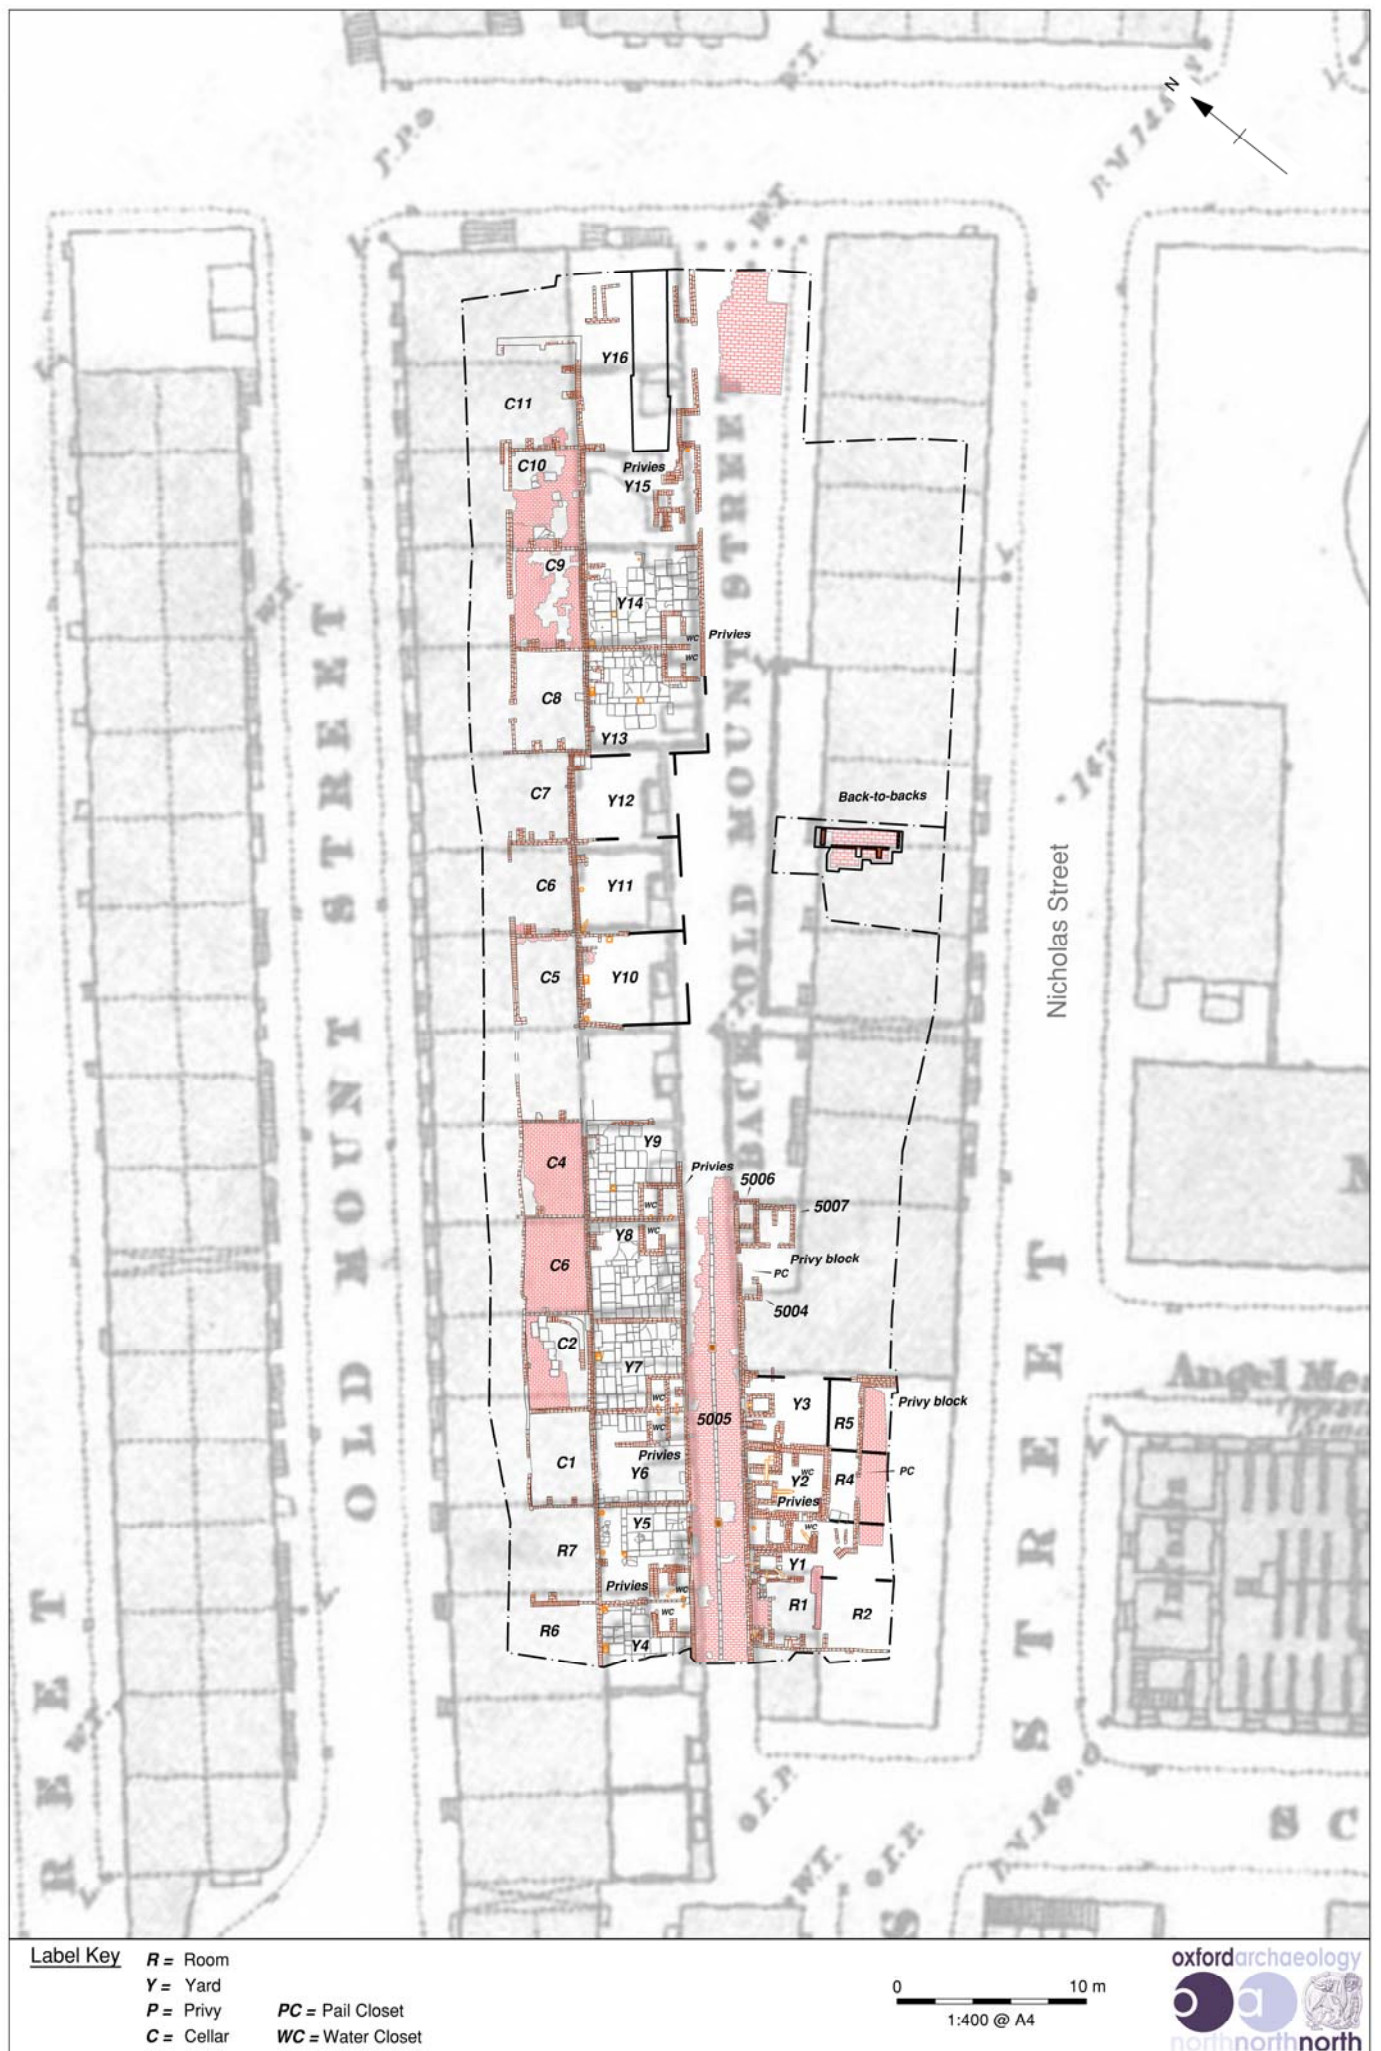
Figure 12: Plot 5 remains superimposed on the Ordnance Survey 5ft:1 mile map of 1850

- 4.2.18 The cartographic evidence also indicates that Plot 5 contained housing that was constructed between 1818/19 and 1824 (Fig 12). These comprised a row of back-to-backs between Back Old Mount Street and Nicholas Street, though very few remains of these survived, and it may well be that this part of the site was subjected to aerial bombardment during World War II (*Section 3.4.11*). In addition, this plot also contained the only mid-nineteenth-century building encountered in all of the excavated areas. This was small, measuring some 3.5 x 4m, and standing on the eastern side of, Back Old Mount Street (*Section 3.4.29*). On the map evidence alone it could have been interpreted as a blind-back dwelling; however, the excavated remains imply that this was not case. There was, for instance, no evidence for a fireplace, which would usually have been present in a domestic building, and, instead, the only internal feature was a sunken brick-built partition of unknown function.

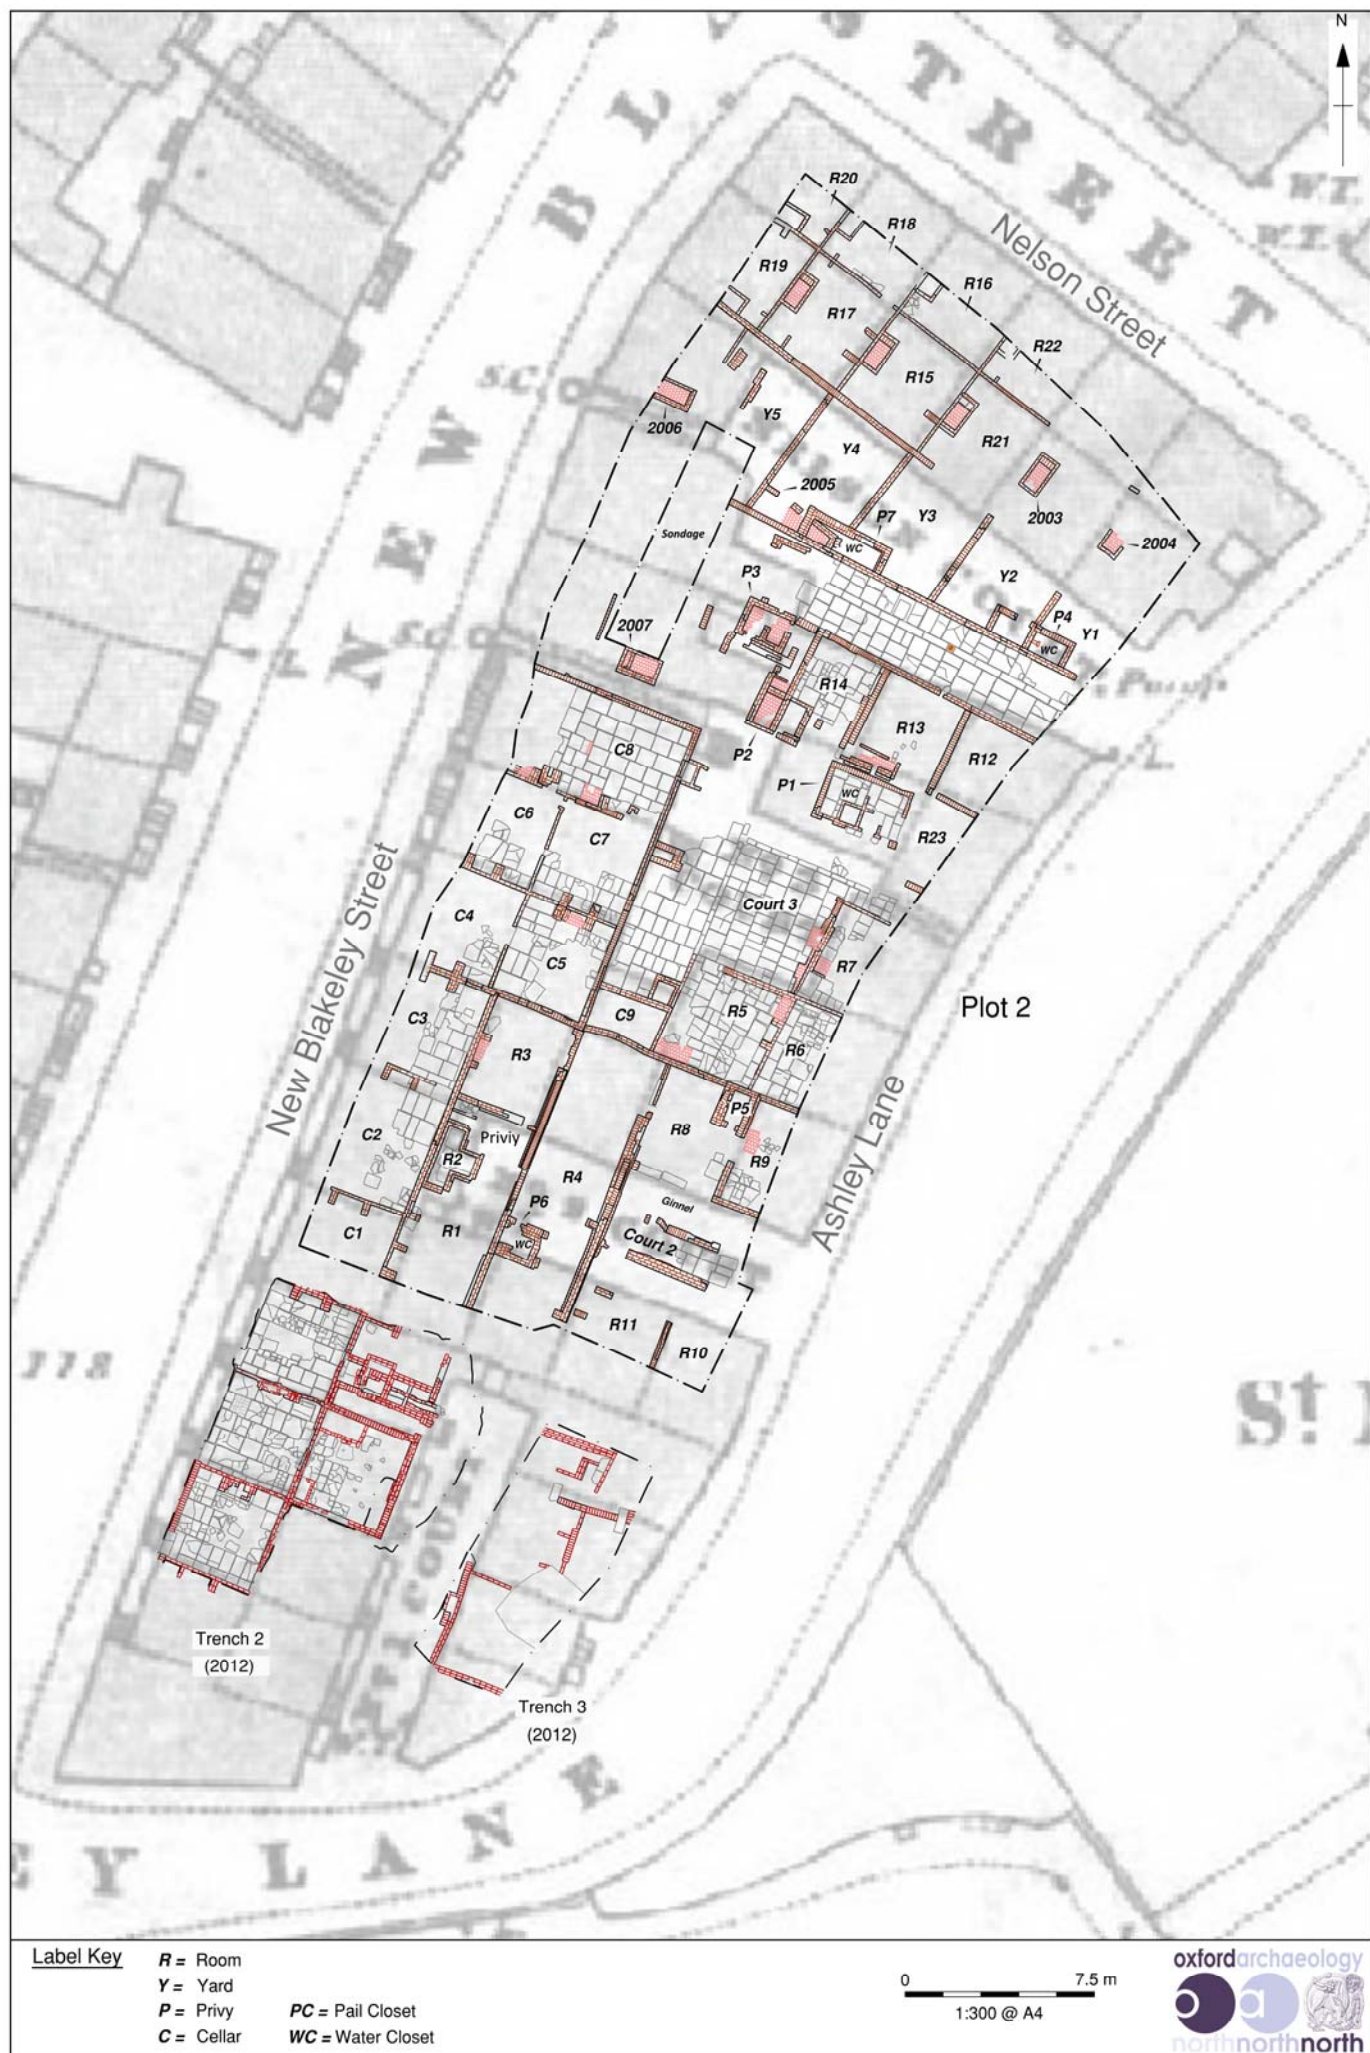
Figure 13: Plot 2 and the 2012 excavation area superimposed on the Ordnance Survey 5ft:1 mile map, 1850
