# Plots 2, 3 and 5, Angel Meadow, Manchester: DRAFT 2 Archaeological Excavation Report

**Client: Orion Heritage Ltd**

OA Reference No: L11148

# Plots 2, 3 and 5, Angel Meadow, Manchester

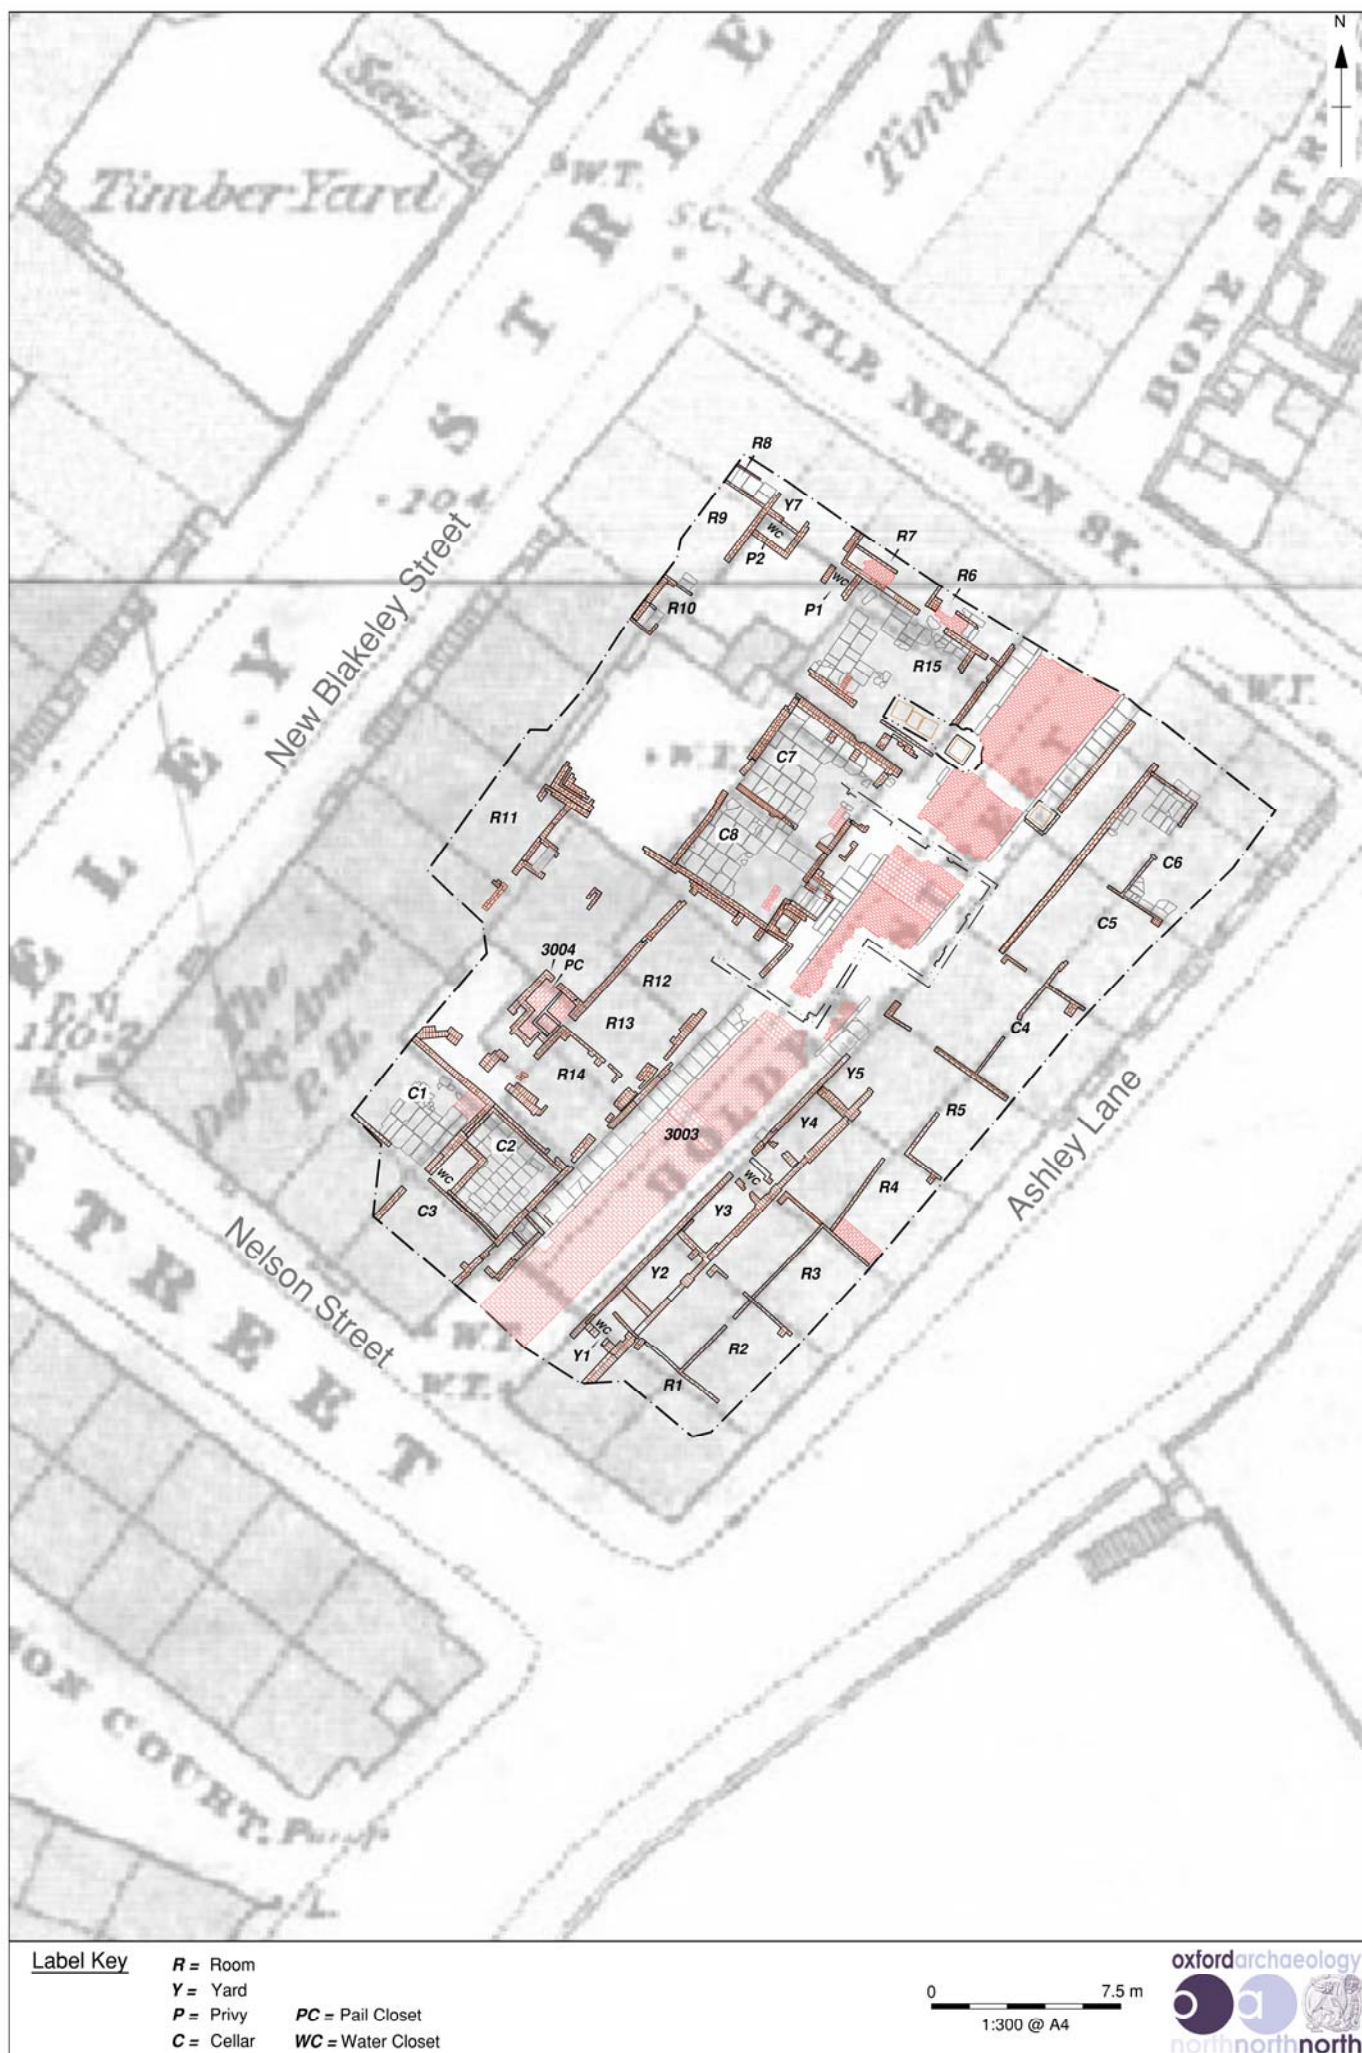
Figure 14: Plot 3 remains superimposed on the Ordnance Survey 5ft:1 mile map, 1850

- 4.2.16 The early nineteenth-century building activity in Plot 3, also on the north-eastern side of the burial ground, indicates that a mixture of house types was constructed in this area between 1818/19 and 1824, flanking Ashley Lane, Holden Street, and New Blakeley Street (Fig 14). The excavated remains consisted of parts of a range of back-to-backs between Holden Street and Ashley Lane (*Section 3.2.16*), heated by fireplaces on their north-eastern cross walls, with staircases on the opposing cross walls,

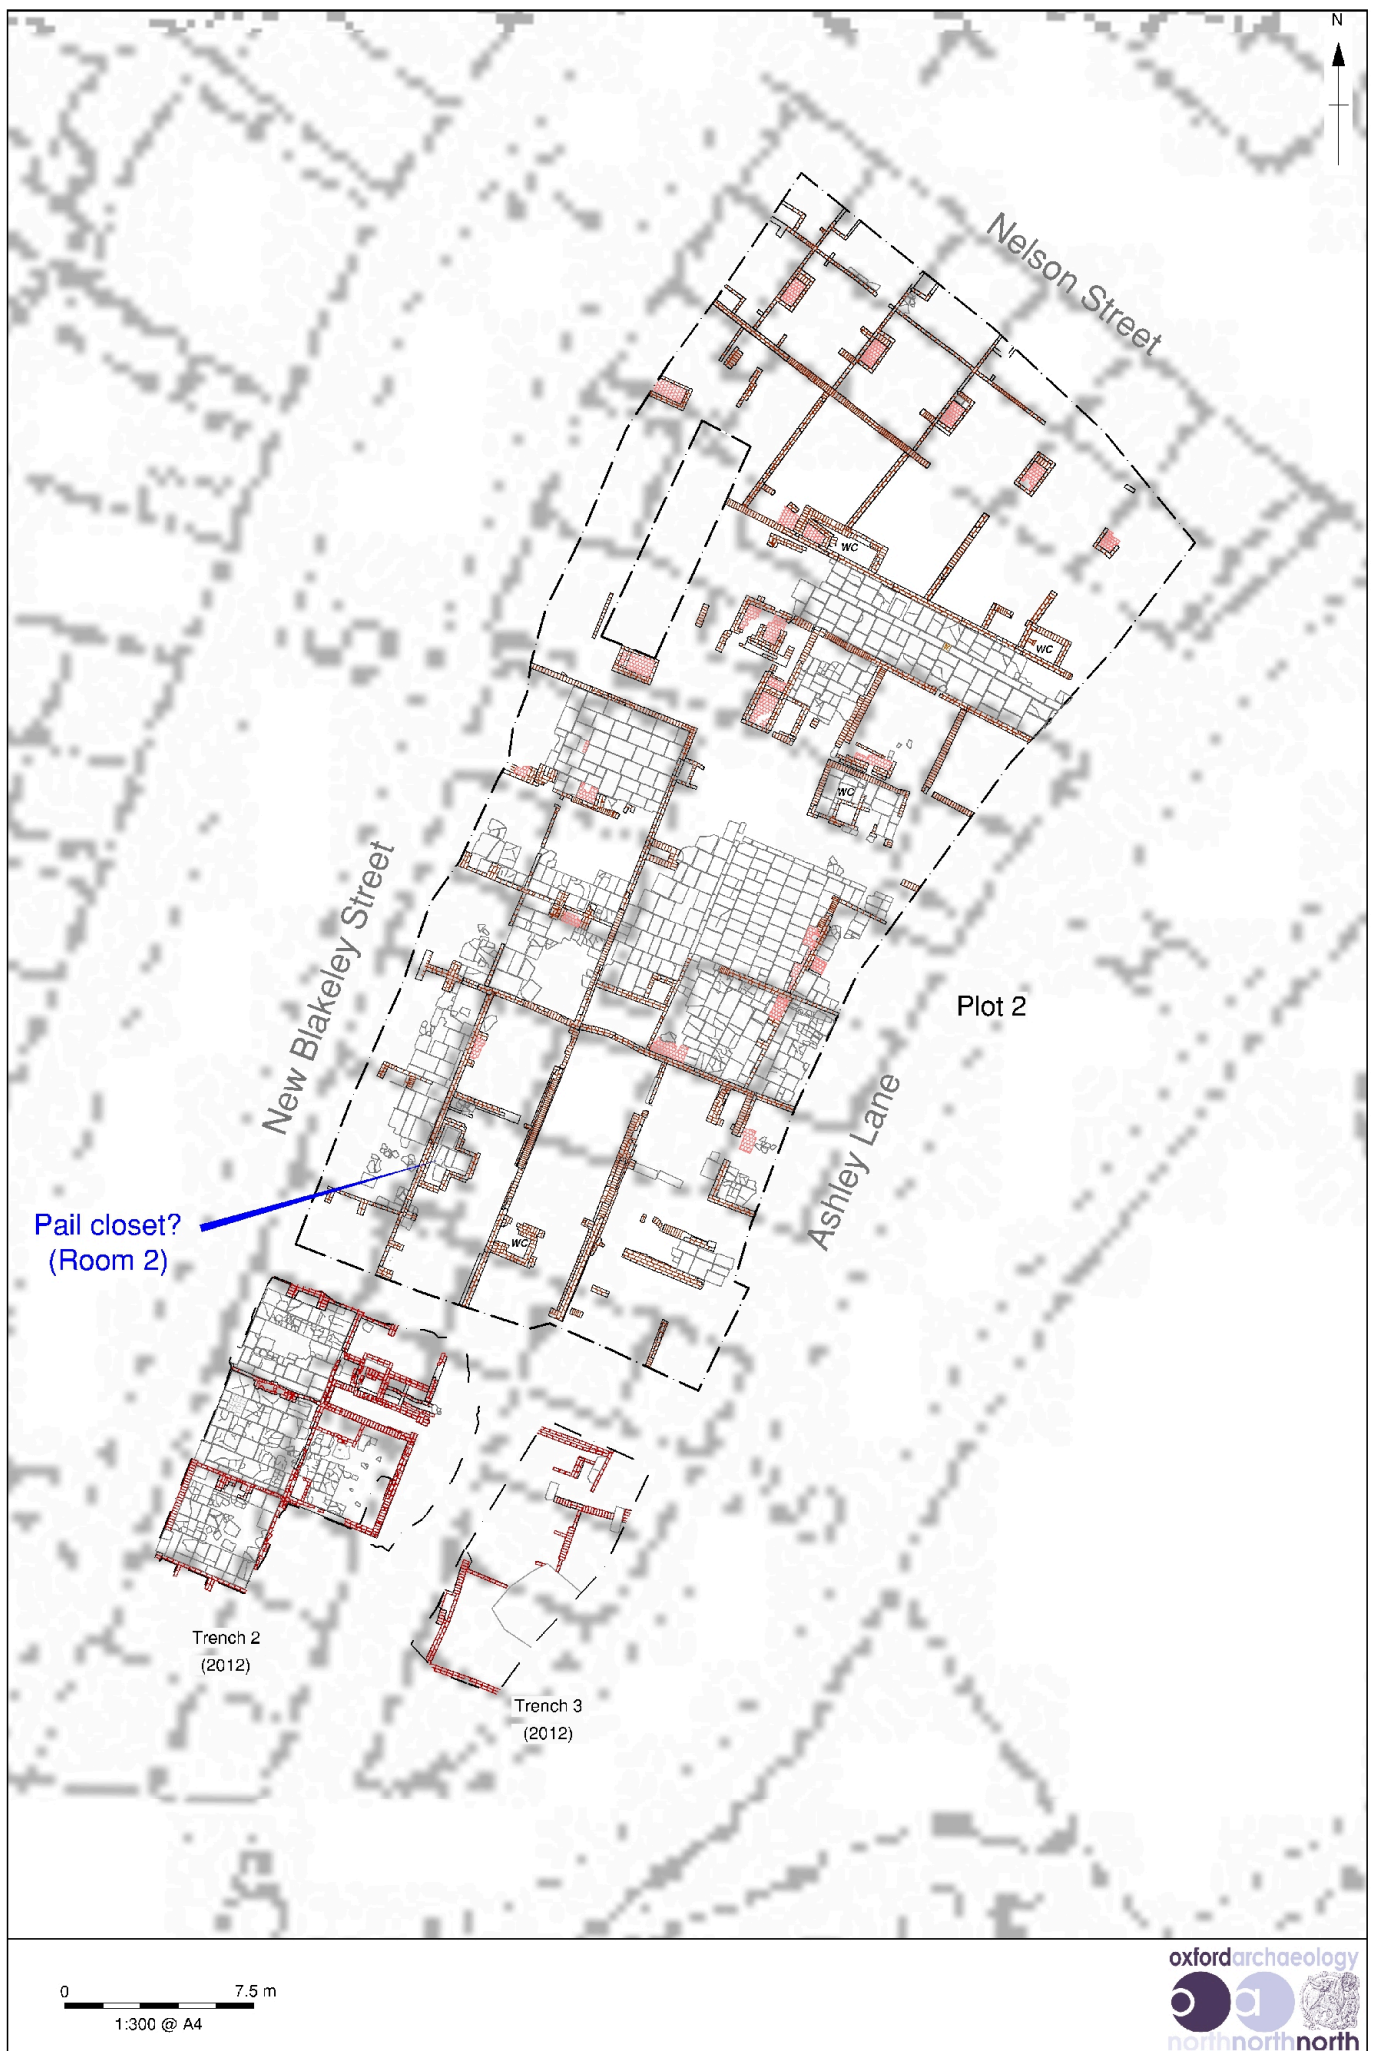
Figure 15: Plot 2 and the 2012 excavation areas superimposed on the Ordnance Survey 1:2500 map 1893

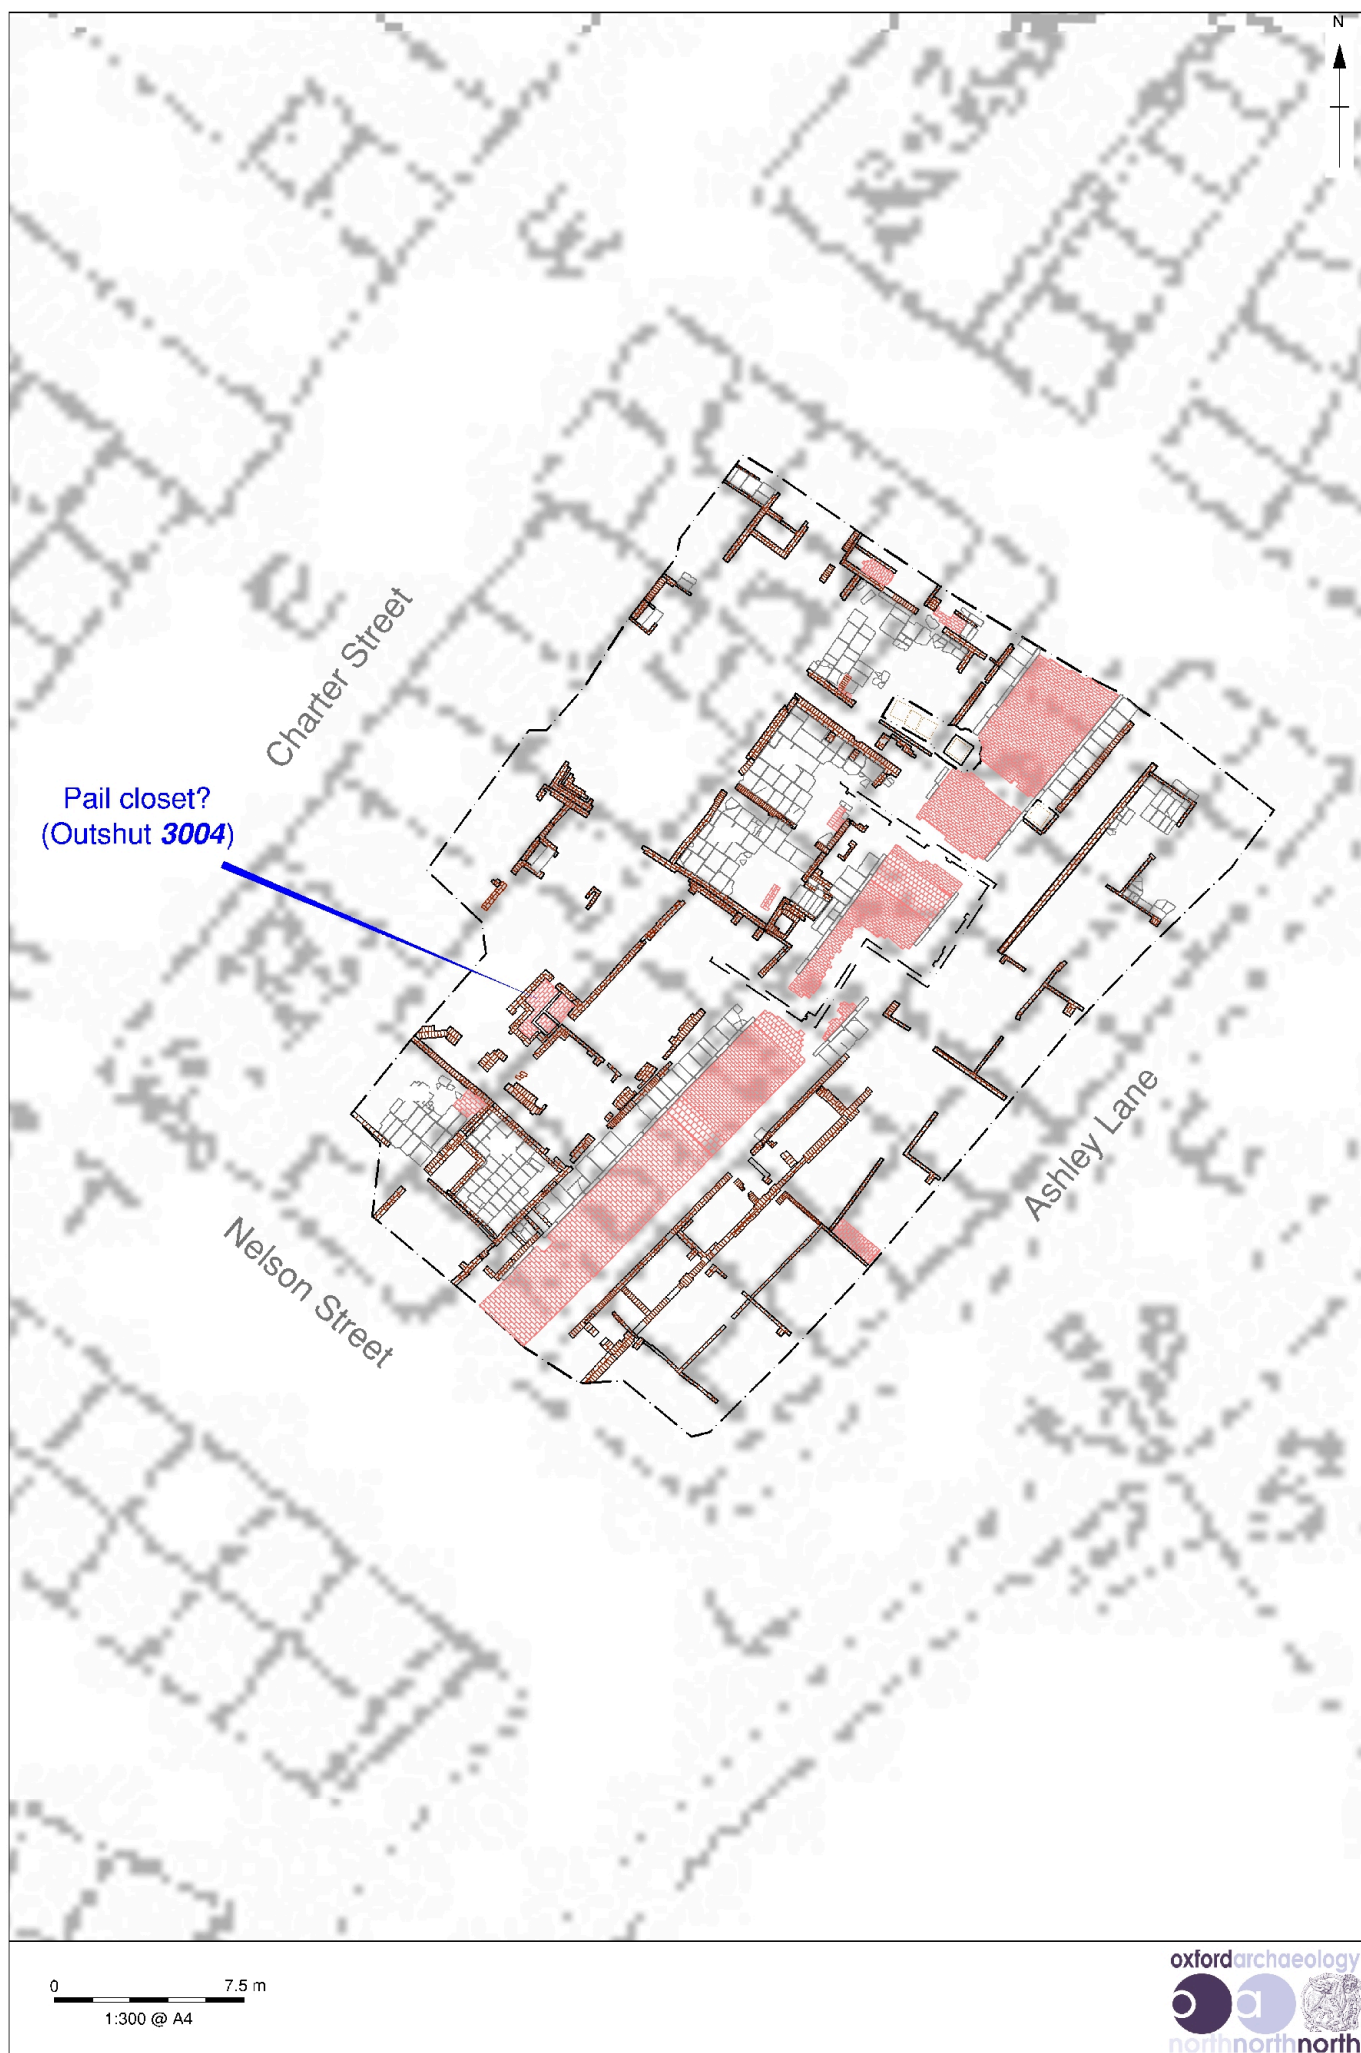
Figure 16: Plot 3 remains superimposed on the Ordnance Survey 1:2500 map 1893

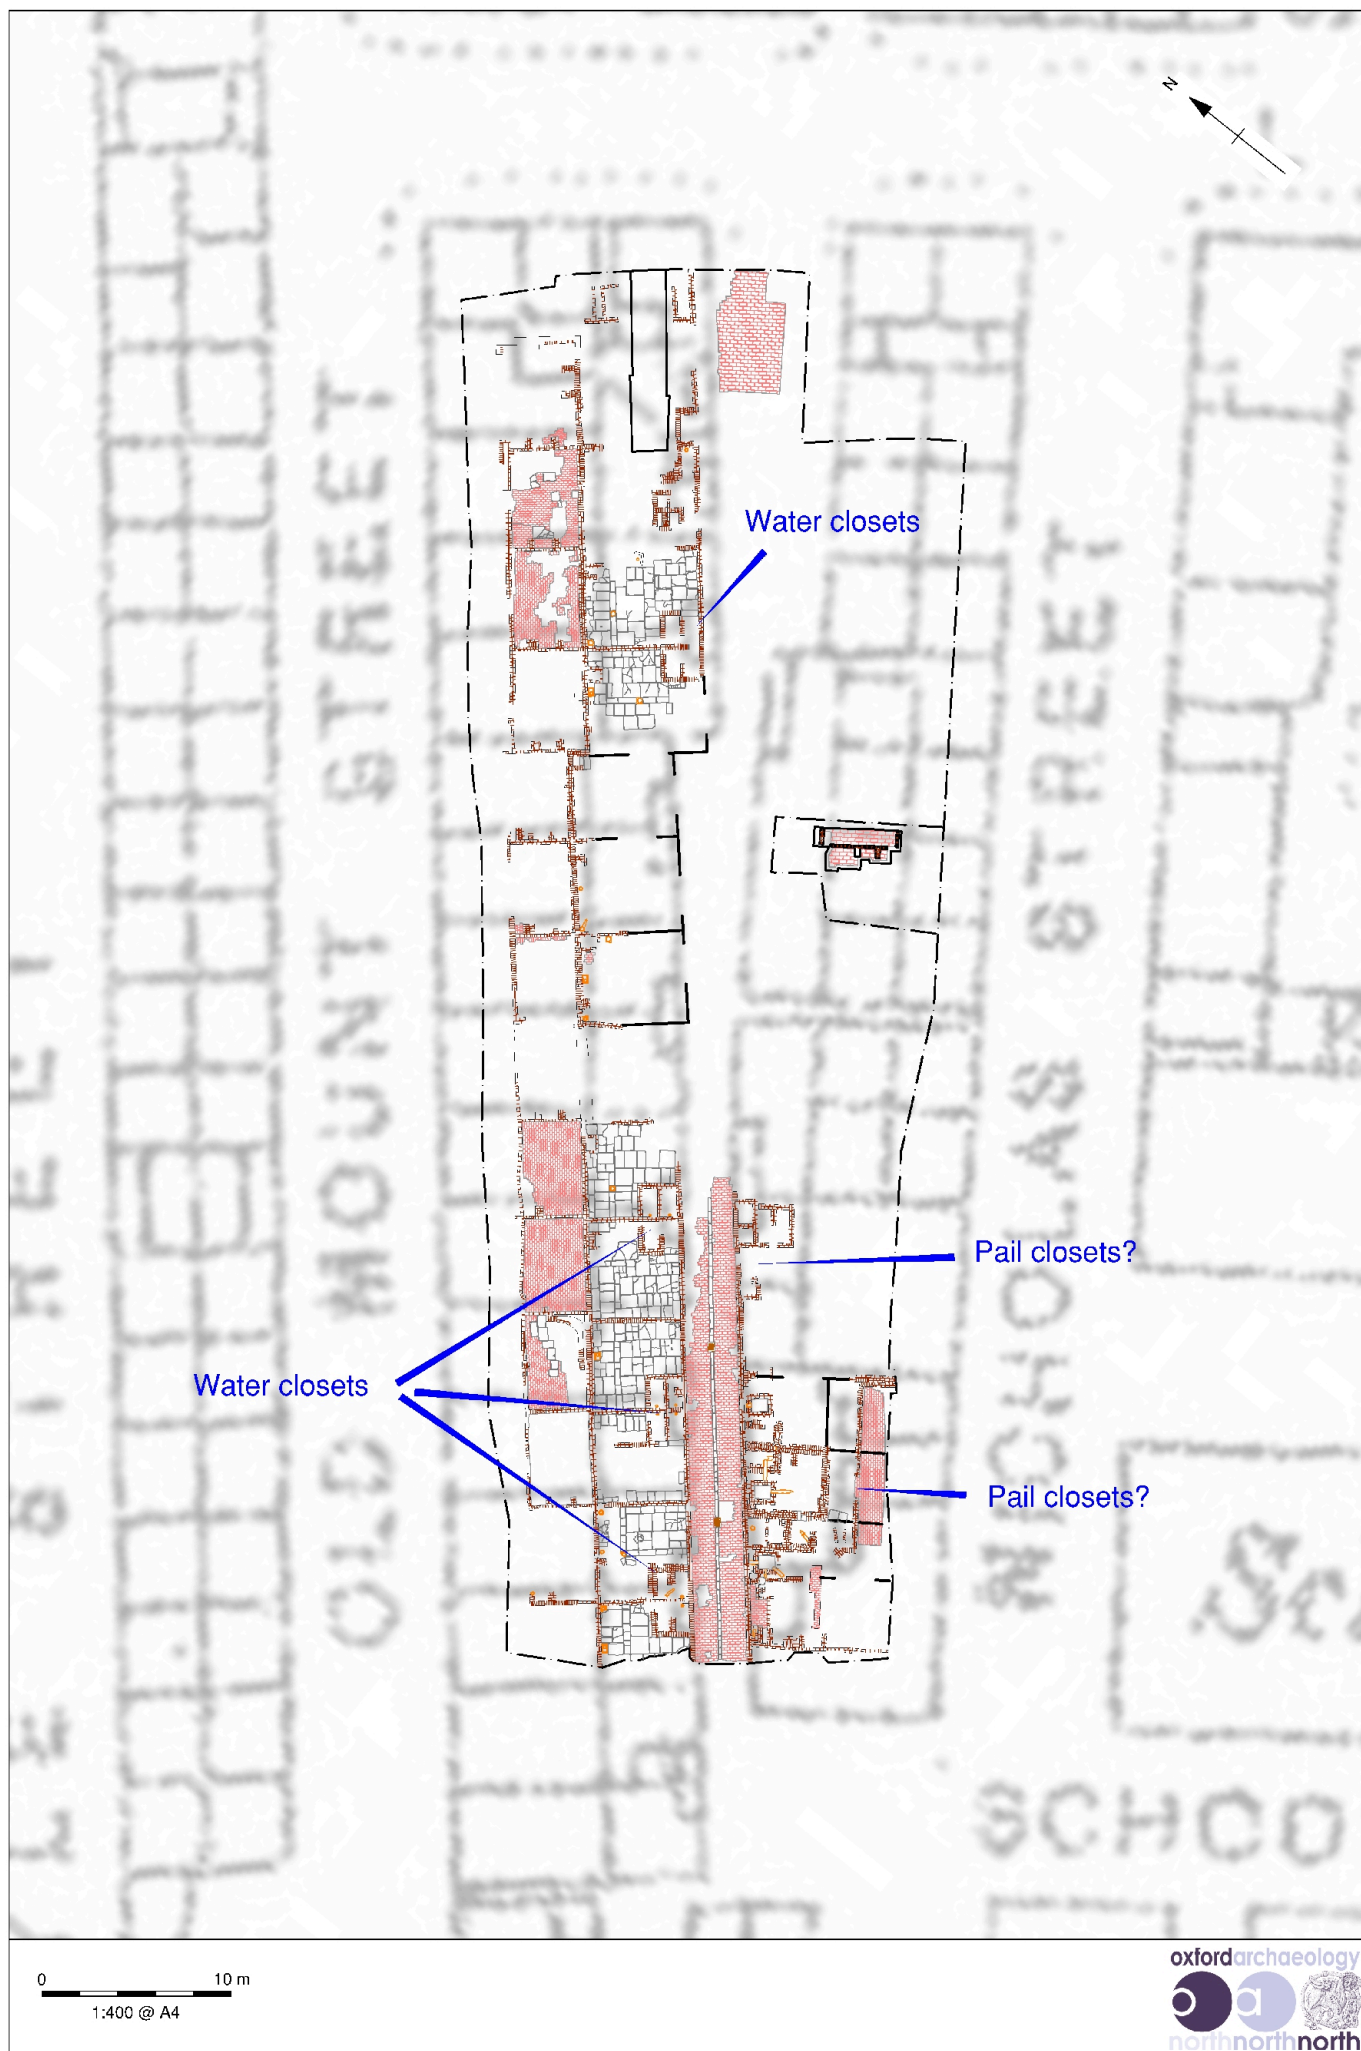
Figure 17: Plot 5 remains superimposed on the Ordnance Survey 1:2500 map 1893
