**Job title:** Didsbury Point

**Report type:** Geo-Environmental Appraisal

**Prepared for:** Southway Housing

**Date:** May 2021

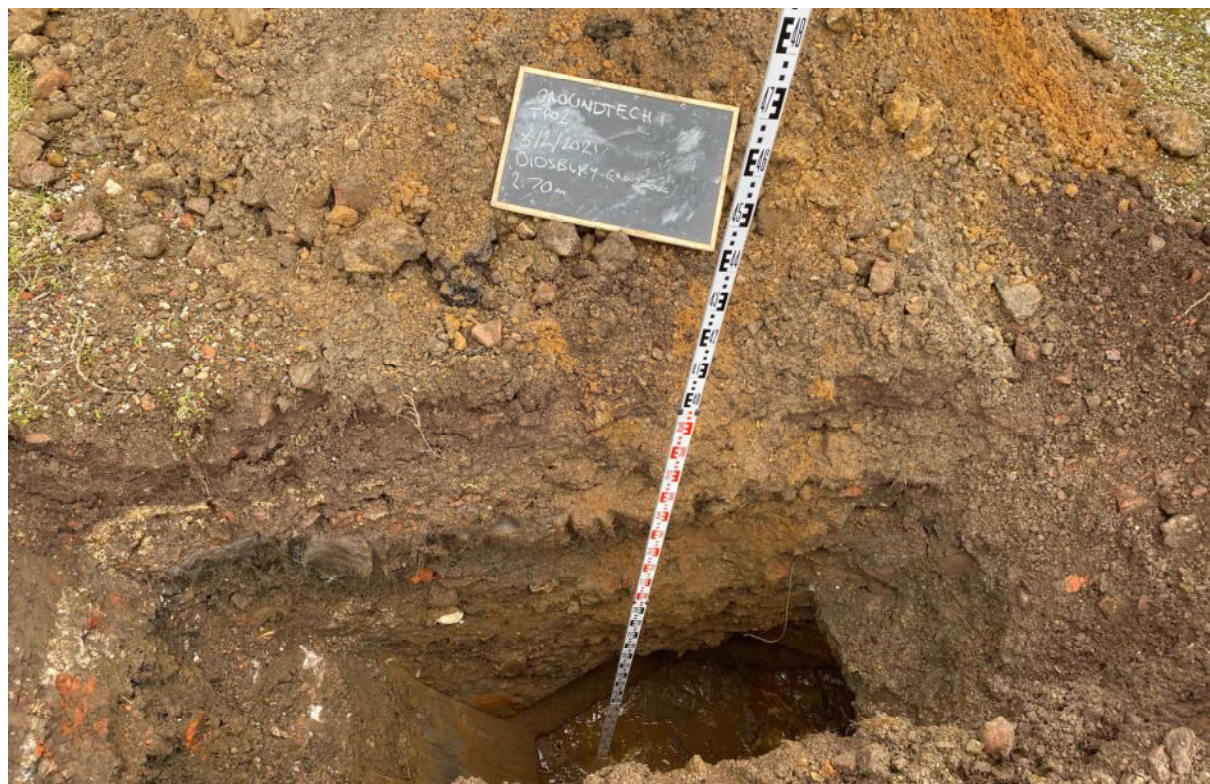
Photograph 4 - TP02

This trial pit was used to identify and to understand the tarmacked area of the site, Tarmac was encountered to a maximum depth of 0.2m bgl and was observed as a degraded tarmac recovered as a gravel. This was then followed by a light grey sub-base material to a maximum depth of 0.4m bgl. Finally, the subbase was underlain with a Geo-membrane layer that separated the road construction in this area with the Made Ground encountered throughout the rest of the site.

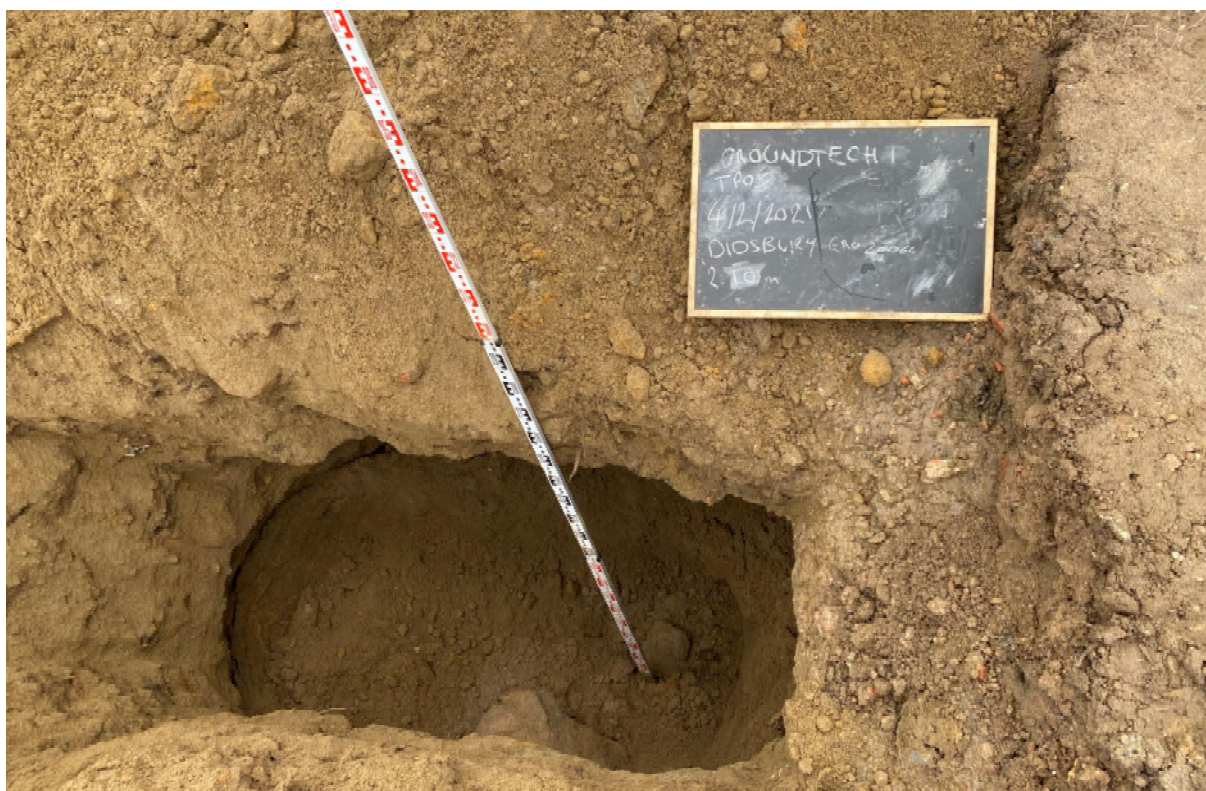
Photograph 5 – TP03

**TP03** - this trial pit was excavated in the central south eastern area of the site. Made Ground was encountered to a maximum depth of 1.1m bgl and was underlain with natural Sand deposits of grey and orange to a maximum depth of 2.1m bgl. A soil percolation test was conducted within this location between depths of 1.5m and 2.1m bgl to determine soil infiltration rates within the underlying natural strata.

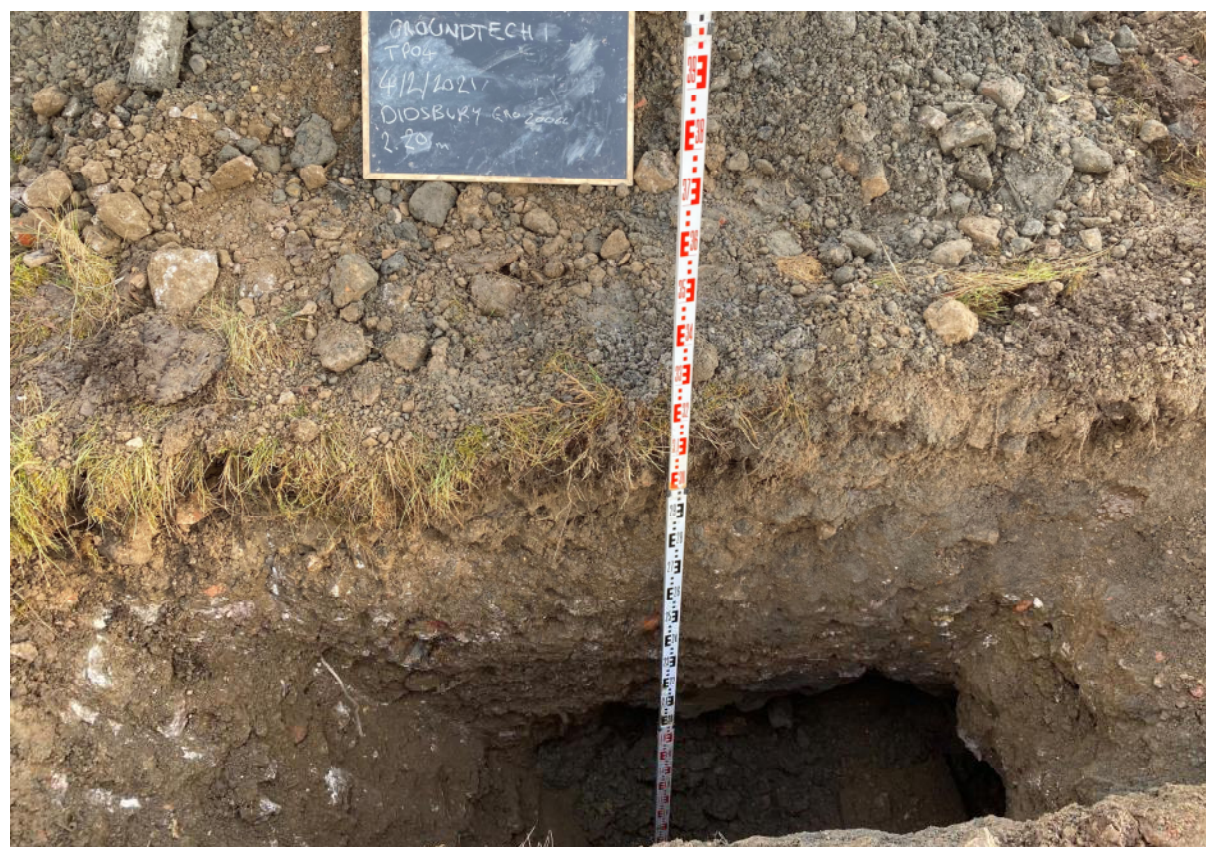
Photograph 6 – TP04

*TP04* - this trial pit was excavated in the north western area of the site. Made Ground was encountered to the base of the trial pit at 2.1m bgl. Multiple concrete obstructions were encountered within this trial pit between depths of 0.8m and 1.5m bgl, these were remnants of former slab foundations associated with the previous hospital building on site. Beneath this, redundant utilities were encountered in the form of plastic and metal piping, these are also presumed to be associated with the former hospital buildings on site.

Tracked high specification plant is recommended to maintain the build programme. Breaking equipment may also be required locally to penetrate obstructions identified by the Ground Investigation such as within TP04 and likely to be widespread given the history of the site.

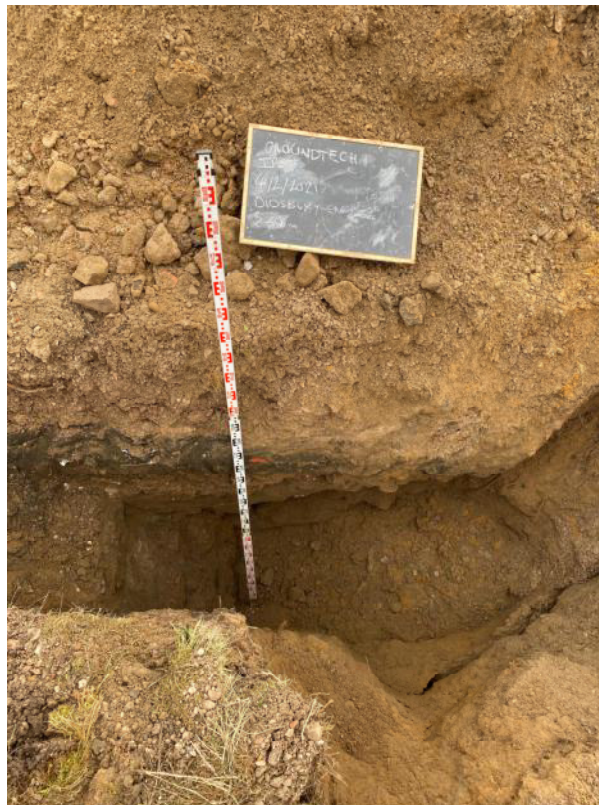
Photograph 7 – IP3

Three soil percolation tests were carried out at both positions IP3 and TP03 at a depth of 1.6m bgl and 2.1m bgl respectively. The calculated soil infiltration rates ranged between  $1.14 \times 10^{-6}$  m/s and  $3.28 \times 10^{-6}$  m/s which indicate poor drainage conditions are present within the underlying soils.
