Proposed residential development

The Greenfinch

Didsbury

Ground Investigation Report

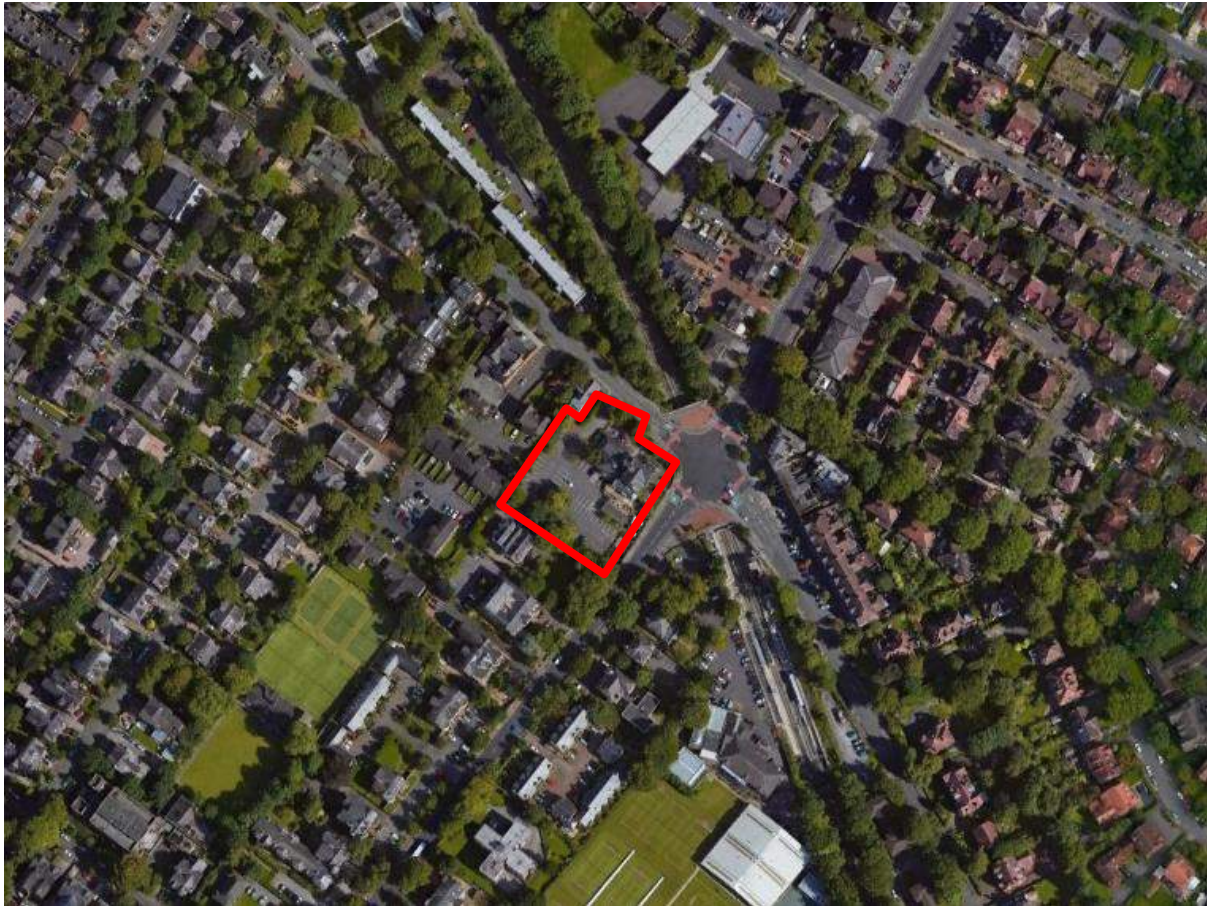
## Aerial photograph of site

Approximate site boundary edged in **RED**.

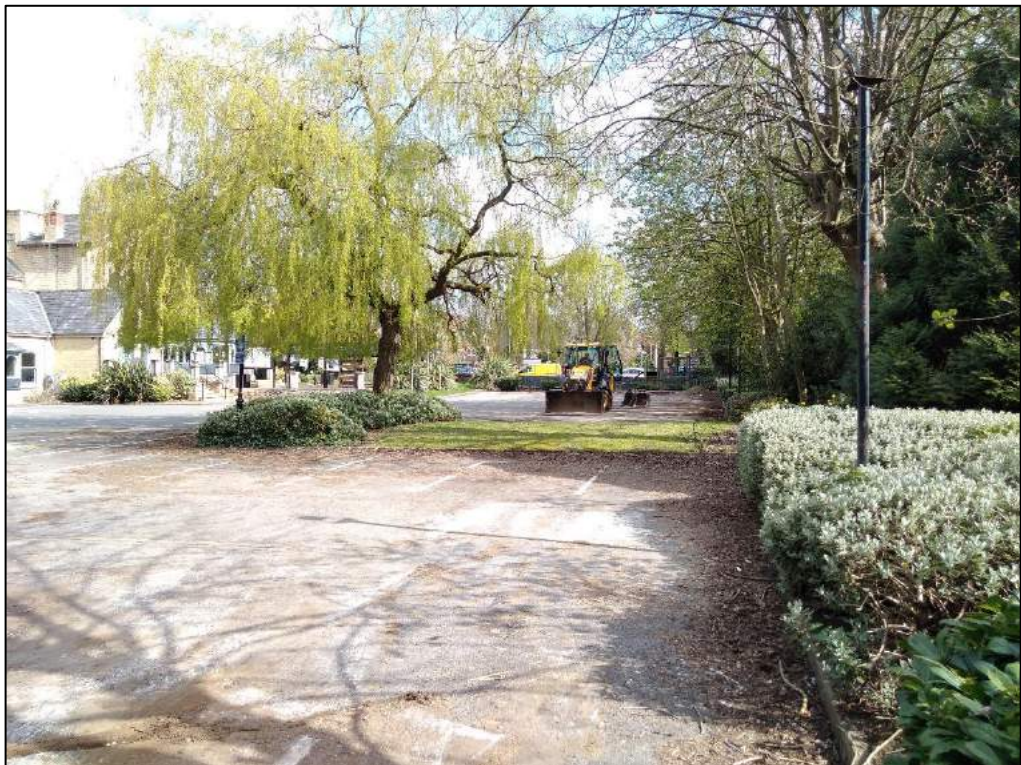
**Photograph 02:** Southwest corner of site looking east. April 2021

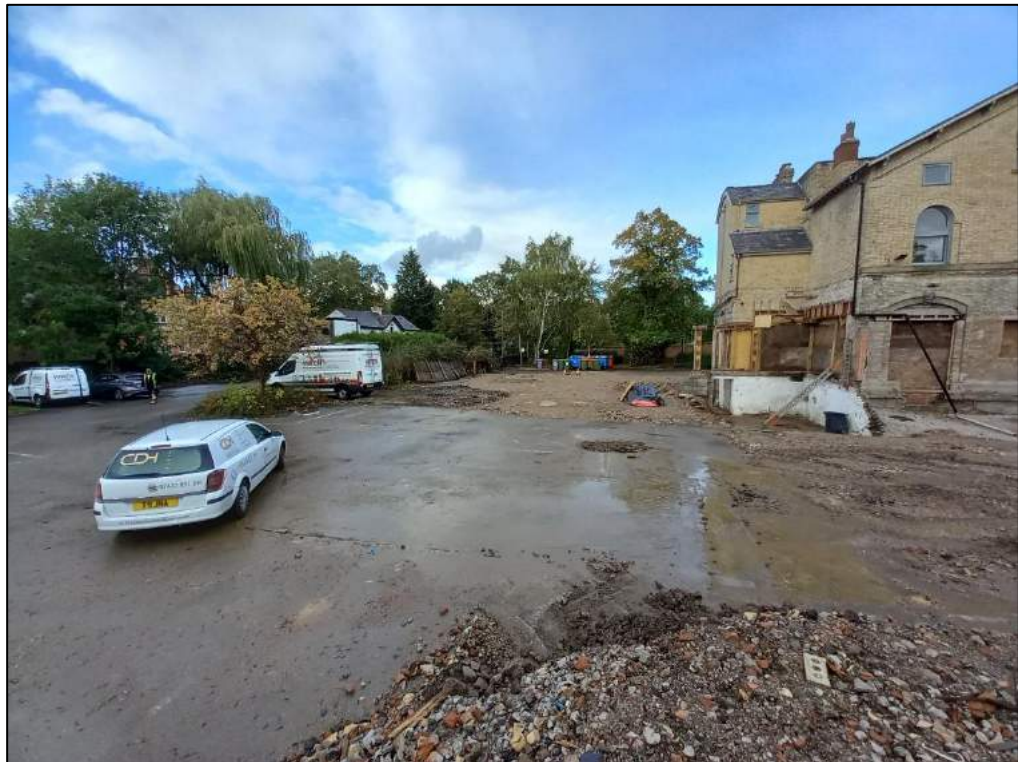
**Photograph 03:** Looking north, showing partially demolished former The Greenfinch building. October 2022

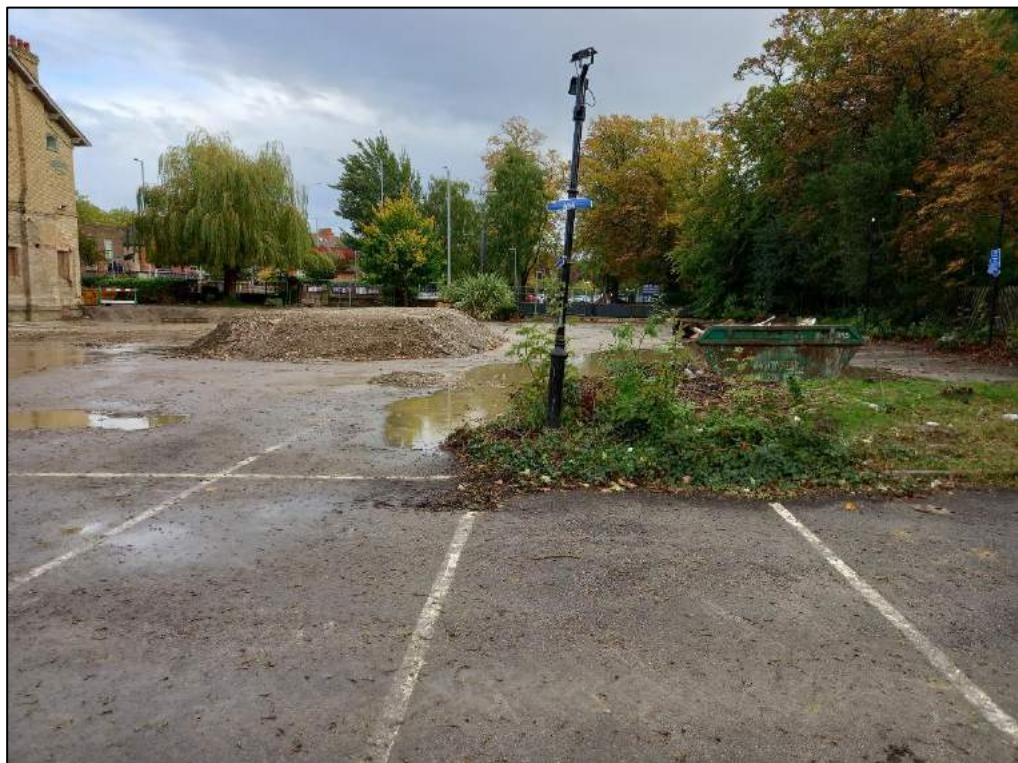
**Photograph 04:** Looking east, showing existing car parking area and stockpile on site. October 2022

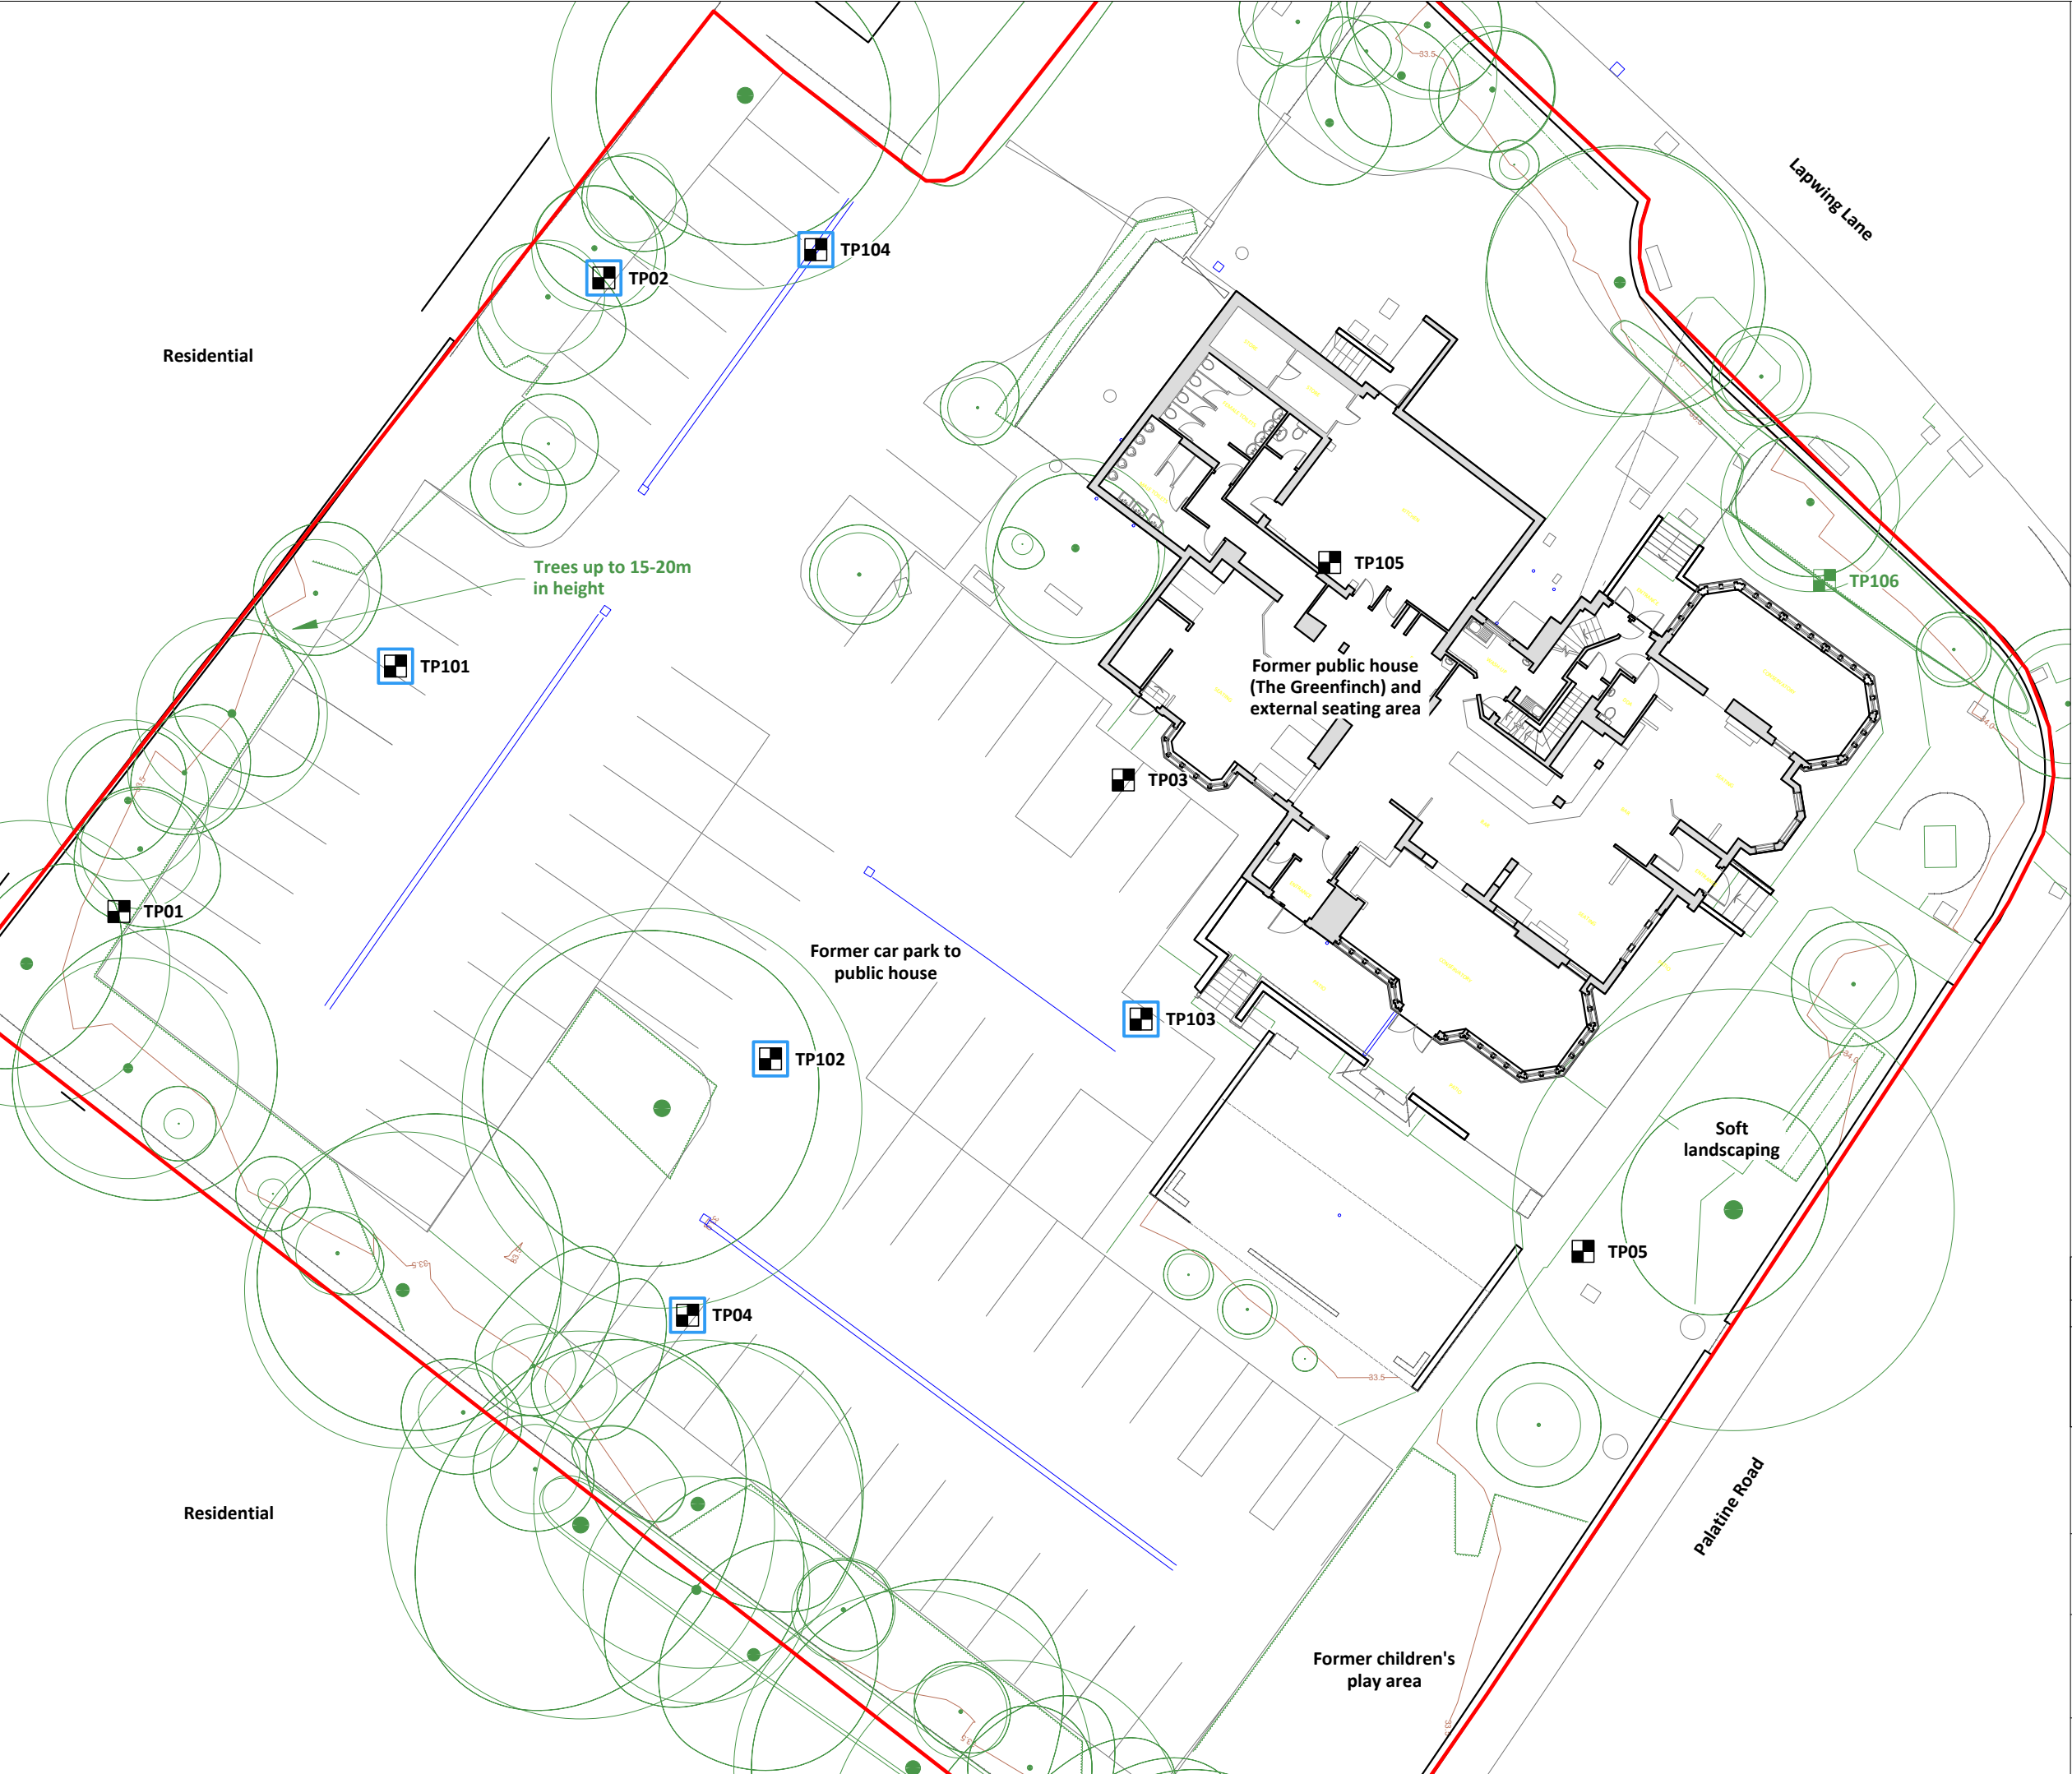
| PROJECT NO.<br>STT5335 | SCALE AT A3<br>1:250 | DRAWING NO.<br>02 |

- Key**
- TP Hand excavated trial pit
  - TP Machine excavated trial pit
  - Infiltration testing performed
  - Site boundary

| TITLE<br>Exploratory hole plan (current layout) | | |

- 4.1.2 A plan of the site showing observed/existing site features and position of exploratory points is presented on Drawing 02rev01.
- 4.1.3 The extent of fieldwork activities and position of exploratory points were determined by Soiltechnics.

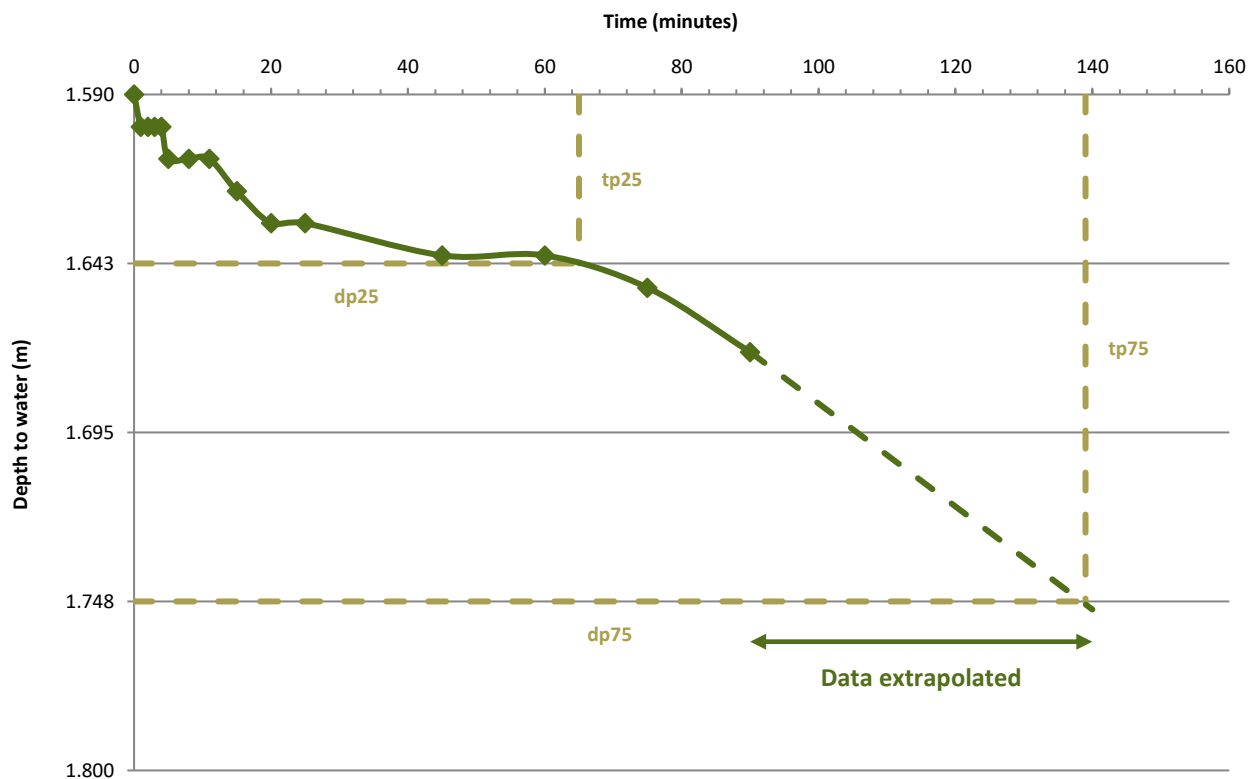
| $a_{p50}$ | Internal surface area up to 50% effective depth and including the base | 1.967m <sup>2</sup> m <sup>2</sup> |
| $t_{p75-25}$ | Time for the water level to fall from 75% to 25% effective depth | 4440 s |

| f | Soil infiltration rate | 1.68E-05 m/s |

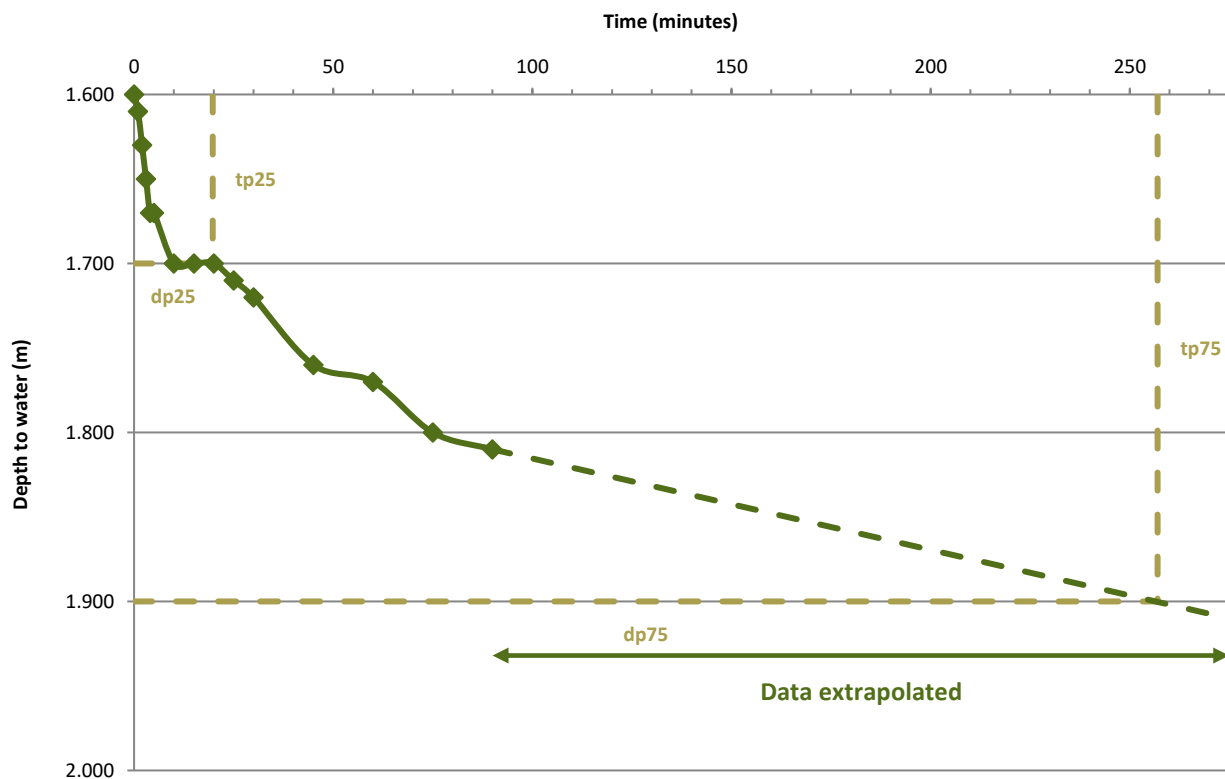
## Soil infiltration test (following BRE Digest 365 2016)

| f | Soil infiltration rate | 8.11E-06 m/s |

In summary infiltration rates of  $\sim 1.0 \times 10^{-5}$  m/s were recorded in TP101 and TP102 in the SW of the site. Slower infiltration rates of  $< 1.0 \times 10^{-5}$  m/s were recorded elsewhere, with a site-wide average of  $9.55 \times 10^{-6}$  m/s.

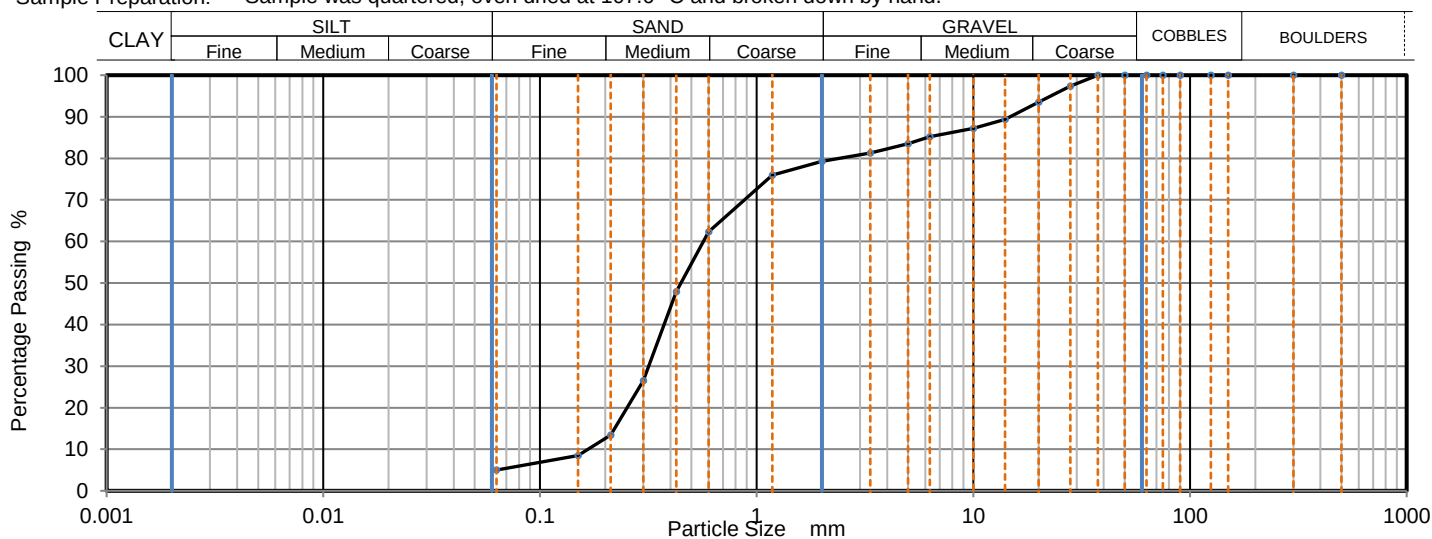
Laboratory Reference: 1843894  
Hole No.: TP01  
Sample Reference: 3  
Sample Description: Brownish grey slightly clayey gravelly SAND  
Sample Preparation: Sample was quartered, oven dried at 107.6 °C and broken down by hand.

Depth Top [m]: 1.00  
Depth Base [m]: Not Given  
Sample Type: B

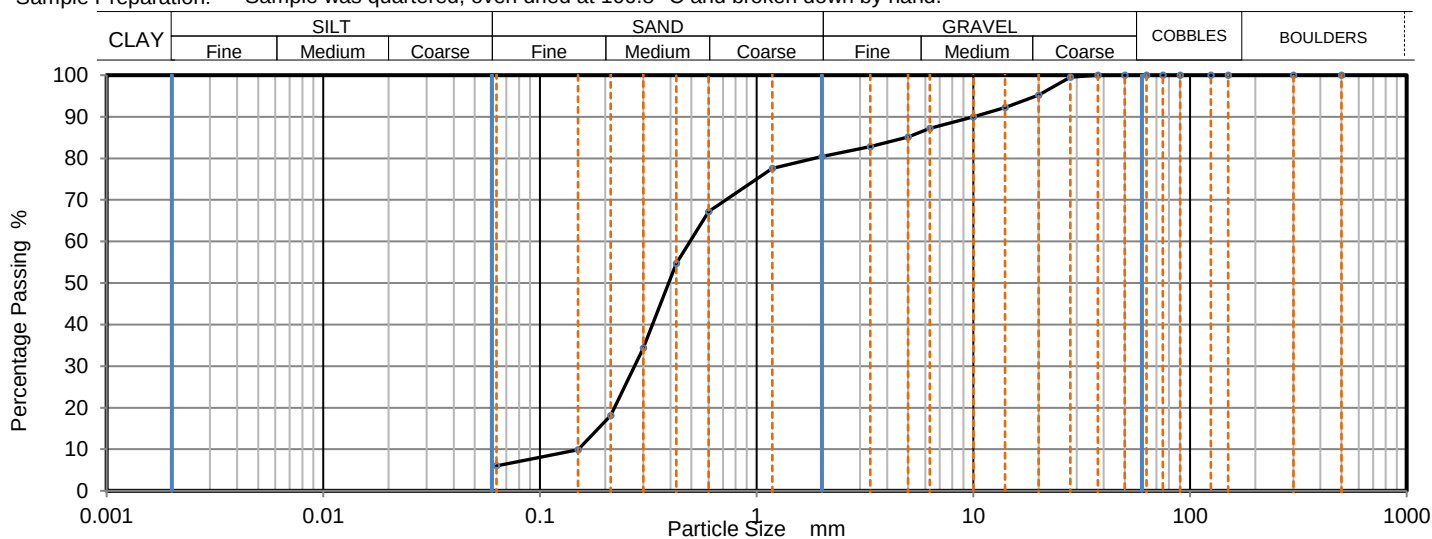
Laboratory Reference: 1843895  
Hole No.: TP01  
Sample Reference: 5  
Sample Description: Brown slightly clayey gravelly SAND  
Sample Preparation: Sample was quartered, oven dried at 106.8 °C and broken down by hand.

Depth Top [m]: 2.50  
Depth Base [m]: Not Given  
Sample Type: B

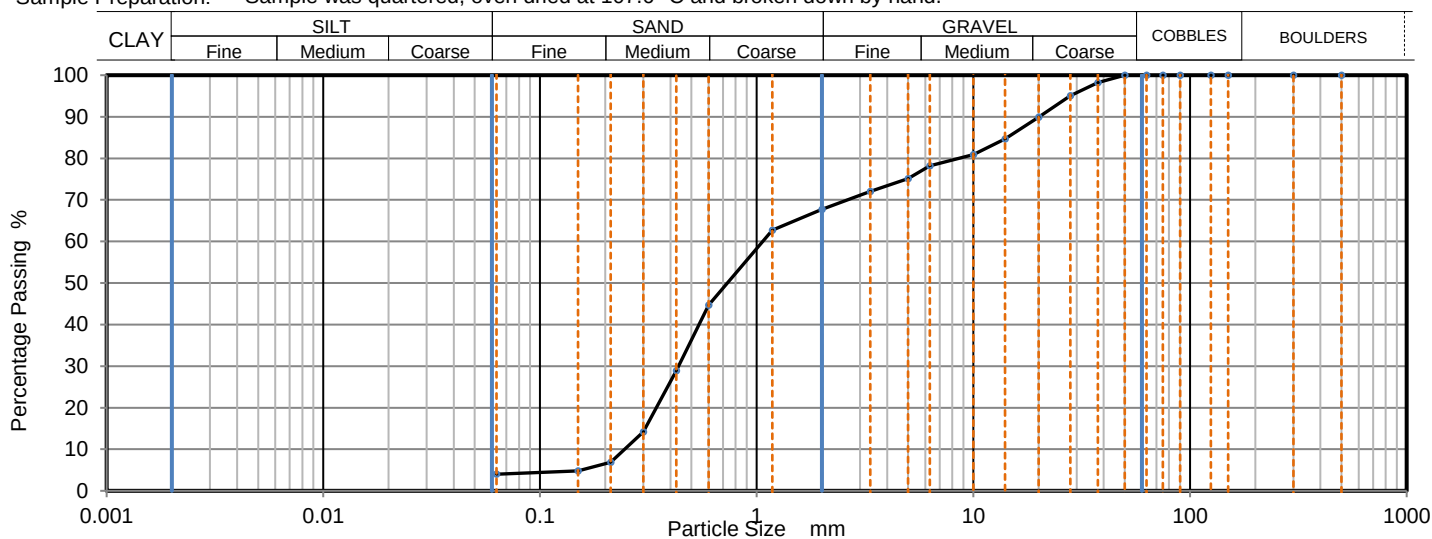
Laboratory Reference: 1843898  
Hole No.: TP04  
Sample Reference: 4  
Sample Description: Brownish grey slightly clayey gravelly SAND  
Sample Preparation: Sample was quartered, oven dried at 107.6 °C and broken down by hand.

Depth Top [m]: 1.30  
Depth Base [m]: Not Given  
Sample Type: B

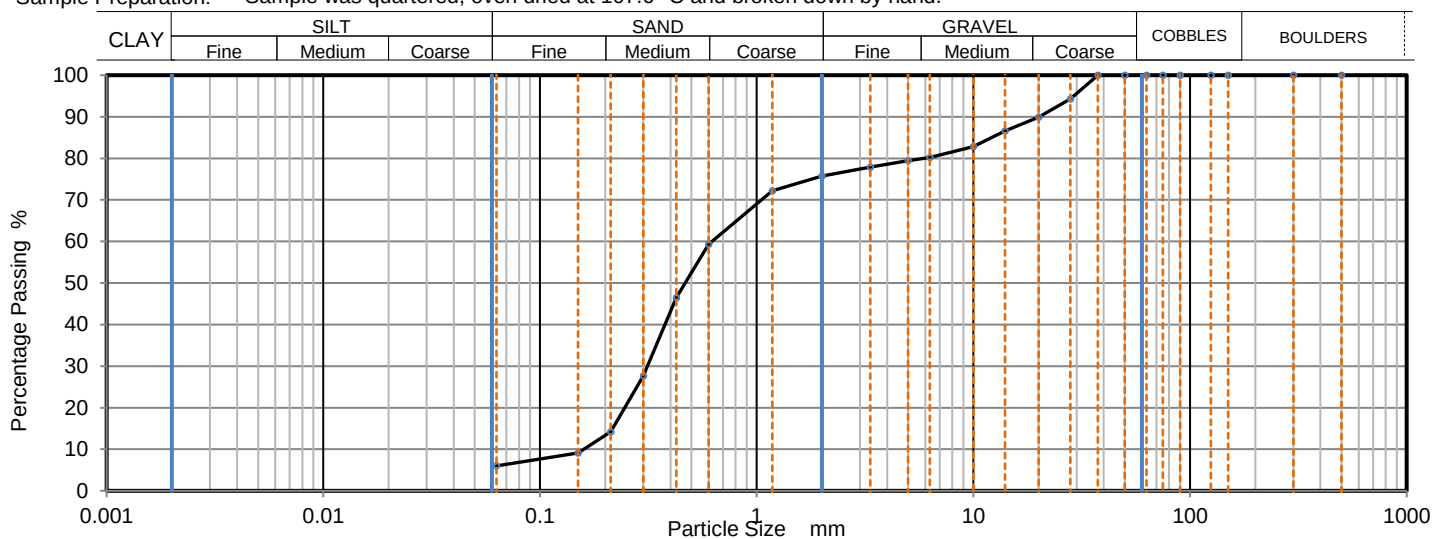
Laboratory Reference: 1843899  
Hole No.: TP05  
Sample Reference: 5  
Sample Description: Brownish grey slightly clayey gravelly SAND  
Sample Preparation: Sample was quartered, oven dried at 107.6 °C and broken down by hand.

Depth Top [m]: 1.80  
Depth Base [m]: Not Given  
Sample Type: B
