# St. Michaels

## Phase 2 Ground Investigation

Curtins Ref: 078847-CUR-00-XX-RP-GE-001

Issue Date: 03 October 2022

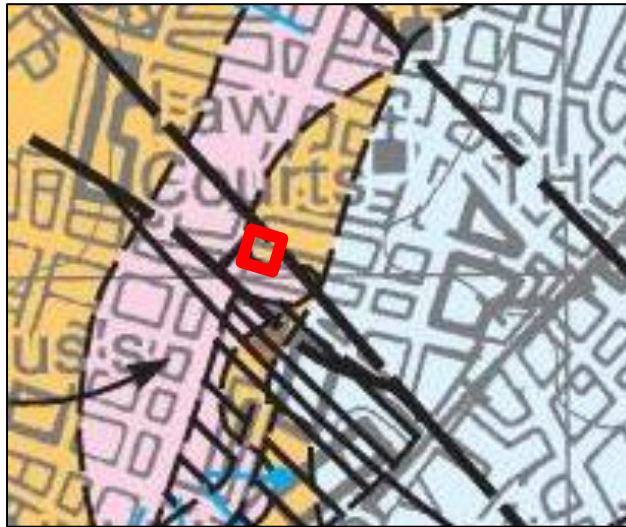
**Figure 2.3.2** – Extract of BGS 1:50,000 Geological Map. Approximate site location in Red.

A summary of the superficial stratigraphy is presented in *Figure 2.3.2*.

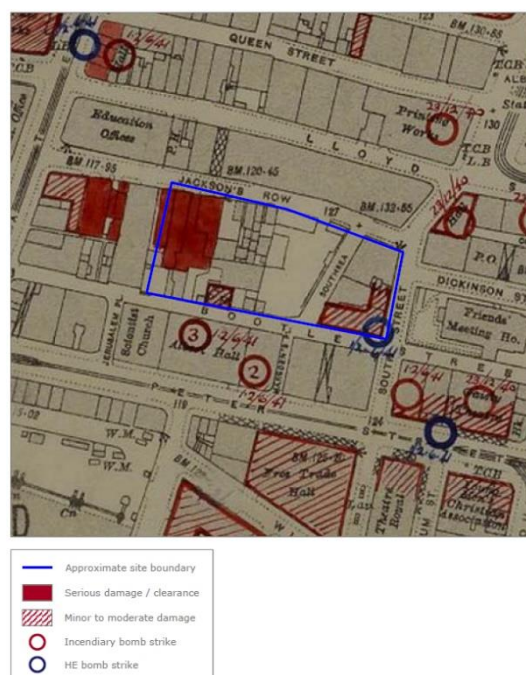
**Figure 2.5** – Extract of Manchester Damage Map (wider site area from WSP report shown in blue, approximate Curtins site boundary shown in black).

A Detailed UXO Assessment was commissioned by WSP, identifying the Curtins site as low risk. Within the report the Manchester damage map for the area is included, *Figure 2.5* below. This notes a bomb strike on site in the southeast corner and another approximately 60m southeast of the site. Areas of minor to moderate damage are noted on site to the southeast and 15m west and 60m southeast, and serious damage noted 20m and 80m northwest of the site, associated with the ruins noted on historical mapping.

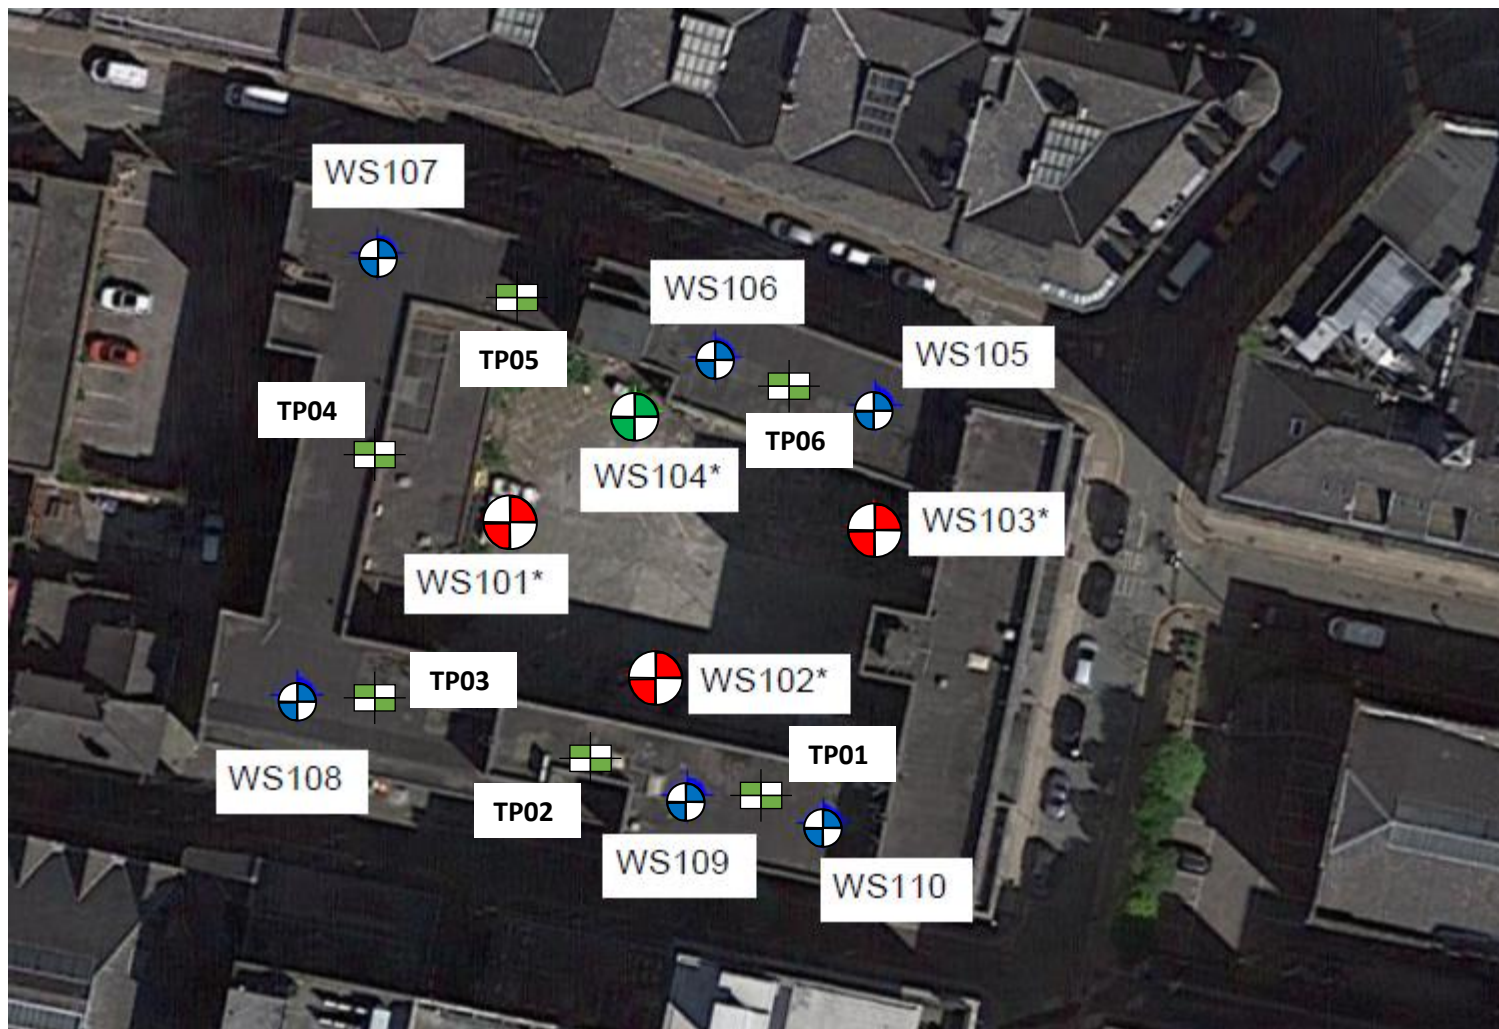
| 078874-CUR-00-XX-DR-GE-003-V02 | | | |

- Curtins Borehole Plan
- Development Drawings
