**EXPLOSIVE ORDNANCE  
DESKTOP STUDY  
FOR:**

**PROJECT 21013**

**HOUGH END SPORTS FIELDS  
PRINCESS ROAD  
MANCHESTER**

## EXPLOSIVE ORDNANCE DESKTOP STUDY

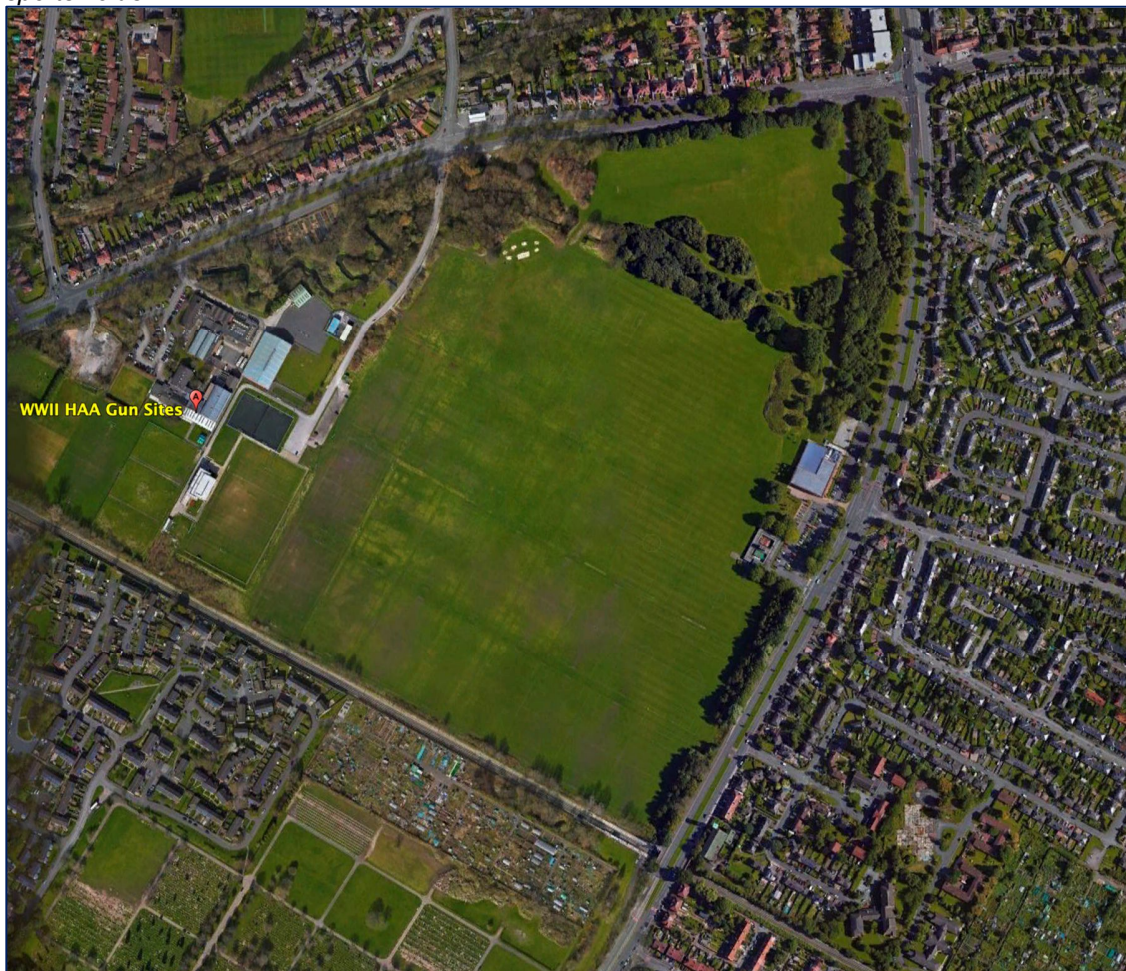
**Photo 3.1:** The Site area at present is unoccupied with exception of the leisure Centre which is located on the eastern edge of the Site Boundary. The area is mostly grassed and utilised as sports fields.

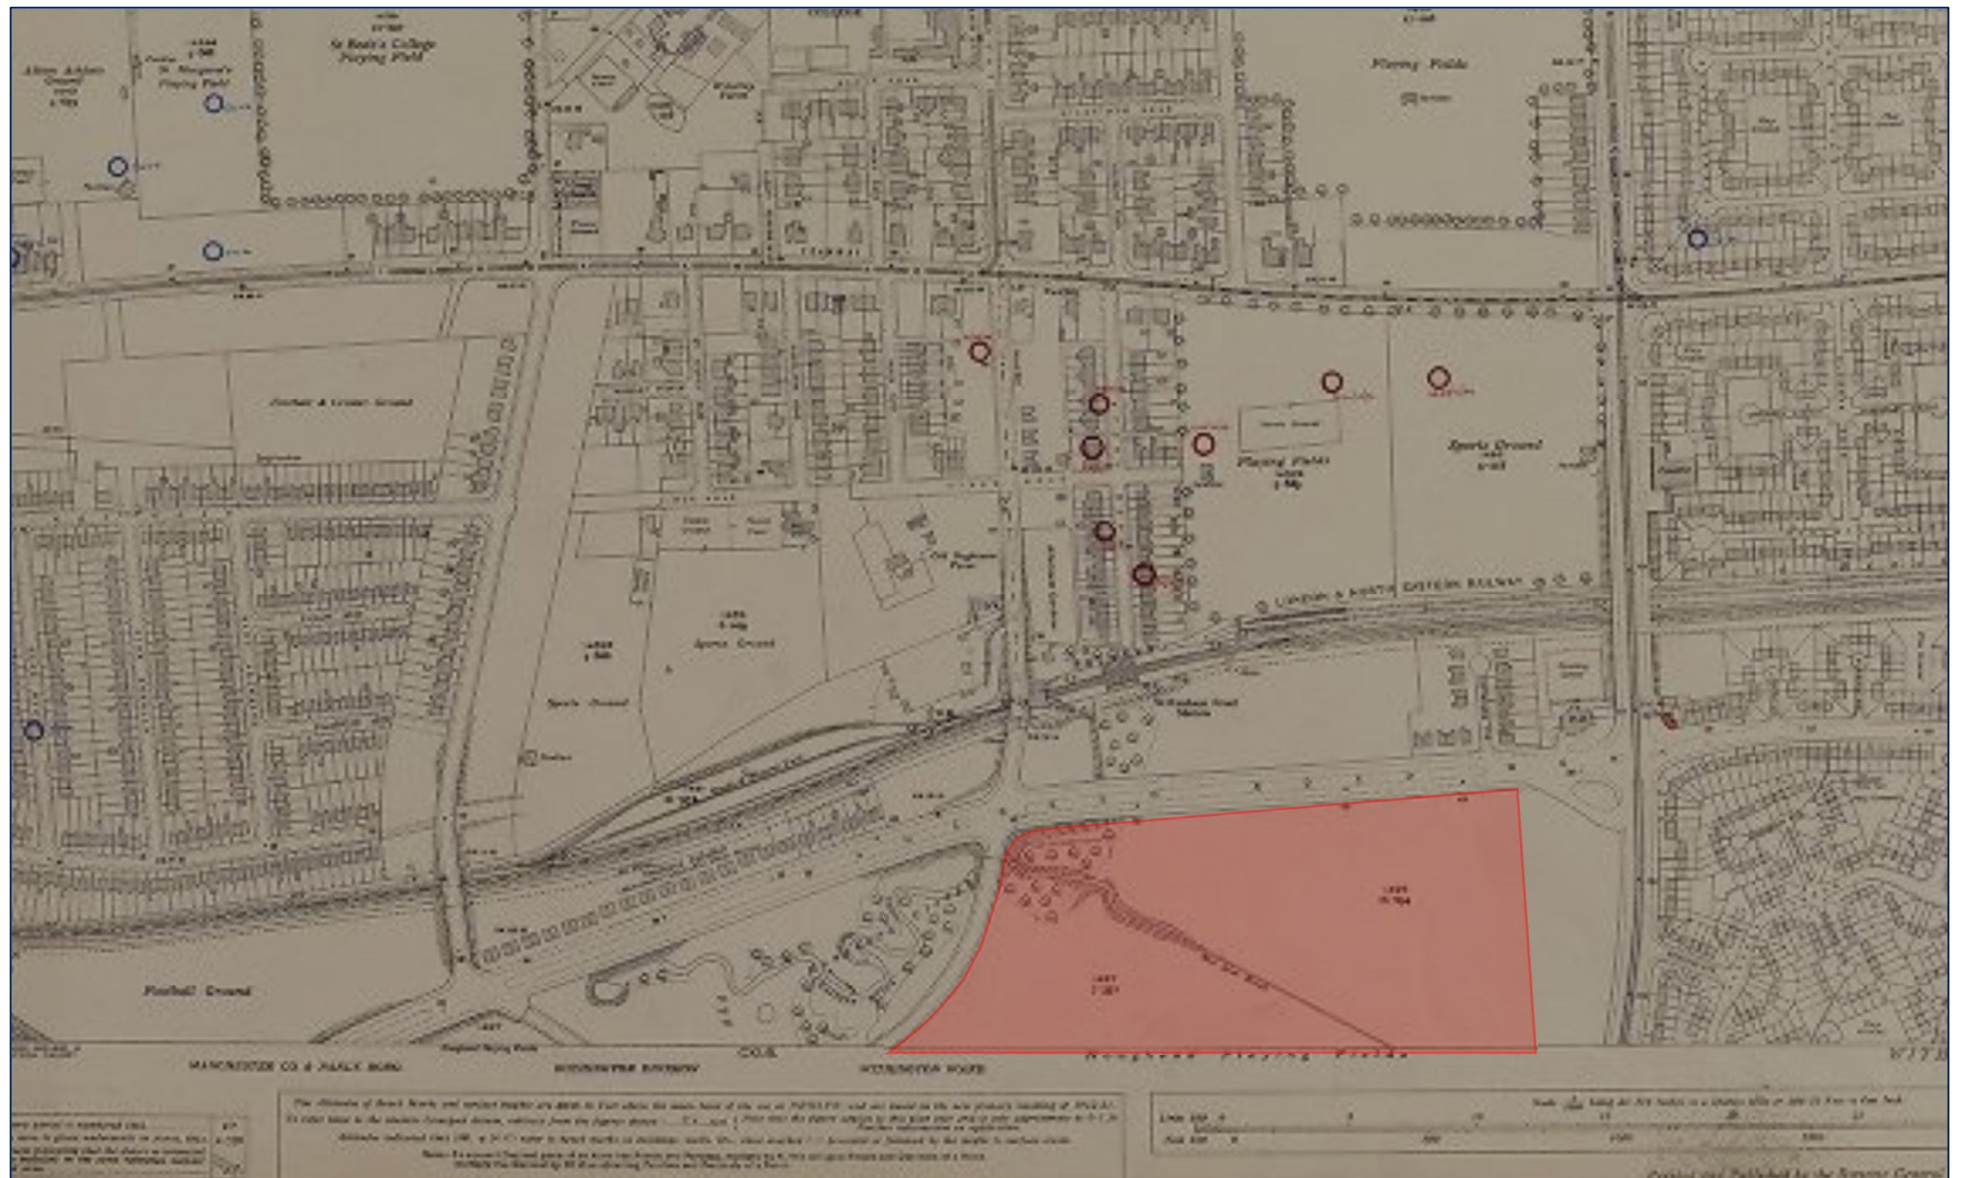
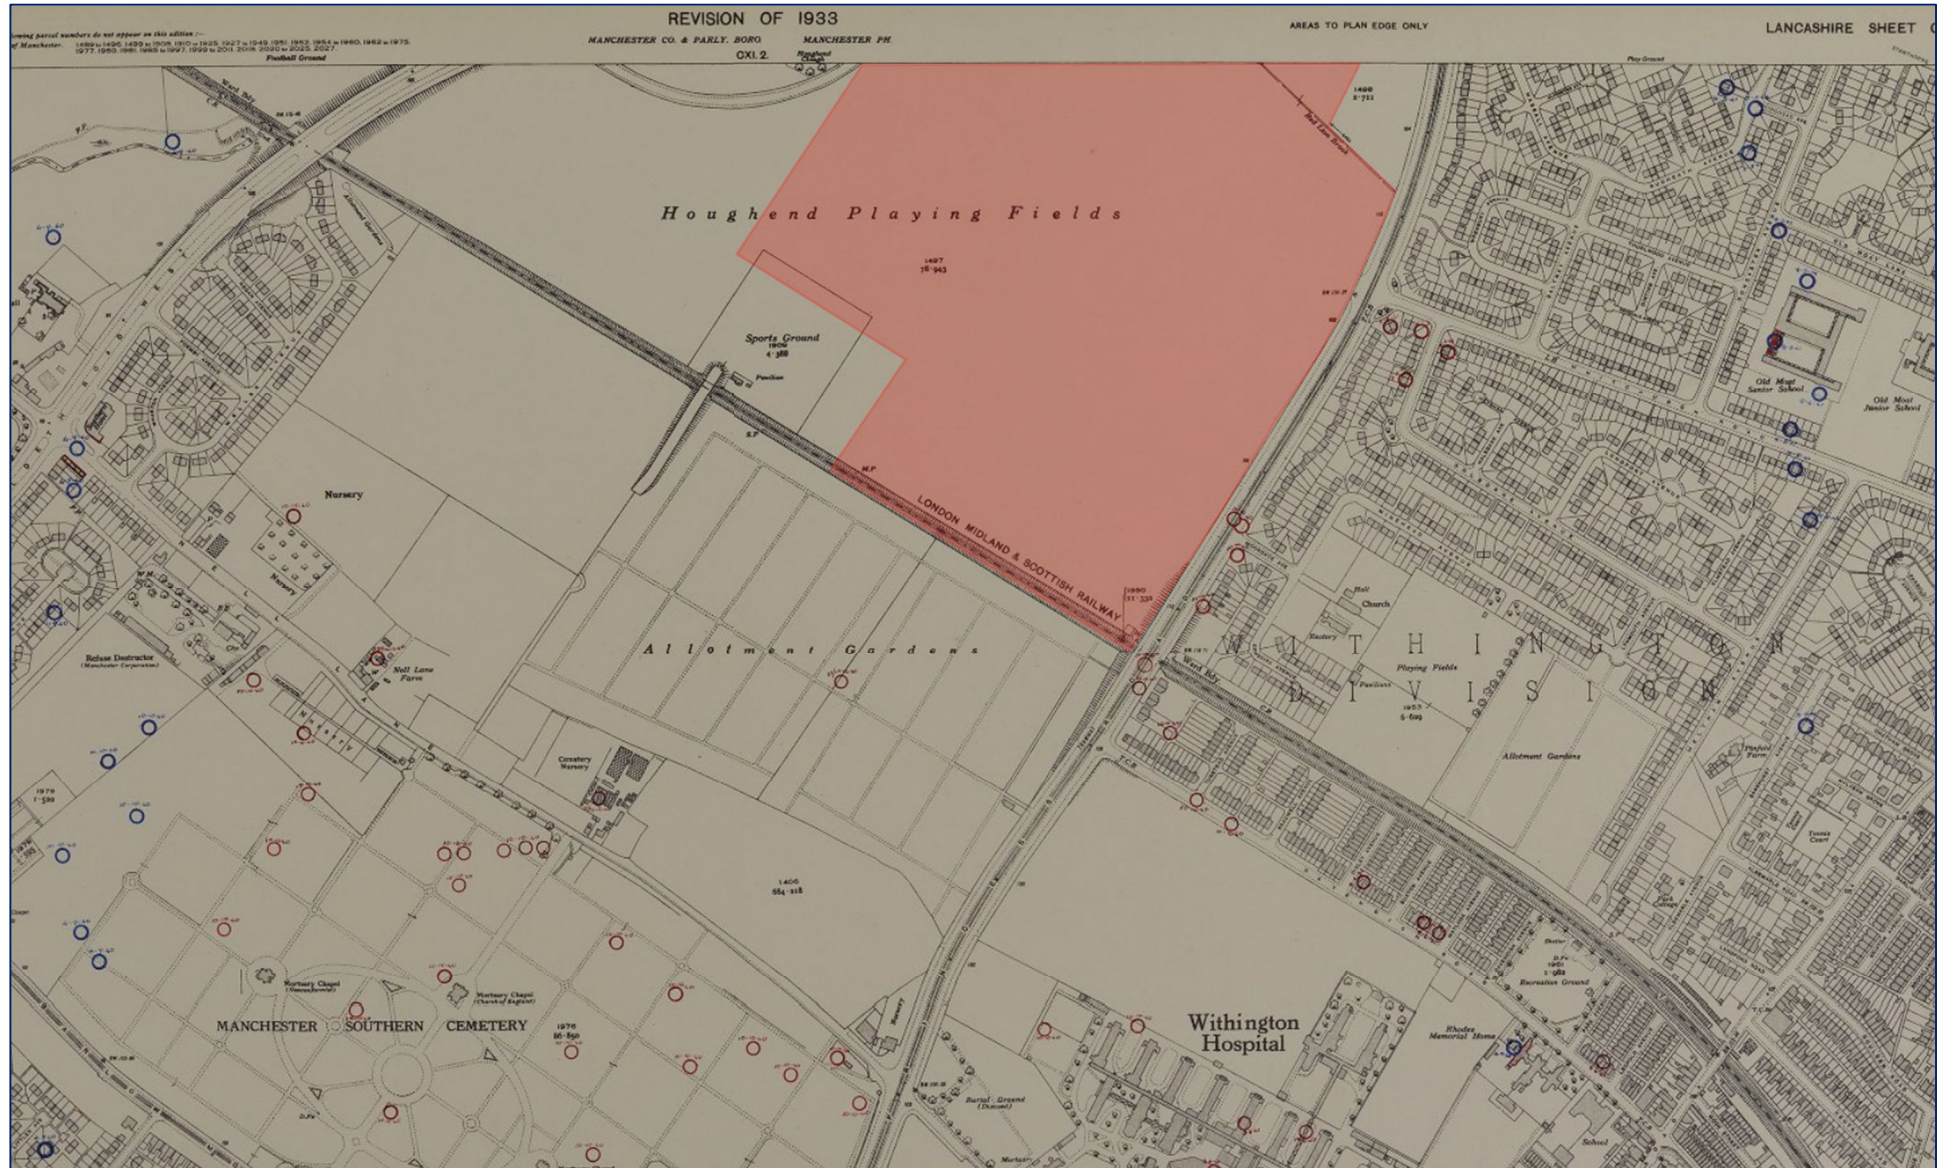
Site Position: Site shaded in Red.

**NOTE:** The below maps highlight Bomb damage caused throughout WW2 (Manchester Blitz Period) the varying degrees of Red indicates more damage sustained (shaded red – repairable/Dark red – beyond repair). The red circles indicate HE Bomb Strikes and the red circle coloured blue highlights a UXB. The Site does not indicate any bombs within its confines. However, due to the nature of the ground conditions throughout WW2 it would have been possible for bombs to have landed within its confines and remained undetected to this day.

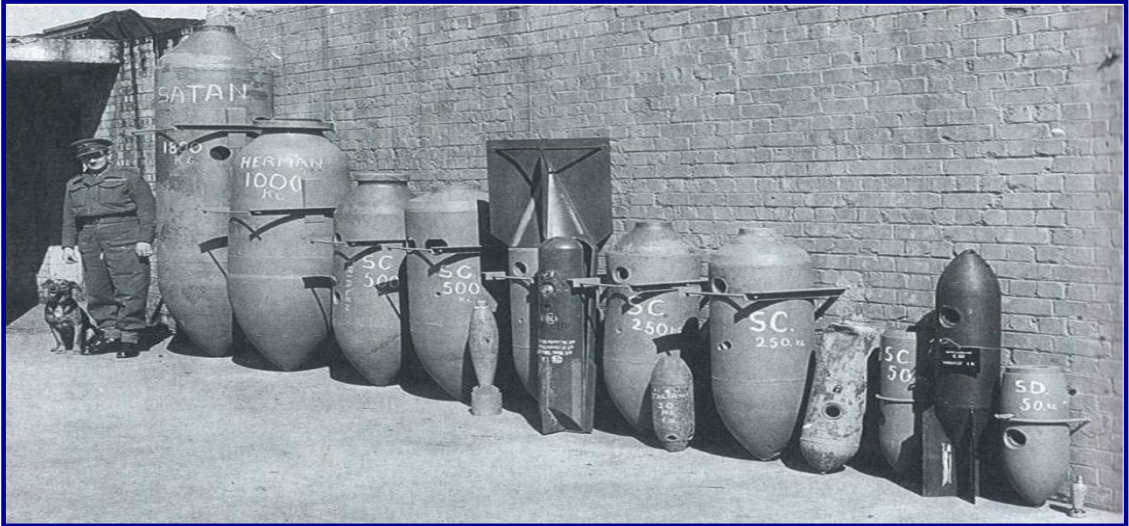
**FIGURE 3:** Range of HE bombs dropped on the United Kingdom.

**NOTE:** The smaller sub-munitions (Bomblets) seen to the right, ranged in size between 1 and 3kg, were dropped in large numbers and were intended as incendiary bombs, anti-personnel bombs or as bombs filling both roles. The smaller bomblets were dropped in larger container bombs designed to hold between 360 and 620 of the bomblets. The containers were designed to burst open at a predetermined height above ground level, dispersing the bomblets over a wide area. Air raid damage was far greater by using both incendiary, and HE bombs on a single raid. The fires started by the incendiaries being rapidly spread by the blast waves from the HE bomb. This scenario was shown to devastating effect on the 14<sup>th</sup> February 1945 in the German city of Dresden. Where fires started and spread by the bombing increased to a point where the oxygen was being sucked into the flames at such a high speed that the fire became a “Fire Storm”. At the time the city's population had increased due to a high number of refugees fleeing the Russian advance to the east, the exact civilian death toll from fire and suffocation will never be known, but is considered to be somewhere between 25,000 and 100,000.

**High Explosive (HE) Bomb.** Some of the most common type of ordnance to be dropped on the United Kingdom, HE bombs are often the type encountered as UXBs. Relatively thick cased, they are still recovered in remarkably good condition. Ranging in size from 50 to 1700 kg, their typical release height (1,500m) allowed them to penetrate deep into the ground as a result of design or flaw. Towards the end of the bombing campaign, as steel became scarce the German Engineers produced a range of bombs that used steel reinforced concrete as the bomb body. Figure 6.3 shows the range of steel HE bombs dropped on the UK.

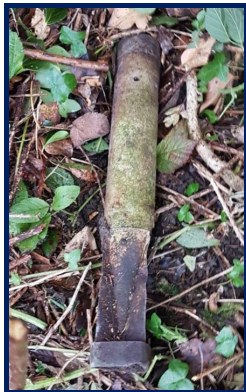
#### FIGURE 4: Incendiary Bombs.

Left, 1kg incendiary bomblet, and right a 50kg incendiary bomb containing bottles of white phosphorus.

**NOTE:** Incendiary bomblets were made of a flammable alloy similar in appearance to aluminium, which resists corrosion well. The tail unit was made of thin tin-plate steel and is more prone to have rusted away. Some Incendiary models were fitted with a High Explosive (HE) steel nose. With the tail and explosive nose attached the bomb was 480mm long.

**Incendiary Bomb.** The larger incendiary bombs, containing bottles of white phosphorus and an incendiary mixture contained within a thin steel case were designed to burst on contact with the ground. A fixed dispenser on the aircraft delivered the smaller type of bomb or ‘Bomblet’ to the target area in container bombs or; both types of container would open dispersing the smaller Incendiary bombs. Relatively small and light they were unlikely to penetrate the ground to any significant depth. However, once concealed in bomb damage rubble or below water they were easily missed and are still unearthed today from in-fill and drained land. Later versions of the incendiary bomb contained an additional explosive charge used as a short delay “Booby Trap” device that contained a significant amount of high explosive. The Booby Trap component was designed to kill or injure fire fighters and hinder the damage control. See Figure 4.

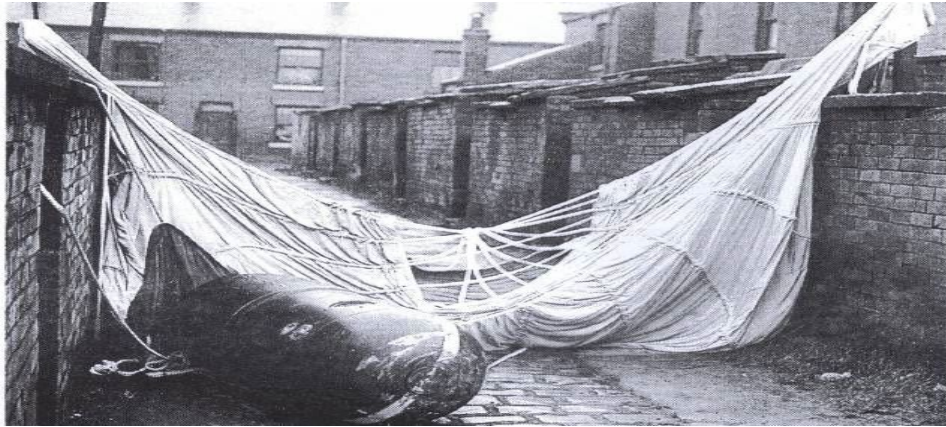
**FIGURE 5:** Common Airdropped Mines.

Parachute & Ground Mines

**NOTE:** all mine fuzes were designed to arm after deployment from the ship, submarine or aircraft, some fuze designs incorporated anti-removal booby traps. Unexploded mines found today are the result of a failure within the arming mechanism or procedure whereby the mine never fully armed. Sudden shock or jarring of a weapon in this state has the potential to complete the arming sequence and could result in the mine detonating with lethal consequences.

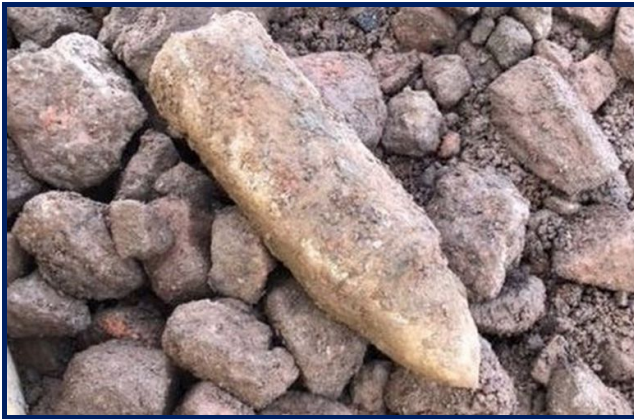
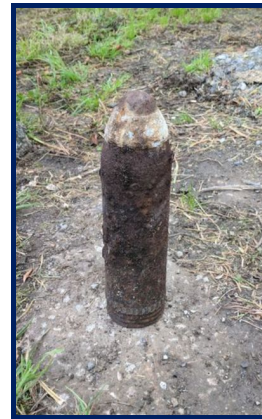
**FIGURE 6: Generic Shell Design**

Generic High Explosive (HE) Shells (recent finds on site around the UK)
