## Preliminary Bat Roost Assessment

Wythenshawe Hospital

Ref: P.1721.22

September 2022

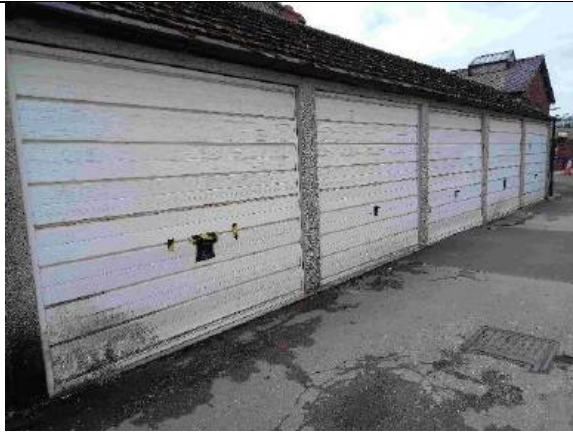
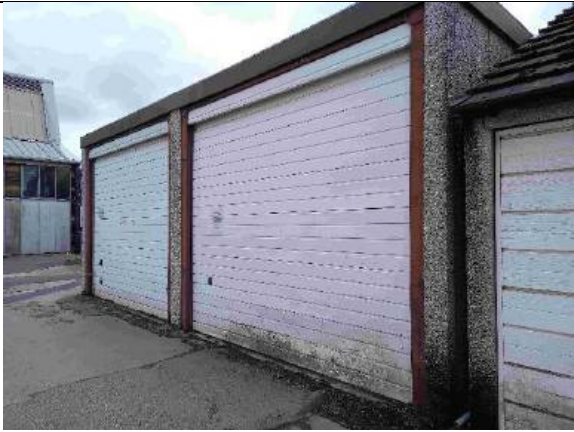
Building B1 is a single storey garage currently in use as offices and storage. The western section of the roof is pitched and tiled, and the eastern section is sloped and constructed in corrugated metal sheets with a dense coverage of moss identified on both sections. The garage exterior walls are covered in pebble dash render on all elevation and the fascias are wooden with small gaps identified between the fascias and walls. Garage doors are present on the northern elevation of the building and small gaps were identified between the garage door frames and walls. Internally, the roof is lined and supported by wooden beams. No evidence of bats or other species were noted during the internal or external inspection. Building 1 is displayed within photographs 1 -5 within Appendix 3.

The building was assessed to have **negligible** hibernation potential for crevice and void dwelling bats and **low** potential for day and maternity roosts for crevice dwelling bats and **low** potential for void dwelling bats. Overall, the building is classified as having **low** bat roosting potential.

| <p>Photograph 1: Garages (B1)</p> | <p>Photograph 2: Garages (B1)</p> |

The buildings within the site are to be demolished, therefore buildings B1 and B5d, assessed to provide **low** bat roost potential, will require a minimum of one nocturnal survey undertaken between May and August to assess if bats are using the buildings within the site as a roost and to inform further recommendations if required.

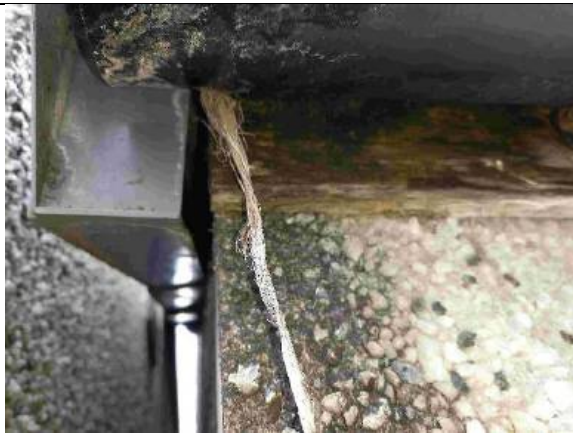
| <p>Photograph 3: Gaps between facias and walls on garages (B1)</p> | <p>Photograph 4: Internal of one garage (B1)</p> |

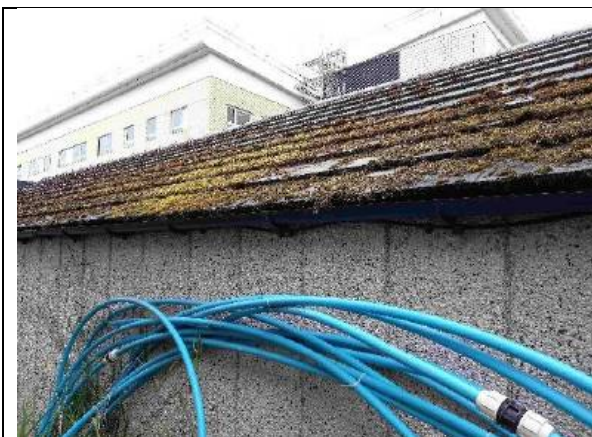
Photograph 5: Dense moss coverage on roof of garages (B1)

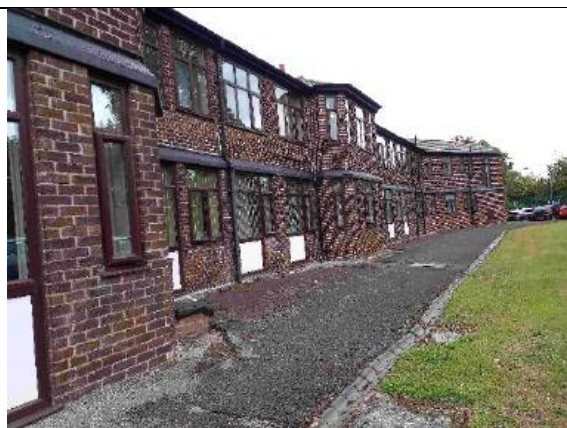
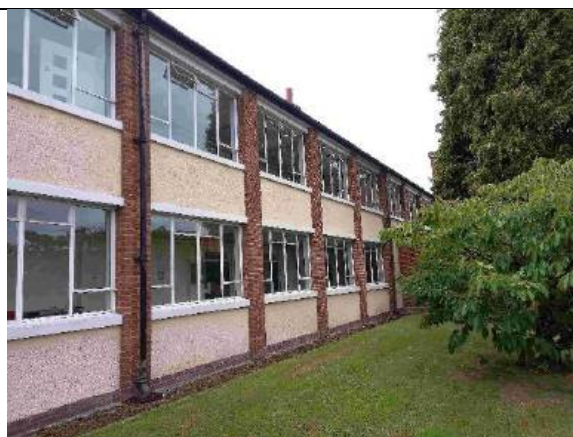
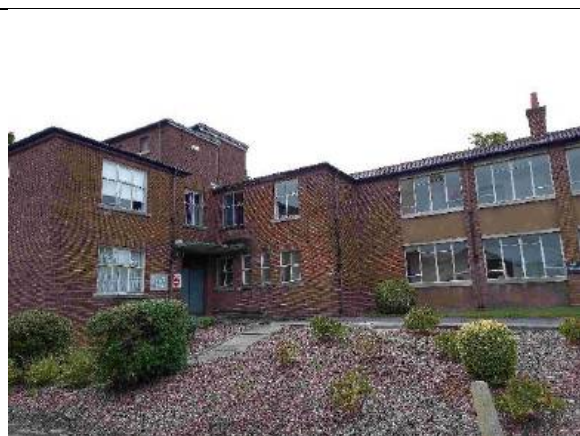
Building B2 is a large, two-storey hospital clinic constructed in brickwork walls with a multi pitched tiled roof with wooden fascias and soffit boards. Lifted and slipped tiles were noted within the roof and along the ridgeline and gaps were identified underneath and between adjoining fascias. Chimneys and flue vents are present within the roof and lifts were identified within the surrounding flashing. The brickwork has large areas of missing mortar and cracks present throughout all elevations. The windows are a mixture of double-glazed and single-glazed and sit within wooden frames with pebble render present underneath the windows on the southern elevation. Two storey extensions are present off the northern elevation and are constructed in brickwork walls with flat felt roofs and wooden fascias. Lifts were identified within the felt and very small gaps identified underneath the fascias. No evidence of bats or other species were noted during the external inspection. Building 2 is displayed within photographs 6 - 9 within Appendix 3.

The building was assessed to have **negligible** hibernation potential for crevice and void dwelling bats and **moderate** potential for day and maternity roosts for crevice dwelling bats and **moderate** potential for void dwelling bats. Overall, the building is classified as having **moderate** bat roosting potential.

Photograph 6: Southern elevation of B2

Photograph 8: Northern elevation of B2

Photograph 9: Building B2

Buildings B2, B3, B4, B5a, B5b and B5c were assessed to provide **moderate** bat roost potential therefore will require a minimum of two nocturnal surveys undertaken between May and September (with at least one survey to occur between May and August) to assess if bats are using the buildings within the site as a roost and to inform further recommendations if required.

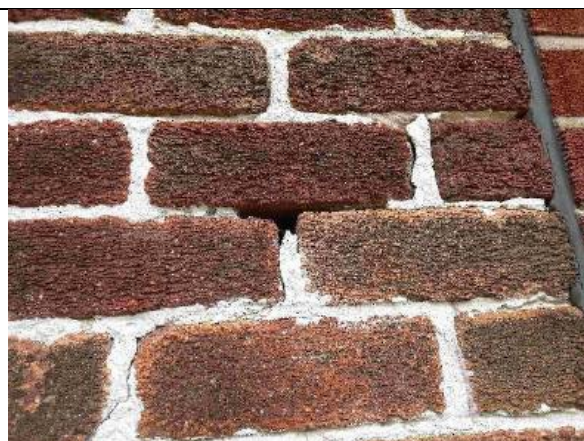
Photograph 7: Missing mortar on B2

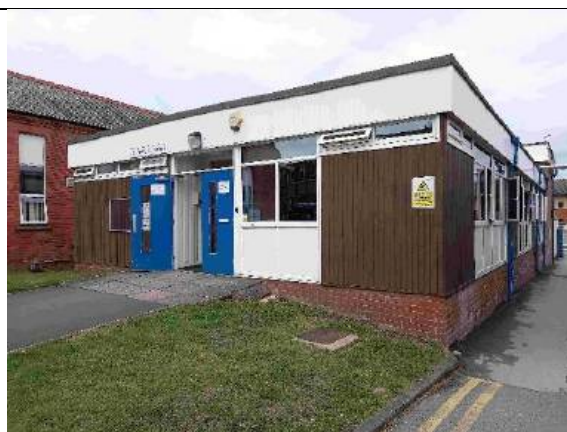
Building B3 is a single storey office constructed in brickwork walls with wooden panel cladding present on the southern half of the building. The brickwork is in good condition with only small areas of missing pointing noted throughout. The roof is constructed in felt and surrounded by wooden fascias and soffit boards. The roof contains multiple lifts and gaps throughout and the fascias were noted to be broken, with large gaps and holes identified with the fascias and soffit boards. No evidence of bats or other species were noted during the external inspection. Building 3 is displayed within photographs 10 - 13 within Appendix 3.

Photograph 10: Southern elevation of B3

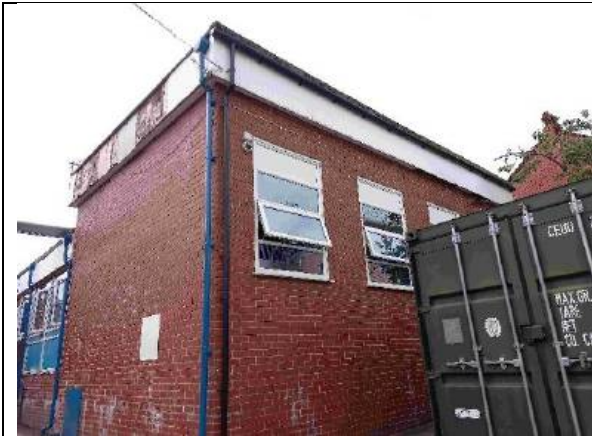
The building was assessed to have **negligible** hibernation potential for crevice and void dwelling bats and **moderate** potential for day and maternity roosts for crevice dwelling bats and **moderate** potential for void dwelling bats. Overall, the building is classified as having **moderate** bat roosting potential.

Photograph 11: Broken fascias on building B3

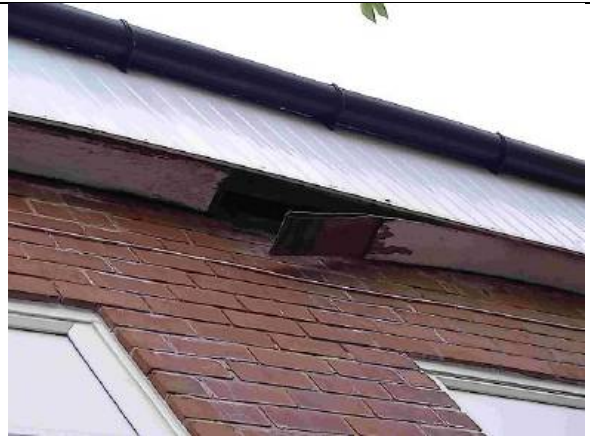
Photograph 12: Broken soffit board on B3

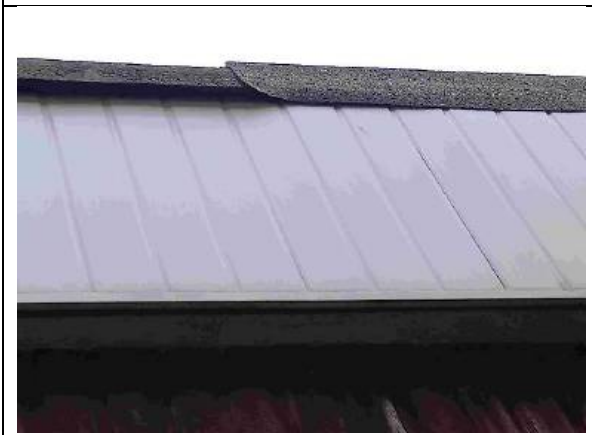
Photograph 13: Lifted felt on roof of B3

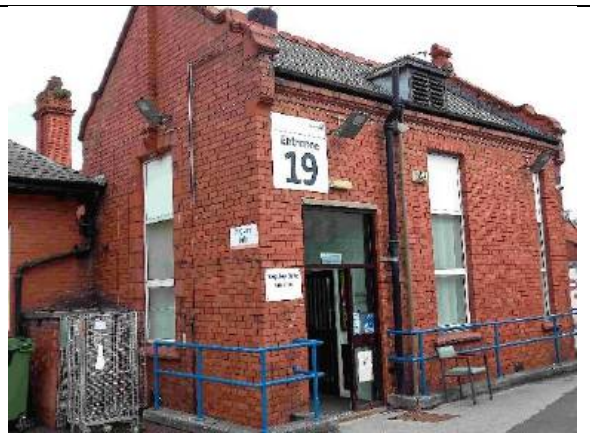
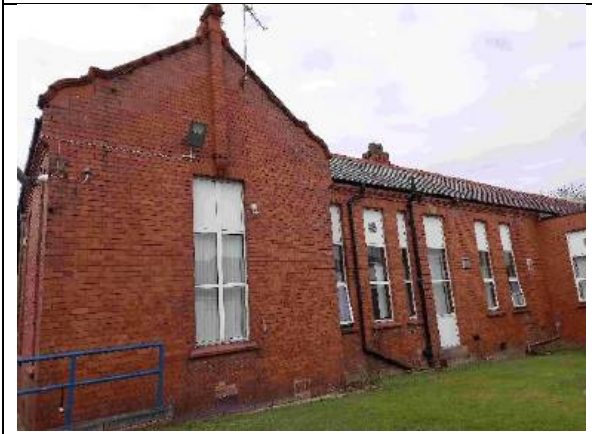
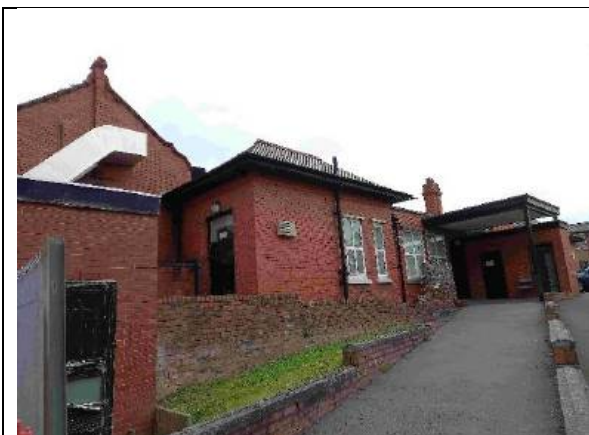
Building B4 is a single storey hospital clinic constructed in brickwork walls with a multi-pitched tiled roof. The brickwork has cracks and missing bricks with large areas of missing pointing identified on all elevations. Tiles were noted to be missing, slipped and lifted throughout the roof and along the ridgeline. Chimneys and flue vents were identified within the roof and vegetation was noted to have encroached the chimneys and lifts identified in the surrounding flashing. Gaps are present underneath and between wooden facias and soffit boards as well as between the facias and roof tiles. No evidence of bats or other species were noted during the external inspection. Building 4 is displayed within photographs 14 - 17 within Appendix 3.

Photograph 14: Building B4

Photograph 15: Eastern elevation of B4

Photograph 17: Western elevation of B4

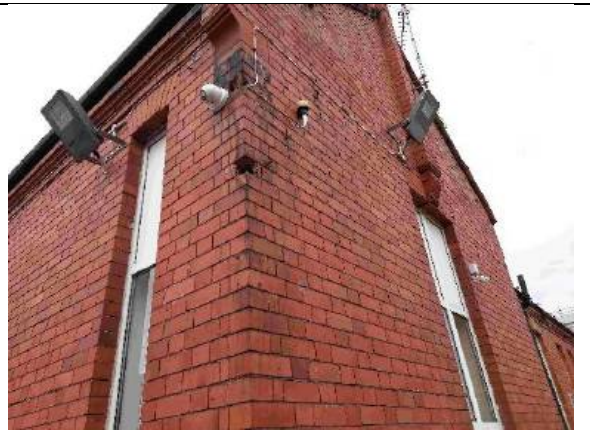
The building was assessed to have **negligible** hibernation potential for crevice and void dwelling bats and **moderate** potential for day and maternity roosts for crevice dwelling bats and **moderate** potential for void dwelling bats. Overall, the building is classified as having **moderate** bat roosting potential.

Photograph 16: Missing brickwork on B4

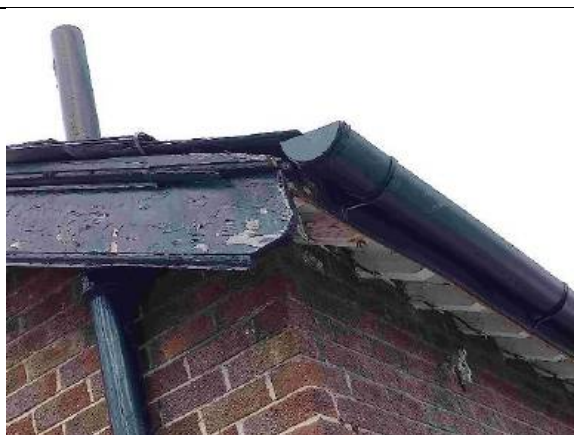
Building B5a is a single storey hospital clinic constructed in brickwork walls with a multi-pitched tiled roof with raised skylights present. The raised skylights are boarded with plywood and gaps are present between the boards. The brickwork has cracks and areas of missing pointing identified on all elevations. Tiles were noted to be missing, slipped and lifted throughout the roof and along the ridgeline. Painted wooden facias and soffit boards surround the building and gaps were noted throughout and the paint peeling. Gaps were also identified at the gable ends as well as between the facias and roof tiles. Double glazed uPVC windows are present throughout and no gaps identified between the frames and brickwork. No evidence of bats or other species were noted during the external inspection. Building 5a is displayed within photographs 18 - 21 within Appendix 3.

The building was assessed to have **negligible** hibernation potential for crevice and void dwelling bats and **moderate** potential for day and maternity roosts for crevice dwelling bats and **moderate** potential for void dwelling bats. Overall, the building is classified as having **moderate** bat roosting potential.

Photograph 18: Gaps between roof tiles and facias on B5a

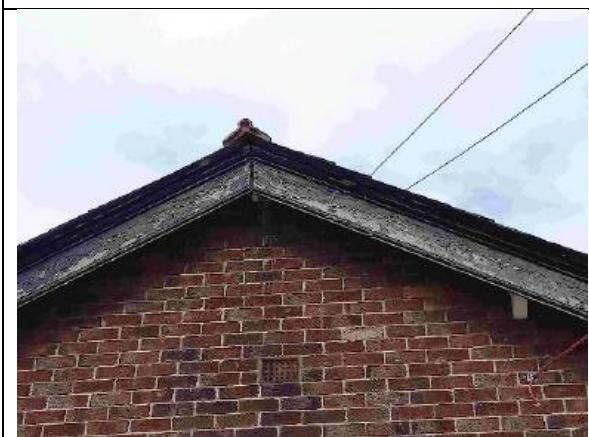
Photograph 19: Gap at gable end of B5a

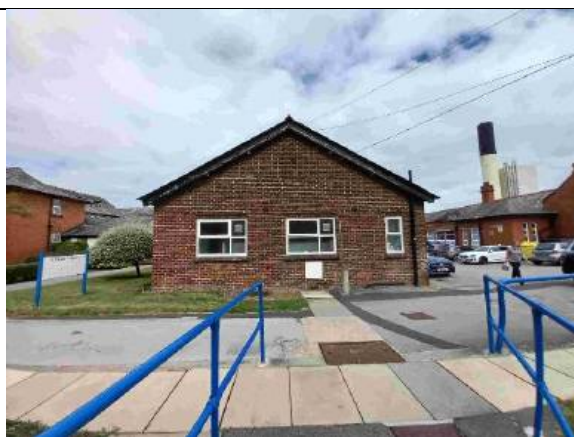
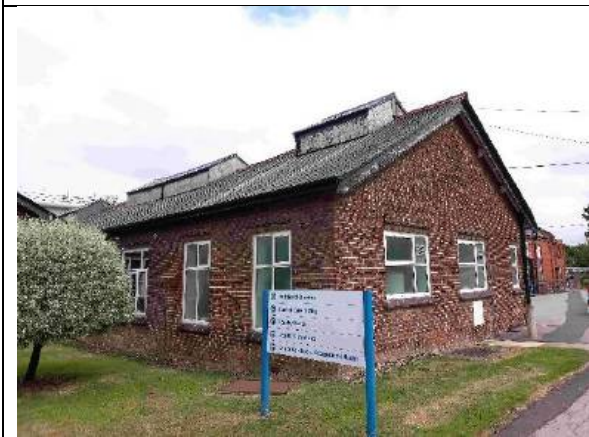
Photograph 20: Southern elevation of B5a

Photograph 21: Building B5a

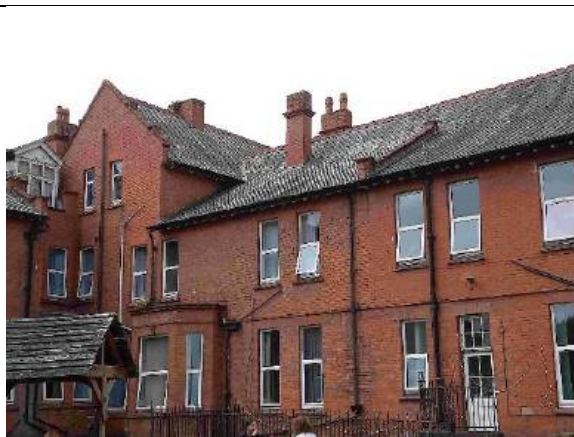
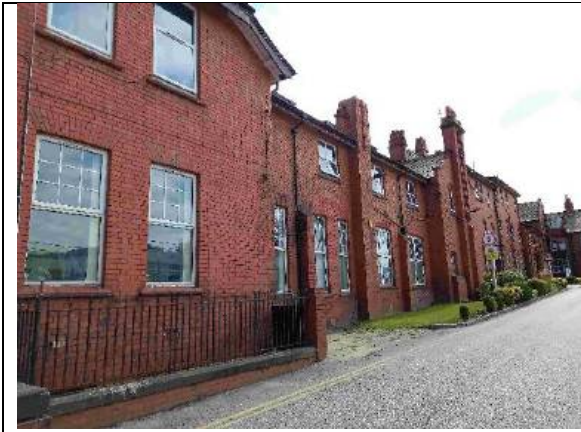
Building B5b is a large, multi-storey hospital clinic directly connected to B5a and B5B. The building is constructed in brickwork walls with a multi-pitched tiled roof with chimneys and flue vents present throughout. The brickwork contains cracks with large areas of missing pointing present throughout. The roof has missing, lifted and slipped tiles throughout and along the ridgeline and the flashing around the chimneys noted to be lifted with small areas encroached with vegetation. The windows are a mixture of double and singled glazed and sit within both uPVC and wooden frames and some smaller windows

were noted to be boarded up. No evidence of bats or other species were noted during the external inspection. Building 5b is displayed within photographs 22 - 23 within Appendix 3.

The building was assessed to have **negligible** hibernation potential for crevice and void dwelling bats and **moderate** potential for day and maternity roosts for crevice dwelling bats and **moderate** potential for void dwelling bats. Overall, the building is classified as having **moderate** bat roosting potential.

Photograph 22: Eastern elevation of B5b

Photograph 23: Western elevation of B5b

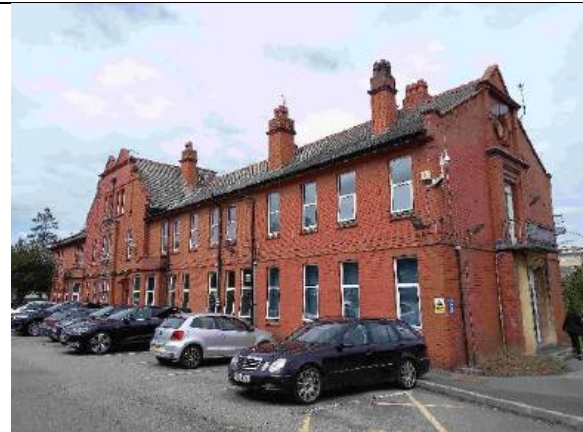
Building B5c is a large, multi-storey hospital clinic directly connected off the southern elevation of B5b. The building constructed in brickwork walls with a multi-pitched tiled roof with chimneys and flue vents present throughout. The brickwork contains cracks with large areas of missing pointing present throughout. The roof has missing, lifted and slipped tiles throughout and along the ridgeline and the flashing around the chimneys noted to be lifted with small areas encroached with vegetation. The windows are a mixture of double and single glazed and sit within both uPVC and wooden frames and some smaller windows were noted to be boarded up. The windows are a mixture of styles with wooden fascias and soffit boards present on the dormer and bay windows and gaps identified between the fascias and soffit boards. No evidence of bats or other species were noted during the external inspection. Building 5c is displayed within photograph 24 within Appendix 3.

The building was assessed to have **negligible** hibernation potential for crevice and void dwelling bats and **moderate** potential for day and maternity roosts for crevice dwelling bats and **moderate** potential for void dwelling bats. Overall, the building is classified as having **moderate** bat roosting potential.

Photograph 24: Southern elevation of B5c

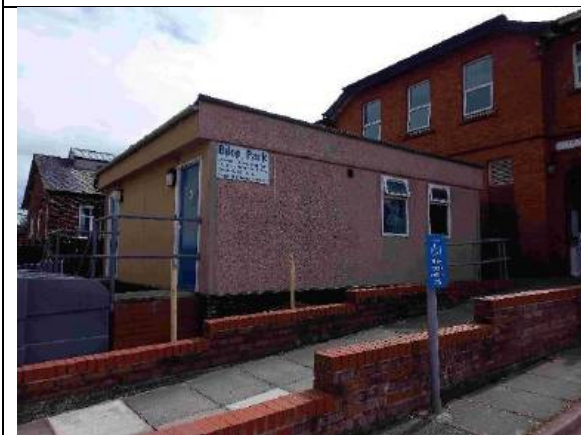
Building B5d is a small facility building containing showers, toilets, lockers and bike stands located north of B5b. The building is constructed in pebbledash style cladding with a flat felt roof. Small lifts were identified within the felt roof and gaps identified between the cladding. No evidence of bats or other species were noted during the external inspection. Building 5d is displayed within photograph 25 within Appendix 3.

The building was assessed to have **negligible** hibernation potential for crevice and void dwelling bats and **low** potential for day and maternity roosts for crevice dwelling bats and **low** potential for void dwelling bats. Overall, the building is classified as having **low** bat roosting potential.

Photograph 25: Building B5d

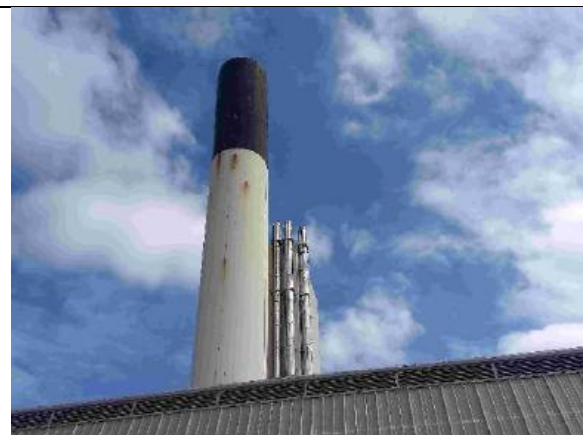
Building B6 is a large disused industrial chimney constructed in steel. No evidence of bats or other species were noted during the external inspection. The chimney (B6) is displayed within photograph 26 within Appendix 3.

Due to the unfavourable roosting materials that would result in temperature fluctuations and lack of access points the chimney (B6) was assessed to have **negligible** hibernation potential for crevice and void dwelling bats and **negligible** potential for day and maternity roosts for crevice dwelling bats and **negligible** potential for void dwelling bats. Overall, the building is classified as having **negligible** bat roosting potential.

Photograph 26: Chimney (B6)
