# BRIDGEWATER HOUSE DEANSGATE

## Bat Emergence Survey Report

*July 2022*

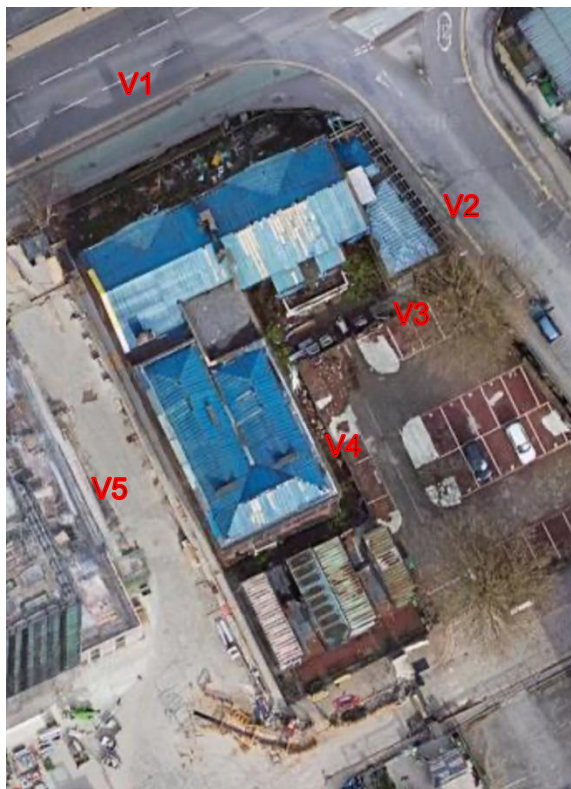
Figure 2.1 Surveyor Locations

2.3.2. Please refer to Figure 2.1 for locations of vantage points used during the surveys.

2.3.3. The dusk survey was undertaken in line with guidance as set out in Collins (2016). Surveyors used heterodyne handheld bat detectors. All surveyors were suitably experienced undertaking bat emergence surveys. Please refer to Table 2.1 below for details of surveyors.

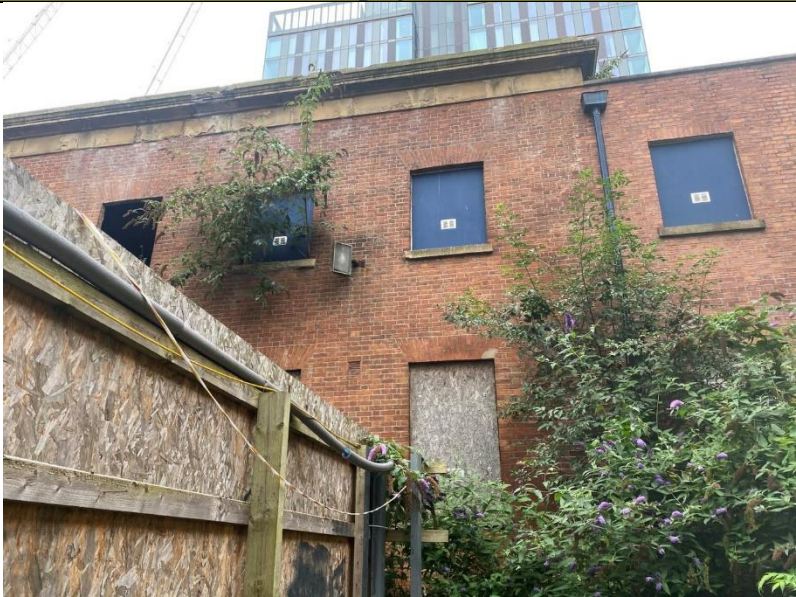
- 3.2.1. A multi-storey red brick building with a multi-pitched roof which had been soft stripped. The external brick work was in good condition with no obvious crevices within the brick work. Air bricks were present on the majority of aspects of the building and may lead to a suitable cavity for roosting bats.

| Feature | Photograph |
|---|---|
| Eastern aspect of the building | |

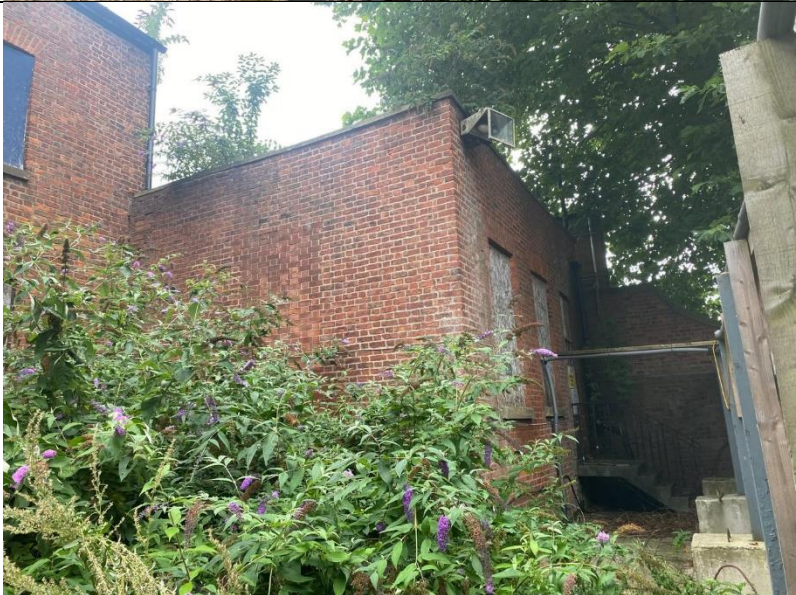
- 3.2.3. The roof was constructed of plastic sheeting and wooden frame. The tiles had been removed during the survey. The plastic sheeting provided no suitable access to the loft space. The central aspect of the building comprised a flat roof and constructed of concrete with no loft space present.

| Feature | Photograph |
|---|---|
| Flat roof aspect of the building | |

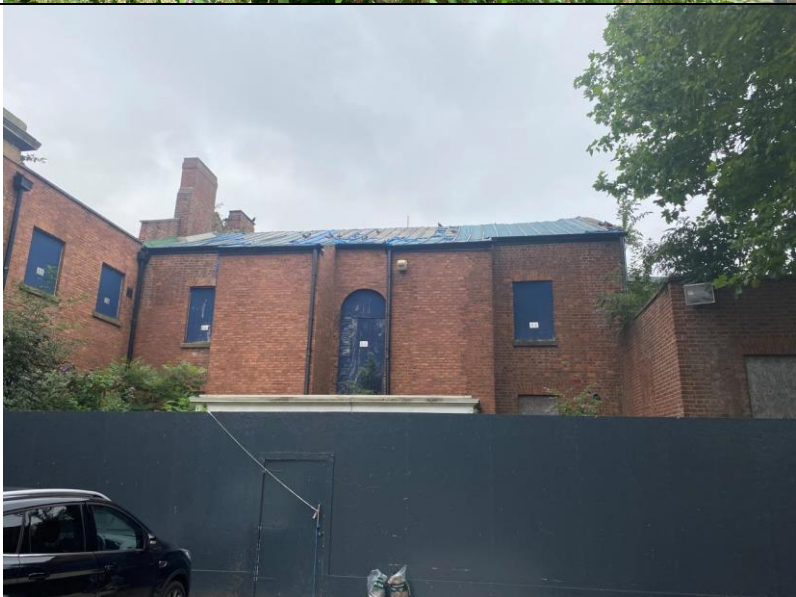
| Feature | Photograph |
|---|---|
| Soft stripped roof | |

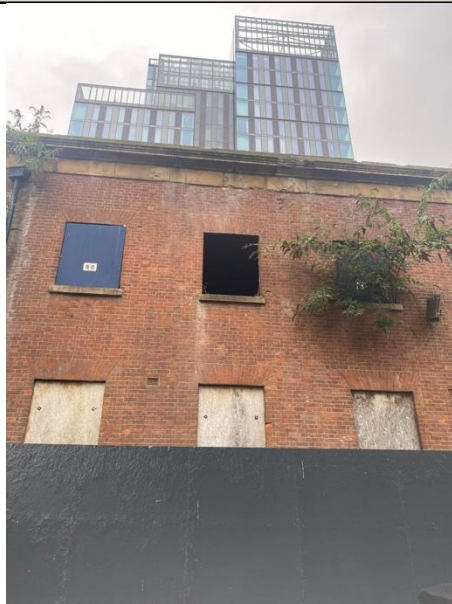
- 3.2.2. The majority of windows and doors has been secured with wooden boards and gaps were present in a number to provide internal access to the building.

Boarded and non-boarded window on the eastern aspect, and air brick.

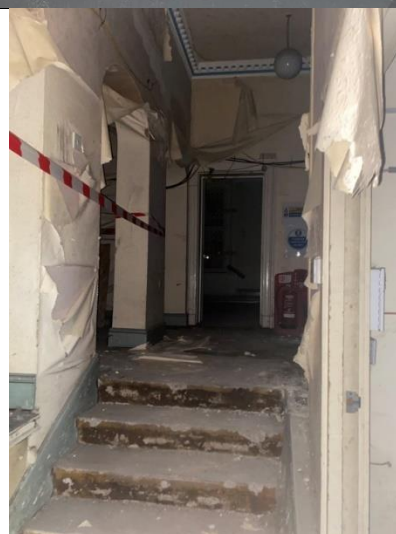
- 3.2.4. External crevices were observed between the wooden fascias on the northern aspect of the building and the brick work.
- 3.2.5. Internally, the building comprised a complex of rooms which has been plastered and painted however were in a poor state of repair.

Internal aspect
