**LIDL GB LTD**

Lowry House, Chorlton

Phase II Geo-Environmental Assessment Report

MS/C5061/11249

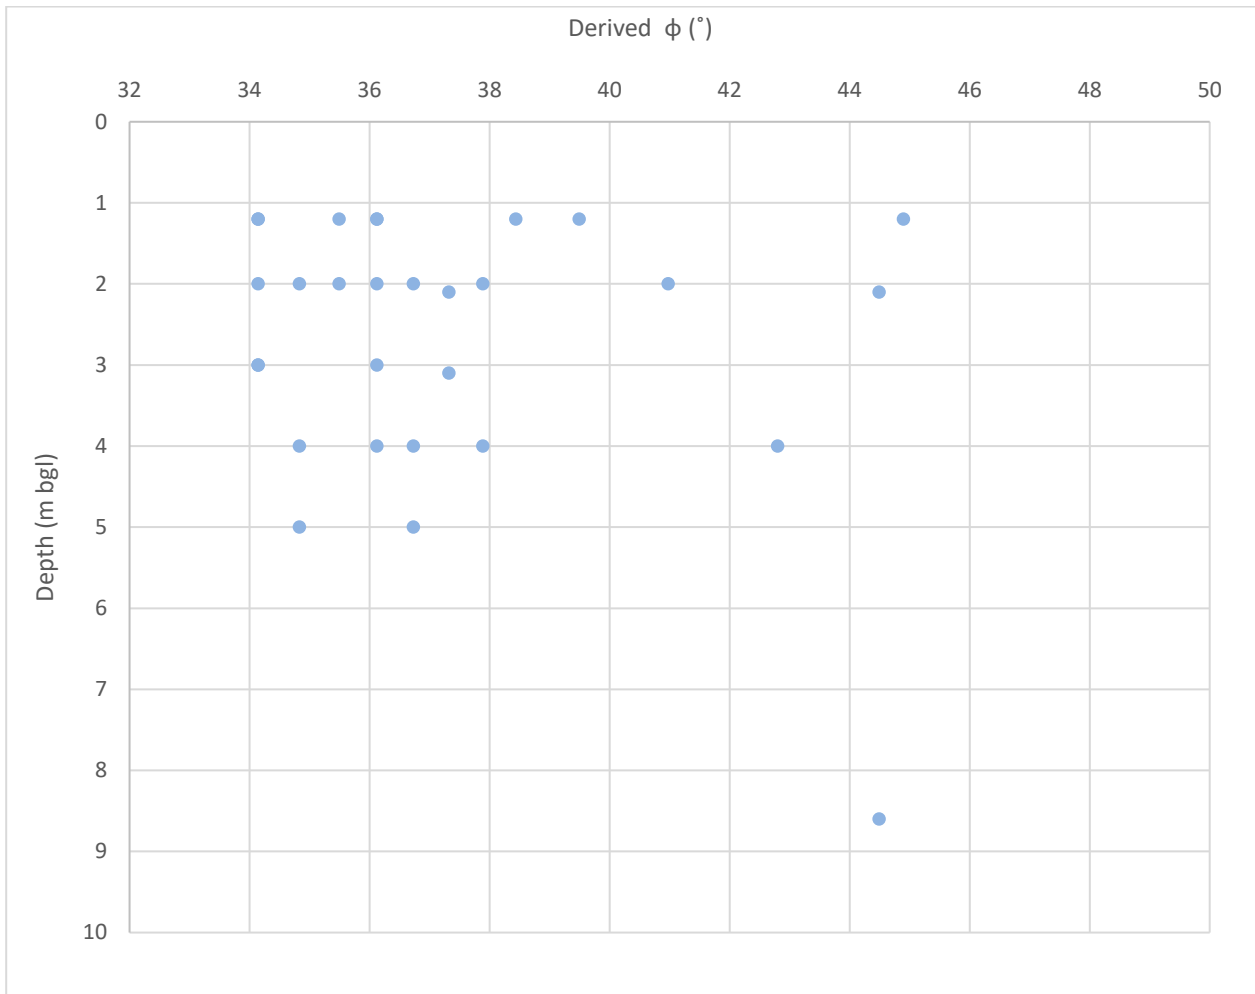
The angle of shearing resistance ( $\phi'$ ) of the granular (coarse) soils within the first 5.00m has been derived from the uncorrected SPT N value data and the correlation of Hatanaka and Uchida (1996).

The above graph shows that the density of the granular material generally remains similar with increased depth.

Based on the above graphs, the characteristic  $\phi'$  value at 1.00mbgl is interpreted to be  $34^\circ$  for Ultimate Limit State conditions and with extrapolation, is interpreted to be  $33^\circ$  at 0.45m bgl (i.e. minimum founding depths in granular strata).

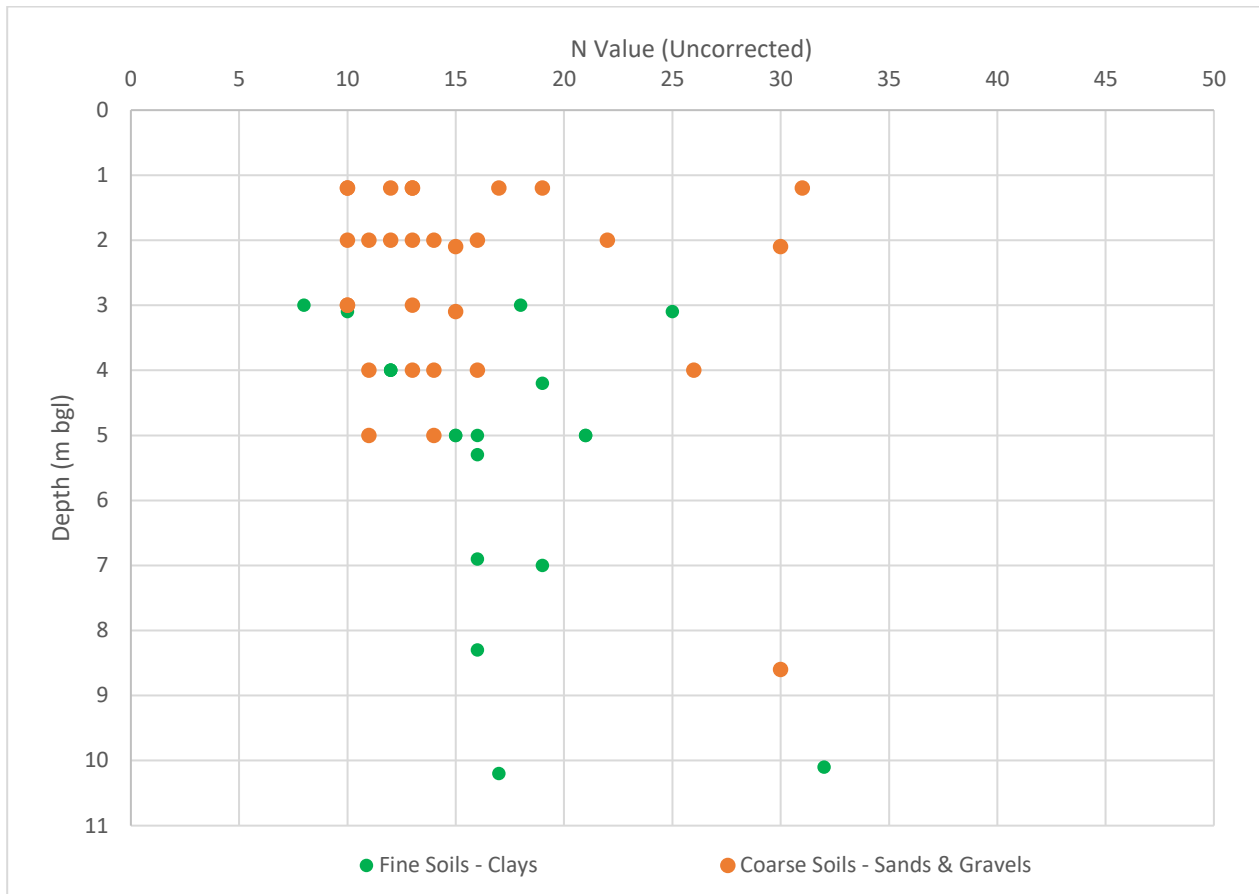
A depth (m bgl) vs SPT N value graph is also provided below to provide a profile of the cohesive and granular materials underlying the site.

The above graph shows there is no significant increase in soil strength or density as depth increases.

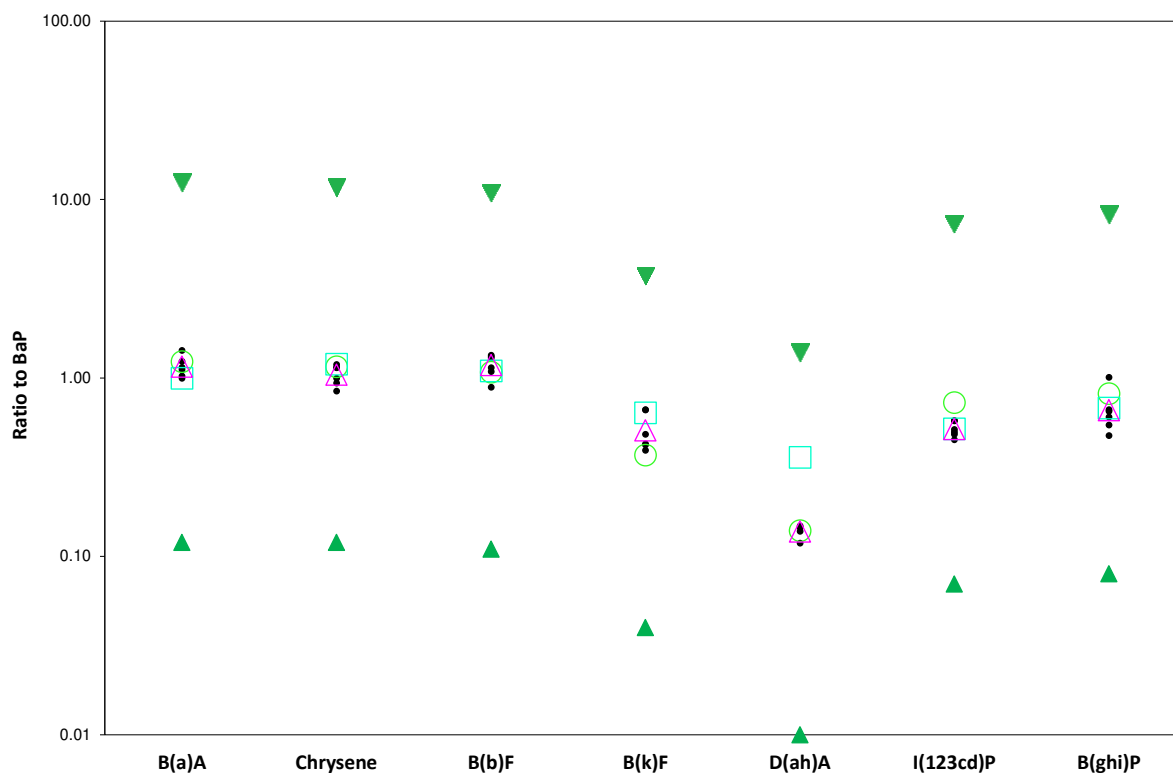
The graph below summarises the site data with respect to how the ratios of carcinogenic PAHs relate to B(a)P, within the confidence limits provided in the PHE documents.

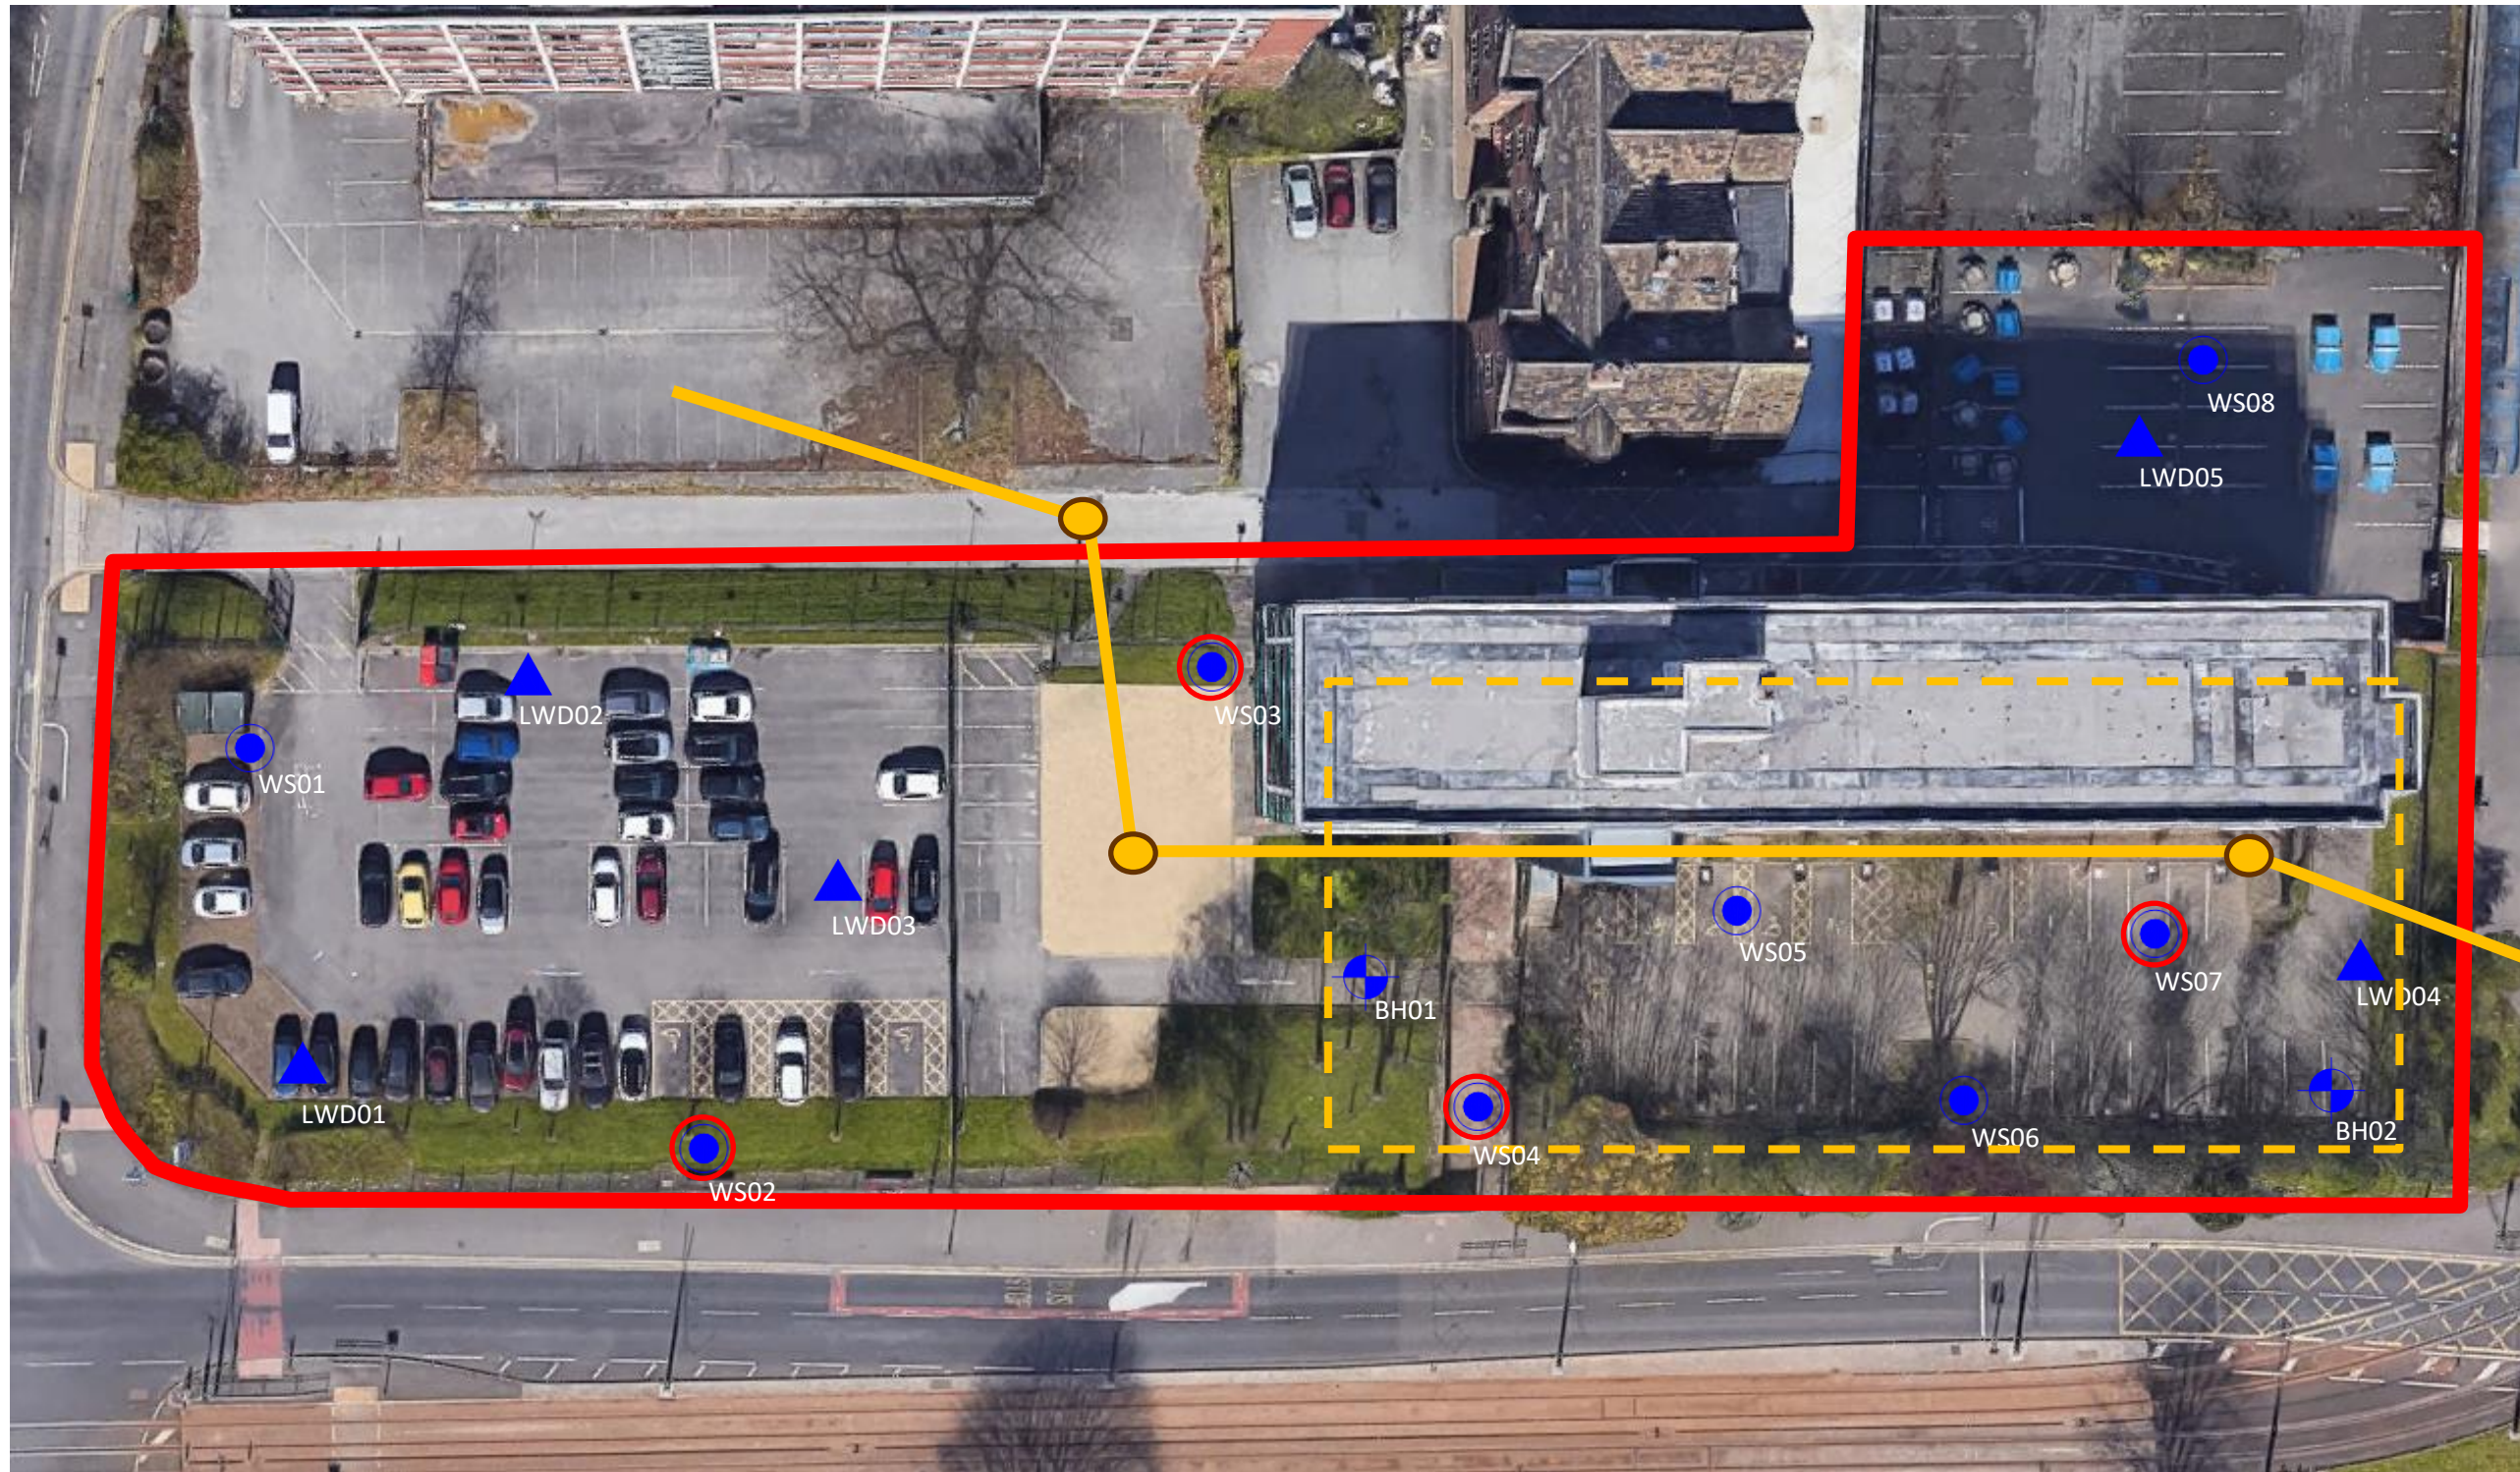
- APPROXIMATE SITE BOUNDARY
- WINDOW SAMPLE BOREHOLE  
BHXX
- CABLE PERCUSSIVE BOREHOLE  
WSXX
- BOREHOLE INSTALLATION
- LIGHTWEIGHT DEFLECTOMETER TEST  
LWDXX
- APPROXIMATE SEWER LOCATION
- APPROXIMATE MANHOLE LOCATION
- APPROXIMATE PROPOSED STORE FOOTPRINT

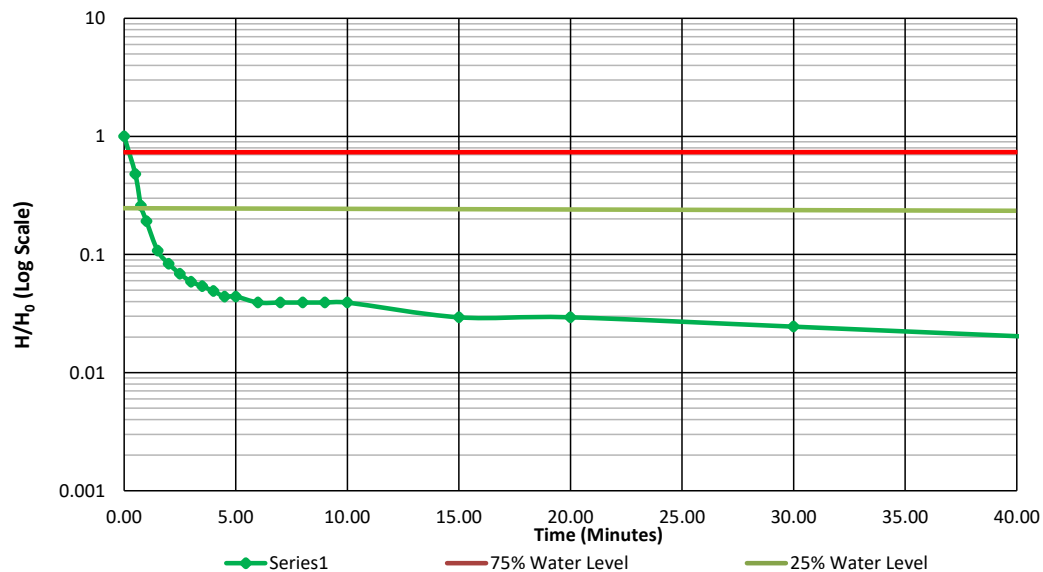
WS04  
Test 1

#### Head Ratio Vs Time

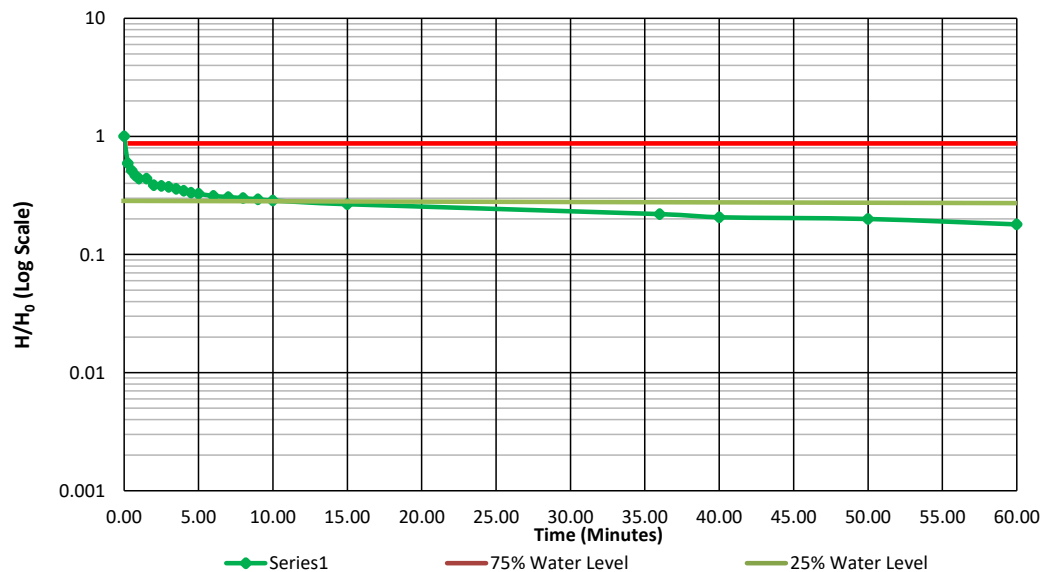
WS07  
Test 1

#### Head Ratio Vs Time

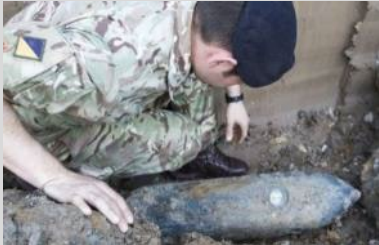
SC 250

Bomb body and tail painted grey/green with a yellow stripe on the tail unit. Steel construction.

8 x variants. Additional fittings: Kopfring nose for limited penetration and Stabbo nose for dive-bombing.

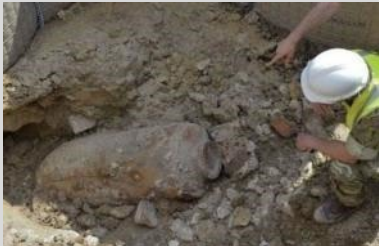
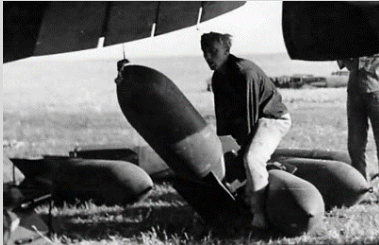
SC 500

Bomb body and tail painted grey/green with a yellow stripe on the tail unit. Steel construction.

8 x variants. Kopfring nose for limited penetration. Stabbo nose for dive-bombing.

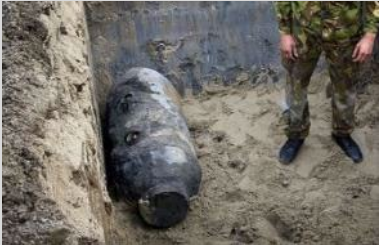
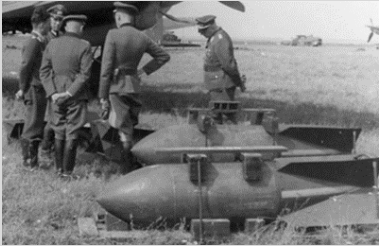
Bomb body and tail painted grey/green or buff with a yellow stripe on the tail unit. Steel construction.

3 x variants. Kopfring nose for limited penetration.

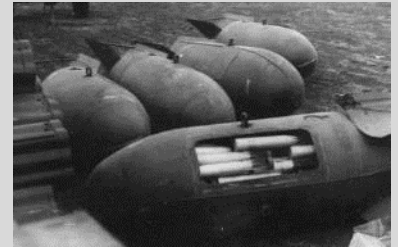
**B-1E Sub-Munition**

**Bomb Weight:** 1-1.3kg (2.2-2.87lb)  
**Incendiary Weight:** 680g (1.4lb)  
**Filling:** Thermite  
**Fuse Type:** Simple impact fuse  
**Body Dimensions:** 247mm length x 50mm diameter  
**Appearance:** Grey body and dark green painted tail unit. Magnesium alloy case.  
**Operation:** Small percussion charge ignites Thermite (>1,000°C burn).  
**Variants:** Most common variant: B 2EZ (2kg) included a small HE charge  
**Remarks:** Drop containers varied in size. The smallest cluster bomb held 36 x B-1Es and the largest 620 x B-1Es.

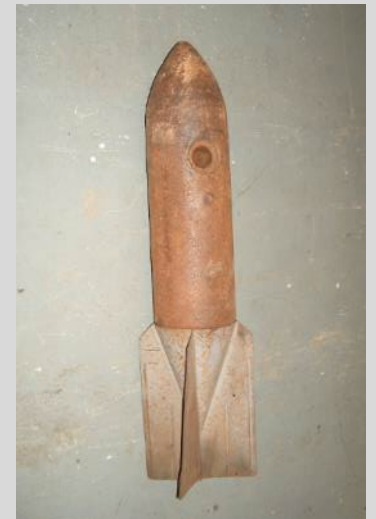
**Brand C50**

**Bomb Weight:** 41kg (90.4lb)  
**Incendiary Weight:** 13kg (30lb)  
**Filling:** Main fill (86% Benzine, 10% Rubber) plus 4% Phosphorus in glass bottles  
**Fuse Type:** 1 x electrical impact fuse  
**Bomb Dimensions:** 762mm length x 203mm diameter  
**Appearance:** bomb body and tail painted grey or green with the rear of the bomb painted red and a red band around the centre of the body.  
**Variants:** C 50 B: 77% White Phos fill  
 C 250 A: 87.7% Petroleum, 11.7% Polystyrene, 0.5% White Phos (185kg version)
