Manchester City Council  
**Parsonage Garden's, Didsbury**

# **Heritage Statement**

Project Reference: AMP44657.3

Project Title: Fletcher Moss Botanical Gardens - Stenner Lane Boundary Walls

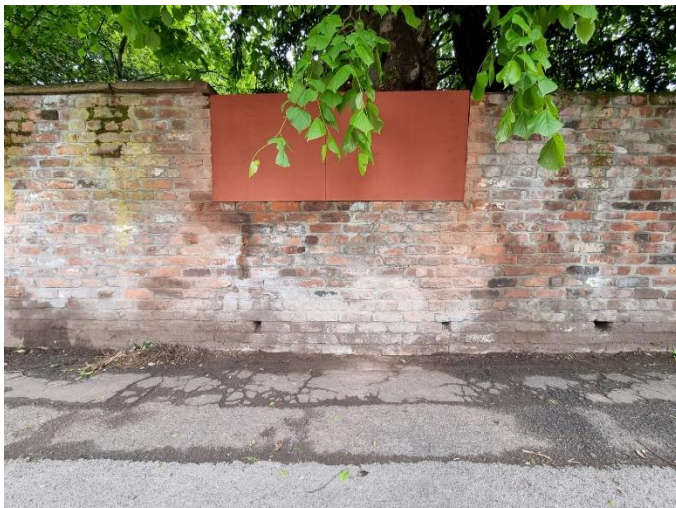
The Section of wall located on Stenner Lane adjacent The Didsbury Public House, shows the boundary wall which had the upper nine courses of brickwork removed due to heath and safety concerns due to the amount of wall movement caused by the growth of the adjacent tree and tree routes, this section of wall is to be removed and rebuilt with a new foundation back on its original line, pointing up of all joints to brickwork and copings will also be undertaken to match existing.

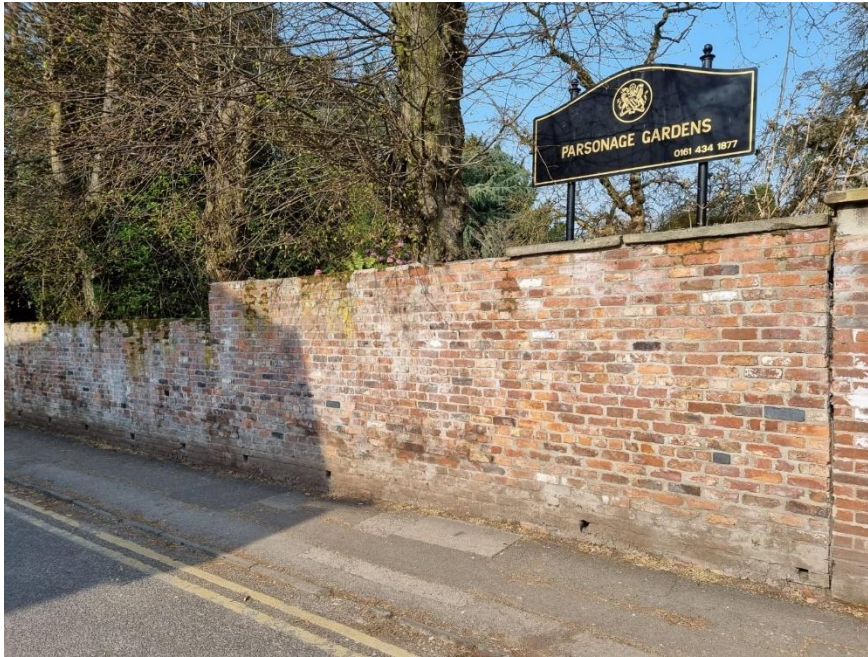
The Section of wall located on Stenner Lane is the boundary wall which is proposed for removal and rebuilding. This section of wall will be rebuilt to the existing lower wall height to have continuity of the wall height at the boundary and to reduce the likelihood of future leaning and movement.

The section of wall adjacent to the stone arch entrance that is leaning outwards towards the path it is proposed this section of wall be carefully dismantled down to the pavement level and rebuilt, with those bricks either beyond repair or missing, replaced on a like-for-like basis. The newly built wall will be built to the height of the adjacent boundary wall reducing its original height by 5 courses of brick. An expansion joint will be required where the newly built wall meets the existing wall. New coping stones will be required to the tops of all new and existing wall heads.
