Phase I Geoenvironmental Site Assessment  
27-33 King Street West and The Carriage Works

Reference: 15-644-R1-2  
Date: August 2022

# PHASE I GEOENVIRONMENTAL SITE ASSESSMENT

27-33 King Street West and The Carriage Works  
St Marys Parsonage  
Garden Lane and Smithy Lane  
M3 2JP

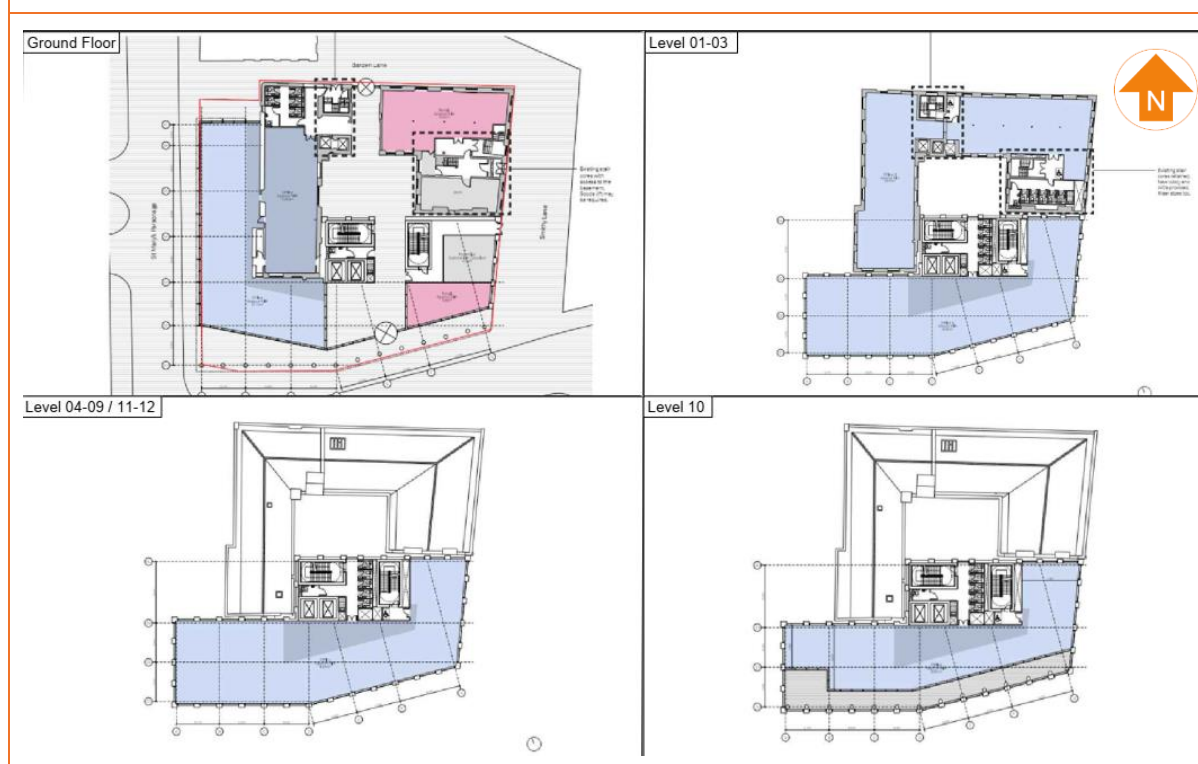
FIGURE 1.1 SNAPSHOT OF PROPOSED DEVELOPMENT

A snapshot of the proposed development layout is indicated in Figure 1.1.

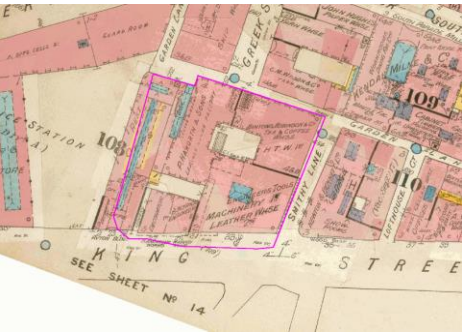
| MAP EDITION | HISTORICAL LAND USE | HISTORICAL MAP EXCERPT |
|---|---|---|
| <p><b>1917</b><br/><b>40':1"</b></p> | <p>The town plan published in 1917 shows the commercial use for the site. The southeast commercial unit is recorded as an Engineers Tools, Machinery and Leather Warehouse. The northeast unit is recorded as a Tea and Coffee Warehouse. A disused Engine is recorded within the north sector of the building on site. The northwest unit is recorded as a Leather Goods Factory. Two Decorators and an Electrical Engineer are recorded in the southwest units. The map indicates that the building material is brick, stone, or concrete with small areas of wood in the west sector. A tank appears to be present in the courtyard in the northern central sector.</p> | |

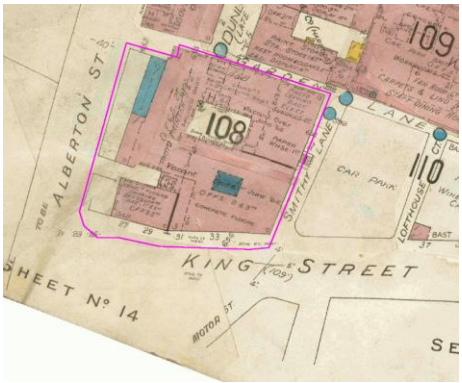
| MAP EDITION | HISTORICAL LAND USE | HISTORICAL MAP EXCERPT |
|---|---|---|
| <p><b>1962</b><br/><b>40':1"</b></p> | <p>The commercial units on the west of the site have been reduced in size to make way for the footpath adjacent to Alberton Street. Simplex Electrical Company is no longer recorded in the southeast unit. Offices are recorded on the 2<sup>nd</sup> and 3<sup>rd</sup> floors with the rest of the unit recorded as vacant. The northeast unit is recorded as Photocopying (basement), Electrical Sundries (1<sup>st</sup> floor) and a Paper Warehouse (1<sup>st</sup> floor). The northwest unit is recorded as offices and a Photo Printer. The southwest unit is recorded as Drawing Office Equipment (basement, 1<sup>st</sup> and 2<sup>nd</sup> floors) and offices (3<sup>rd</sup> floor).</p> | |

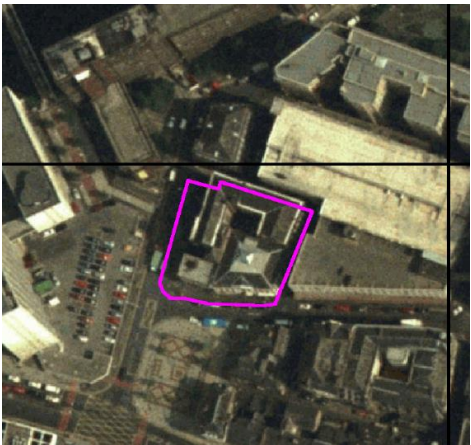
| MAP EDITION | HISTORICAL LAND USE | HISTORICAL MAP EXCERPT |
|---|---|---|
| <b>2000</b><br><b>Aerial</b><br><b>Photography</b> | No significant changes to the subject site. | |

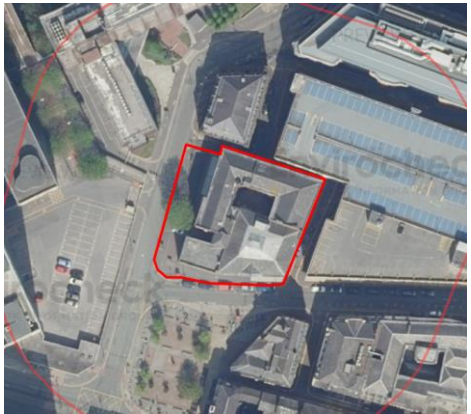
| MAP EDITION | HISTORICAL LAND USE | HISTORICAL MAP EXCERPT |
|---|---|---|
| <b>2022</b><br><b>Aerial</b><br><b>Photography</b> | No significant changes to the subject site. | |

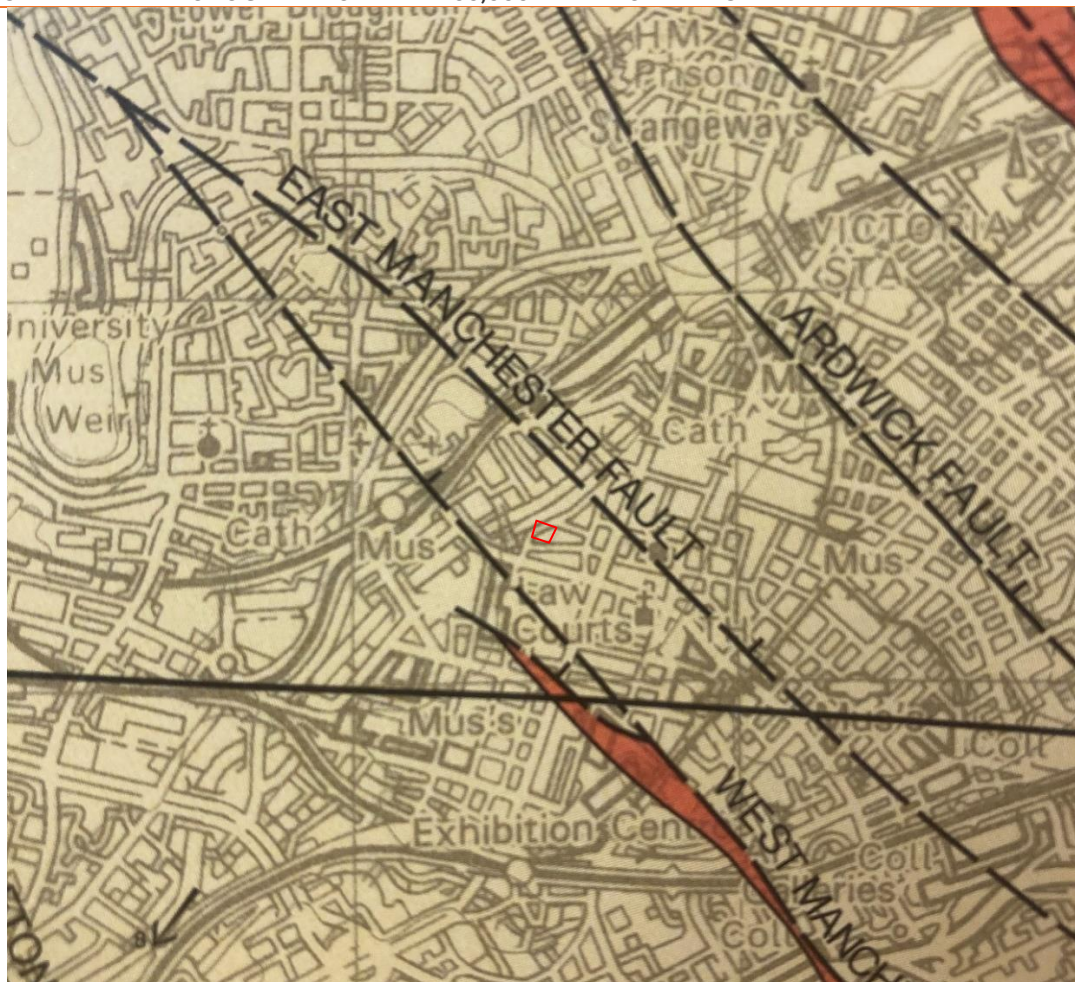
FIGURE 4.4 PHOTOGRAPH OF THE 1:50,000 PLAN FOR THE SITE

Figure 4.4 is a photograph of the 1:50,000 plan for the site which confirms the absence of any coal seams within the vicinity of the site.

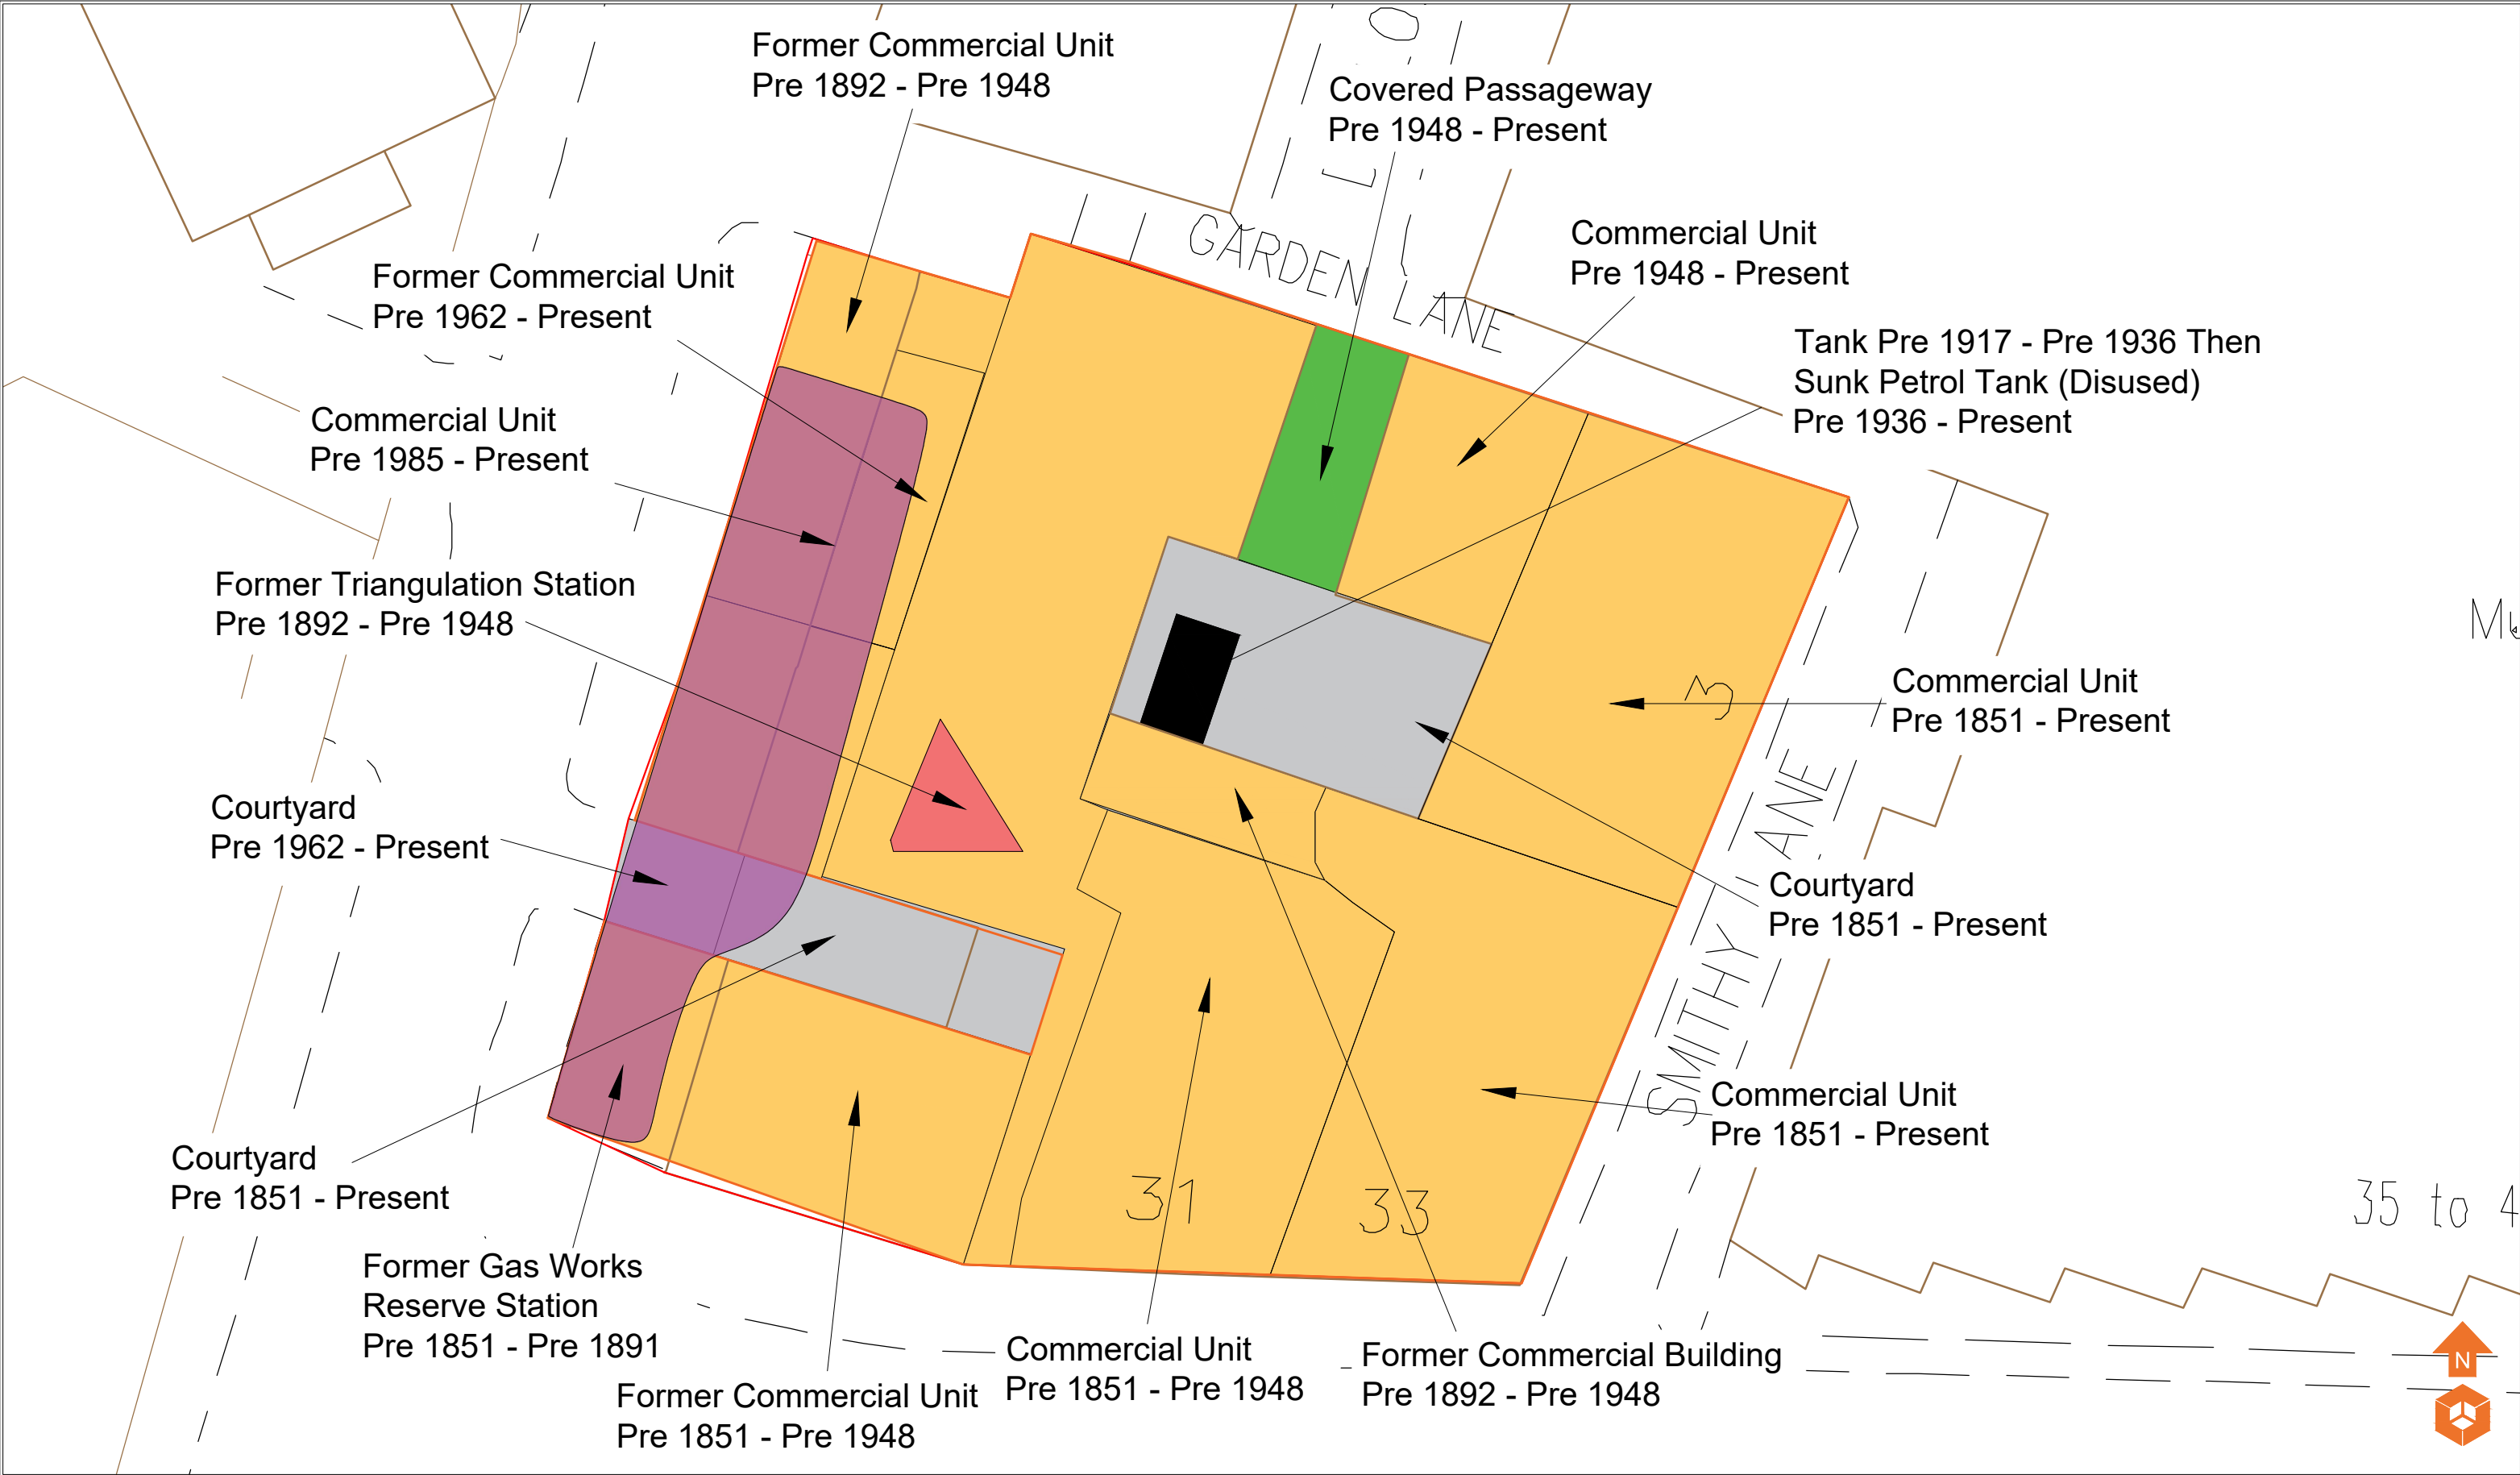
Historical Features

- Commercial Units
- Commercial Units
- Former Triangulation Station
- Former Gas Works Reserve Station
- Courtyard
- Covered Passageway
- Tank

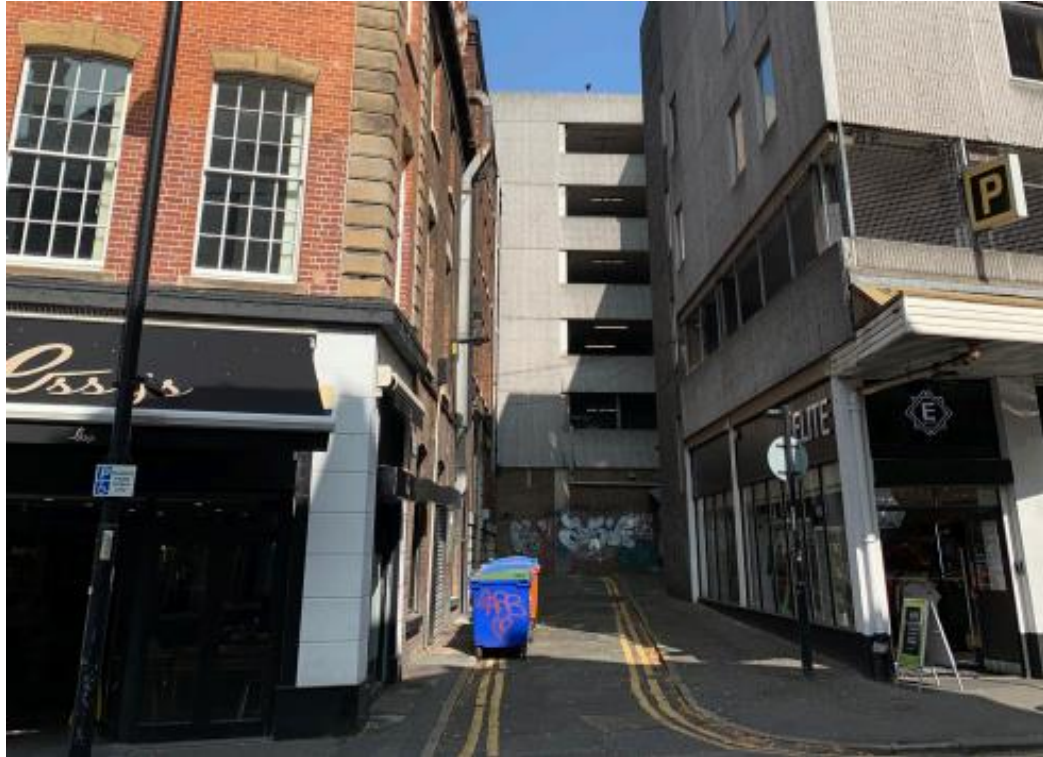
PLATE 1 VIEW OF EASTERN SITE BOUNDARY, FACING NORTH

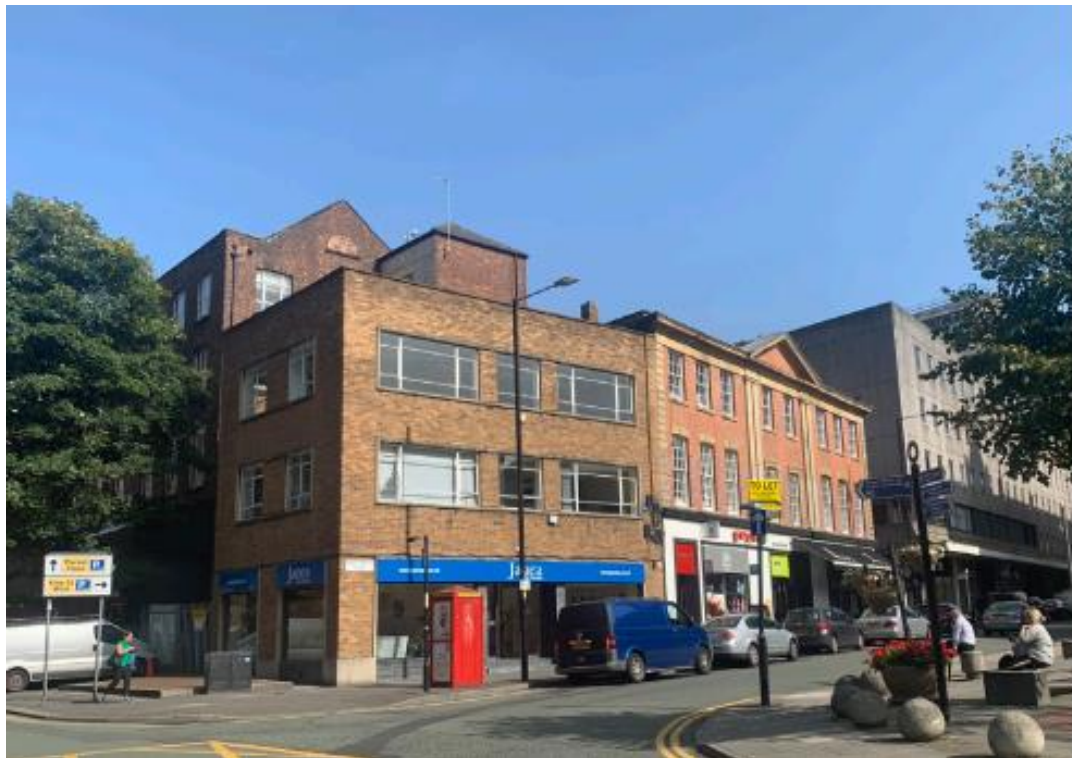
PLATE 2 VIEW OF SOUTHERN SITE BOUNDARY

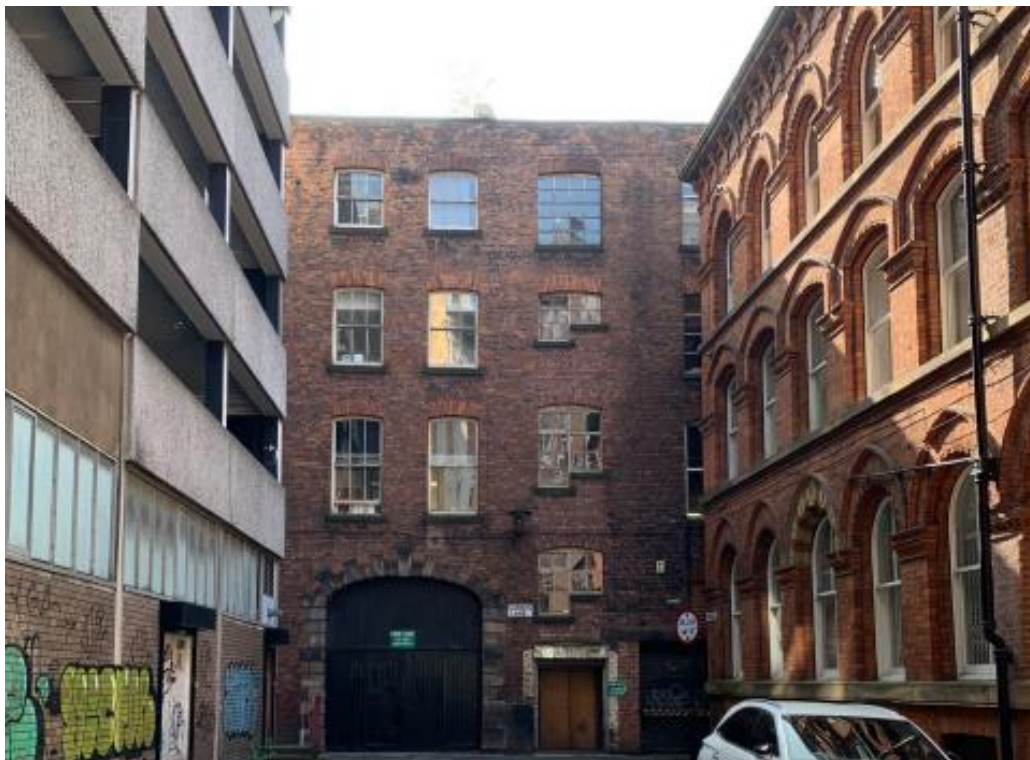
PLATE 3 VIEW OF BUILDING AND GATE IN THE NORTH FROM GARDEN LANE

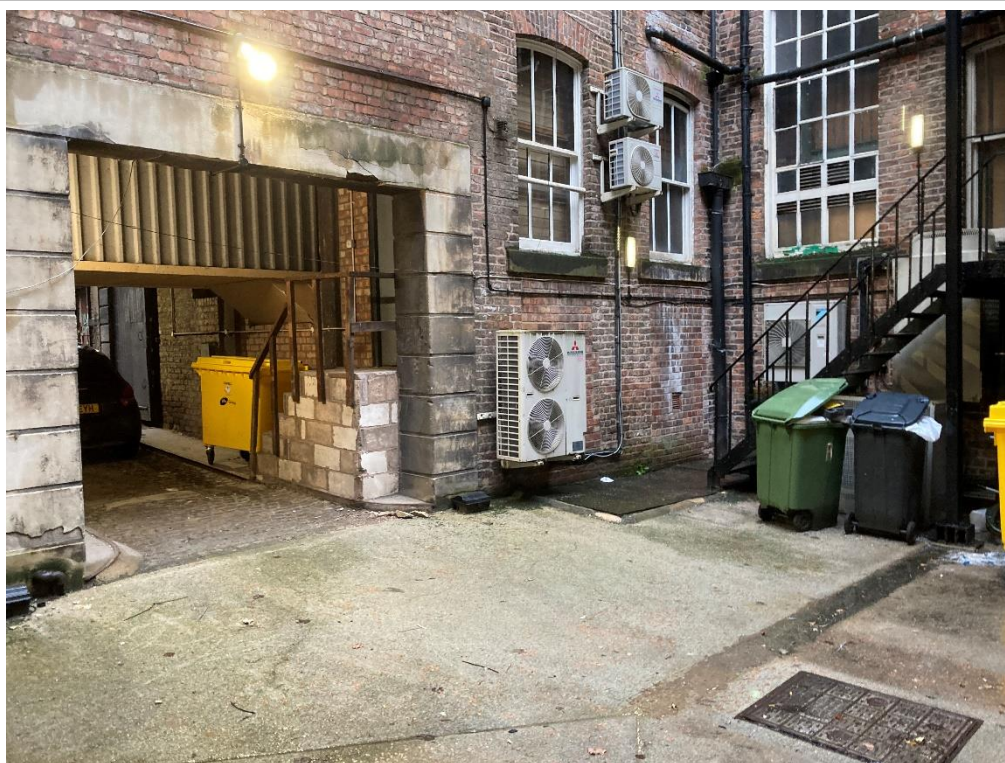
PLATE 4 CENTRAL COURTYARD

| <b>Hazardous Material Storage</b> | An underground storage tank is present in the courtyard in the central sector. A manhole which appears to be a tank service point was also noted in this location. | |

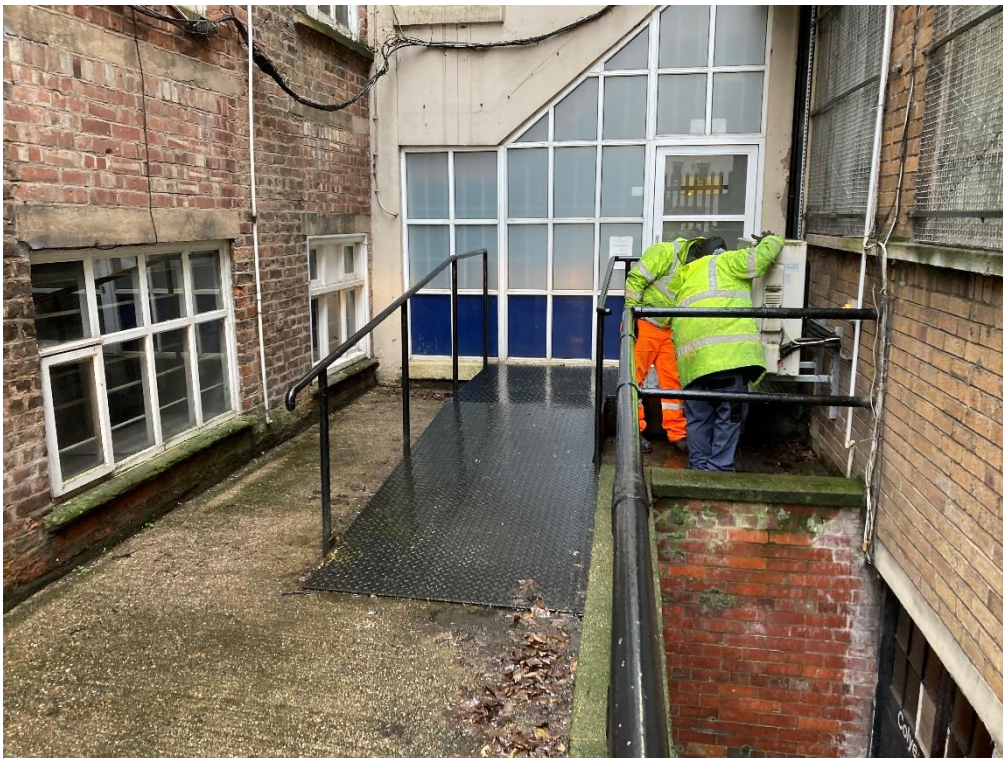
PLATE 6 COURTYARD OFF ST MARY'S PARSONAGE
