Boatmans, 42 City Road East, Manchester, M15 4QF

Type 3 Fire Risk Assessment

**Project Number**  
144867

**Date**  
15/02/2021

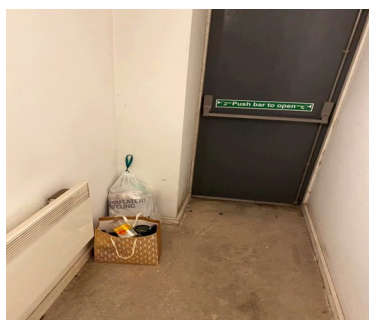
Image Ref: 001

Overall a good standard of housekeeping was observed. Some rubbish was observed in the back escape stairs close to the exit. Regular inspections of the facility are required to stop the build-up of rubbish.

| Topic Area | | Combustible Materials. | | | | | |
|---|---|---|---|---|--|---|---|
| 3 | N | Owner/Manager | Ensure that combustible rubbish and waste is removed from the workplace, at least daily, and stored away from the building so that a fire in it will not put the workplace at risk. | Overall a good standard of housekeeping was observed. Some rubbish was observed in the back escape stairs close to the exit. Regular inspections of the facility are required to stop the build-up of rubbish. | | Employees, Tenants, Contractors, Visitors, Public | 001 |

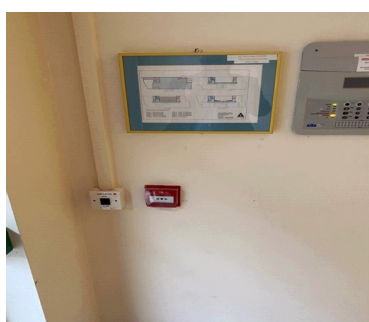
Image Ref: 002

Fire alarm call points are in suitable locations. The manual call point at the main entrance requires the appropriate fire instruction signs.

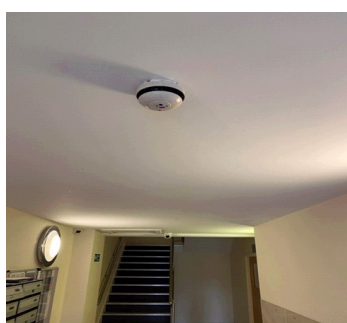
Image Ref: 006

There appeared to be a sufficient number of detectors and sounders to ensure that the fire alarm is audible in all the common areas of the property inspected, linked back to the fire panel. The apartments inspected had stand-alone detection. On the corridor level 6, a smoke detector is being held together by black tape. In apartment 2 (Empty) the smoke detector is partially hanging off and is bleeping indicating low battery. These should be repaired. With issues identified with the timber façade and balconies it is recommended as a temporary period to move to a simultaneous evacuation strategy. The alarm system should be extended to be capable of detecting a confirmed fire in any one apartment and transmitting an alarm signal to every other apartment. National Fire Chiefs Council (NFCC) – Simultaneous Evacuation Guidance issued on the 1st October 2020 should be followed. The fire alarm system should be linked to a Alarm Receiving Centre (ARC). ARC will mobilise the local Fire Brigade.

| No. | Risk Result Level | Responsibility | Control Description | Comments | Person in Danger | Image Ref |
|---|---|---|---|---|---|---|
| 4 | N | Owner/Manager | Provide a fire alarm system of the appropriate type, suitable for the environment. | There appeared to be a sufficient number of detectors and sounders to ensure that the fire alarm is audible in all the common areas of the property inspected, linked back to the fire panel. The apartments inspected had stand-alone detection. On the corridor level 6, a smoke detector is being held together by black tape. In apartment 2 (Empty) the smoke detector is partially hanging off and is bleeping indicating low battery. These should be repaired. With issues Identified with the timber façade and balconies it is recommended as a temporary period to move to a simultaneous evacuation strategy. The alarm system should be extended to be capable of detecting a confirmed fire in any one apartment and transmitting an alarm signal to every other apartment. National Fire Chiefs Council (NFCC) – Simultaneous Evacuation Guidance issued on the 1st October 2020 should be followed. The fire alarm system should be linked to an Alarm Receiving Centre (ARC). ARC will mobilise the local Fire Brigade. | Employees, Tenants, Contractors, Visitors, Public | 005<br>006 |

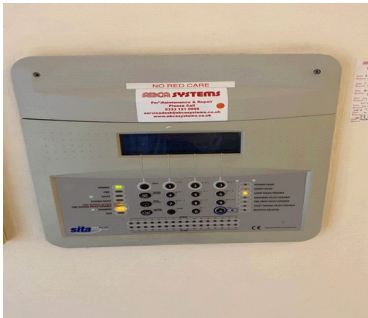
Image Ref: 004

At the time of the assessment the fire panel was found to be in fault and is not being monitored. A recommendation to upgrade the fire alarm system including linking the system to an Alarm Receiving Centre (ARC) is made further on in this assessment. Until the fire alarm system is upgraded the client should put arrangements in place to monitor the fire panel on a daily basis and rectify any faults

Repair faulty or damaged fire alarm system.

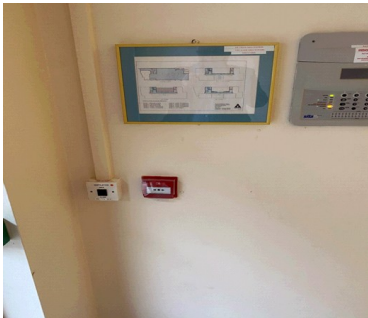
Image Ref: 007

Where fire action notices were observed they were up to date. There were some areas where these are missing. Above the manual call point at the entrance to the building and level 6 next to the lift in the main staircase

| No. | Risk Result Level | Responsibility | Control Description | Comments | Person in Danger | Image Ref |
|---|---|---|---|---|---|---|
| 3 | N | Owner/Manager | Ensure details on fire action notices are correct and up to date. | Where fire action notices were observed they were up to date. There were some areas where these are missing. Above the manual call point at the entrance to the building and level 6 next to the lift in the main staircase | Employees, Tenants, Contractors, Visitors, Public | 007<br>008 |

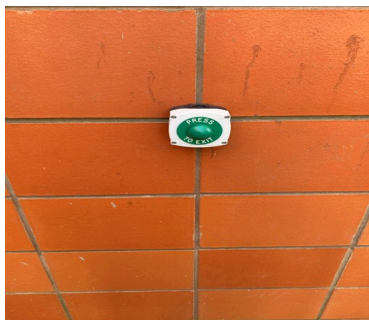
Image Ref: 012

The fire exit from the back staircase leads outside into a fenced area next to the bike store which is opposite a construction site. Signage indicating the route to be taken should be prominently displayed. Once round the corner there is an accessed controlled gate. A green release button operates this gate and is positioned on the wall opposite. Those unfamiliar with the area could easily miss this. Appropriate signage should be provided. A padlock was found on the gate, this should be removed.

| No. | Risk Result Level | Responsibility | Control Description | Comments | Person in Danger | Image Ref |
|---|---|---|---|---|---|---|
| 3 | N | Owner/Manager | Provide additional fire exit signs. | The fire exit from the back staircase leads outside into a fenced area next to the bike store which is opposite a construction site. Signage indicating the route to be taken should be prominently displayed. Once round the corner there is an accessed controlled gate. A green release button operates this gate and is positioned on the wall opposite. Those unfamiliar with the area could easily miss this. Appropriate signage should be provided. A padlock was found on the gate, this should be removed. | Employees,<br>Tenants,<br>Contractors,<br>Visitors,<br>Public | 010<br>011<br>012 |

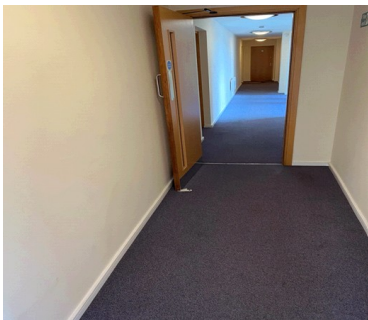
Image Ref: 013

Generally the fire doors were in good repair and working properly when inspected. On level 3 the corridor fire door was wedged open. When the wedge was removed the door slammed shut. The fire door opposite apartment 19 the beading has come away from the glass. Both doors require maintenance

Ensure that internal fire doors are maintained and in good repair.

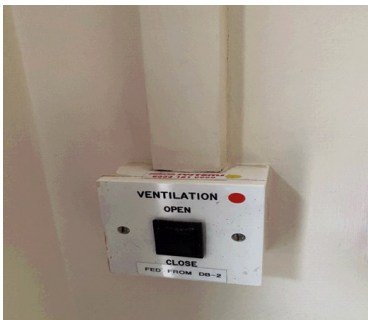
Image Ref: 015

In the main staircase there is an Automatic Opening Vent (AOV) with opening windows on each landing. In the back staircase there are no AOVs but there are opening windows on each landing. At the entrance to the building there is a ventilation switch. The smoke control strategy must be detailed in the fire information box
