# **PORT STREET, MANCHESTER**

## Interpretative Ground Investigation Report

**PROJECT NO. 70084785**

**DATE: NOVEMBER 2021**

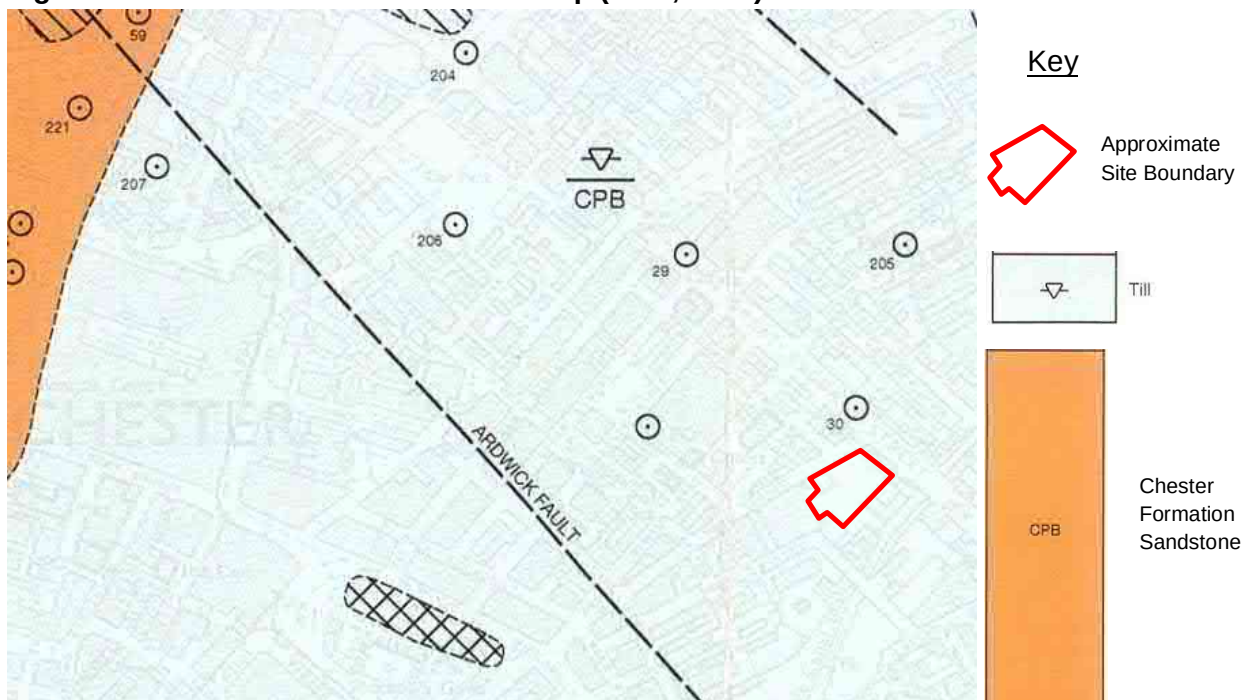
**Figure 3-1 - Extract from Solid & Drift Map (BGS, 2004)**

Published geological mapping (BGS, 2004) indicates the site to be underlain by Glacial Till and sandstone of the Chester Formation (formerly the Chester Pebble Beds Formation). An extract of the geological map is presented below.

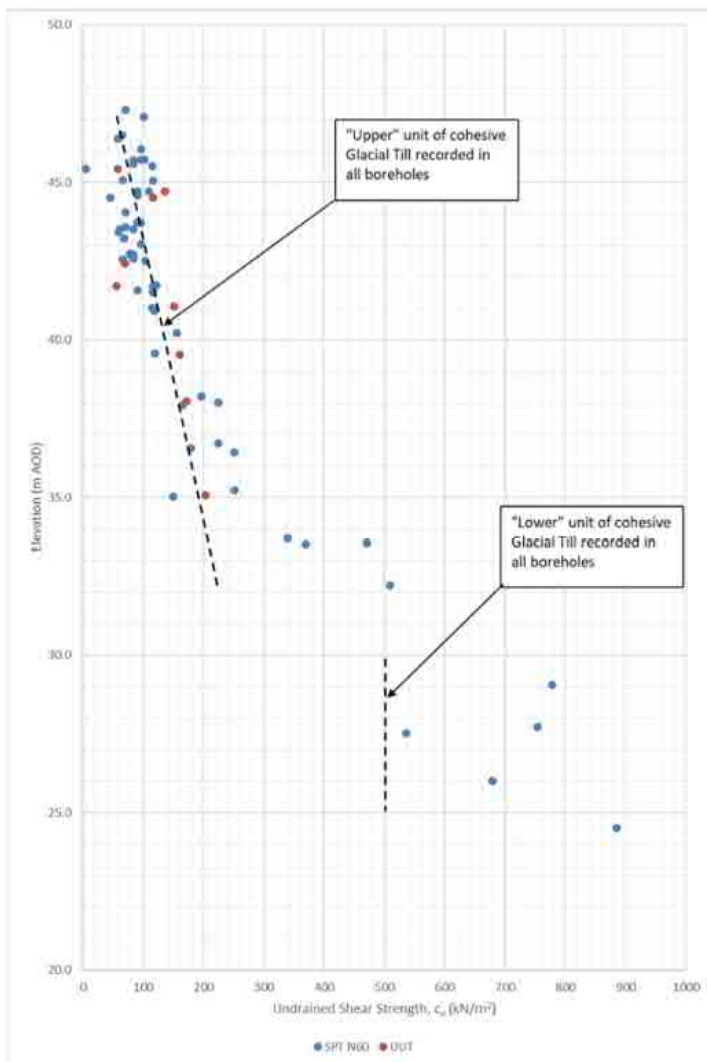
**Figure 7-1 - Undrained Shear Strength vs Elevation - Cohesive Glacial Till**

For the Lower Cohesive Glacial Till recorded in BH01 and BH02, an undrained shear strength of  $450\text{kN/m}^2$  is considered appropriate.

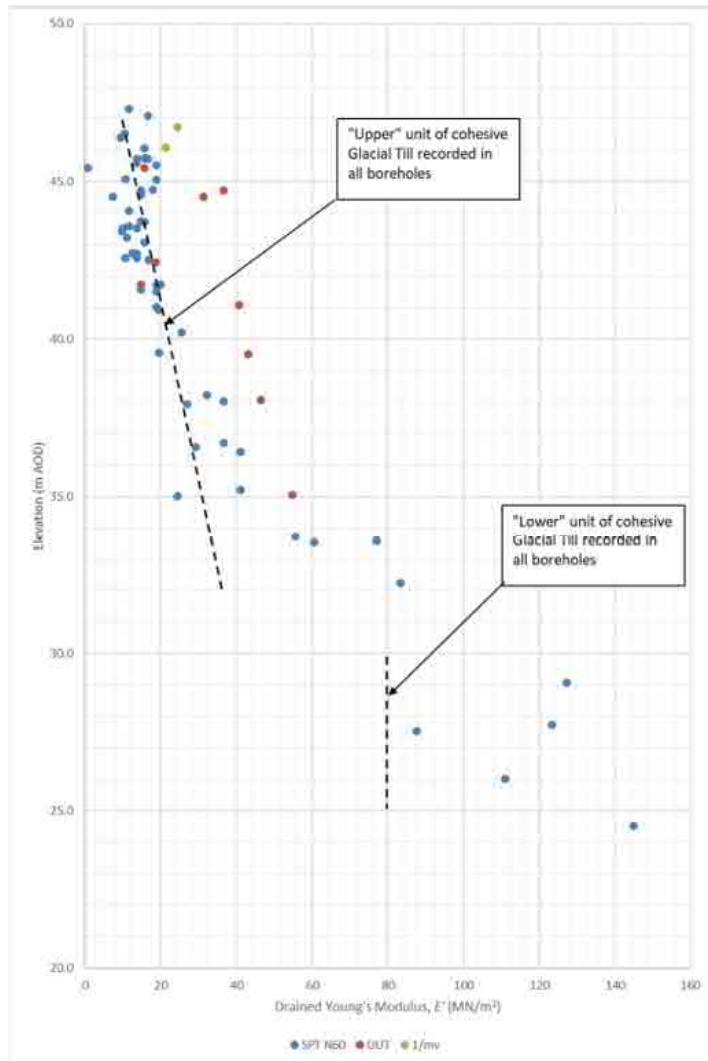
**Figure 7-2 - Drained Young's Modulus vs Elevation - Cohesive Glacial Till**

The results of the above relationship are presented on **Figure 7-2**.

There is a discrepancy between the values of Young's Modulus derived from the laboratory triaxial relationship and from the SPT  $N_{60}$  relationship, with values derived from laboratory testing suggesting a higher stiffness than the SPT  $N_{60}$  relationship. A lower bound value has been taken and for the Upper Cohesive Glacial Till recorded in all the boreholes the following profile of drained Young's Modulus is considered appropriate:

$E' = 10$  MN/m<sup>2</sup> at 47m AOD increasing linearly to 35 MN/m<sup>2</sup> at 32m AOD

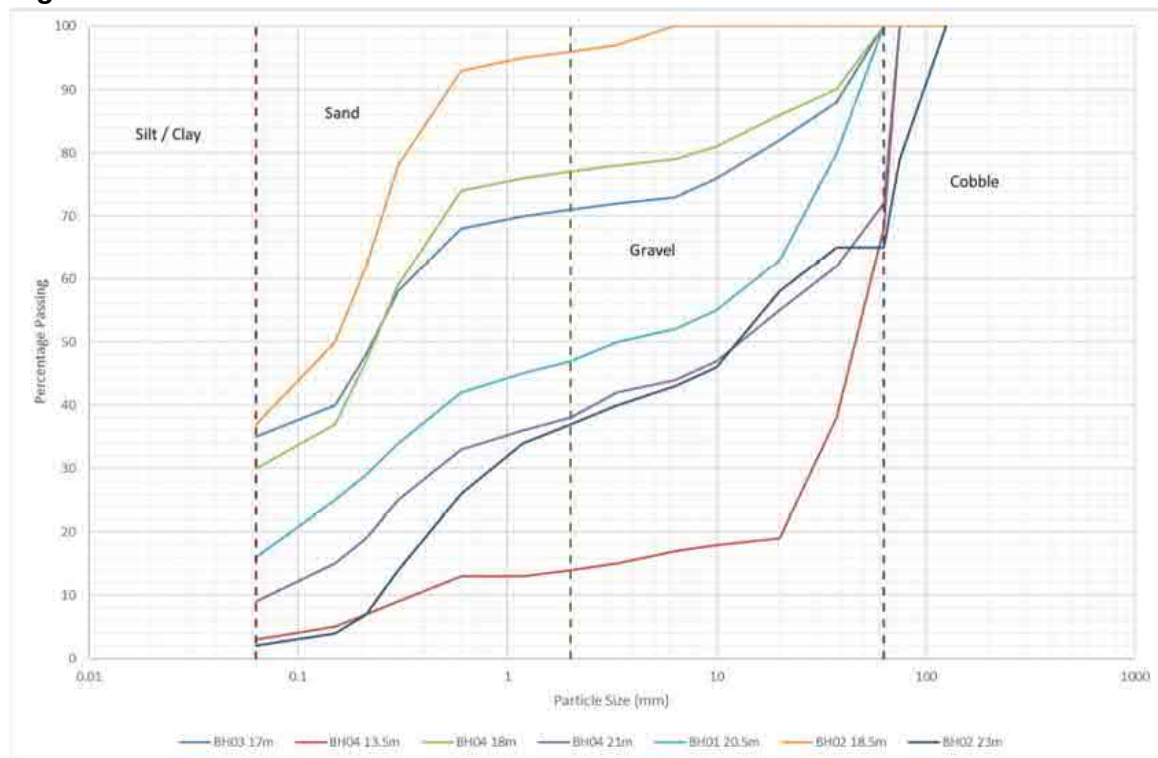
**Figure 7-3 - Particle Size Distribution - Granular Glacial Till**

Results of the particle size distribution tests are shown on **Figure 7-3**. The particle size distribution tests indicate a variable fines fraction and the unit varied between a very clayey Sand/Gravel and a slightly clayey sand/gravel with high cobble content.

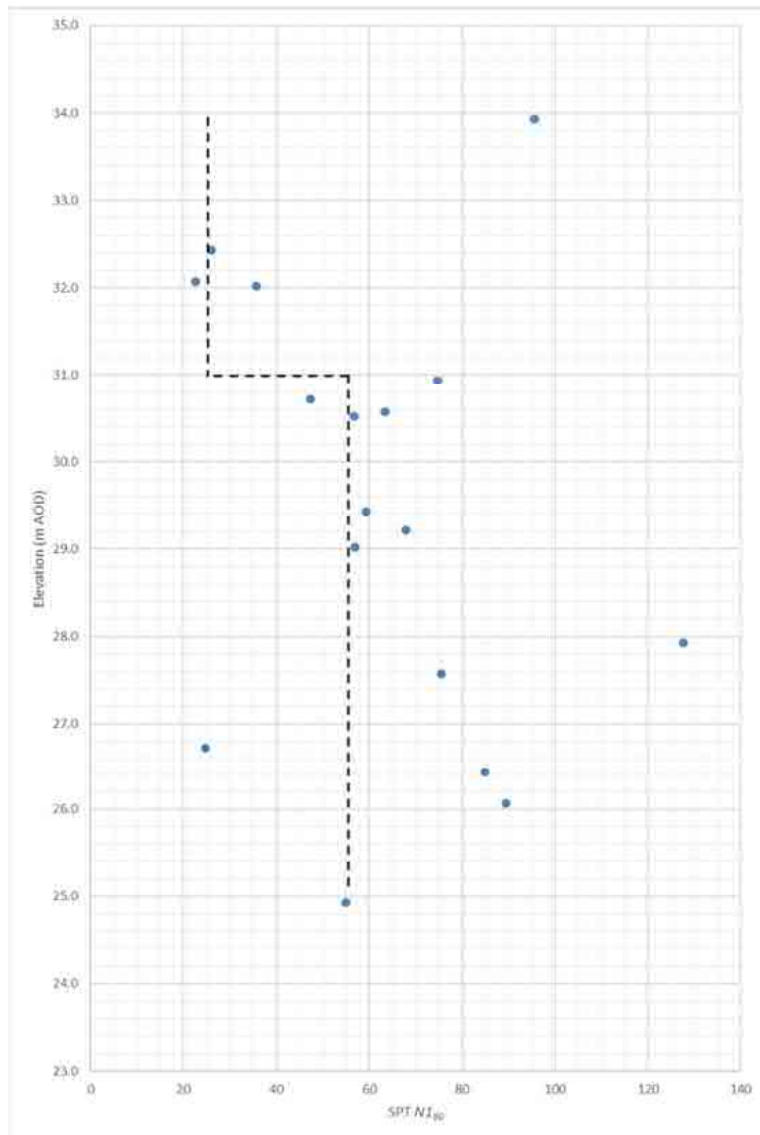
**Figure 7-4 - SPT  $N_{60}$  vs Elevation - Granular Glacial Till**

Based on **Figure 7-4** a representative SPT  $N1_{60}$  of 25 is considered appropriate for the Granular Glacial Till above 31m AOD, increasing to 55 below 31m AOD, corresponding to peak effective angles of internal friction of 35° and 41° respectively.

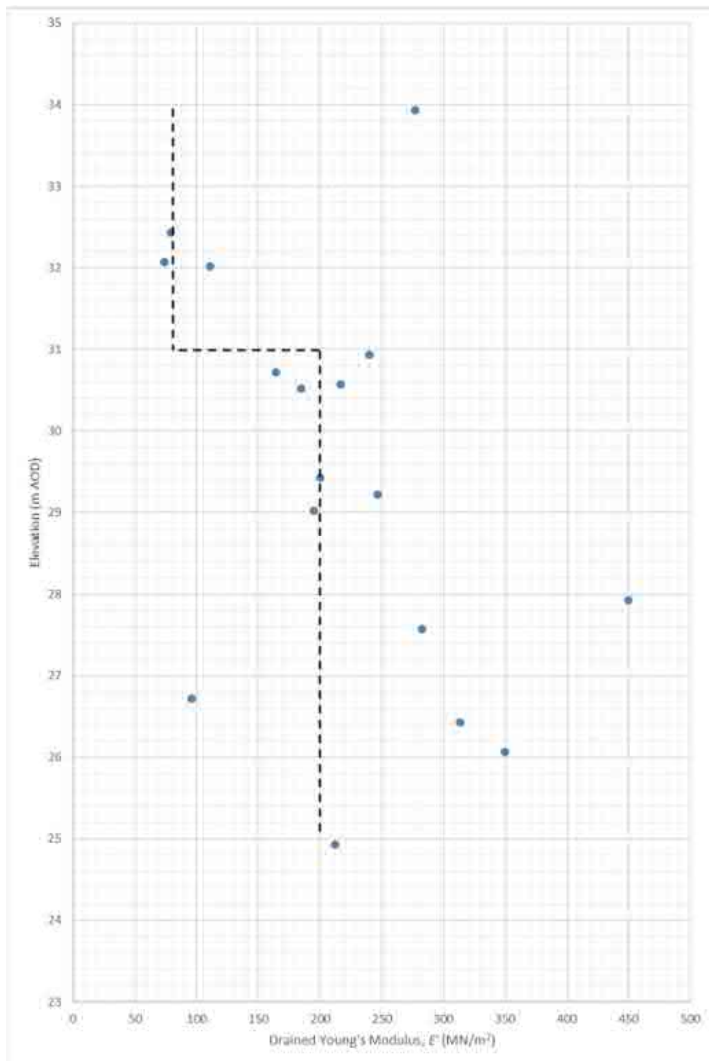
**Figure 7-5 - Drained Young's Modulus vs Elevation - Granular Glacial Till**

$$E' = 200\text{MN/m}^2 \text{ below } 31\text{m AOD}$$

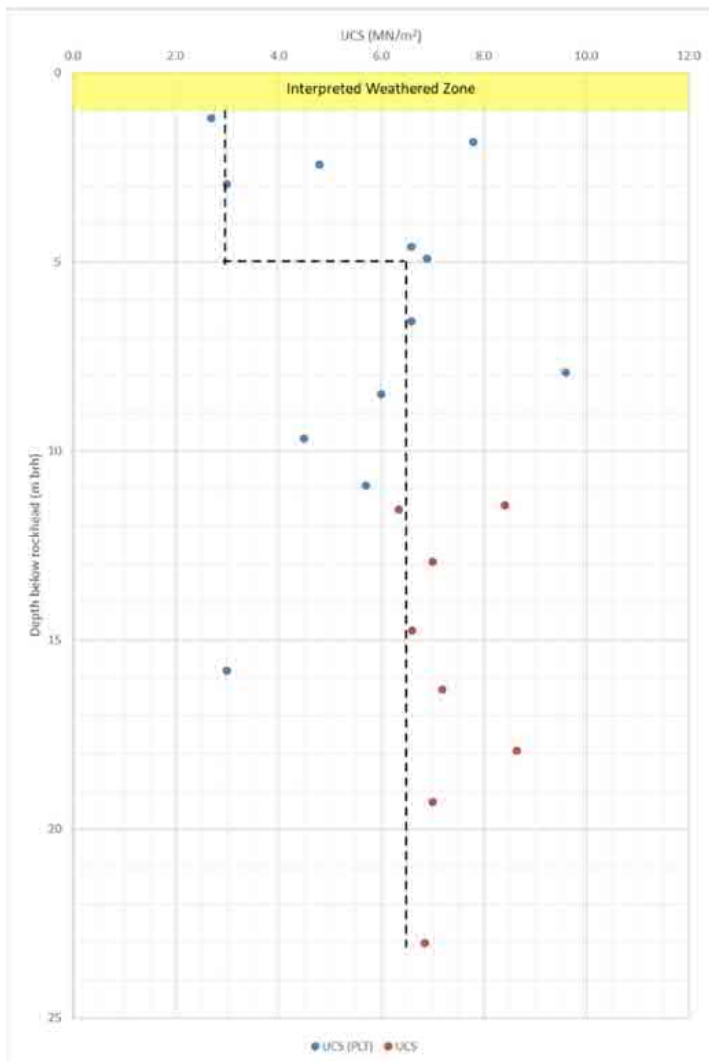
**Figure 7-6 - Unconfined Compressive Strength vs Depth below Rockhead – Chester Formation Sandstone**

UCS =  $6.5\text{MN/m}^2$  below 5m brh
