## GeoEnvironmental Site Investigation Report

Moss Lane East

Manchester

**Report Ref: A4320/21/SI/V2**

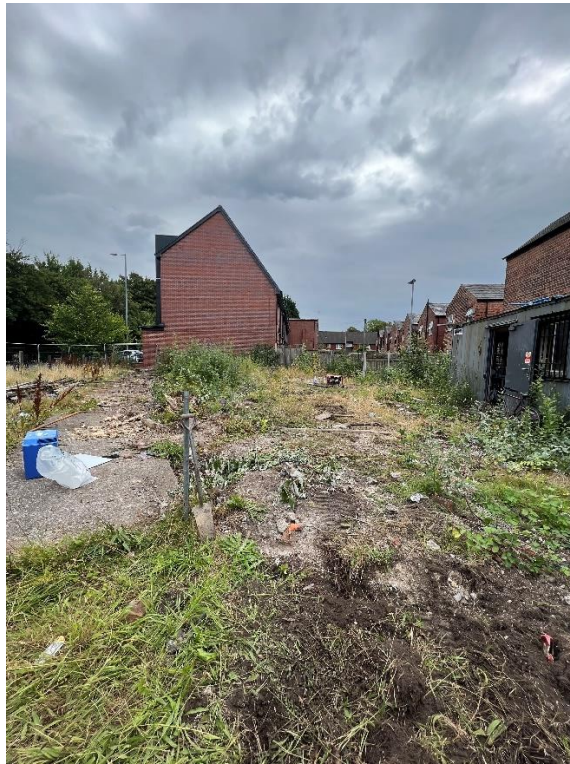
**Figure 2: General Site Photographs**

View of site, Looking East.

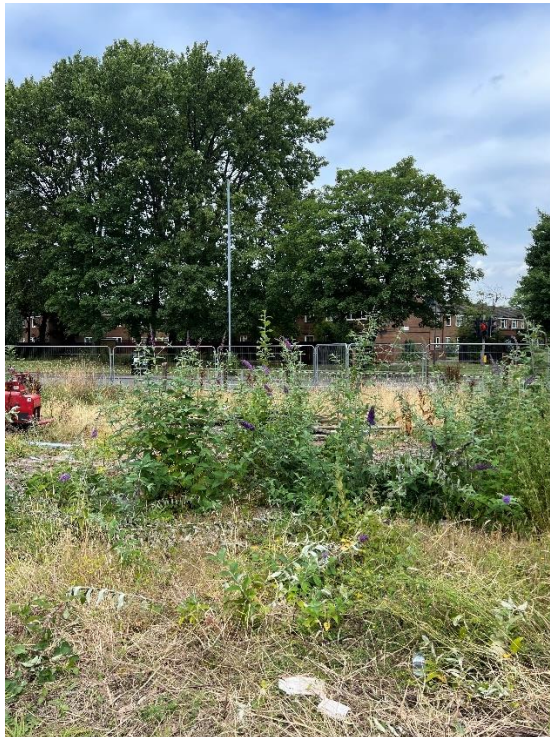
View of site looking North.

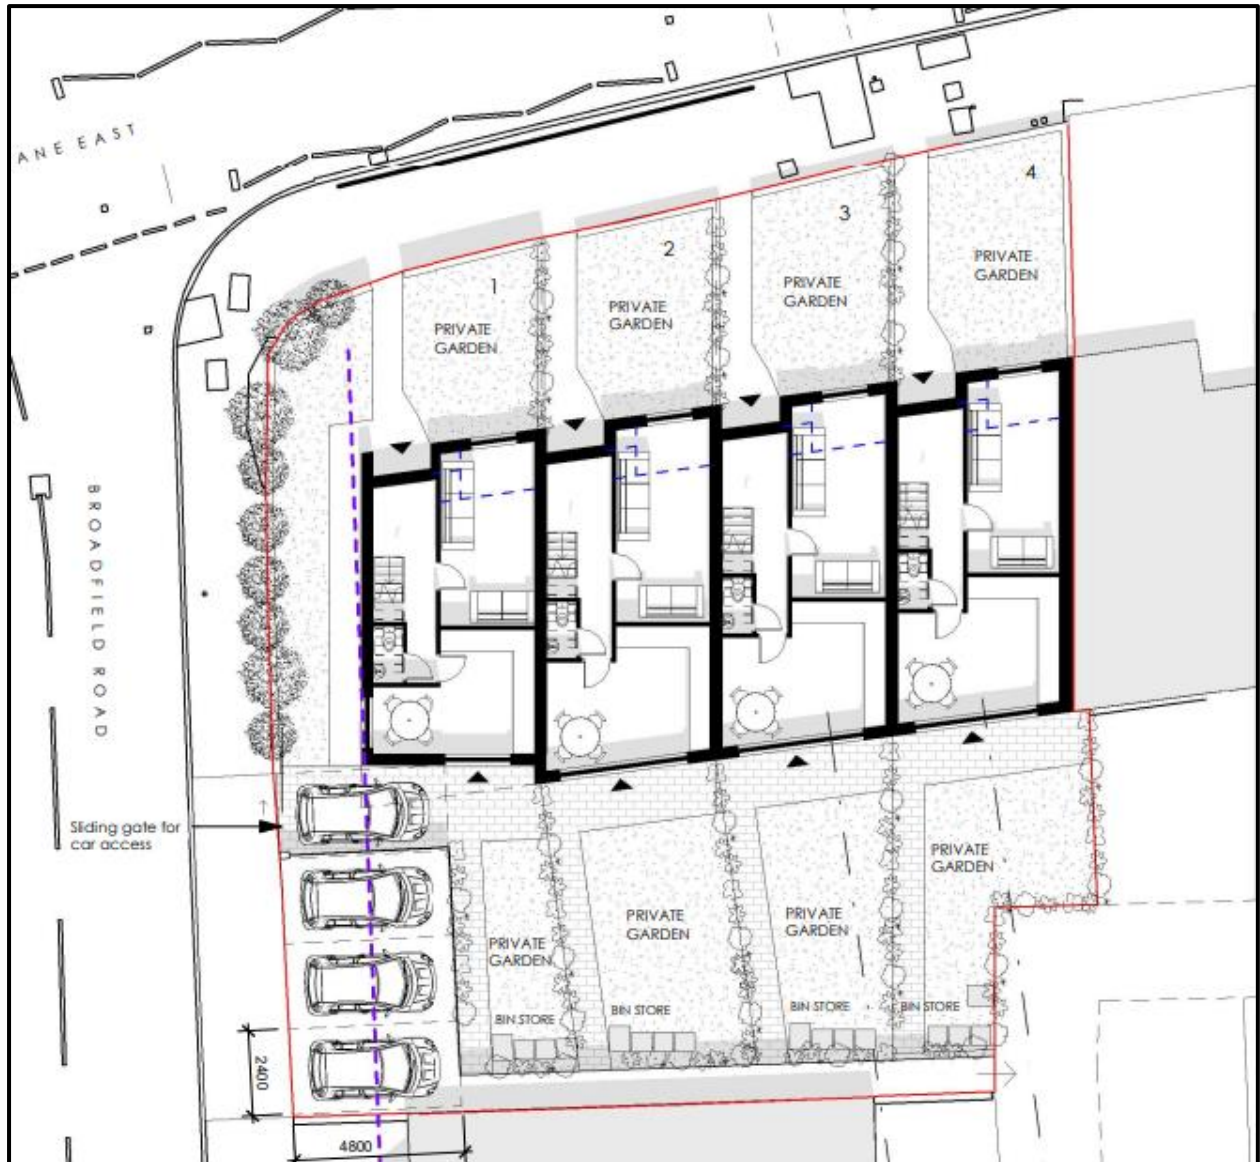
**Figure 3: Proposed Development Plan**

It is understood that the client wishes to construct four residential dwellings with rear and front garden areas and a parking bay in the southwest of site for residents.
