# Archaeological Excavation Report

Mayfield,  
Manchester

**Report No:**  
SA/2021/56

**Project:** Mayfield, Manchester: Archaeological Excavation

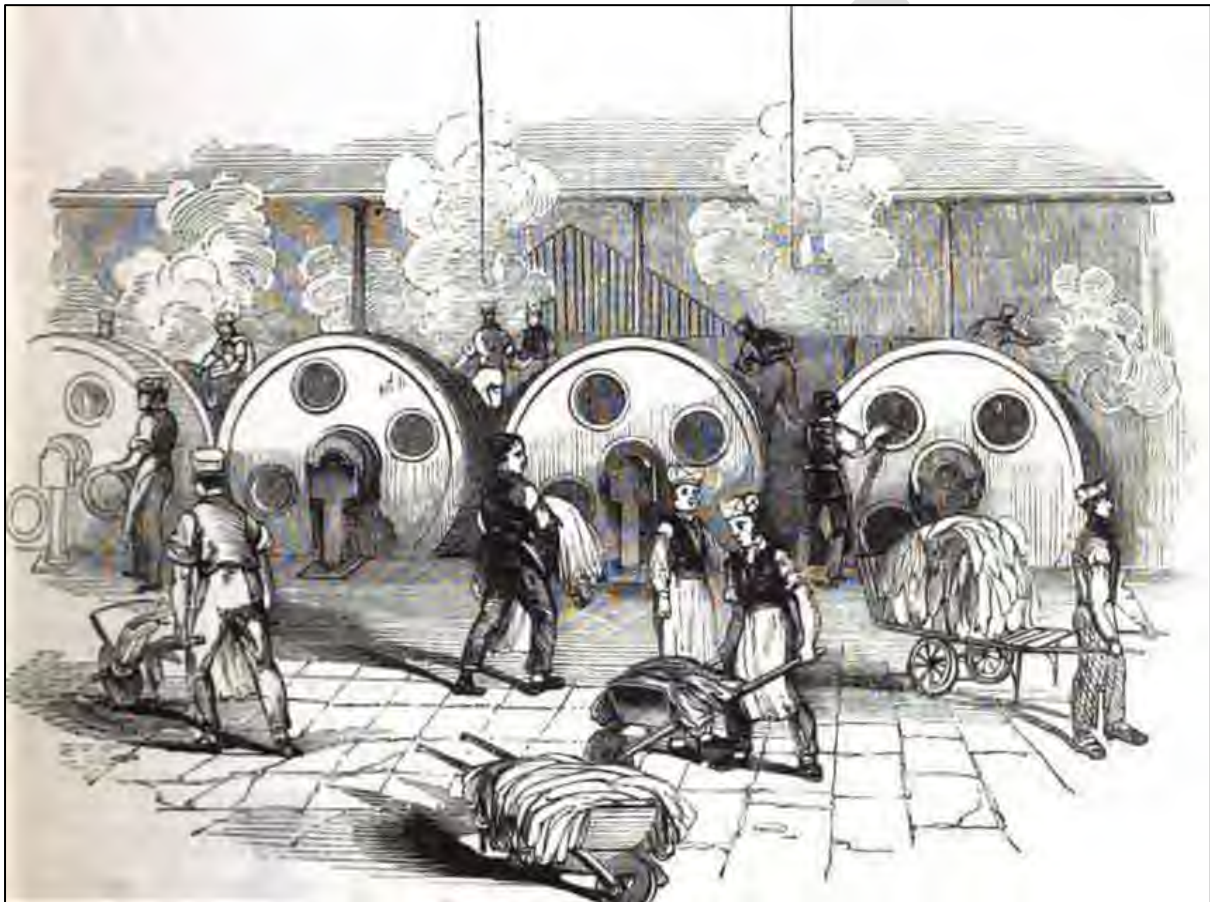
*Plate xx The dash wheels of the Dukinfield Works, Thomas Hoyle & Sons*

By 1828, the dash wheels, which had been used to wash cloth, were replaced with washing machines invented by David Bentley, which washed lengthy pieces of cloth after the bleaching process. The cotton cloth was brought for bleaching in a grey state and several pieces of cloth were sewn together in preparation for bleaching, each 'piece' of cloth often being around 28 yards long and 40 inches wide (Penny Magazine 1843, 290). After the cloth had been bleached, the pieces were again sewn together with more pieces, creating a single piece of cloth reaching approximately 14,000 yards long (*ibid*). The lengthy cloth would then be placed in a washing machine or 'wash engine', which wound the cloth in a spiral, with the water in the machines being renewed throughout the process. Washing machines were used in various stages of the process to keep the cloth clean and prepared for the next stages (Miller, 2012, 15-16).

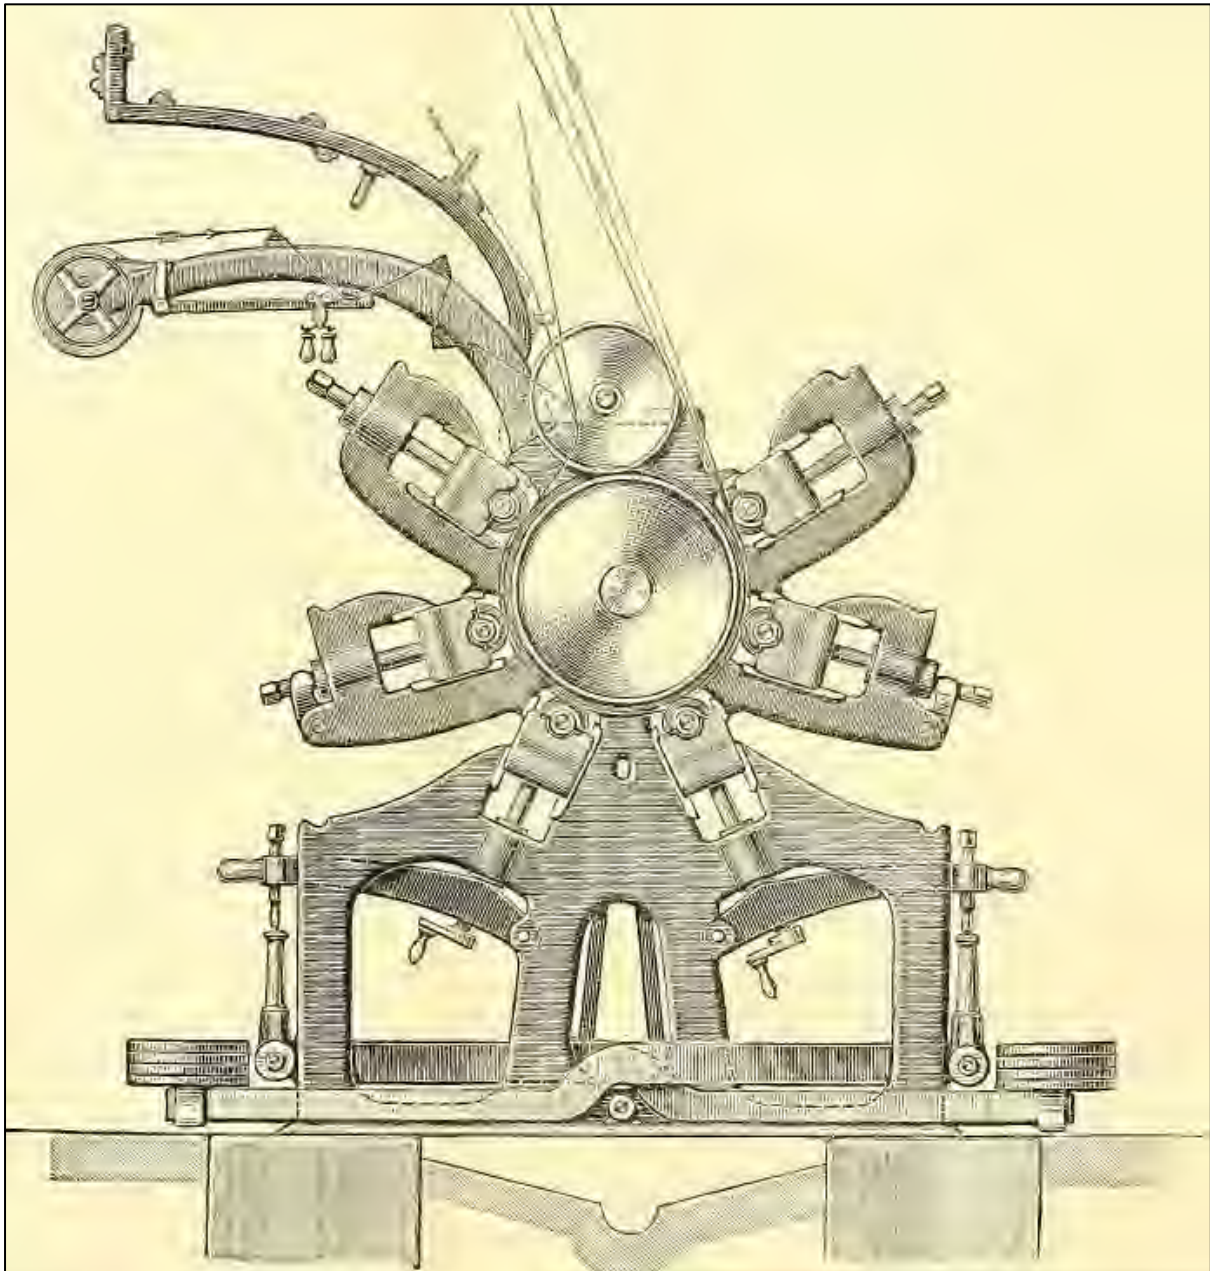
Plate xx: A six colour printing machine depicted in ‘The Printing of Cotton Fabrics’ (Sansone 1887)

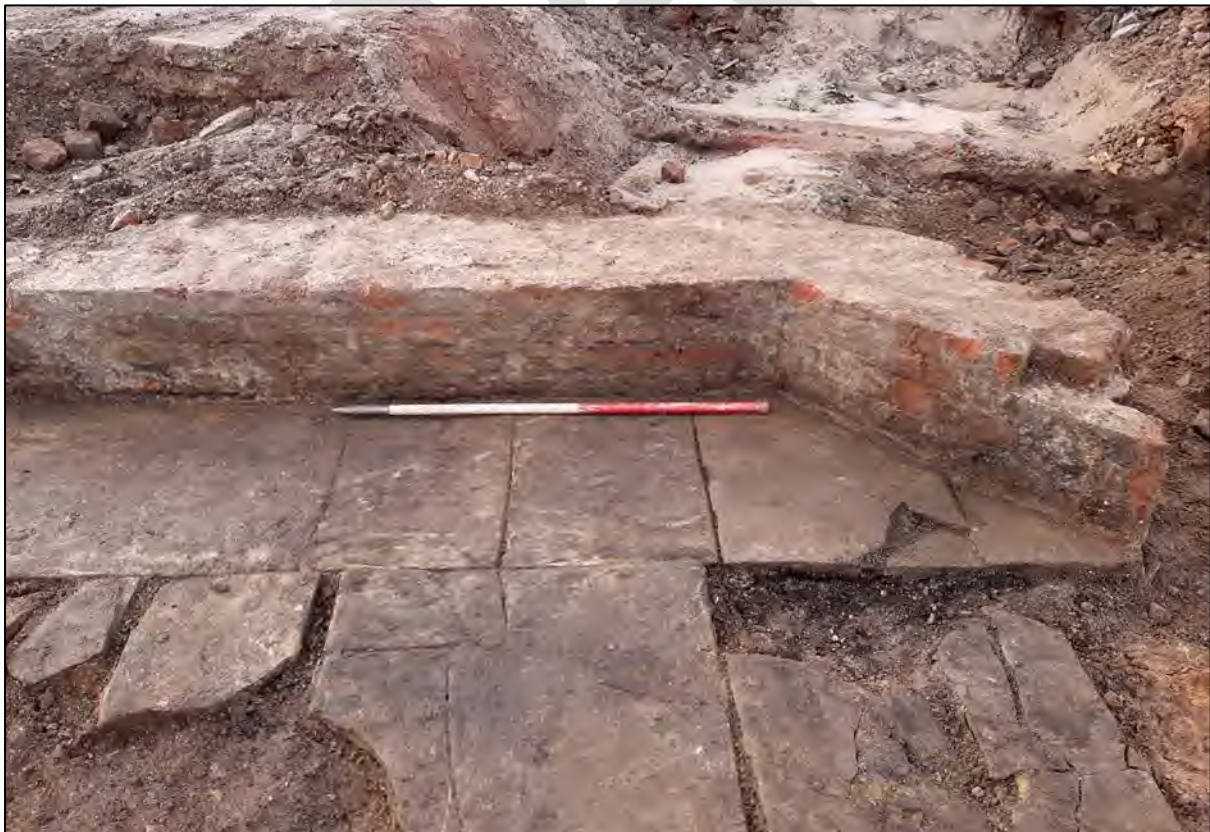
Plate xx: Wall 114, looking south.

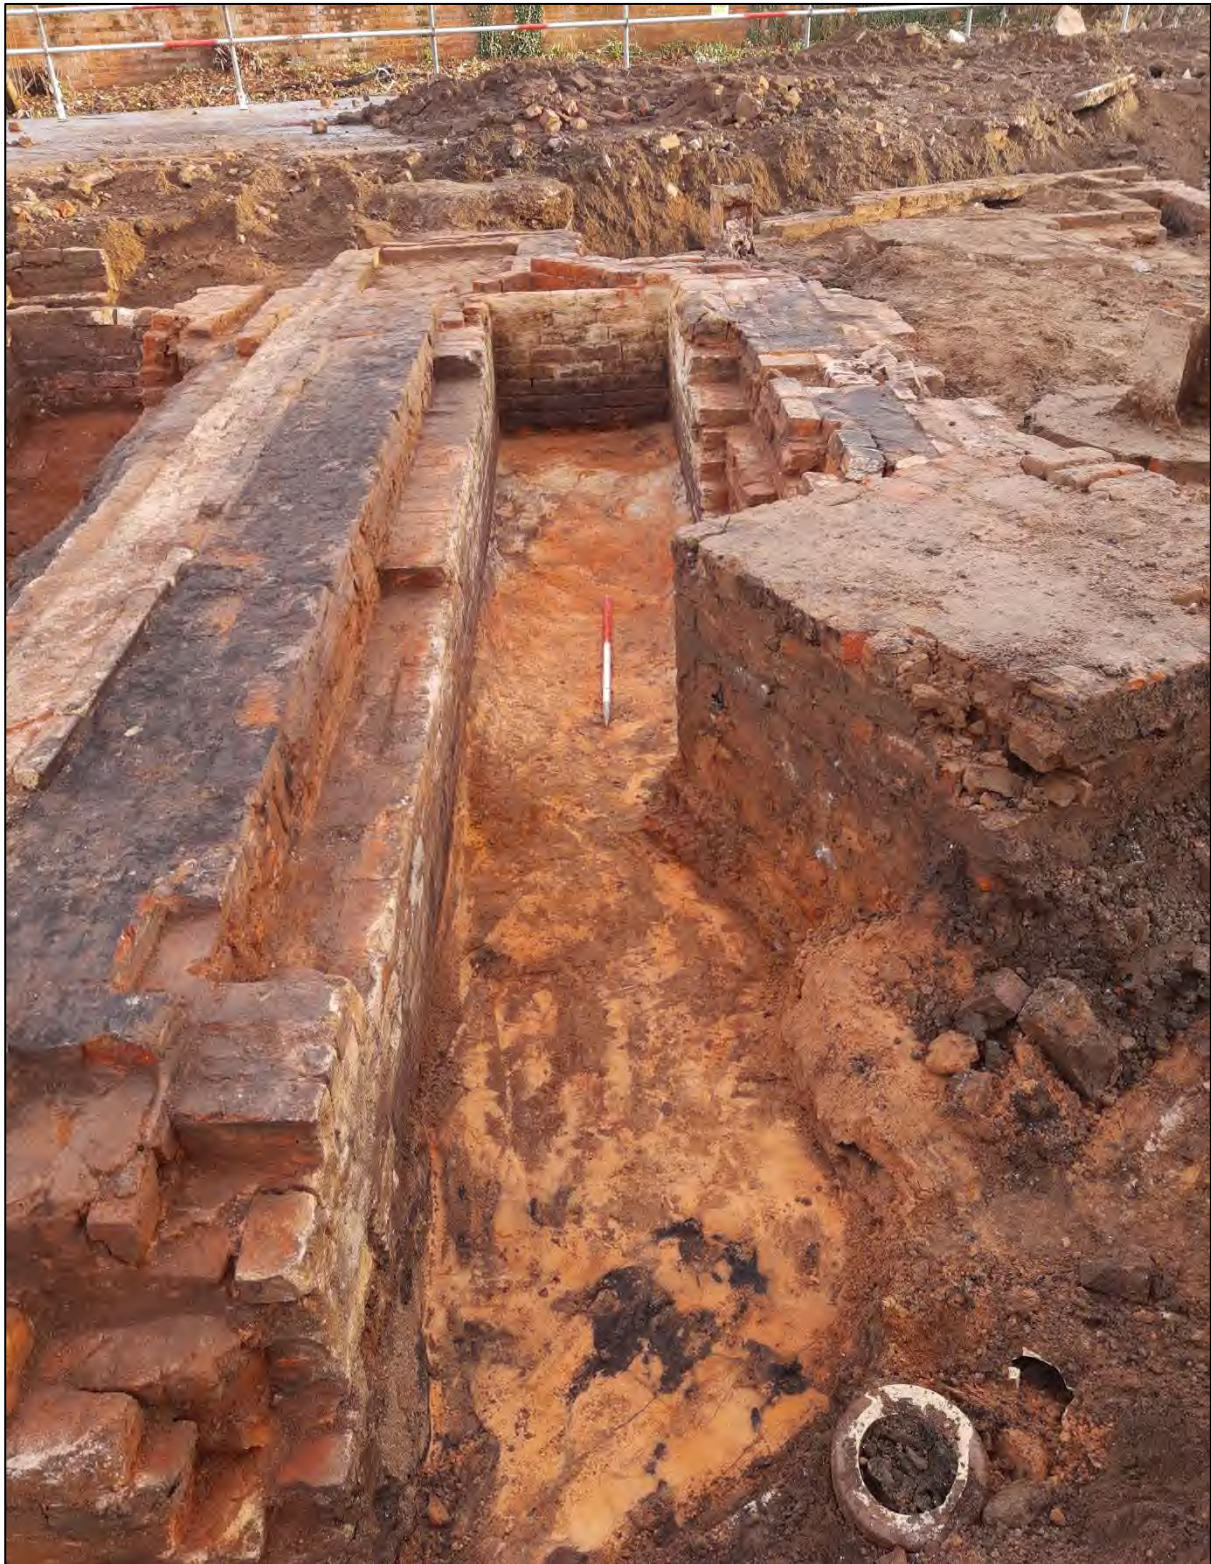
*Plate xx: Boiler 111, looking north*

The two boiler-beds, **111** and **112** were located to the southwest of the chimney at the west of the excavation area. Both boilers were truncated by later activity. This included a further brick stanchion, **109**, which truncated the southeast of boiler-bed **111** and measured 1.2 x 1.1m.

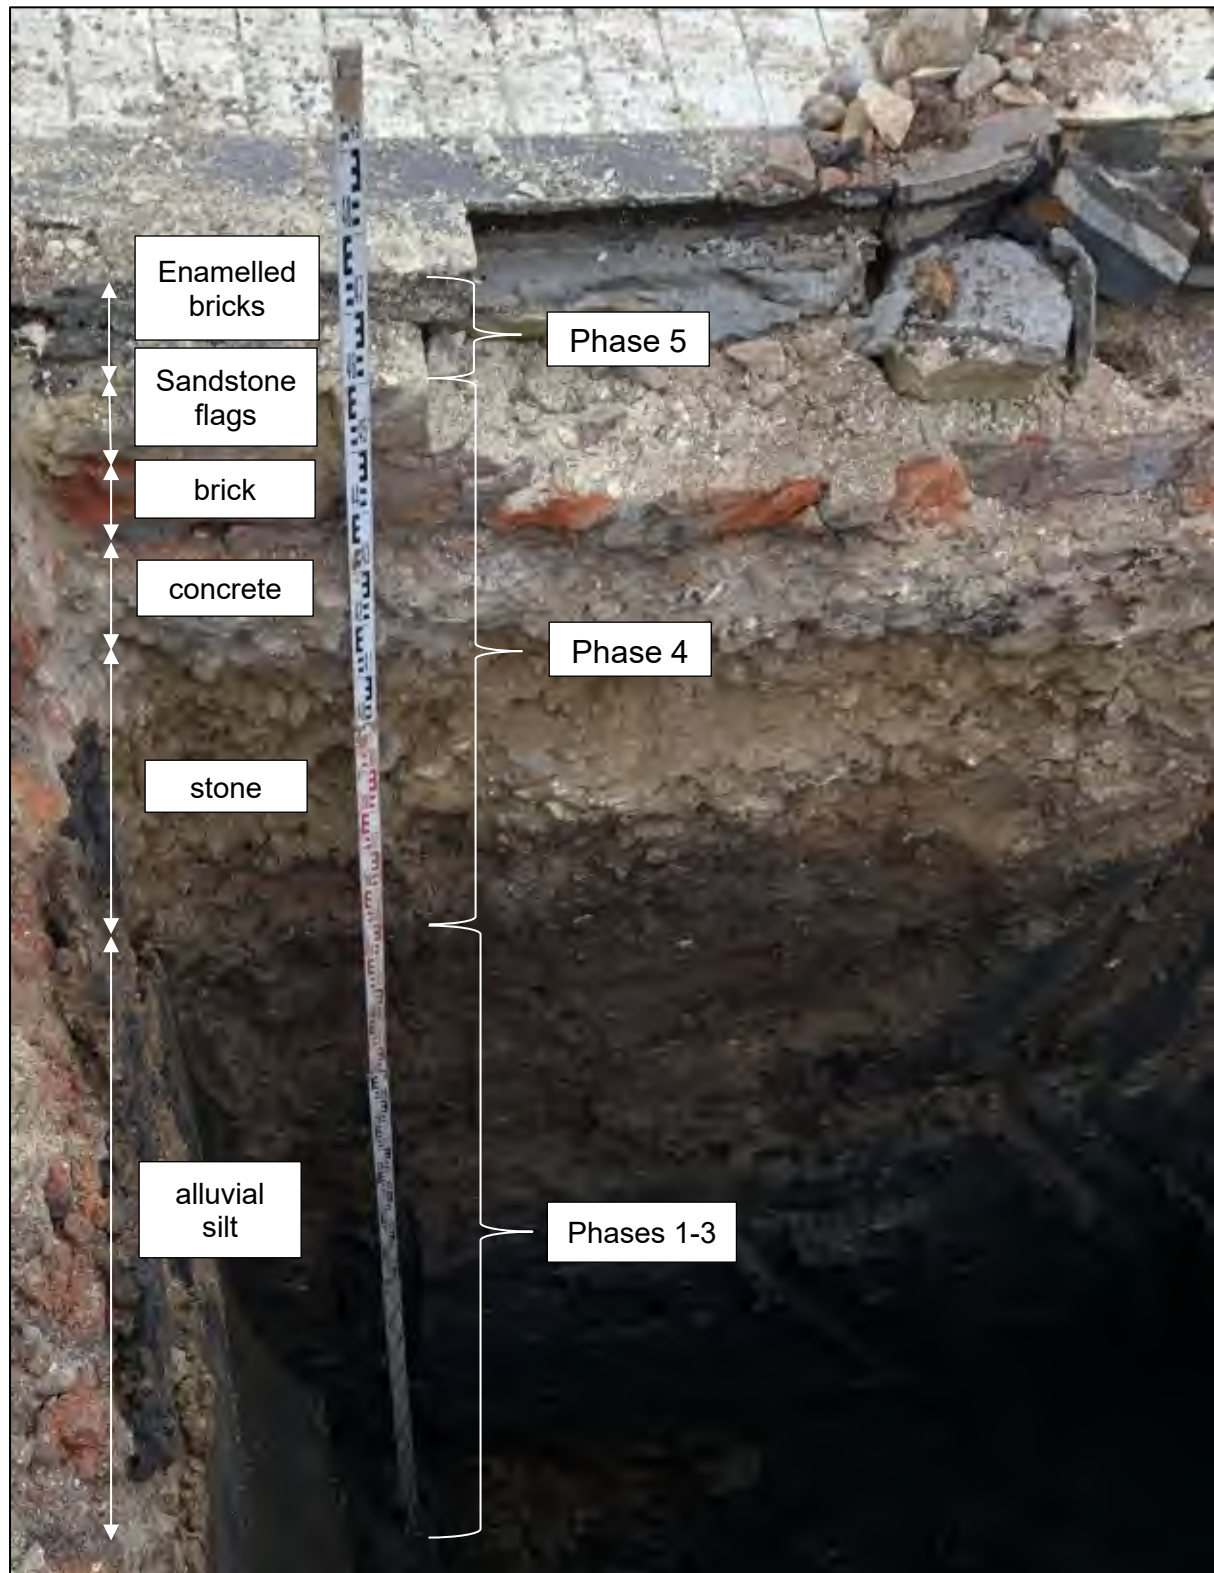
*Plate\_ : Sondage through the base of Pool 226 showing the composition of the foundations above earlier layers of alluvial silt*

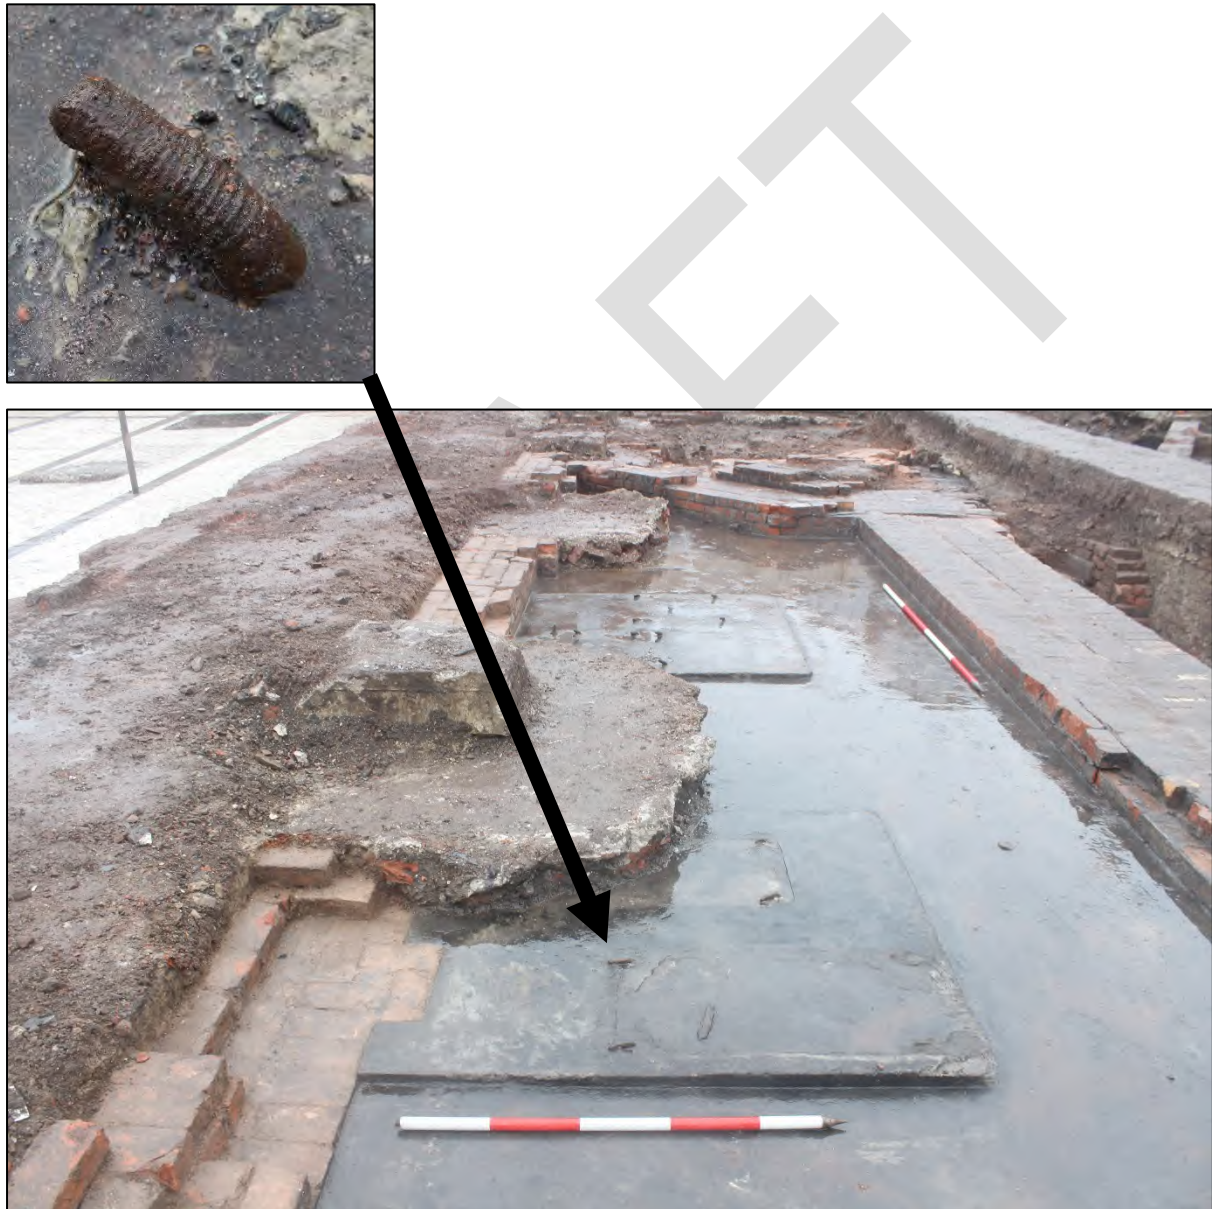
*Plate: Anteroom to the boiler showing stone machine beds 216a (foreground) and 216b in the rear of the shot (1m and 2m scales) Inset: showing threaded bolt*

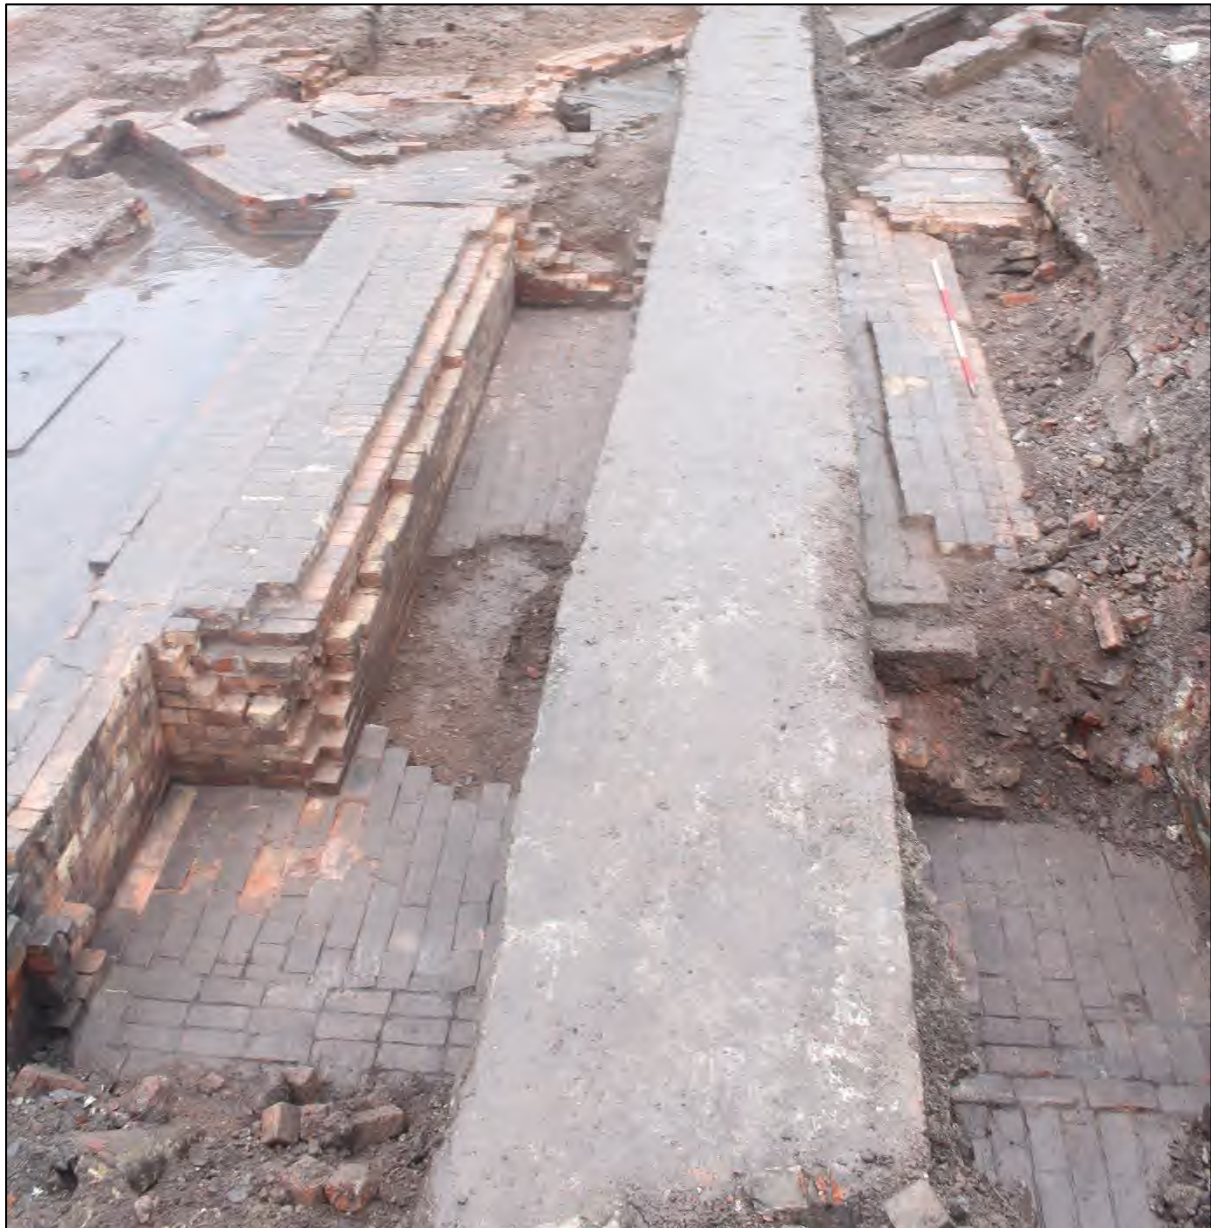
*Plate xx: View of the boilers 221 and 222 and flue 217 looking west (2m scale)*

The east of the structure had been truncated while the west of the feature was the firebrick wall of the flue, 217.

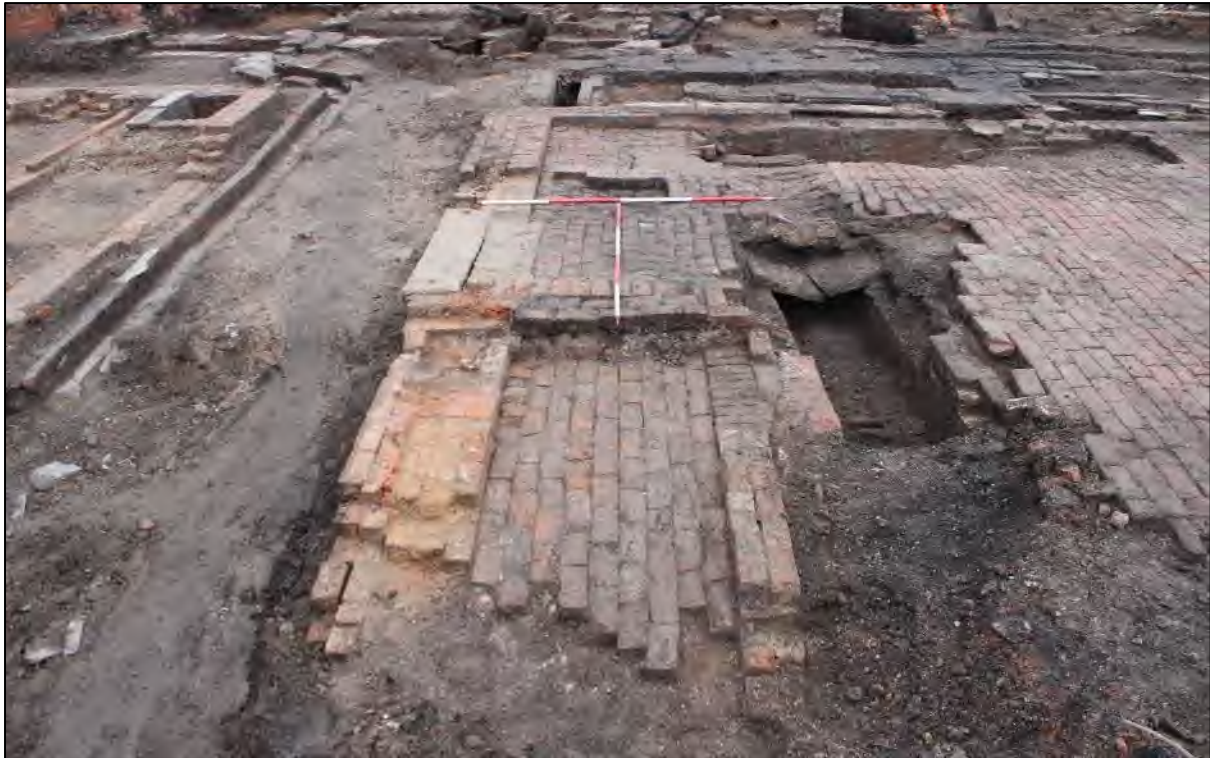
*Plate \_: Walls 3011 and 3057 forming the northern wall of Building B. Note the yellowish-brown mortar and handmade brick forming the original one-and-a-half brick wall. Looking north-east (2 x 2m scales)*

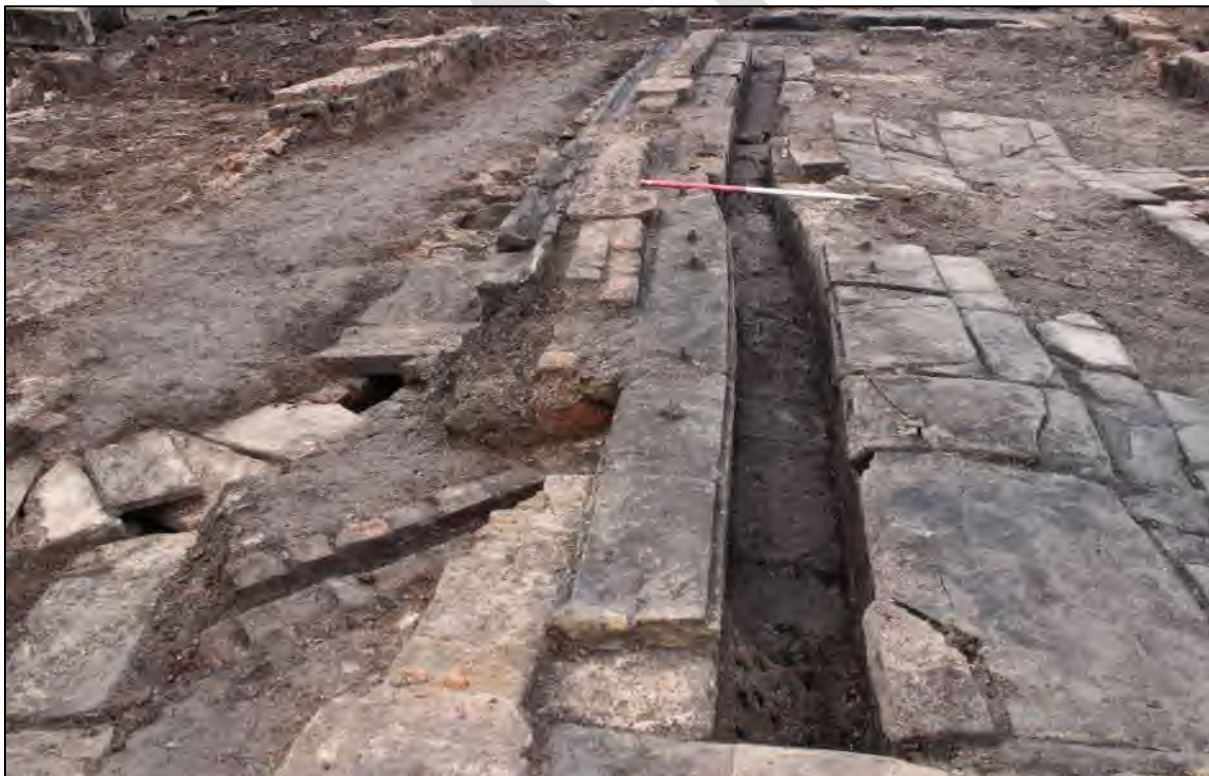
Plate \_\_: View of drain 3038 constructed alongside wall 3027 looking south-west (1m scale)

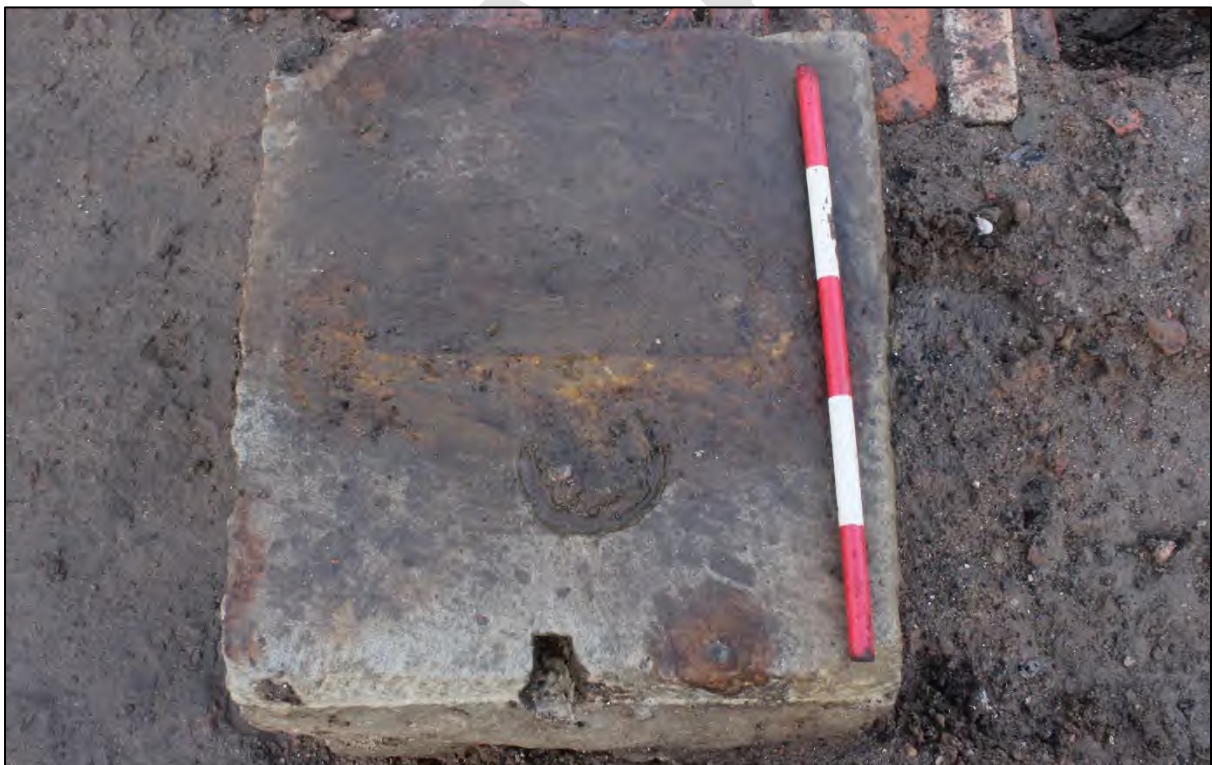
*Plate\_*: Column base 3148 looking north. Note the shadow left behind by the cast iron column base as well as holes left by other potential fittings (0.50m scale)

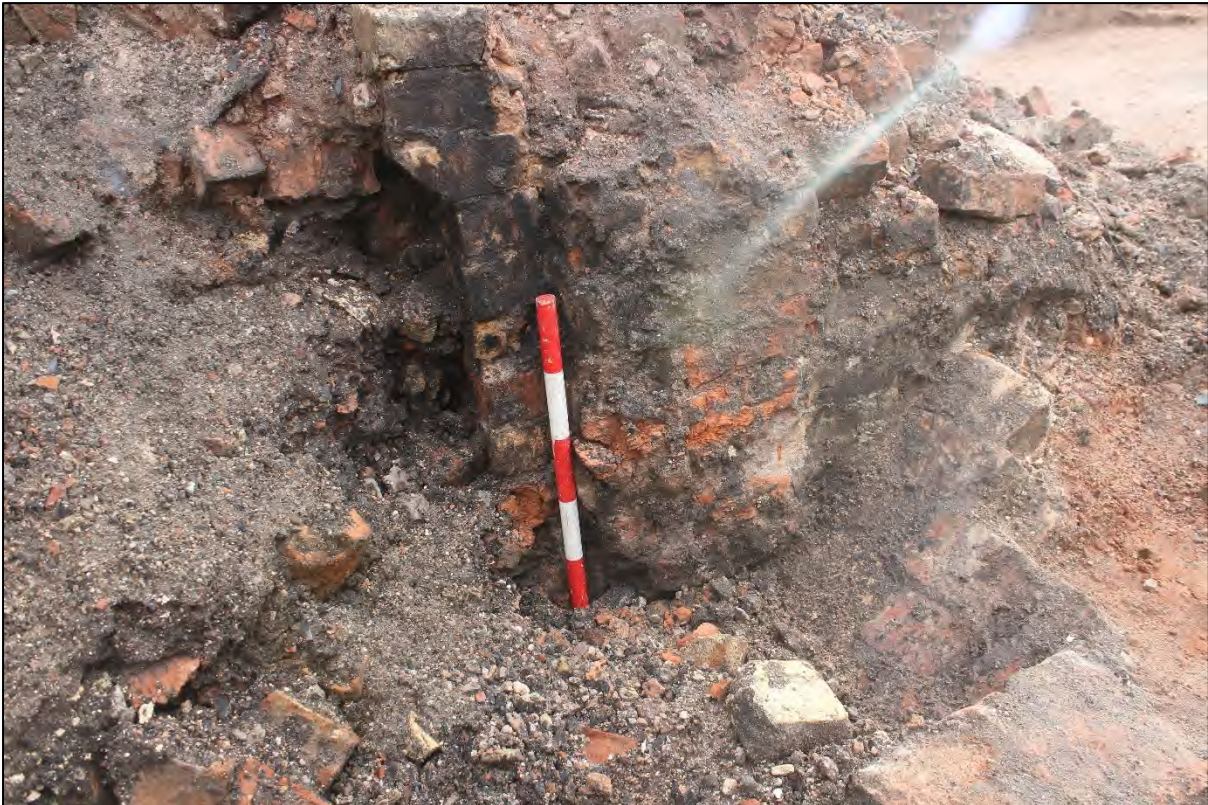
*Plate\_ : Remnant of the vaulted flue to the rear of the boilers, looking east. Note the rebated brick wall and adjacent flue sloping down from below the boiler. This would have been the location of a damper to regulate draught (0.50m scale)*

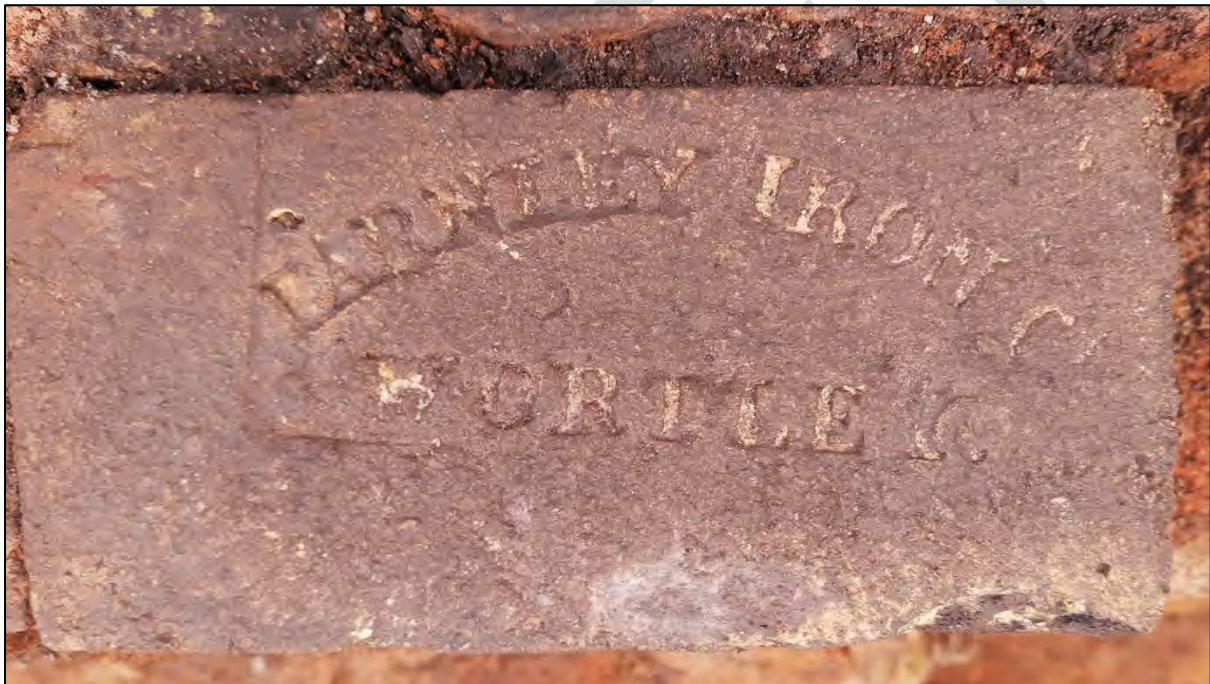
*Plate xx: Firebrick bearing the stamp Farnley Iron Co. Wortley' utilised in Boiler 111*

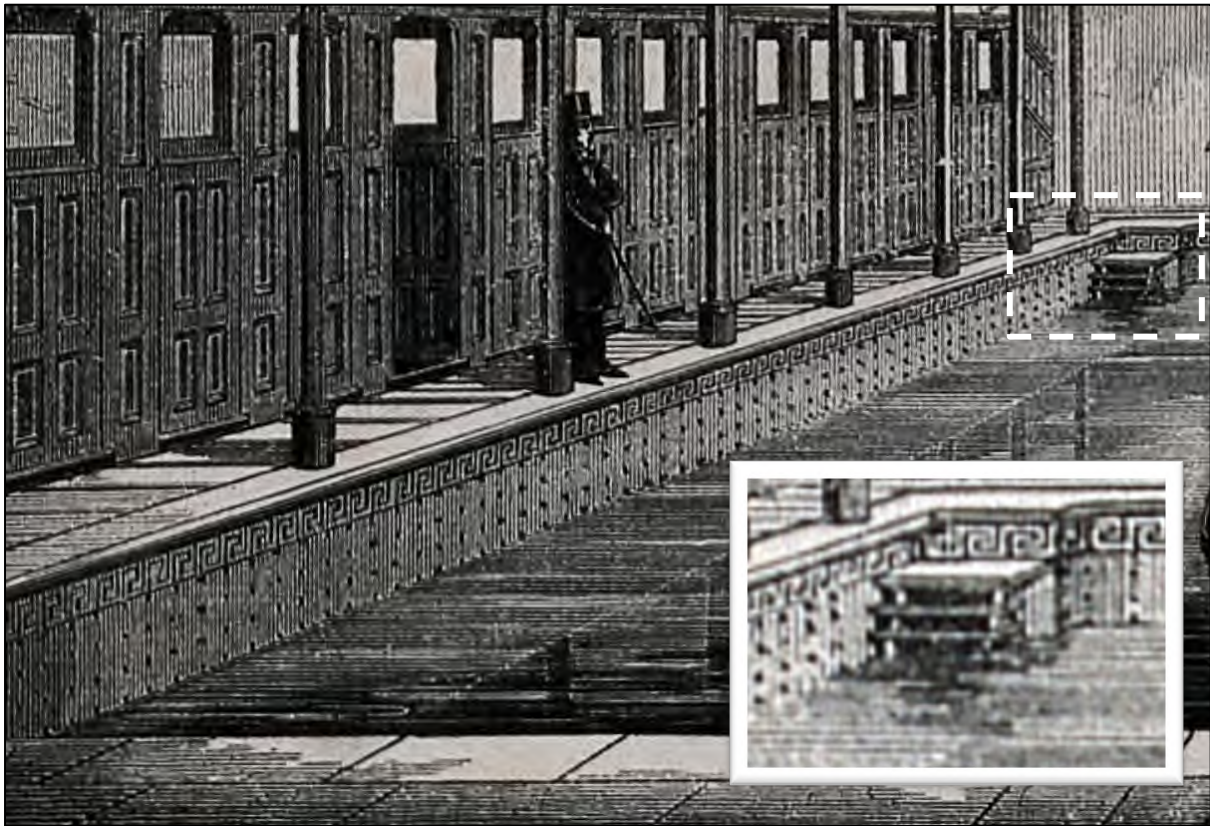
Plate x: Extract from *The Builder* 1858 showing the original tiles and steps installed in the plunge pool of the first-class men's pool at Mayfield Baths (see inset for close-up)

blue and white tiles, finished with an ornamental border. The bottom is laid with Yorkshire flags, an arrangement which appears to be the best that has been suggested, tiles there being liable to get loose and cut the feet; and glazed bricks, if cheap enough, it is thought would be too white for water which, as at present supplied, is said to deposit a small amount of vegetable matter. The appearance of discoloration in the water which there is now — from whatever cause arising — is to be regretted. Some little difficulty, we believe, is found in the action of the water on the ironwork. The drying apparatus in the washing department, appears to act efficiently. Small articles are dried in fifteen minutes, and half an hour serves for almost anything.
