# Television and Radio Baseline Survey Report

Laystall Street / Great Ancoats Street

Ancoats Manchester Ltd

November 2022

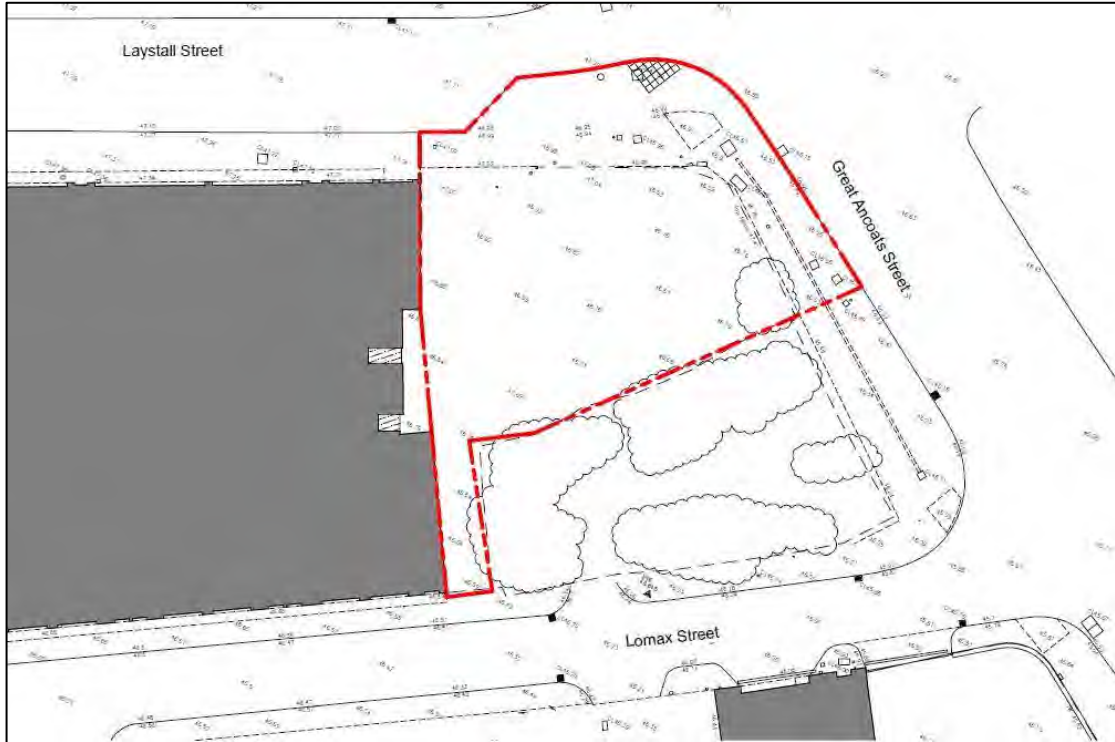
Figure 1 *Proposed development redline boundary*

The proposed development redline boundary is shown in Figure 1<sup>1</sup> below.

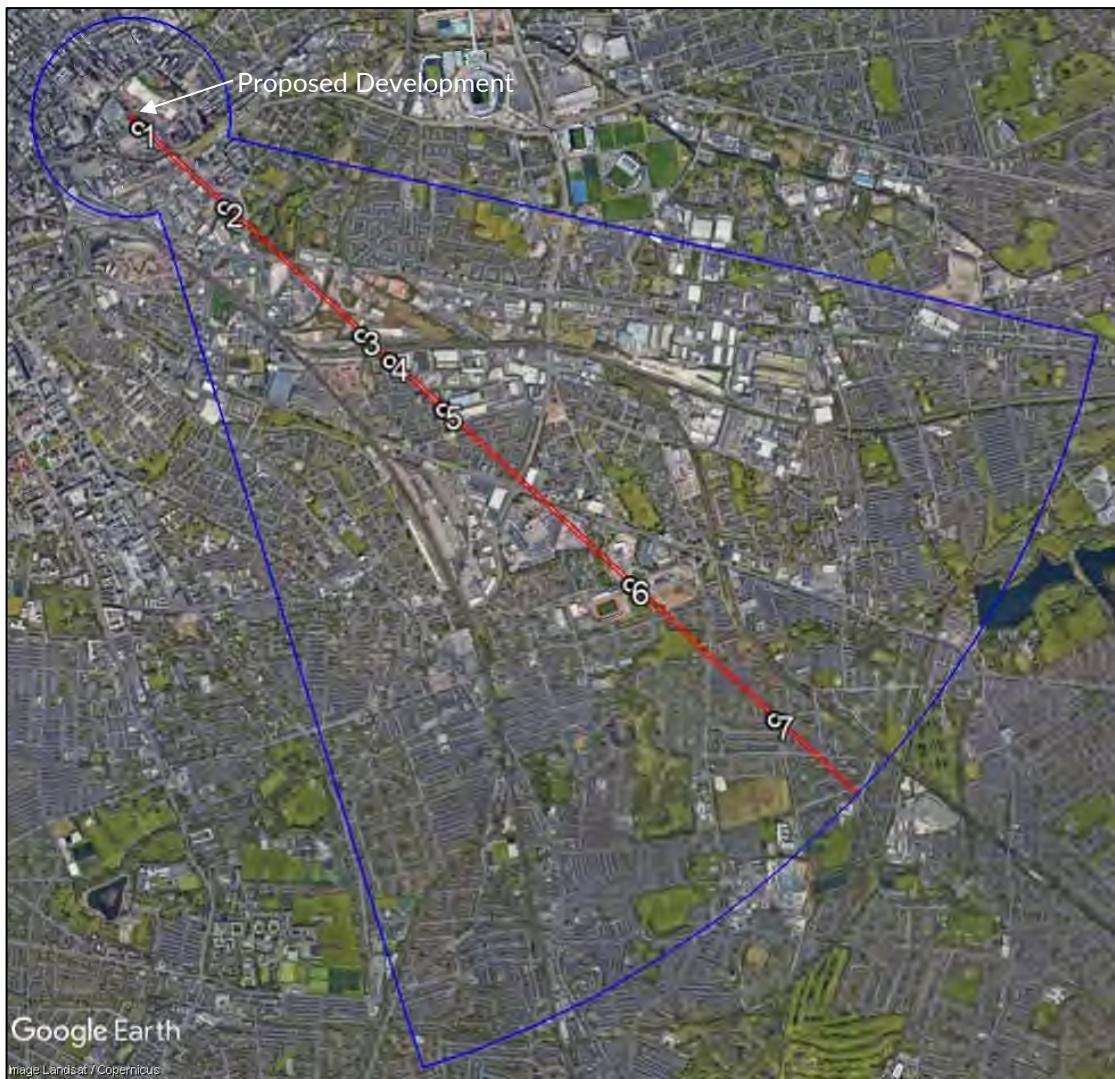
Figure 8 Survey locations

Figure 8 below shows the survey locations overlaid onto aerial photography. Survey locations were chosen pre-survey (within the shadow zone) however safe and available access influenced the specific position on the day. The locations below show the actual survey locations. Survey locations are more closely grouped nearer the proposed development because interference is generally more likely the closer the location is to the obstruction. Radial white icons represent both television and radio survey locations.

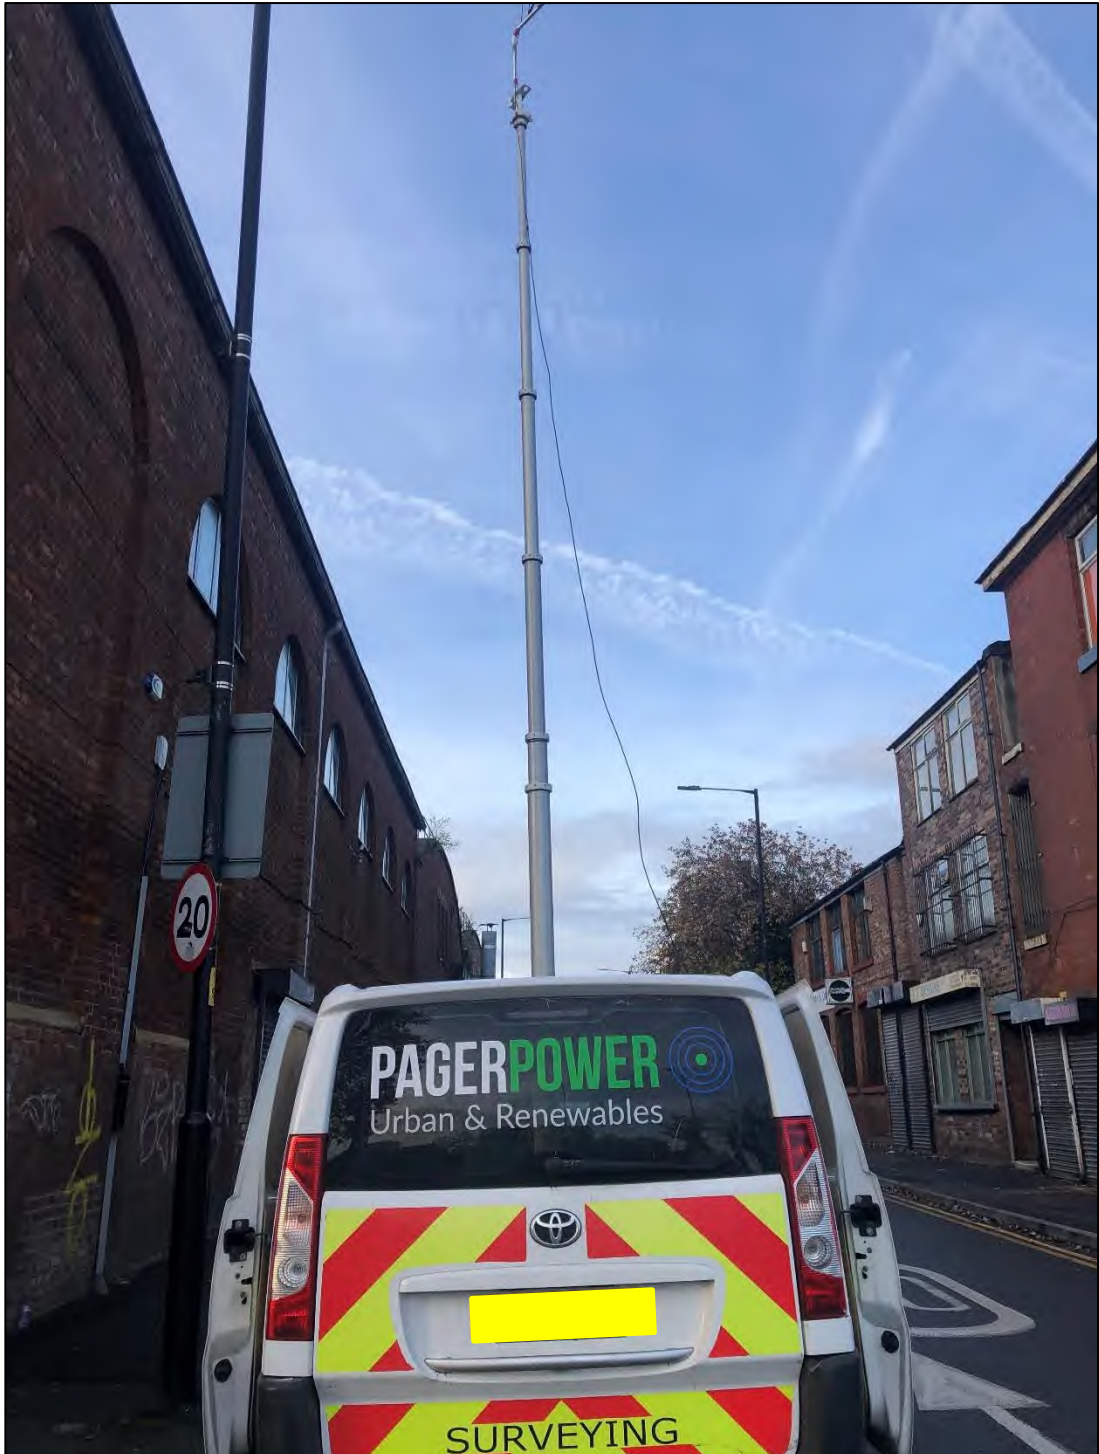
### Location 1

Notes: No HP<sup>11</sup> UHF<sup>12</sup> aerials and one satellite dish was observed.

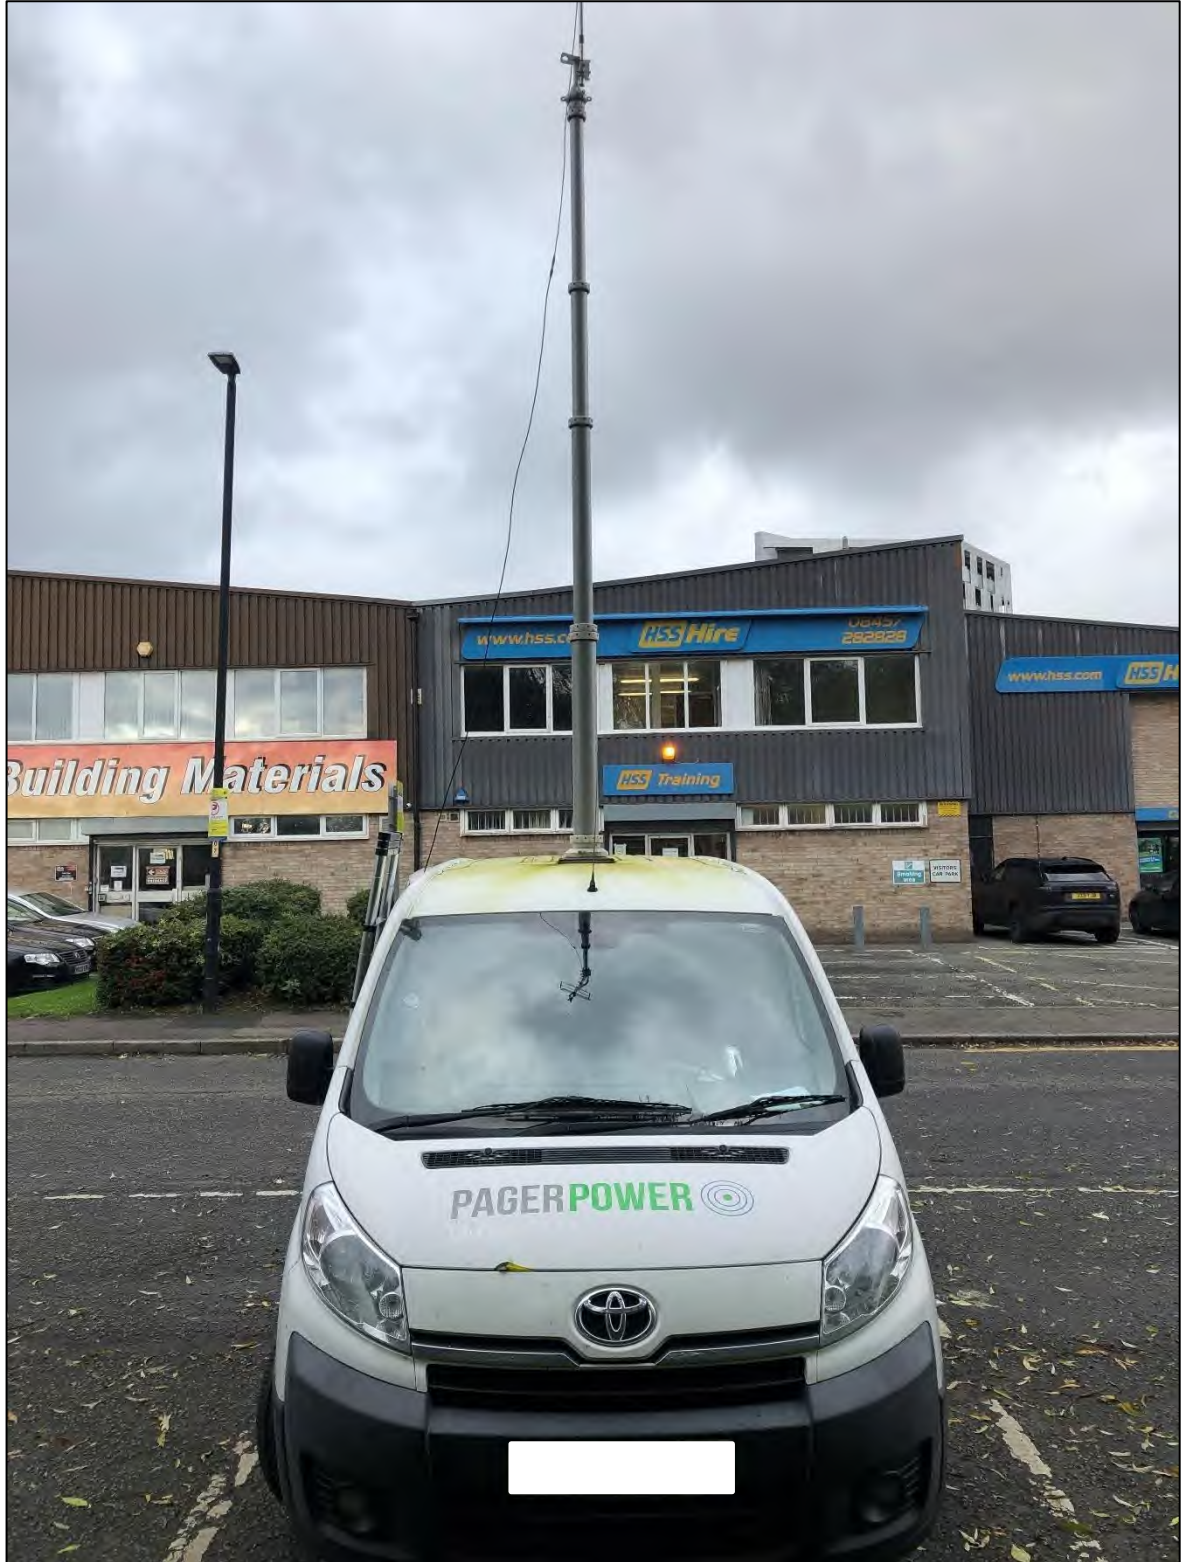
Location 2

Notes: No HP UHF aerials or satellite dishes were observed.

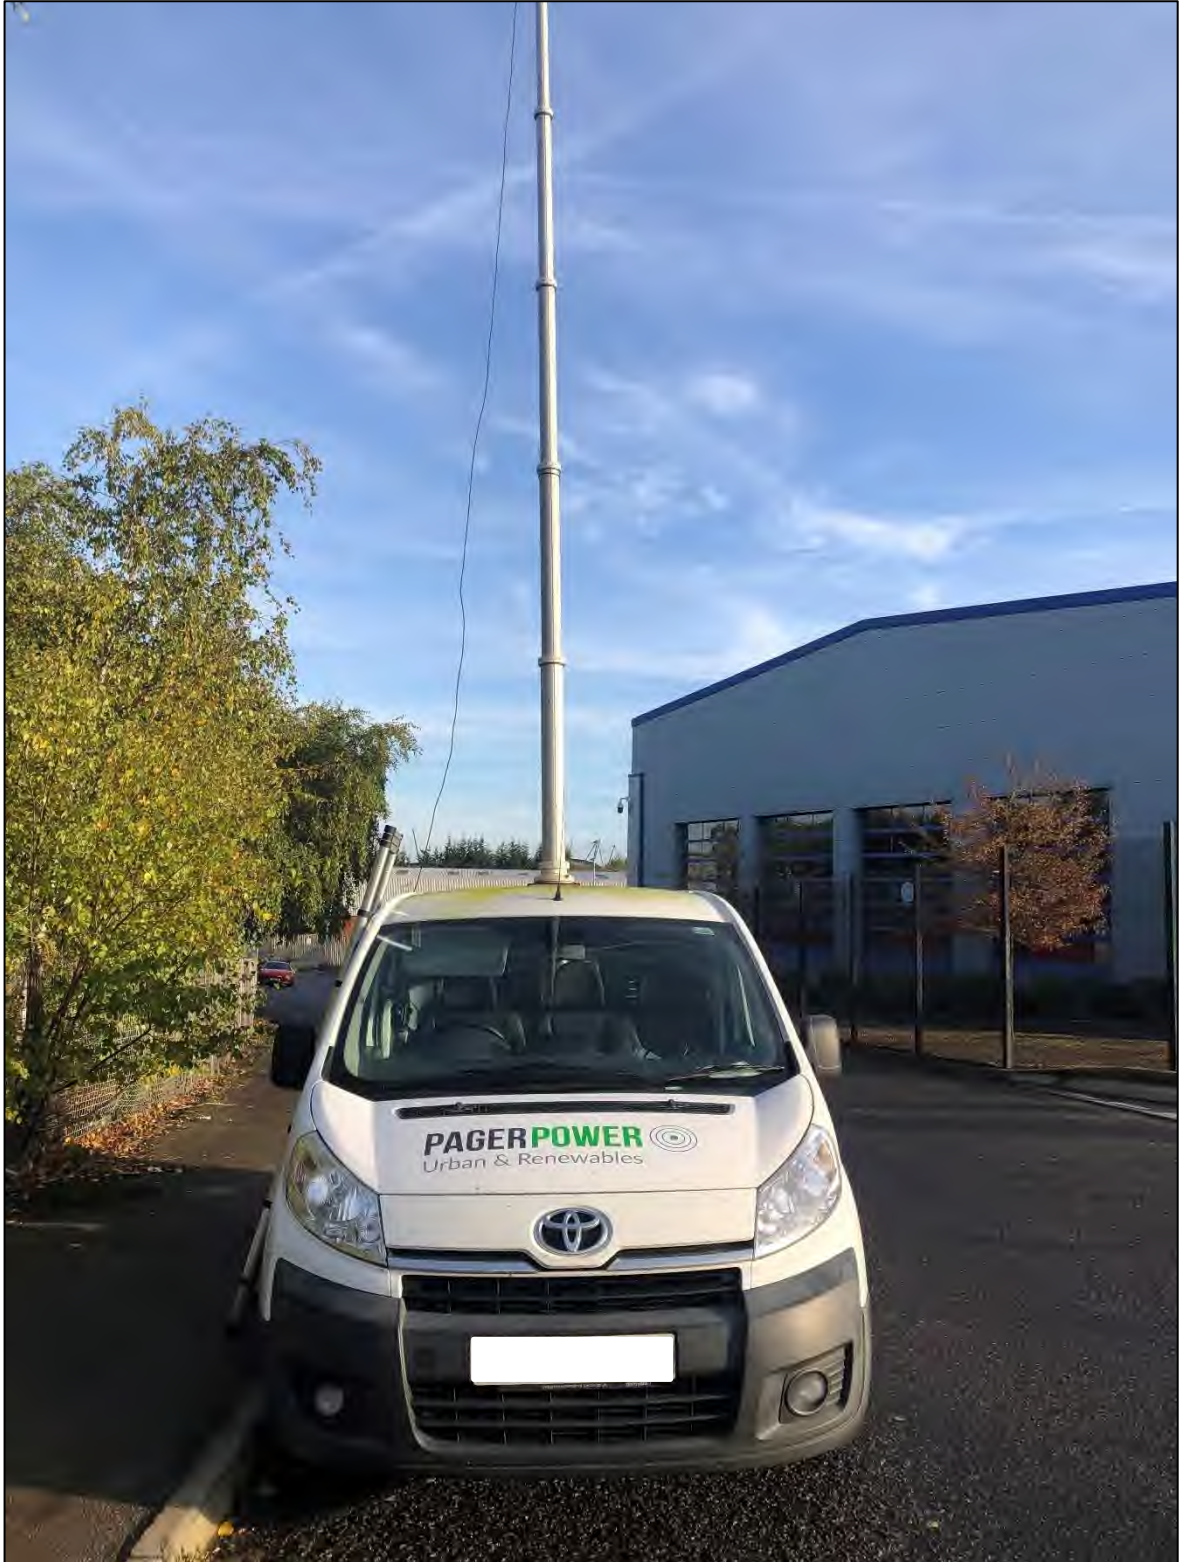
Location 3

Notes: No HP UFH aerials or satellite dishes were observed.

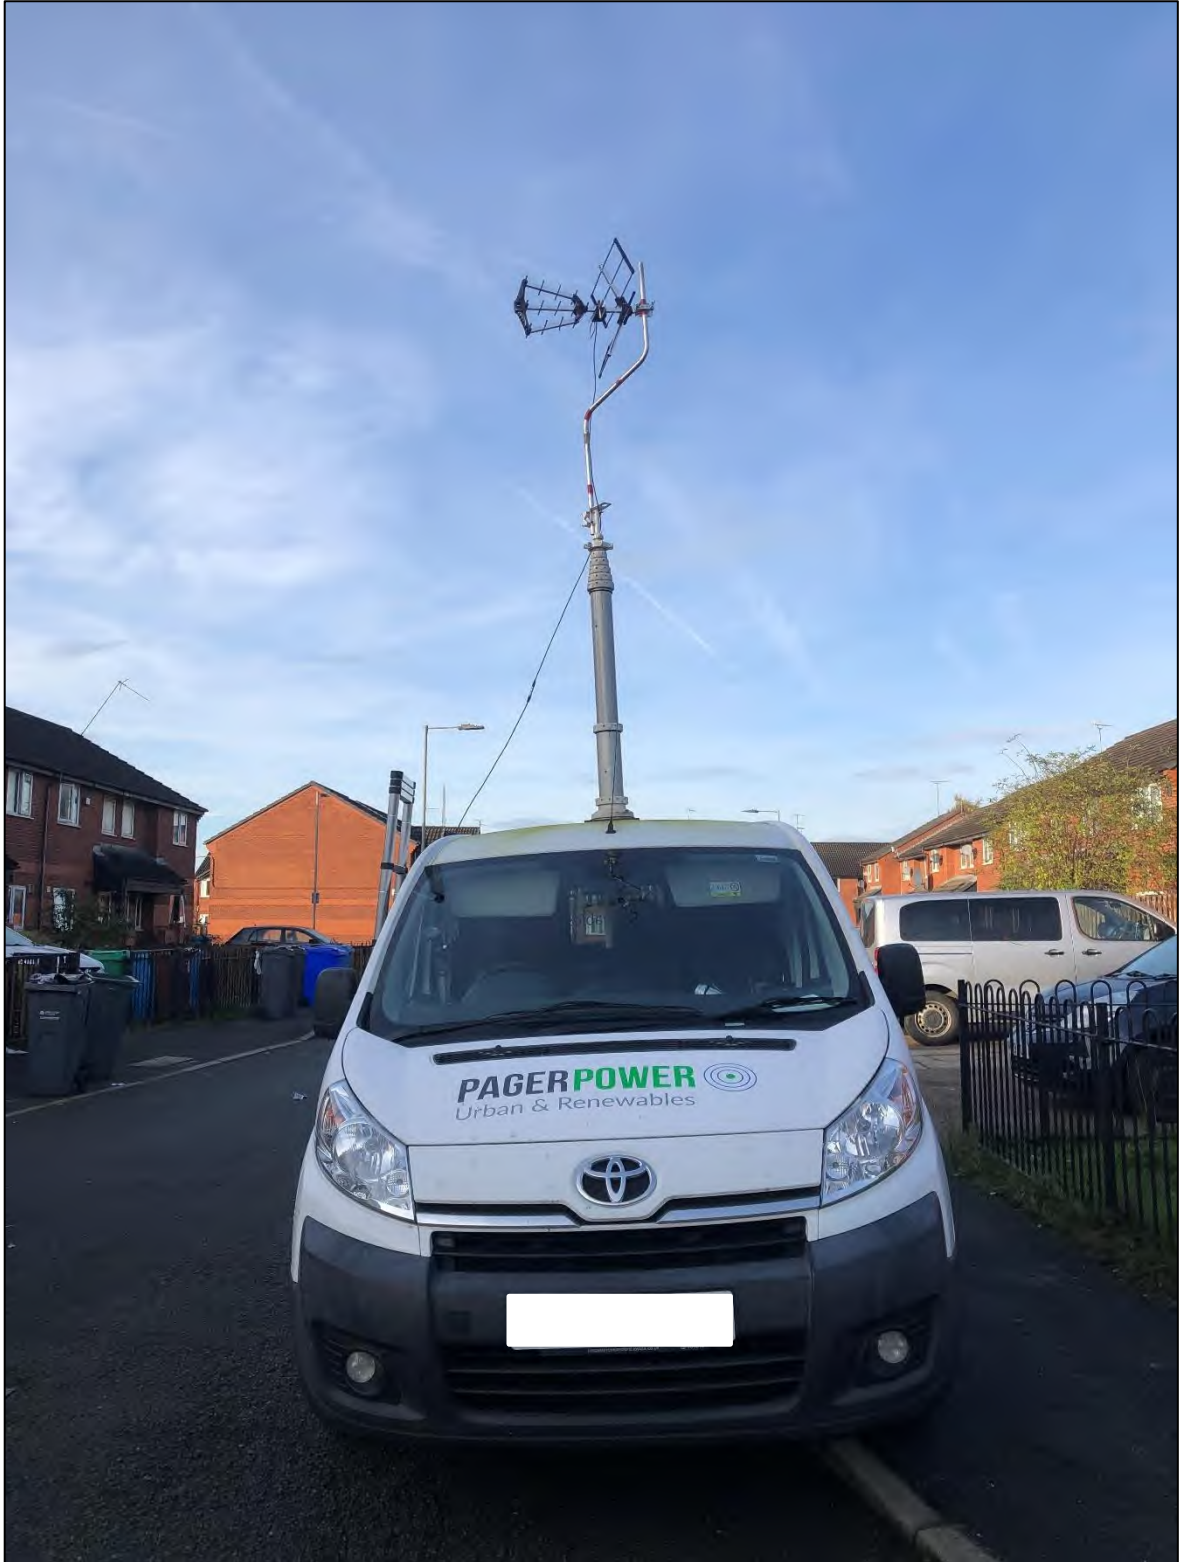
Location 4

Notes: Multiple HP UHF aerials directed towards the Winter Hill transmitter was observed.  
Multiple satellite dishes were observed.

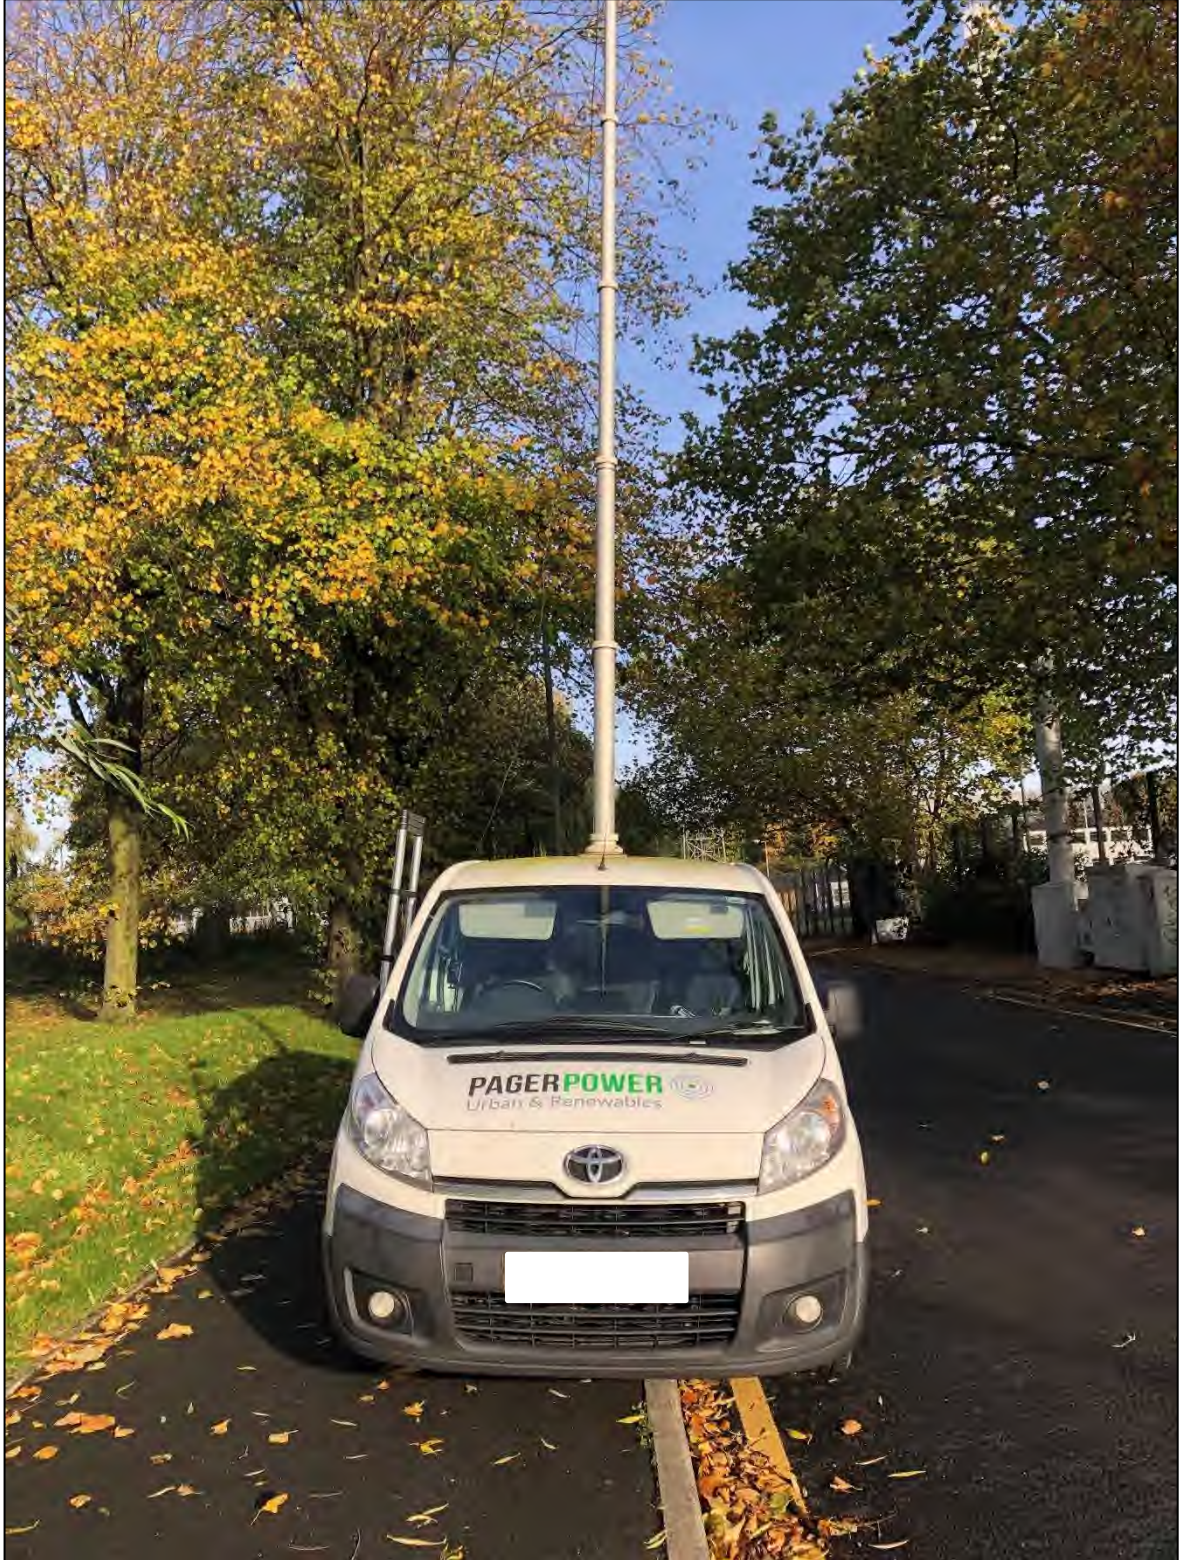
Location 5

Notes: No HP UFH aerials or satellite dishes were observed.

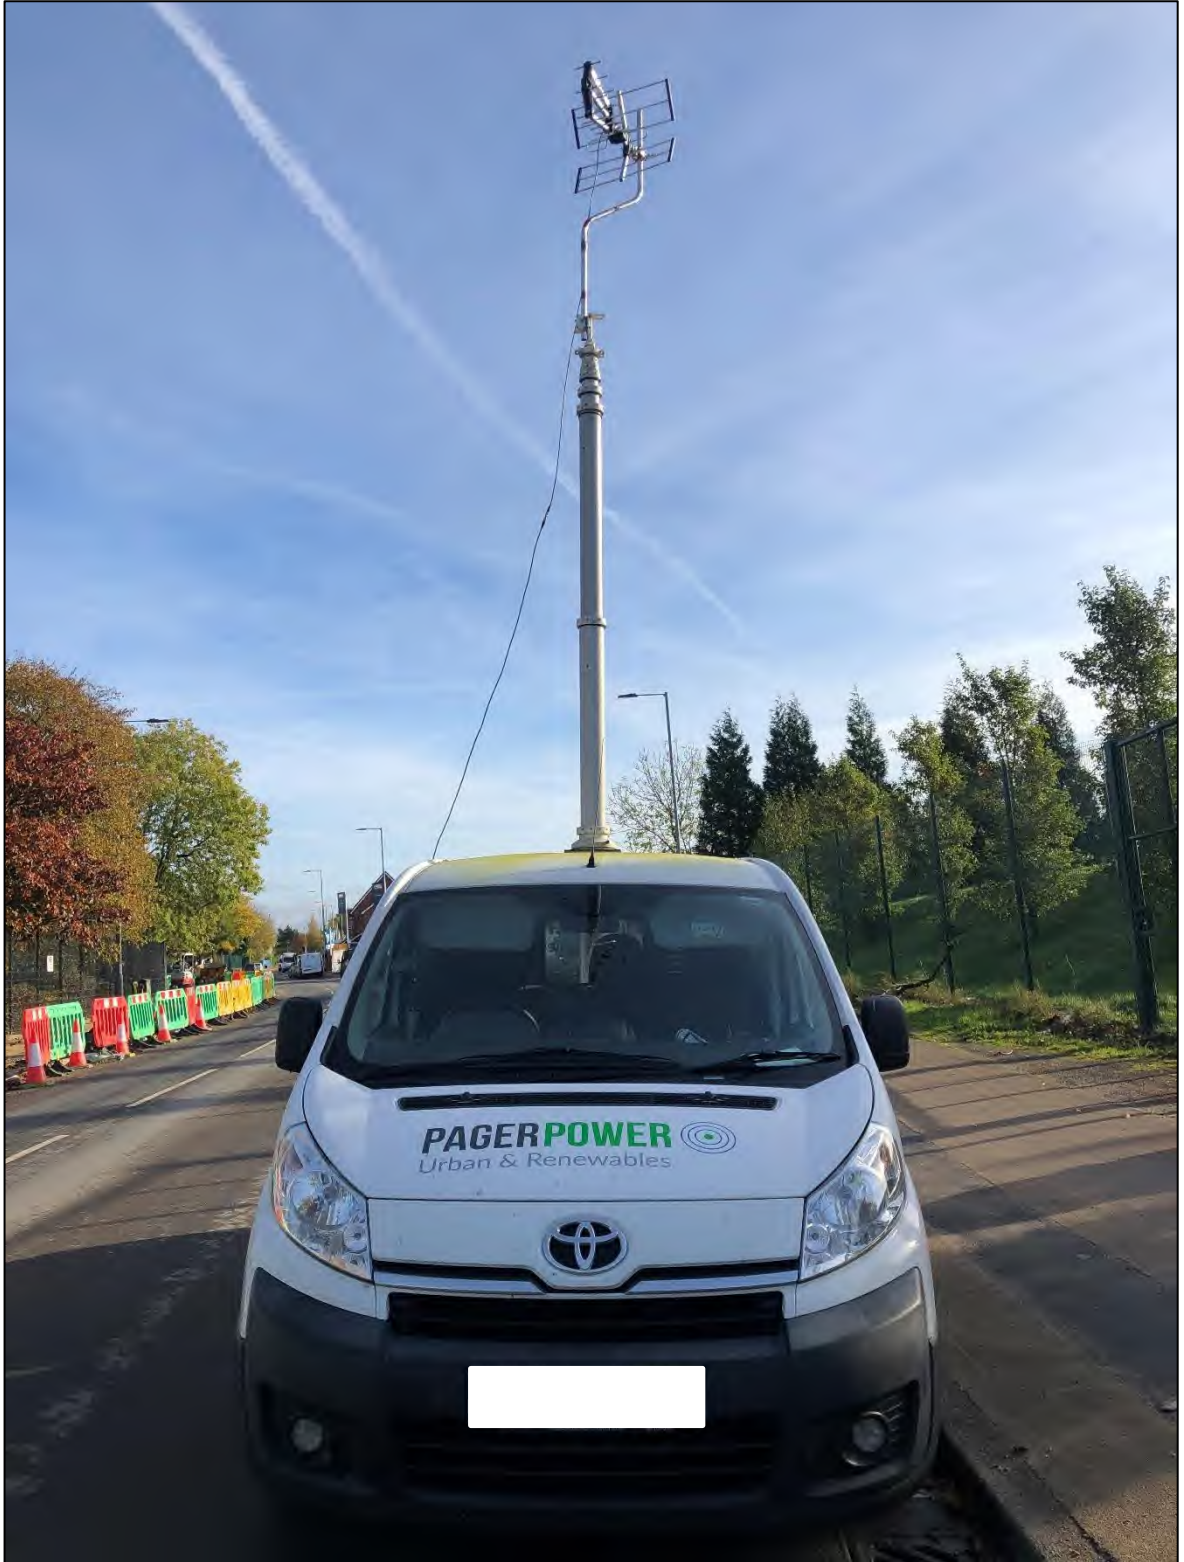
Location 6

Notes: Multiple HP UHF aerials directed towards the Winter Hill transmitter was observed.  
Multiple satellite dishes were observed.

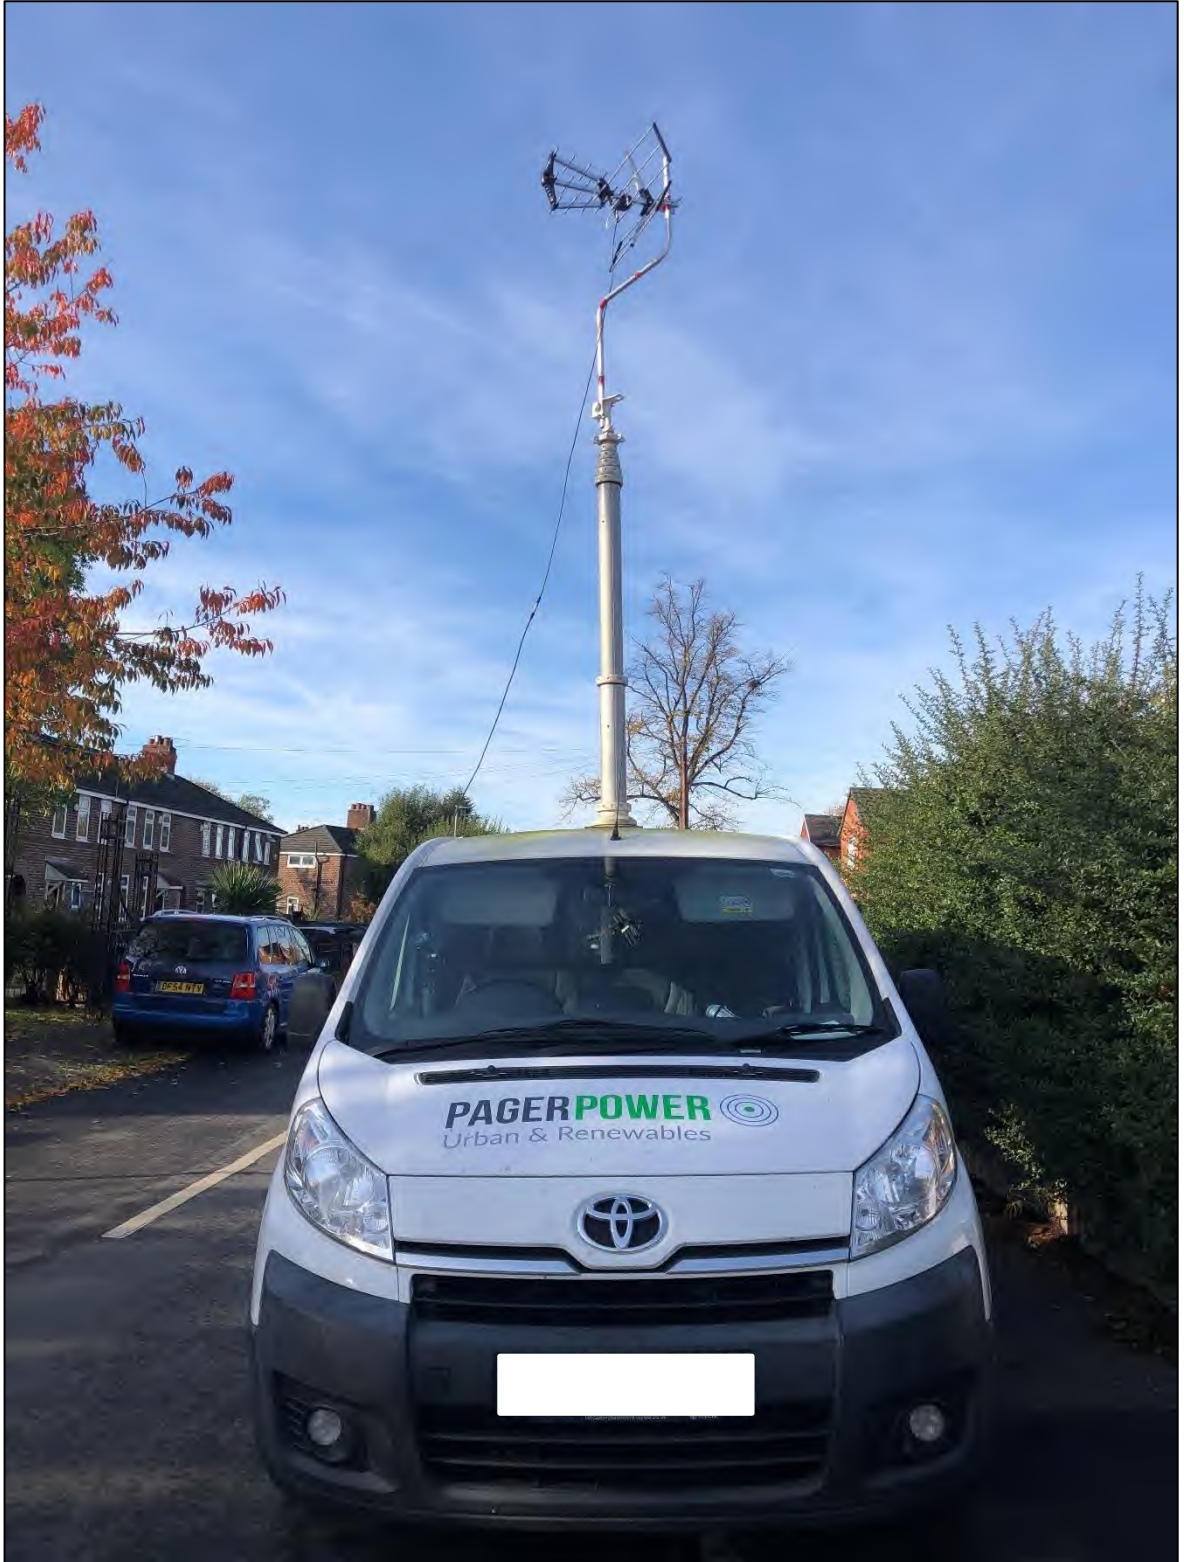
Location 7

Notes: Multiple HP UHF aerials directed towards the Winter Hill transmitter was observed.  
Multiple satellite dishes were observed.
