# BAT SURVEY REPORT

**Gorton Library  
Garratt Way  
Gorton  
M18 8HE**

Manchester City Council

Date: January 2019 – *updated Sept 2022*

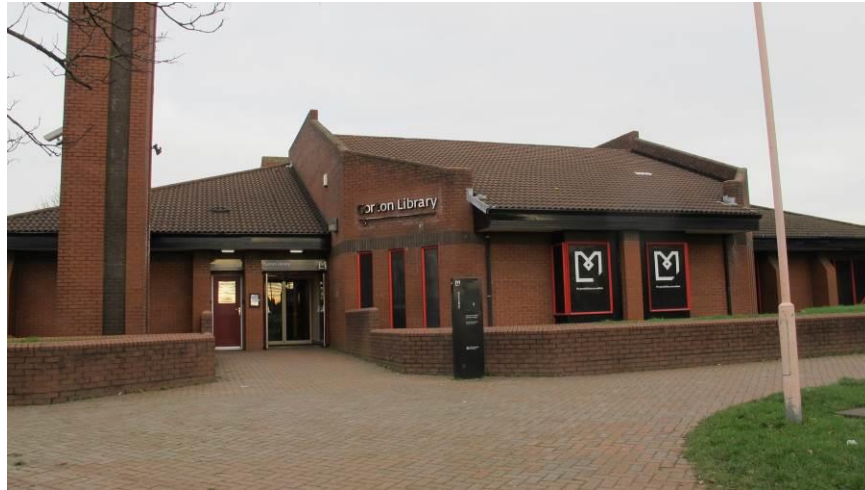
- 4.2** The building which is to be demolished comprises a single storey brick building. The building is complex, and has a multi-hipped roof covered in concrete overlapping roof tiles. The hip and ridge tiles are also concrete. The windows of the building are covered in a metal mesh. Fascia boards and boxed cornices are present around the base of the roof line, which are wooden. A brick chimney and single storey brick structure with a single sloping roof is present at the rear of the building, this houses the boiler and heating system. There are vents within the structure; however there is metal mesh inside the vent negating any access for bats. The building is currently in use as a library.

**Photo 1 — Building Surveyed**

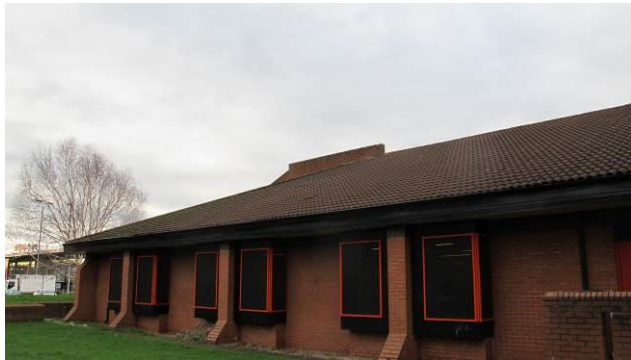
**Photo 2 – side of the building showing the Windows covered in mesh**

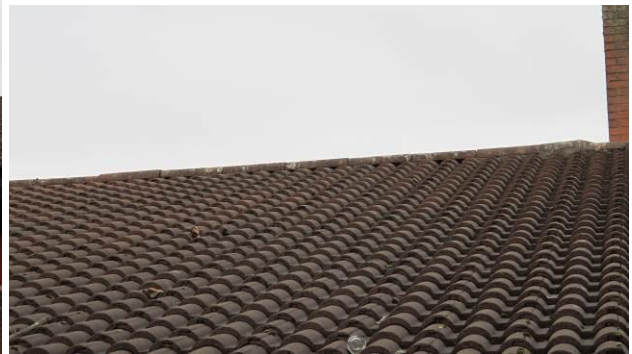
**Photo 3 – overlapping concrete tiled roof**

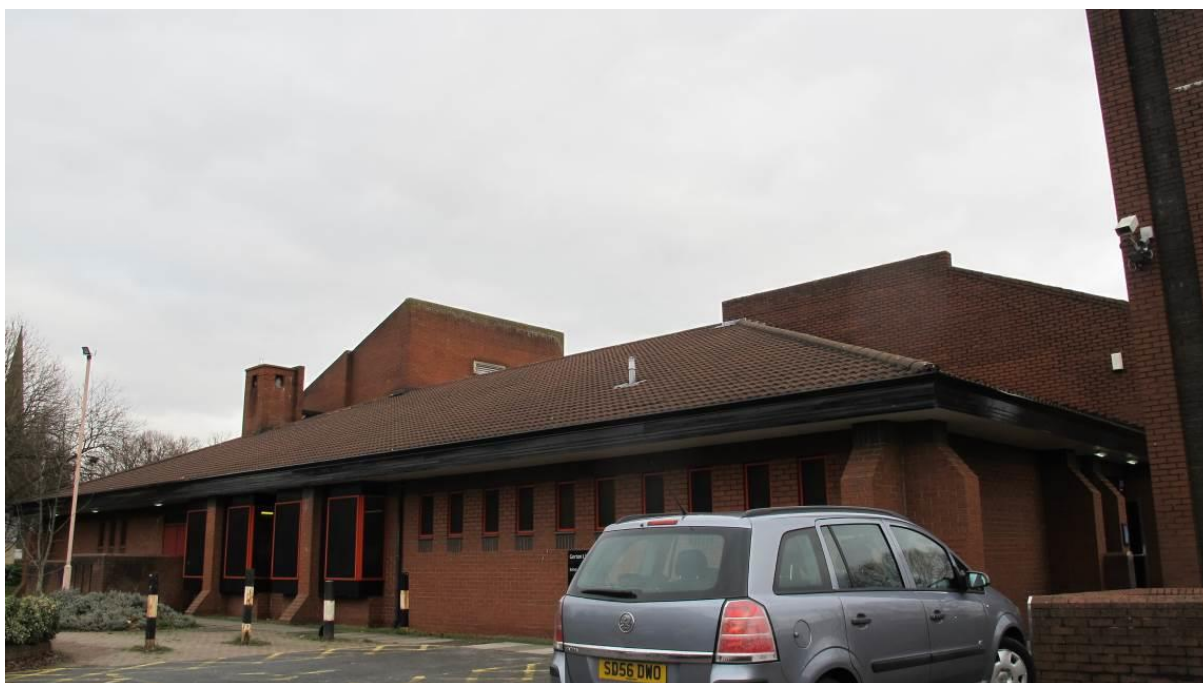
**Photo 4 – structure to the roof which houses the boiler and heating equipment**

- 4.5 Internal access was possible into the rear brick single storey structure and chimney. No bats or signs of bats were found in this section of the roof.

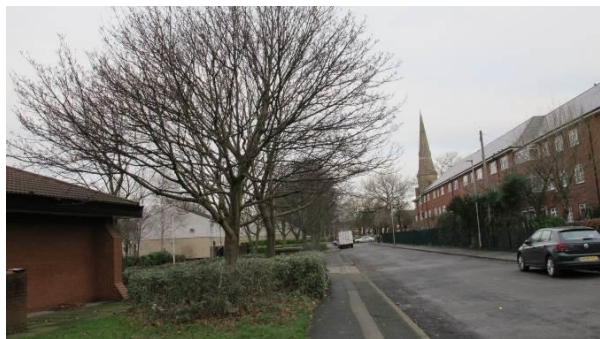
**Photo 5 – trees and shrubs**

The trees, beech hedge, and the shrubs that are present in the grounds have the potential to support nesting birds. All birds, with the exception of certain pest species, and their nests are protected under the terms of the Wildlife and Countryside Act 1981 (as amended). We would therefore recommend that the trees, hedge and shrubs should not be undertaken in the main bird breeding season (March to July inclusive). If this is not possible then we would recommend that the trees, hedge and shrubs be inspected by a suitably qualified ecologist prior to any works commencing.

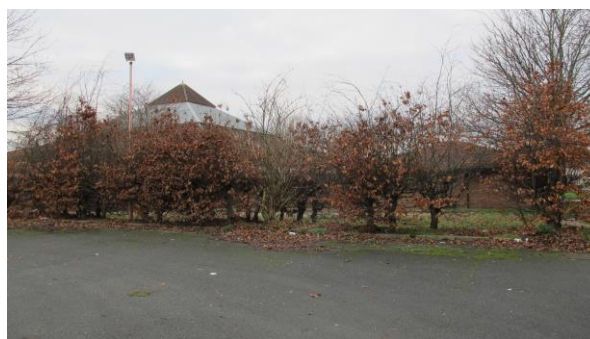
**Photo 6 – beech hedge**

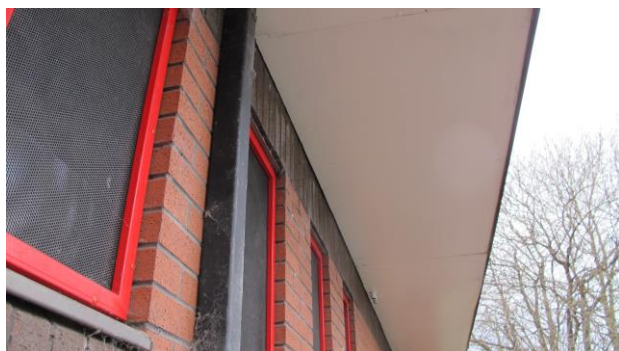
**Photo 7 – underside of the cornice**

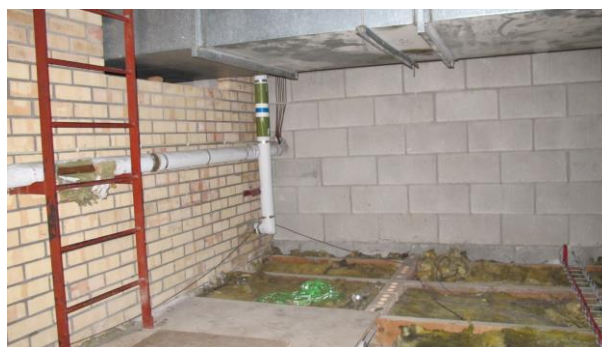
**Photo 8 – Internal view**

- 4.4 Internally it was not possible to access the roof space above the library as the building is still in use and in order to look inside the roof space, ceiling tiles would have had to be removed.
