# Francis Road- Withington Drainage Strategy

*For Step Place and Southway Housing Trust*

*Date:* 14 November 2022

*Doc ref:* 26721-HYD-XX-XX-RP-C-0500

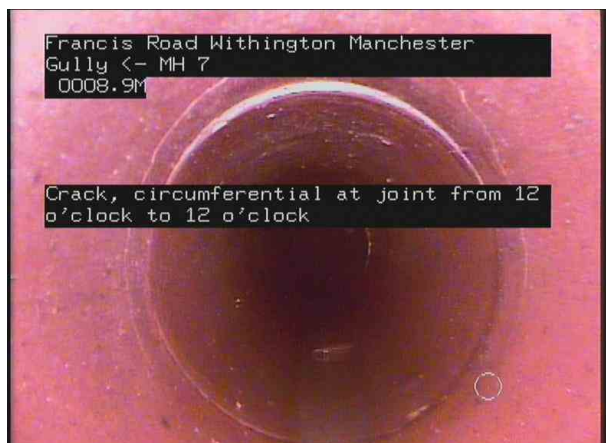
GullyX\_536c09ae-1472-4357-b9f2-305f556a547e\_20210826\_122022\_207.jpg, 00:01:24, 8.90 m  
 Crack, circumferential at joint from 12 o'clock to 12 o'clock

Circumferential crack at 8.9mtrs and root mass ingress at 11.5mtrs.

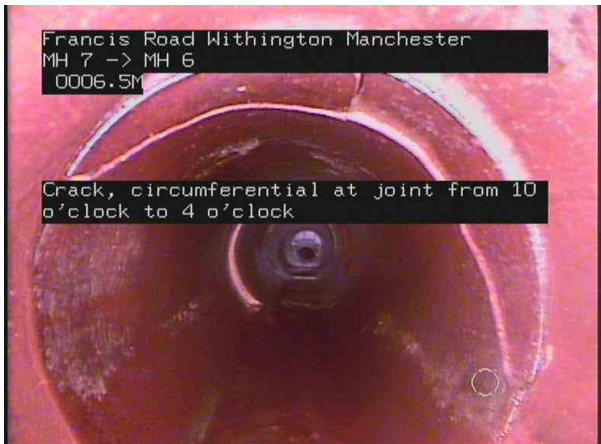
MH  
 7X\_25292549-40df-401b-9bab-38cd316439f5\_20210826\_122  
 433\_611.jpg, 00:00:58, 6.50 m  
 Crack, circumferential at joint from 10 o'clock to 4 o'clock

Cracked pipework at 6.5, 7.9 and 9.2mtrs.

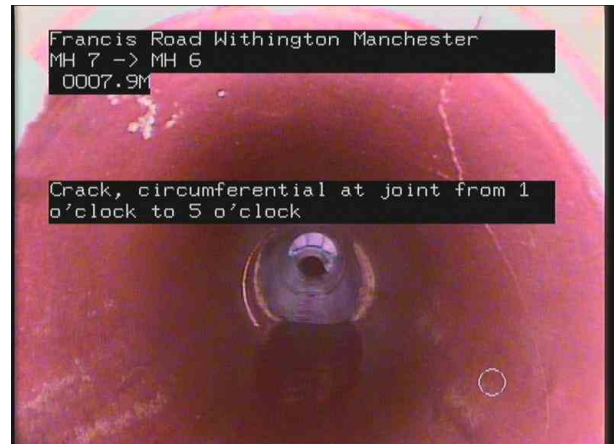
MH  
 7X\_89b47a5e-344b-4ec8-8955-deaf61bfc5f2\_20210826\_1225  
 02\_691.jpg, 00:01:17, 7.90 m  
 Crack, circumferential at joint from 1 o'clock to 5 o'clock

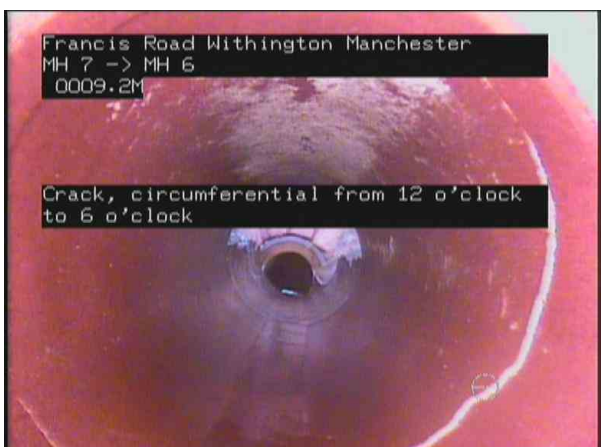
MH  
 7X\_c9e9c15c-2a03-4162-b3da-067901e5d981\_20210826\_12  
 2523\_300.jpg, 00:01:31, 9.20 m  
 Crack, circumferential from 12 o'clock to 6 o'clock

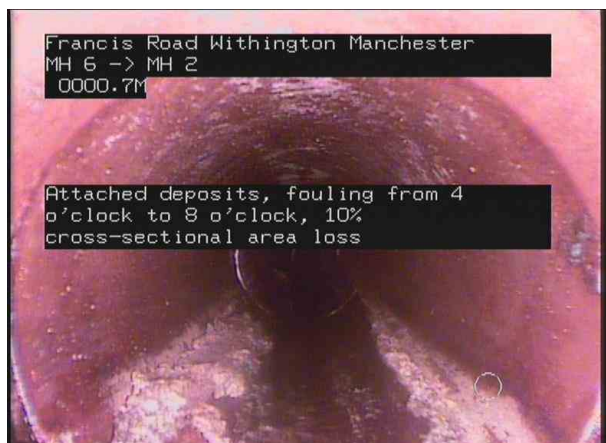
MH  
 6X\_baf85516-2245-4ef0-a9f2-7859f030d3a3\_20210826\_123152\_565.jpg, 00:00:21, 0.70 m  
 Attached deposits, fouling from 4 o'clock to 8 o'clock, 10% cross-sectional area loss

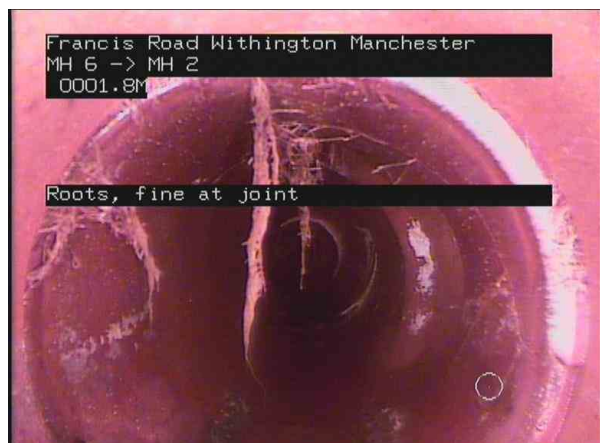
MH  
 6X\_d6fb424a-92dd-4075-b6e5-791b967800ee\_20210826\_123208\_276.jpg, 00:00:34, 1.80 m  
 Roots, fine at joint

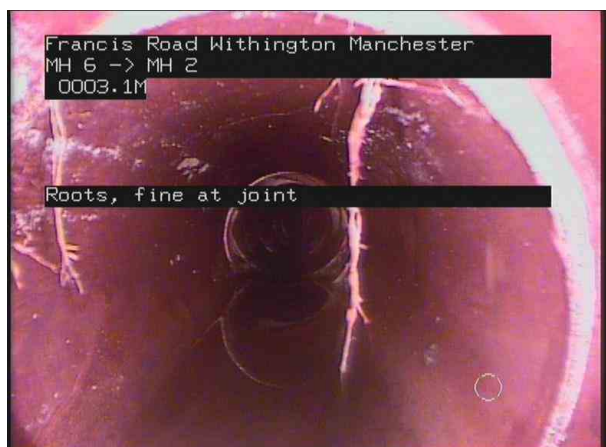
MH  
 6X\_679ccf34-fa3f-4e8c-926d-a5e07571fd54\_20210826\_123234\_241.jpg, 00:00:52, 3.10 m  
 Roots, fine at joint

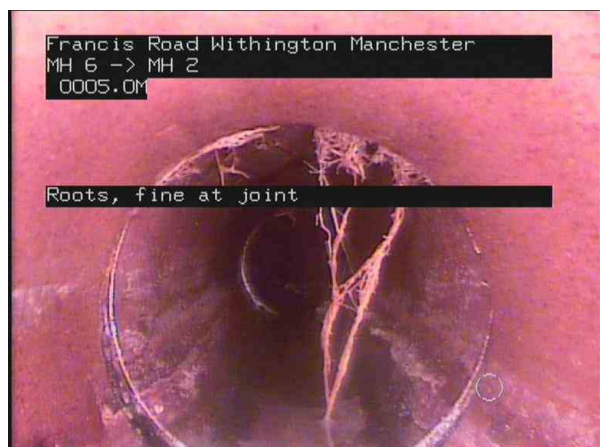
MH  
 6X\_2b885c12-c565-4404-ab17-ac78dacc094\_20210826\_123305\_219.jpg, 00:01:15, 5.00 m  
 Roots, fine at joint

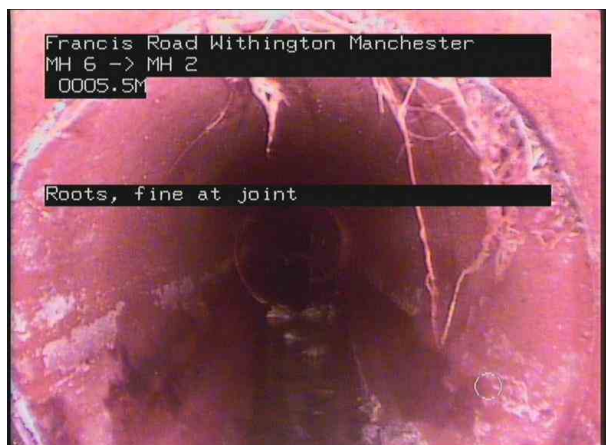
MH  
 6X\_0931c0aa-7d6c-4dae-9774-04790d09fdf7\_20210826\_123  
 316\_936.jpg, 00:01:24, 5.50 m  
 Roots, fine at joint

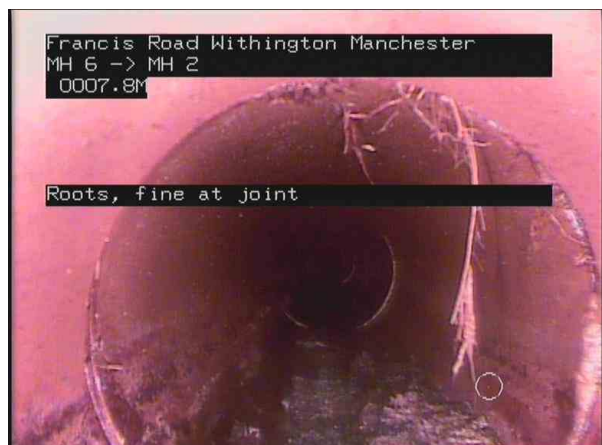
MH  
 6X\_0c4209a3-33c5-41f5-bea8-fe52815a97e0\_20210826\_123  
 345\_638.jpg, 00:01:44, 7.80 m  
 Roots, fine at joint

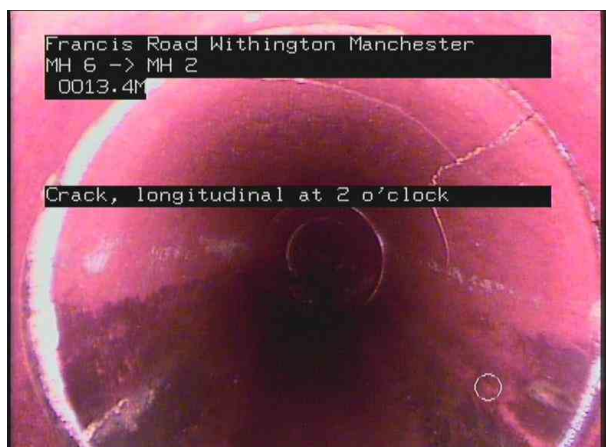
MH  
 6X\_ff37d770-b7c1-479b-9ce7-76d537fff7b8\_20210826\_12344  
 4\_706.jpg, 00:02:33, 13.40 m  
 Crack, longitudinal at 2 o'clock

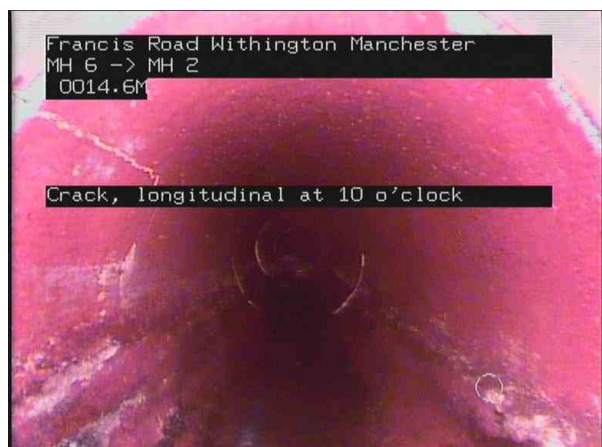
MH  
 6X\_00ad8361-1e3f-4166-ae31-f61304383bb2\_20210826\_123  
 501\_064.jpg, 00:02:47, 14.60 m  
 Crack, longitudinal at 10 o'clock

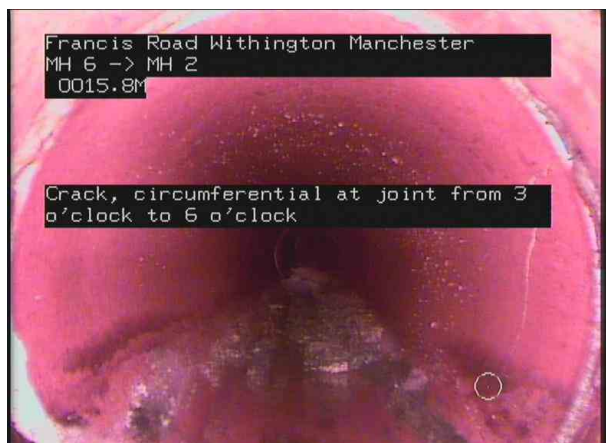
6X\_e716a756-a220-4878-9262-45918efdc0b1\_20210826\_123  
 522\_841.jpg, 00:02:59, 15.80 m  
 Crack, circumferential at joint from 3 o'clock to 6 o'clock

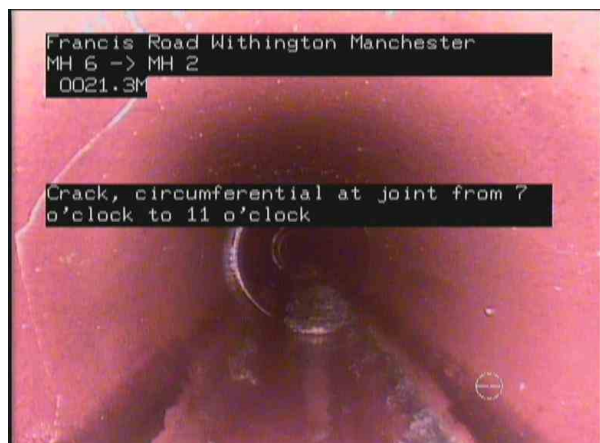
6X\_4a4f01c4-5e6a-4c4c-93da-55acb35d9eeb\_20210826\_123  
 621\_885.jpg, 00:03:44, 21.30 m  
 Crack, circumferential at joint from 7 o'clock to 11 o'clock

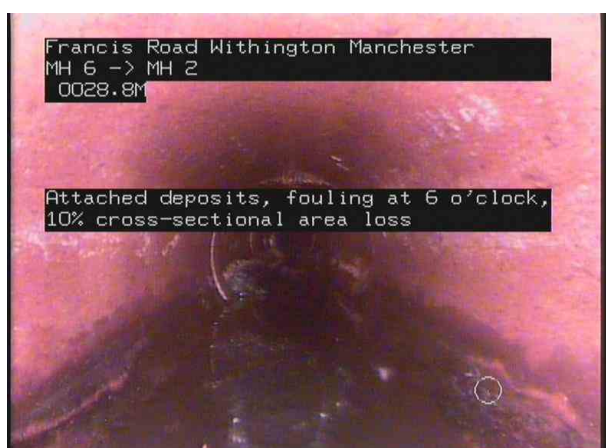
6X\_af82ac79-bb1e-4a9c-a9ae-e427c802b737\_20210826\_123  
 855\_312.jpg, 00:06:06, 28.90 m  
 Attached deposits, fouling at 6 o'clock, 10% cross-sectional  
 area loss

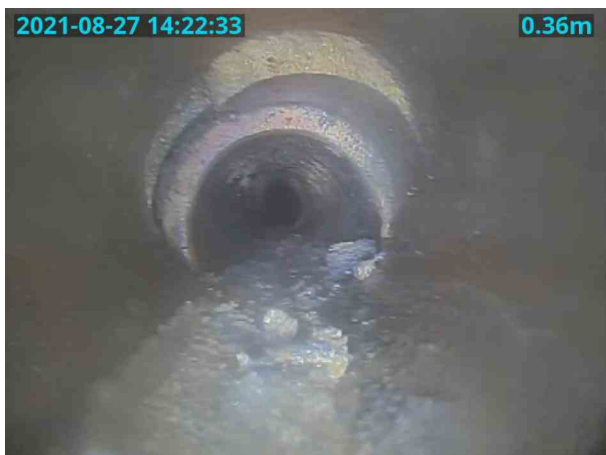
Branch  
 AX\_ad256bea-f4bc-4946-8a56-98df24e15d9c\_20210831\_135  
 028\_248.jpg, 00:00:07, 0.36 m  
 Joint displaced, large

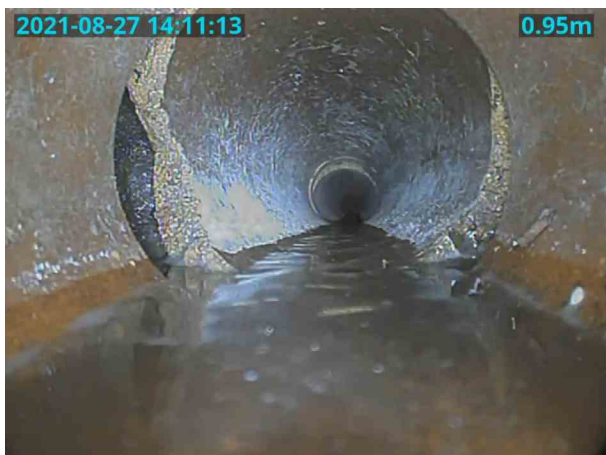
MH  
 8X\_a92836fb-08e2-4164-8299-4596a40a9081\_20210901\_14  
 5602\_292.jpg, 00:00:10, 0.95 m  
 Broken pipe at joint from 6 o'clock to 9 o'clock

Broken pipe at 0.95mtrs and fine roots at 4.73mtrs.

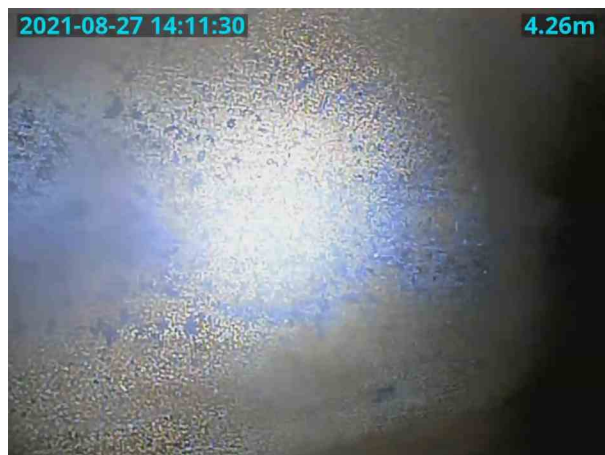
MH  
 8X\_8cf54694-6979-4a55-a66e-17afe0e18629\_20210901\_145  
 653\_452.jpg, 00:00:27, 4.26 m  
 Finish node, major connection without manhole, reference: MH  
 7

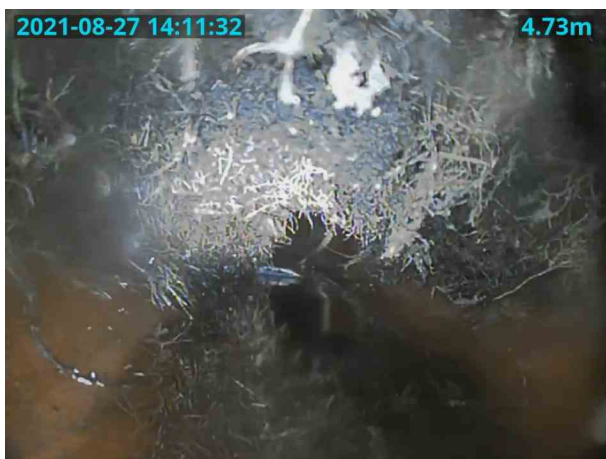
MH  
 8X\_c7efd044-e13a-41ee-a0d0-93e8ff13e98e\_20210901\_1457  
 19\_708.jpg, 00:00:30, 4.73 m  
 Roots, fine

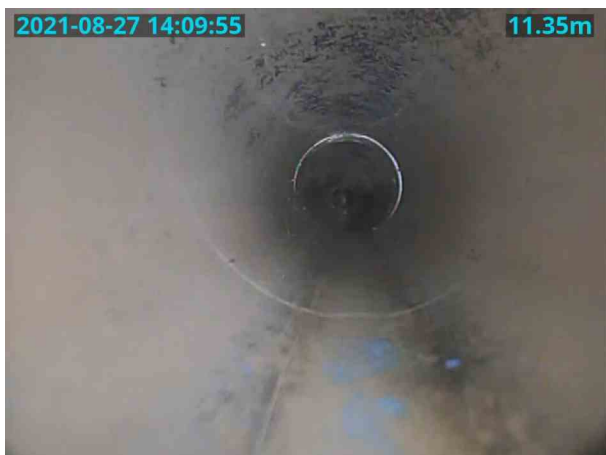
Branch  
 AX\_fa7d7cbc-cd8b-4926-82d2-457244cd1665\_20210901\_150  
 029\_987.jpg, 00:00:34, 11.35 m  
 Crack, circumferential from 12 o'clock to 12 o'clock

| Description | Qty | Rate | Price Total |
|---|---|---|---|
| Install 3 x 100mm diameter localised repairs at 11.35, 13.01 | 1.00 | | £1,378.00 |

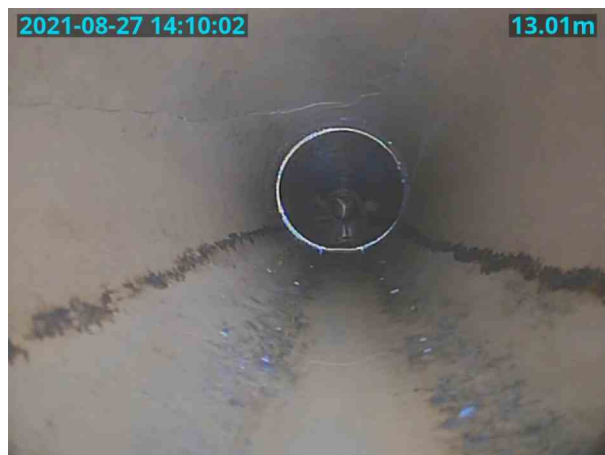
Branch  
 AX\_355f8f57-bb75-4385-89c4-08d93d51f94c\_20210901\_150  
 109\_250.jpg, 00:00:41, 13.01 m  
 Cracks, spiral from 8 o'clock to 1 o'clock

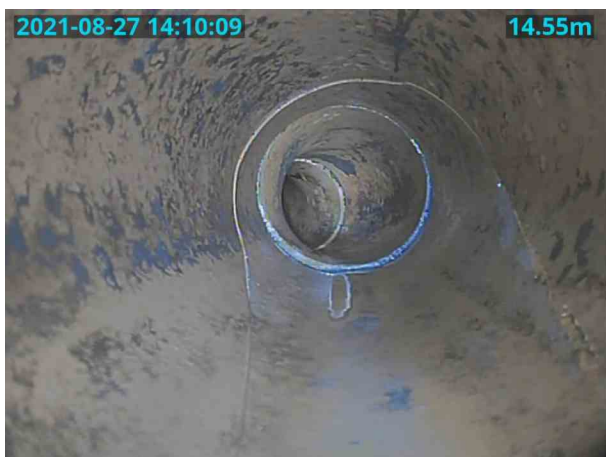
Branch  
 AX\_0926991d-9f18-47d7-b176-fb91759953fe\_20210901\_150  
 130\_870.jpg, 00:00:48, 14.55 m  
 Crack, circumferential from 12 o'clock to 12 o'clock

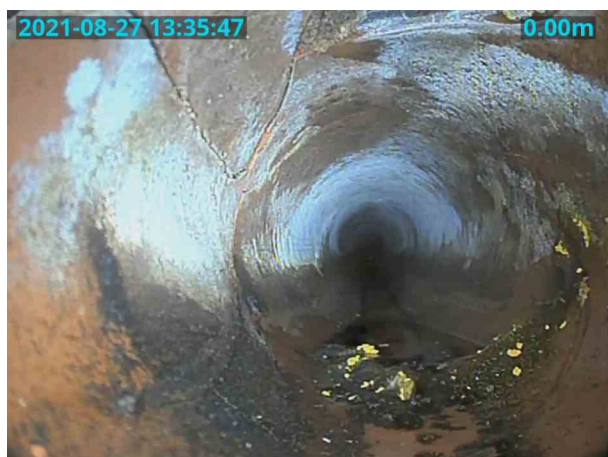
Branch  
 AX\_25e6c52b-56fe-439b-b680-e8e6e77cfe4a\_20210901\_154  
 701\_639.jpg, 00:00:03, 0.00 m  
 Crack, circumferential from 9 o'clock to 2 o'clock

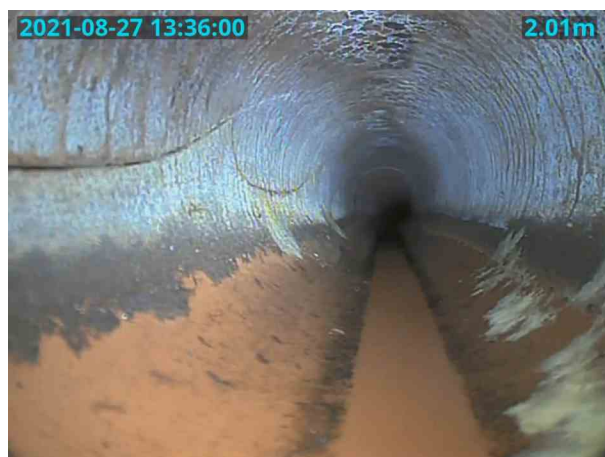
Branch  
 AX\_6146da81-8ca1-470e-ad6c-73b35c180b2b\_20210901\_15  
 4734\_671.jpg, 00:00:16, 2.00 m  
 Crack, longitudinal at 9 o'clock, start
