# PHASE 2 SITE INVESTIGATION

Mayfield Plot M

U+I Group

09 December 2019

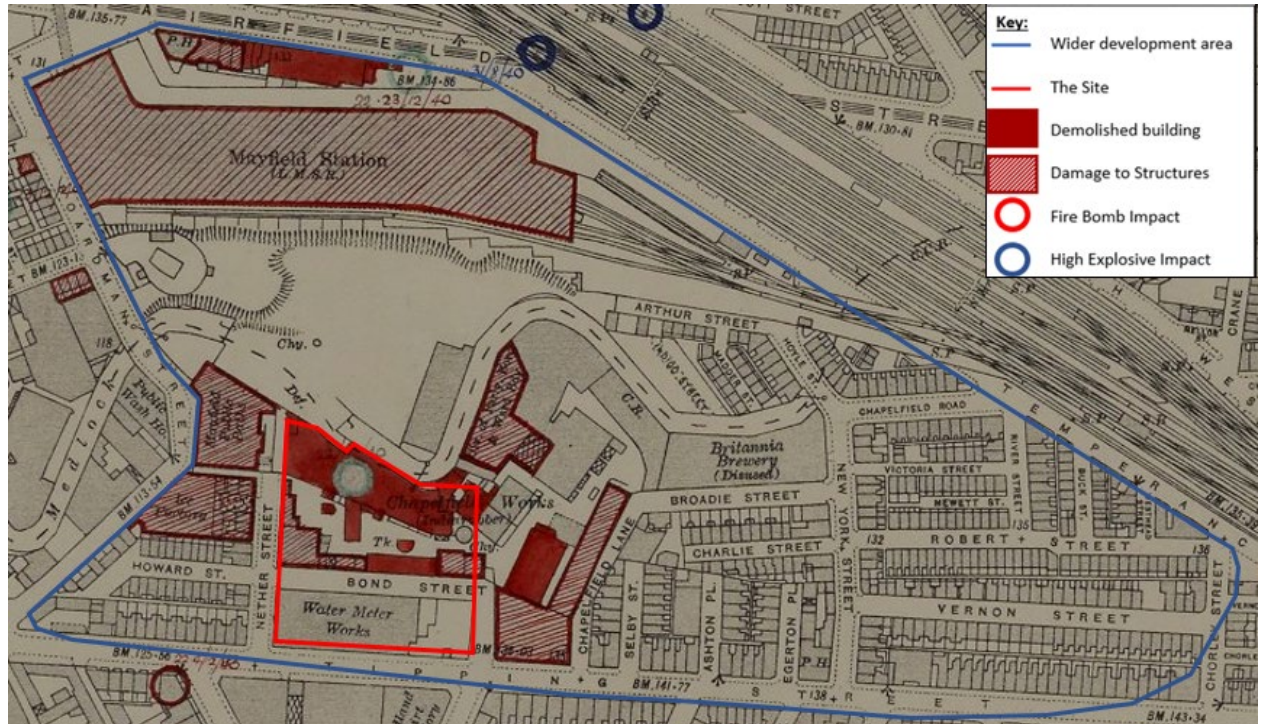
**Figure 3.1: Manchester Bomb Map**

- 3.3.5 A waste transfer station is located immediately 100m east of the site, with a scrap yard located beyond Hoyle Street Industrial Estate.
- 3.3.6 Public records of Manchester bombings were consulted for the site, showing records of high explosive impacts in the area of Piccadilly Station and extensive damage to structures and demolition across the wider Mayfield development, as illustrated in Figure 3.1 below.
