Project Title CSM - Whiteley Hall  
Client Chetham's School of Music  
Location Manchester

Drawing Title Typical Ceiling Detail

9357 BA ZZ 1F DR A (27)001 P2

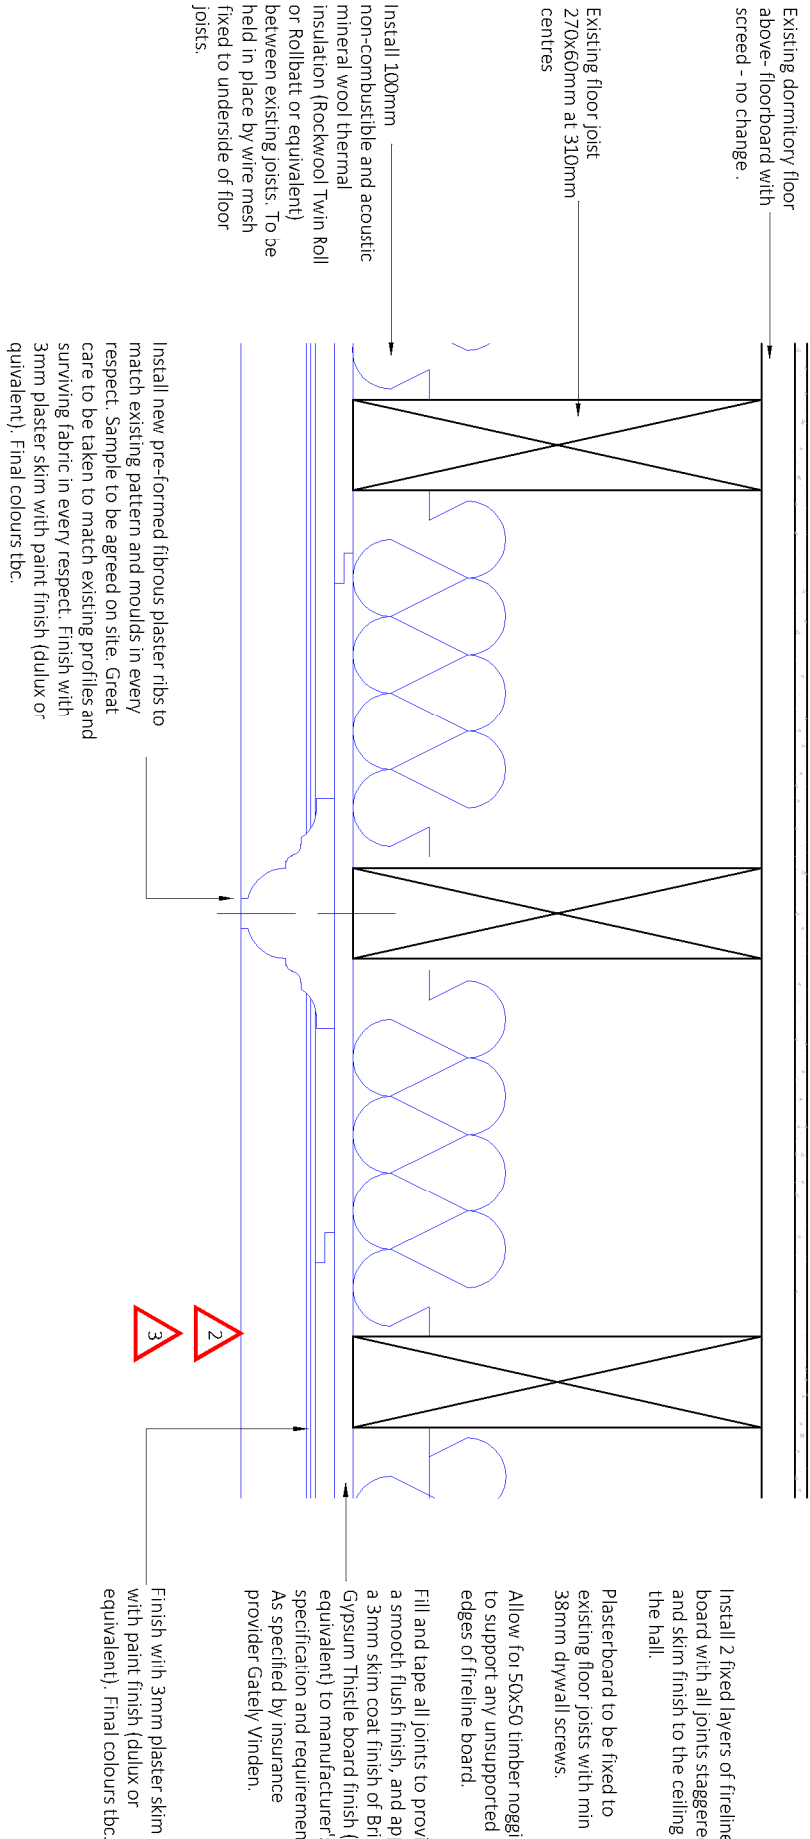
Proposed Detail A - Typical Ceiling Detail 1:5

- Existing fabric to be removed.
- Proposed fabric to be installed.
