9 DOLPHIN STREET  
MANCHESTER

OVERARCHING GEO-ENVIRONMENTAL  
ASSESSMENT REPORT

**Job Number:** LKC 22 1483

**Date:** October 2022

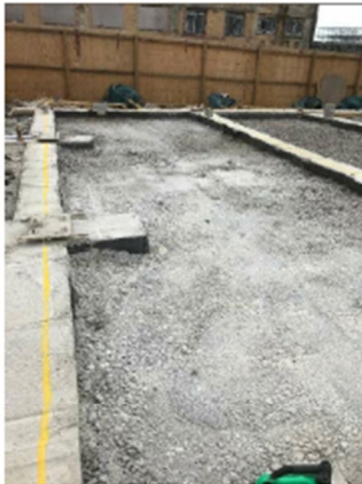
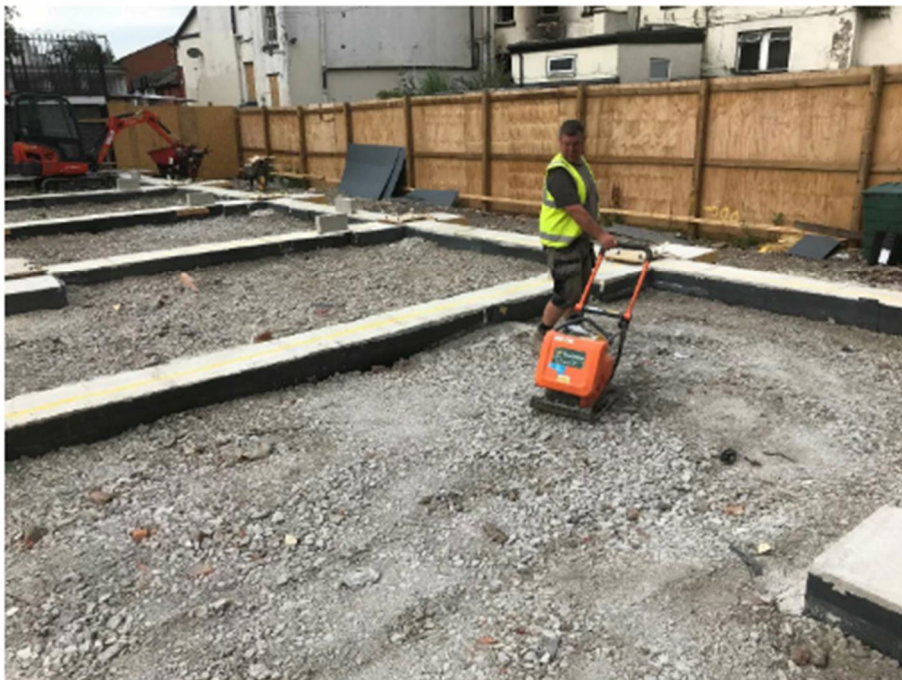
CLEAN MOT BEING INSTALLED

LKC understands that during the enabling works the upper 600mm of ground was excavated and removed from site and replaced with imported MOT Type 1 gravel. Photographs provided by the client are presented in Plate 4-1 below:

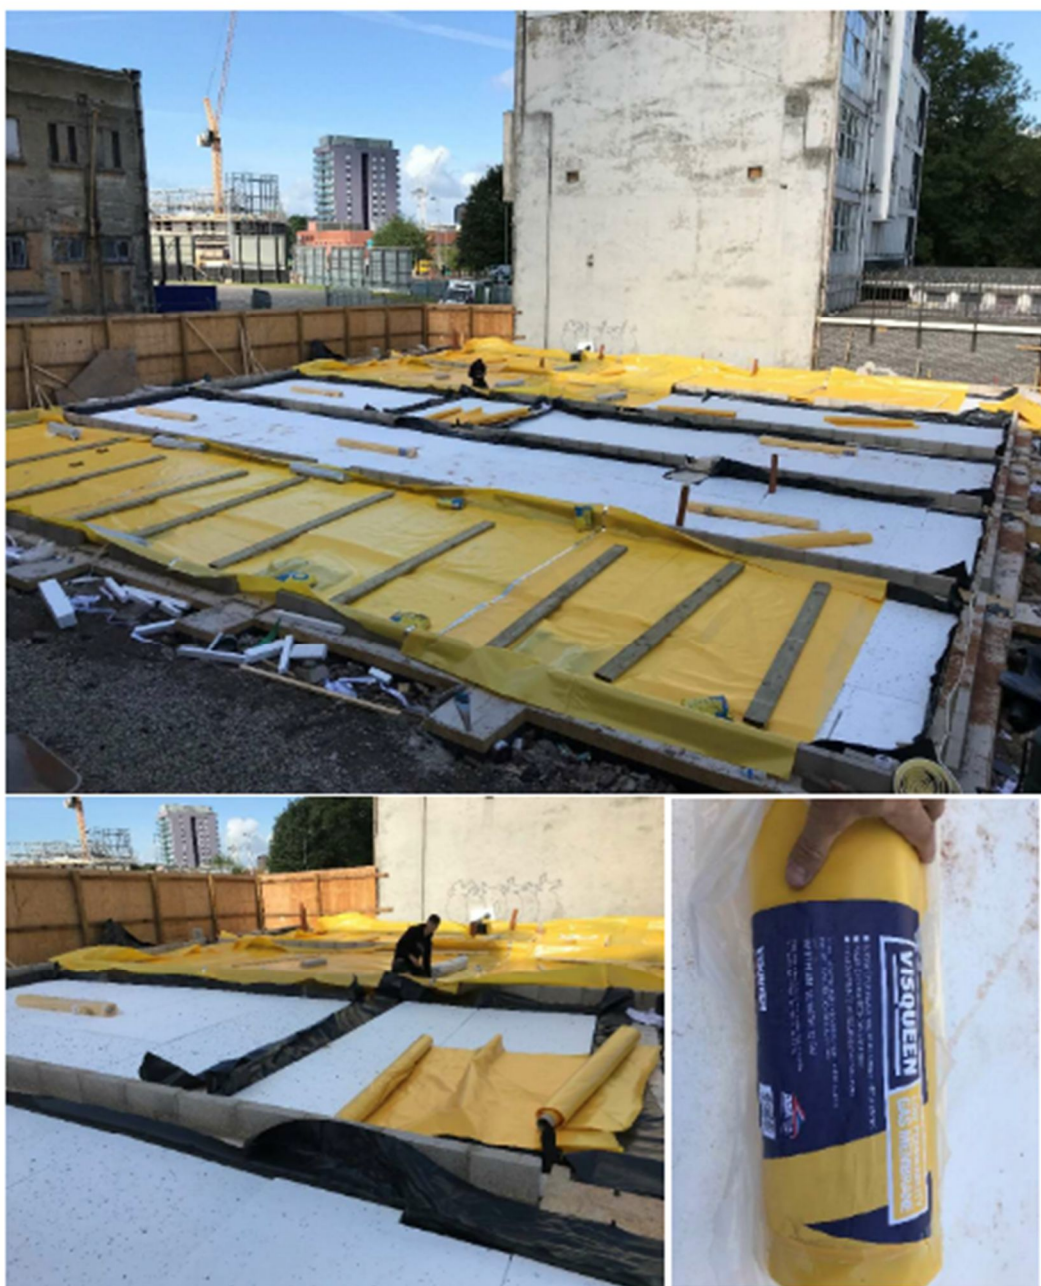
Plate 4-2: Membrane installation photographs.

As part of the construction works, a Visqueen gas membrane was installed as per manufacturer's guidance beneath the cast in-situ floor slab. Photographs provided by the client are presented on Plate 4-2 below.

Given the ground conditions encountered and the presence of a gas membrane, LKC considers the probability of gas posing a risk to site users as unlikely. The consequence is severe, which gives a moderate / low risk. LKC considers there to be a low risk and no further action is required with respect to pollutant linkage 3.

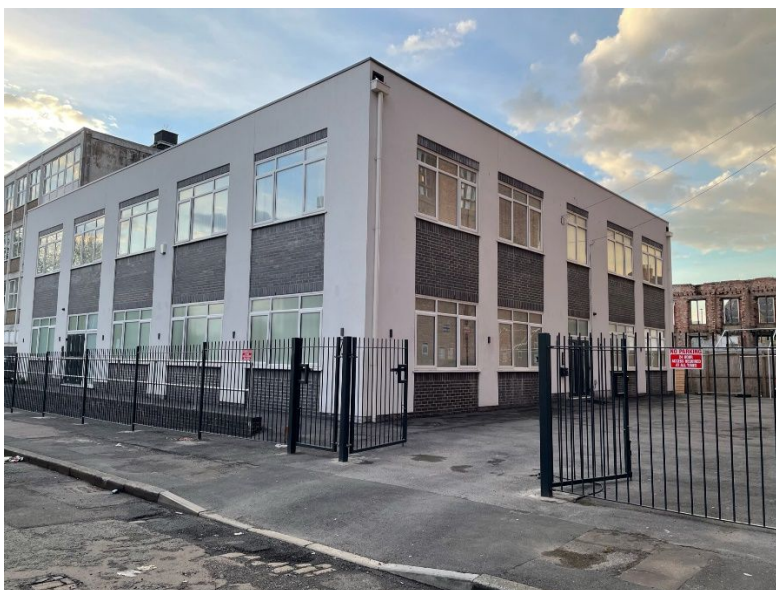
Plate 4-3: Photograph of completed development.

The site has been developed as a two storey brick building. The building is approximately 1.0m higher than Dolphin Street. External areas are surfaced with tarmac. A storage container is present to the rear of the building on the northern part of the site. The eastern part of the site is used as a car park. The site is secured with metal and wooden fencing and bounded to east and west by multi-storey buildings.
