Manchester City Council

**Victoria North Infrastructure  
Works**

**Ground Investigation Interpretative  
Report**

VNIF-ARP-ZZ-YYY-RP-CG-0009

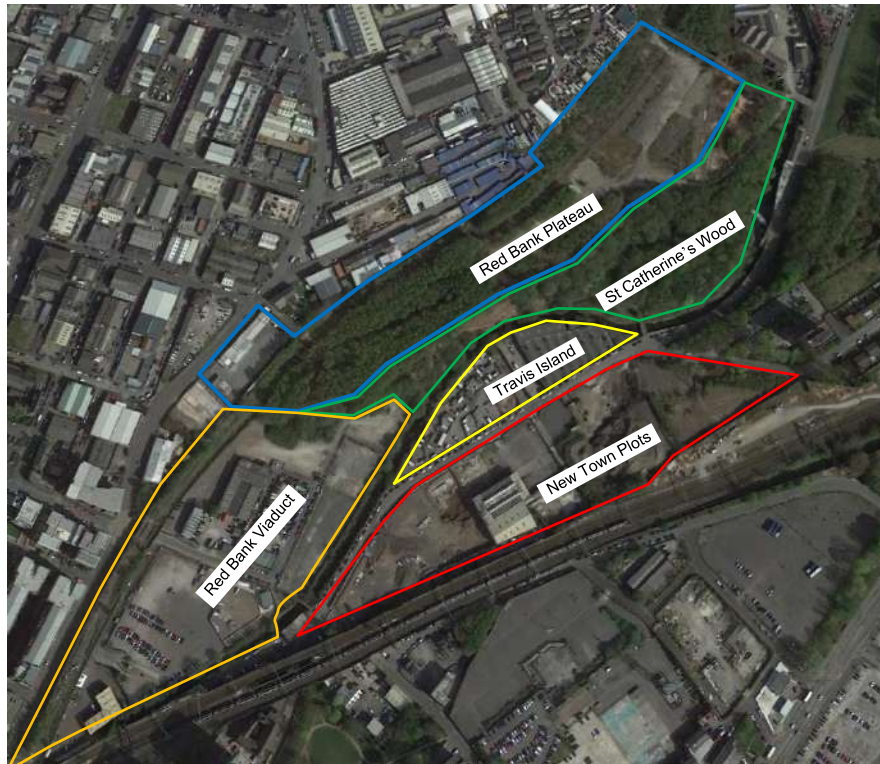
**Figure 2:** The site areas as discussed in the GIR.

The majority of the boundary between Red Bank Plateau and the St Catherine's Wood area (**Figure 2**) is marked by the crest of a series of steep slopes which are generally between 9m and 13m high and locally approach gradients of 1v to 1.6h (Slopes B1 and B2, **Figure 4**). The exception to this is in the north of St. Catherine's Wood adjacent to Slope B1, where Plot RB05b, is proposed in the area above and to the west of the existing steep slopes. Ground levels across the plot vary between c. 43m AOD in the south to c. 41.5m AOD in the north (over a distance of approximately 100m).

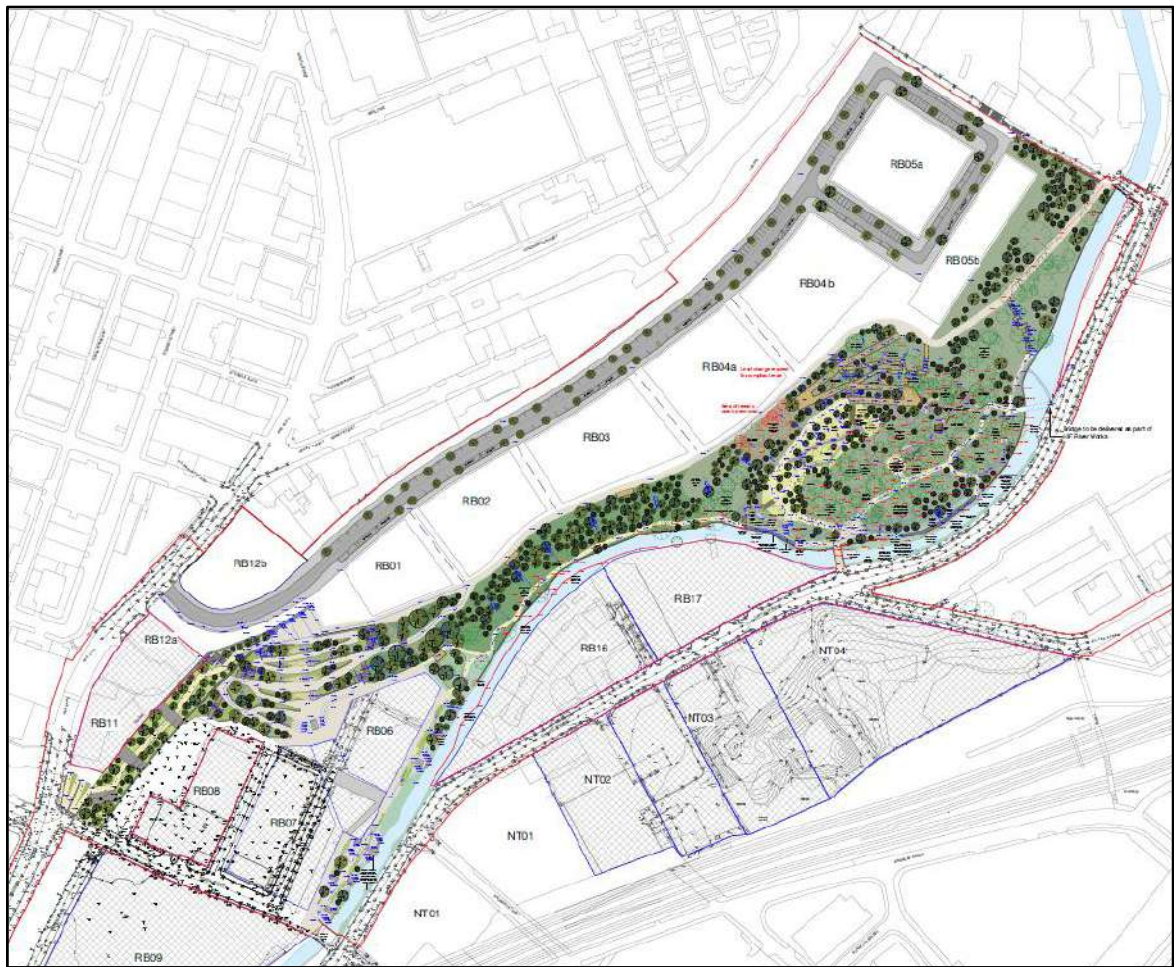
**Figure 3:** HIF Infrastructure Works masterplan

Ultimately, the HIF IW planning application site is to be developed for a predominantly residential use with landscaped areas of public open space. The development plot areas and the landscaping are described in the current proposed masterplan presented in **Figure 3**.

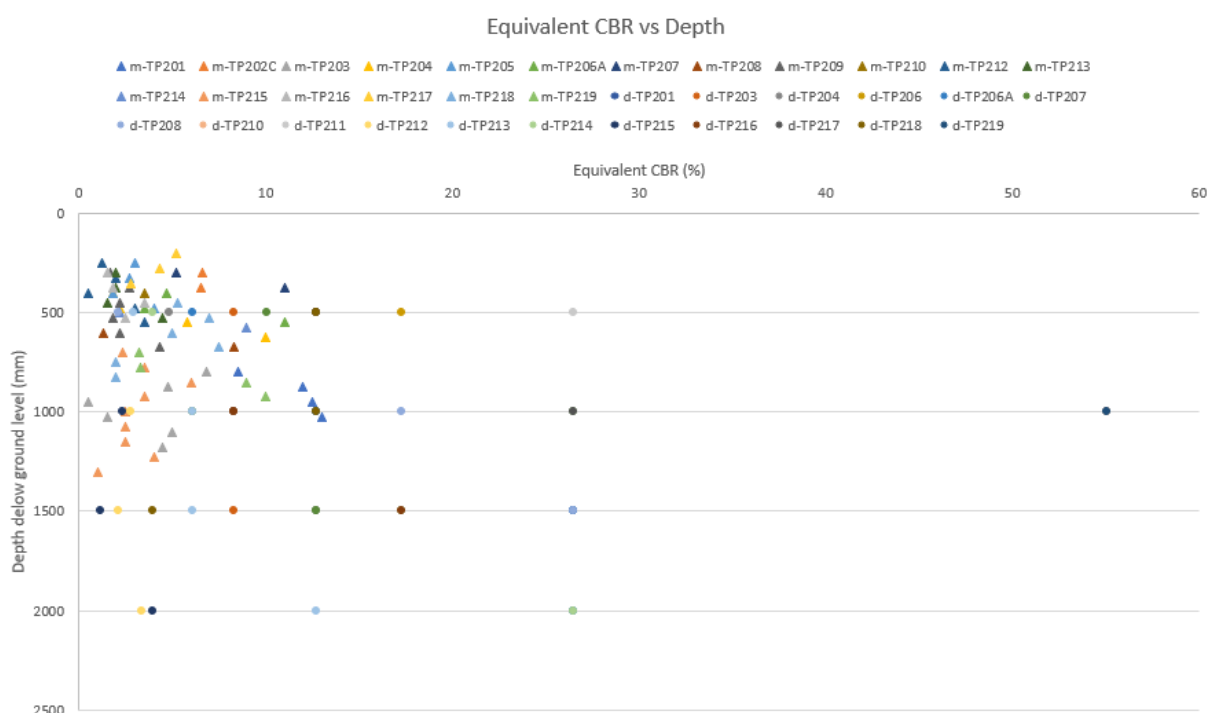
At depths of 500mm, 1000mm, 1500mm and 2000mm below ground level the average equivalent CBR recorded are 9.7%, 16.8%, 13.4% and 14.6% respectively. Outlier results greater than 100% have been excluded from the data analysis. Values from the DCP tests show that the equivalent CBR of the made ground generally increases with depth, however it should be noted that at depth, several tests terminated early due to obstruction so data from depth is relatively limited. Plate load testing should be used to verify formation strength.

**Figure 10:** Equivalent CBR vs depth based on in-situ mexeprobe and DCP results

By inspection, on the basis of the in-situ test data presented in **Figure 10**, it is anticipated that a CBR value of 2% ( $k_{762} = 22 \text{ MN/m}^3$ ) or greater can be anticipated across the sub-formation.
